NASA  
Technical Memorandum 4195

# Evaluation of Composite Components on the Bell 206L and Sikorsky S-76 Helicopters

Donald J. Baker

AUGUST 1990

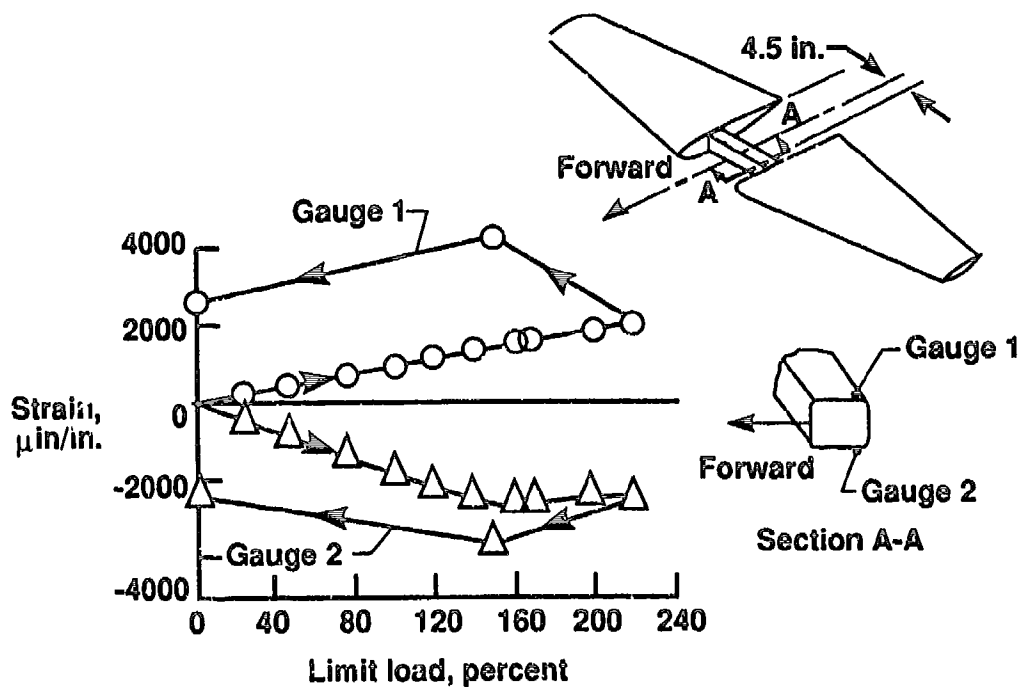
a function of percent limit load are shown in figure 29. The tension strain response was linear up to 160 percent of the design limit load (DLL) and then increased at reduced slope until the maximum applied load of 220 percent of the DLL was reached. The compression strain response was linear to 120 percent of the DLL and then increased at a reduced slope until 170 percent of the DLL was reached. The compression strain did not increase after 170 percent of the DLL. At 220 percent of the DLL the stabilizer made a loud "snap" and the load dropped to 150 percent of the DLL. Attempts to increase the load beyond 150 percent of the DLL resulted in an increased deflection until the test fixture limit was reached. Visual inspection of the stabilizer indicated a buckle in the splice plate on the left-hand leading edge of the torque box. A teardown of the component revealed a loss of shear transfer capabilities between the composite material and the metal honeycomb. The stabilizer tested for certification did not fail but reached the maximum deflection allowed by the fixture at 268 percent of DLL.

Figure 29. Strain as a function of limit load on the S-76 stabilizer.

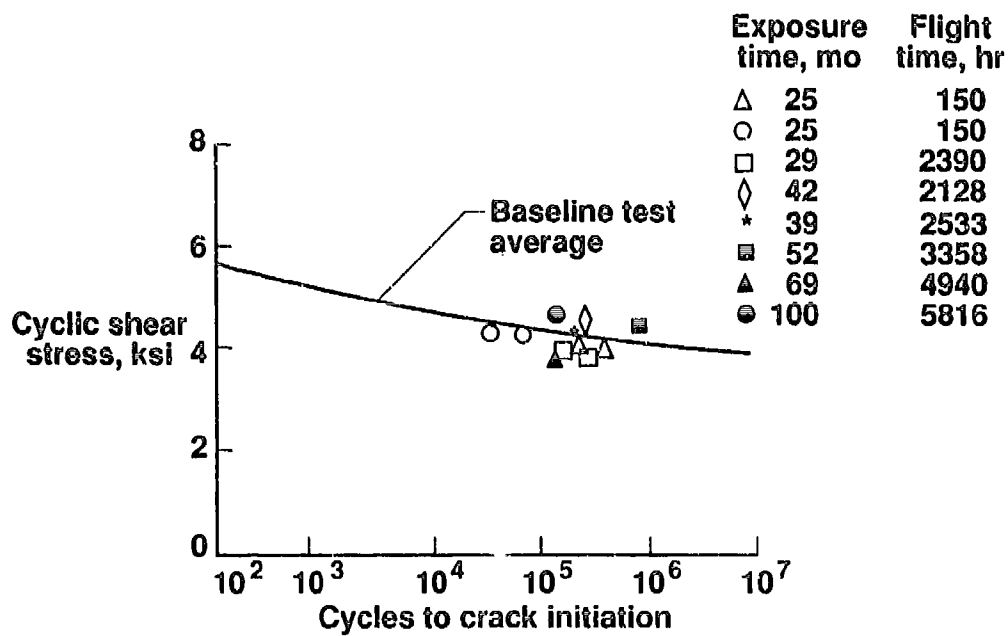
**Tail rotor spars:** Eleven tail rotor spars have been removed for testing. No defects were found during inspections of the spars. Seven of the spars were fatigue tested and the remaining spars were used to obtain specimens for coupon tests. A summary of data for the tail rotor spars is given in table 7 along with data from spars labeled serial numbers 00046 and 00064 (ref. 5). These two spars were removed from a Sikorsky flight test aircraft that was located at West Palm Beach, Florida. The points designated by "First" in table 7 represent the first fracture on one side of the spar. On spars that did not have a complete failure, testing was continued on the other side until fracture occurred, and those results are designated by "Last." Cyclic shear stress as a function of cycles to crack initiation is shown in figure 30 along with the strength of dry spars tested at room temperature for FAA certification. These results indicate a 94-percent strength retention for the exposed spars when compared with strength data from certification tests.

Figure 30. Effect of service environment on S-76 composite tail rotor spurs.
