INVESTIGATION INTO THE FAILURE CAUSE OF A  
DOUBLE ACTING, LEADING EDGE GROOVE,  
TILTING PAD THRUST BEARING

Brian K. Peterson  
Technology Branch  
Turbine Engine Division

October 1990

AERO PROPULSION AND POWER LABORATORY  
WRIGHT RESEARCH AND DEVELOPMENT CENTER  
AIR FORCE SYSTEMS COMMAND  
WRIGHT-PATTERSON AIR FORCE BASE, OHIO 45433-6563

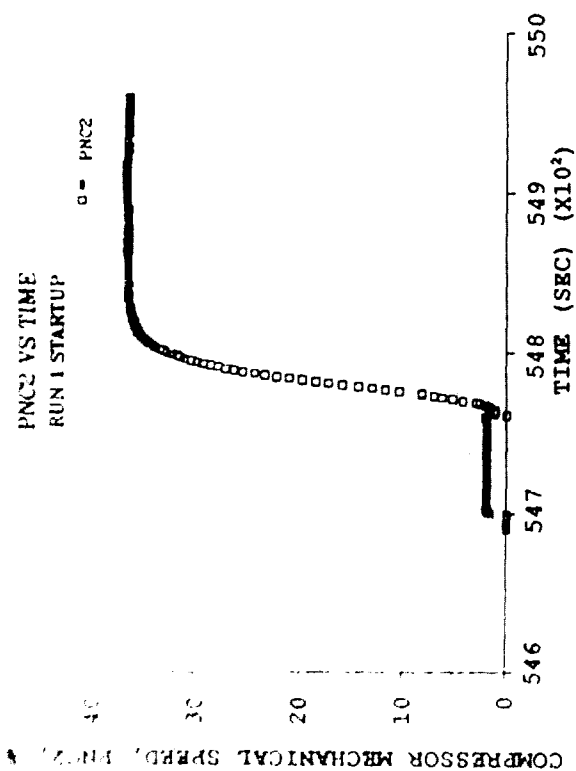
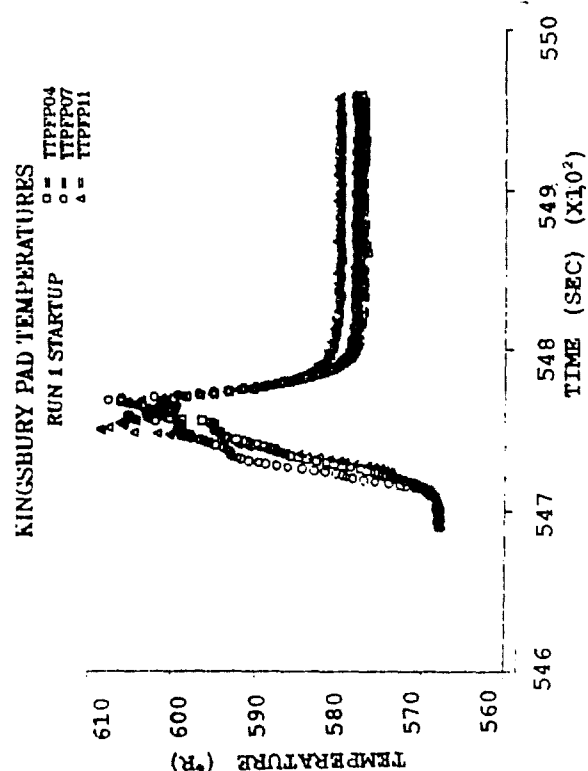
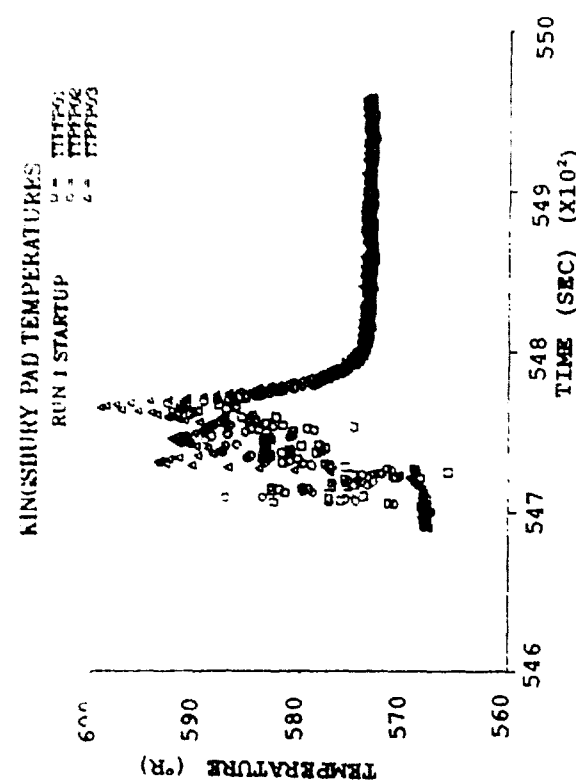
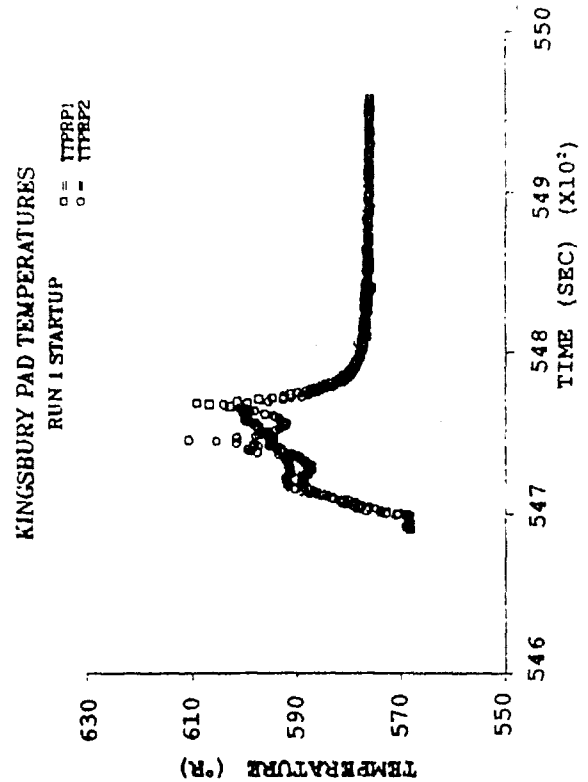
Figure 4.4 Compressor Bearing Speed and Temperature

Thermocouples in the forward and rear bearing pads indicated elevated temperatures and increased bearing stress during compressor start, followed by reduced temperatures occurring when the compressor was throttled above starting speed. This is best illustrated during the first start of the compressor. Plots of speed vs. time and bearing pad temperatures vs. time during the first start are provided in Figure 4.4. Increased bearing stress was observed on both front and rear bearing pads.

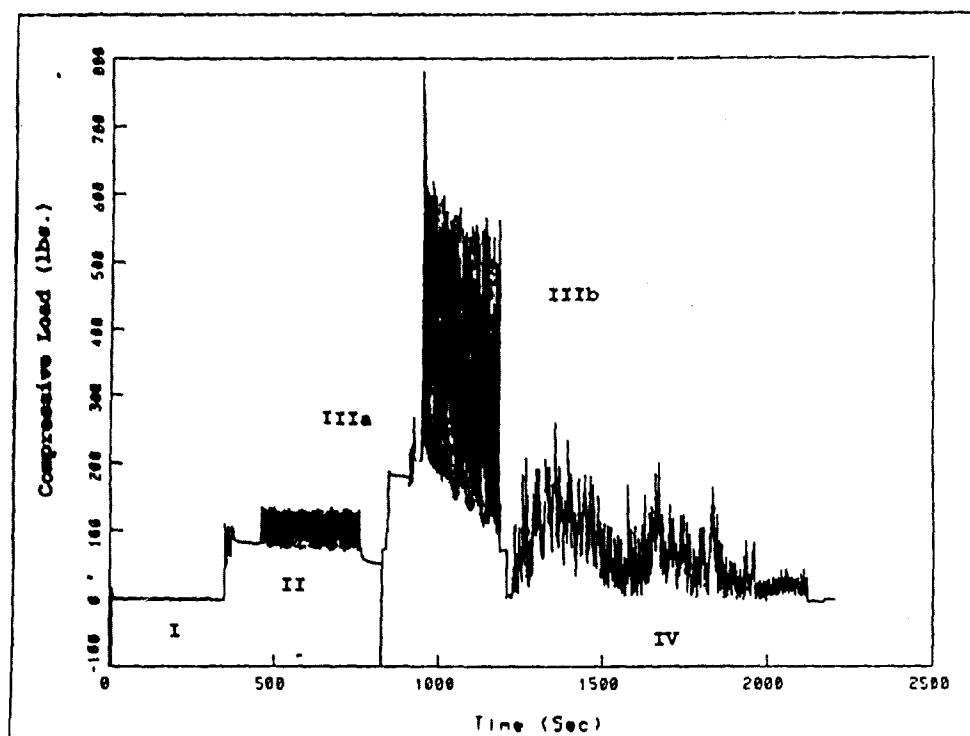
Figure 4.5 Compressive Load Cell Results - Bench Test 1

a. Test Data Results from the load cell measuring compressive load are presented in Figure 4.5. Each of the test segments listed in Table 1 are labeled in Figure 4.5.

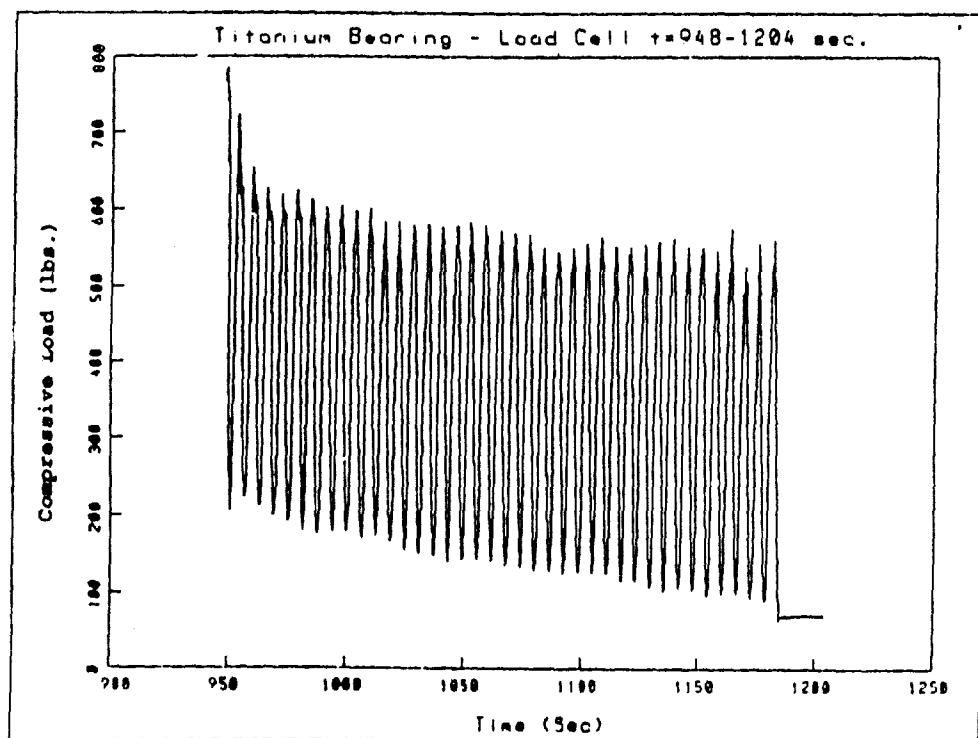
Figure 4.7 Compressive Load Cell Results - Test Segment III

(2) Test Segments III and IV Test segment III was divided into two portions, IIIa and IIIb, and is presented in Figures 4.7a and 4.7b. After approximately 20 seconds into segment III, enough torque was generated to turn the bearing pad slightly. The torque was caused by the radial variations in frictional load because of the change in thrust collar velocity and the distance slid with radial location. The test was halted and a stop was added to counteract the torque. Testing was restarted and the load cycle magnitude increased because of an increased offset in the thrust collar runout. Test segment III was not of sufficient duration to initiate babbitt fatigue.

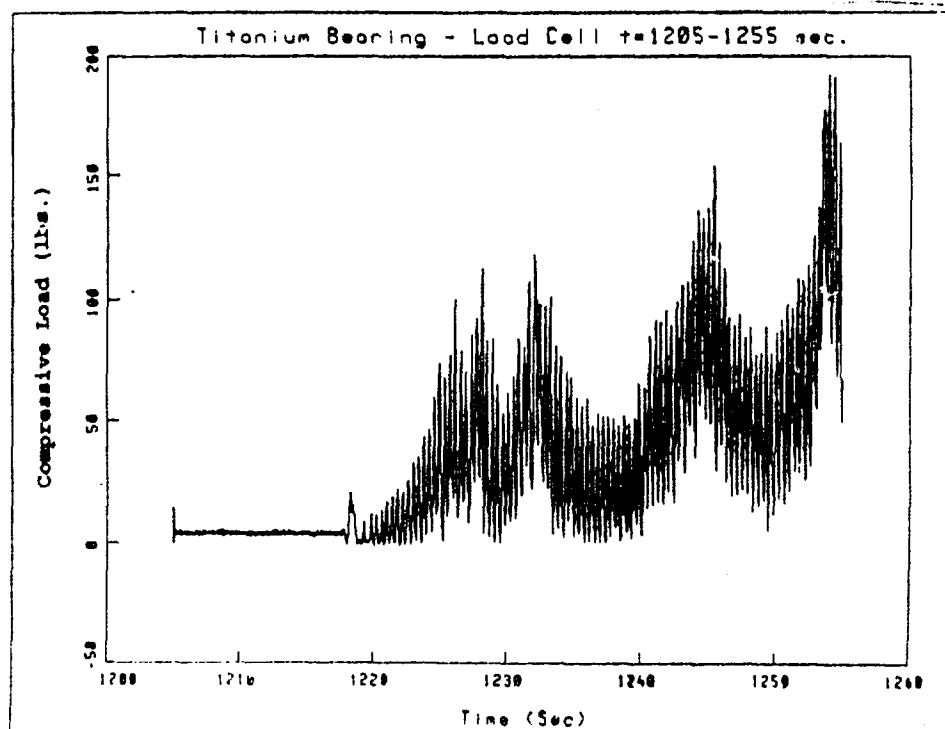
Figure 4.8 Compressive Load Cell Results - Test Segment IV

Load cell results from test segment IV are presented in Figures 4.8a and 4.8b. Bearing failure progressed rapidly during test segment IV because of the increased rotational speed and corresponding increased distance slid. Figure 4.8a presents the load cell data taken throughout test segment IV. Figure 4.8b presents the load cell data of the first 37 seconds of test segment IV. These figures show cyclic loading at three different frequencies. The most evident is the load cycle because of slight offset in the collar face runout, which has the highest frequency. The other two cycles do not have a constant frequency. The cyclic loading of the lowest magnitude frequency is evident in Figure 4.8a and is due to the clearing and generation of wear debris. The cyclic loading with the middle frequency is most visible in Figure 4.8b. Close examination of Figure 4.7b reveals that a frequency of the same order of magnitude was present

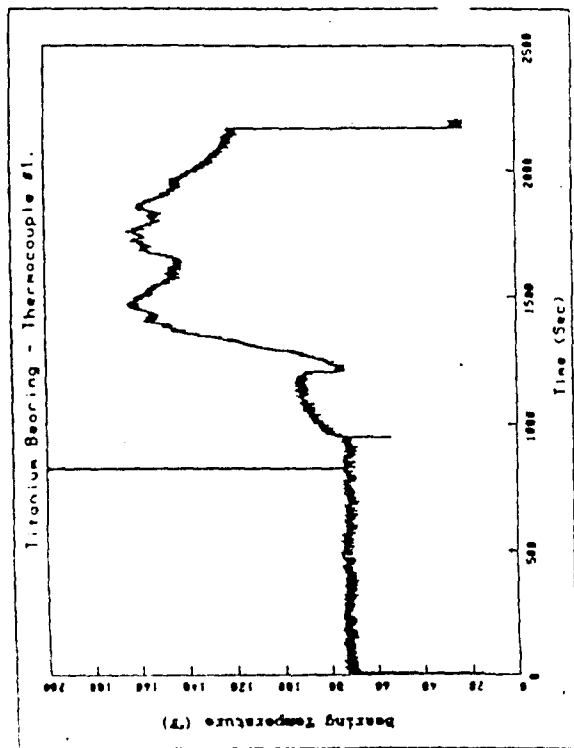
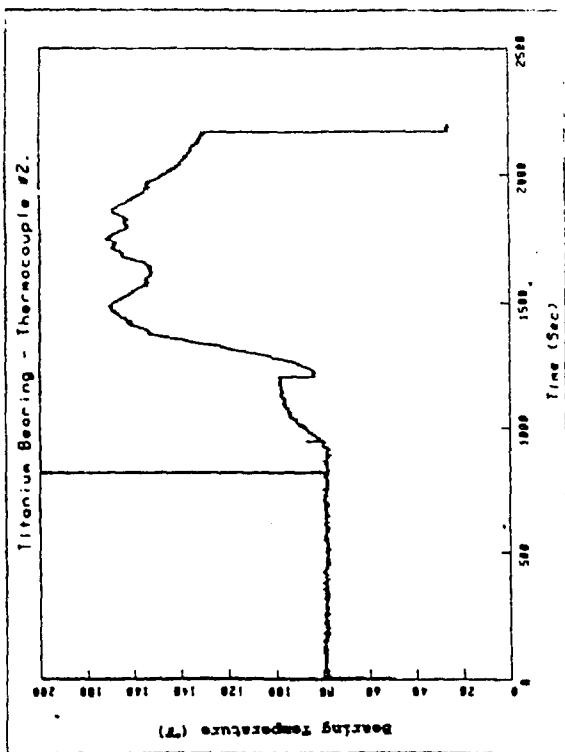
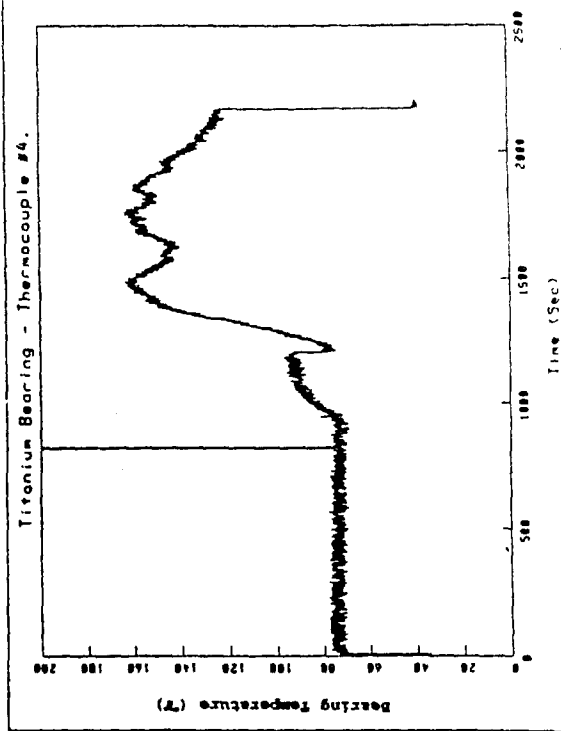
Figure 4.9 Temperature Results - Bench Test 1

Thermocouple results from bench test 1 are presented in Figure 4.9. One thermocouple failed prior to testing. Elevated bearing temperatures did not occur until test segment IIIB when galling occurred.

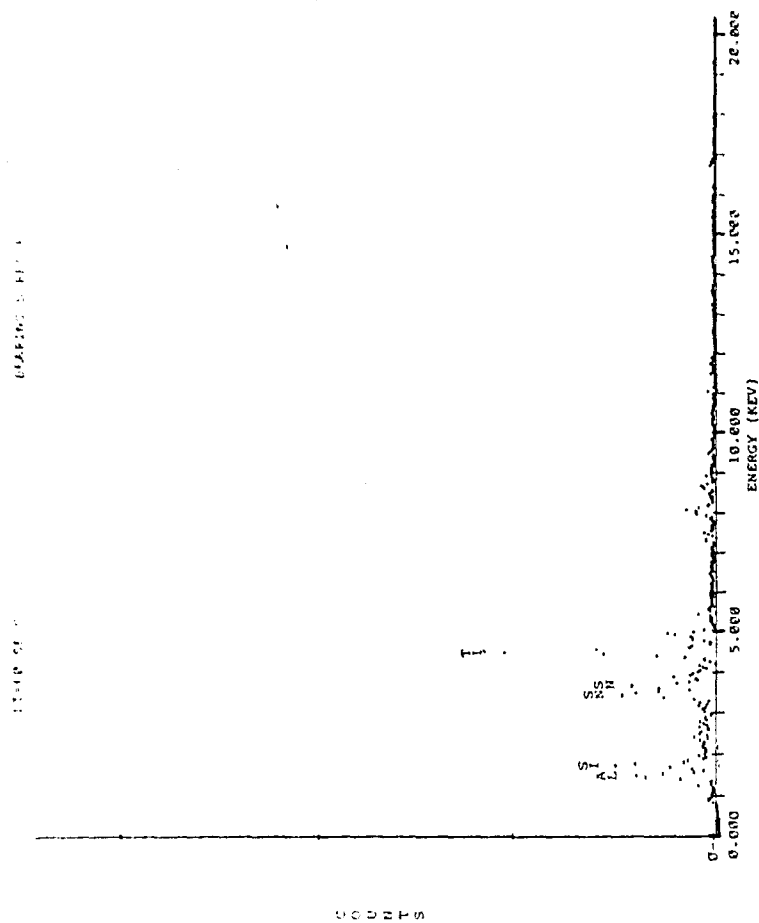
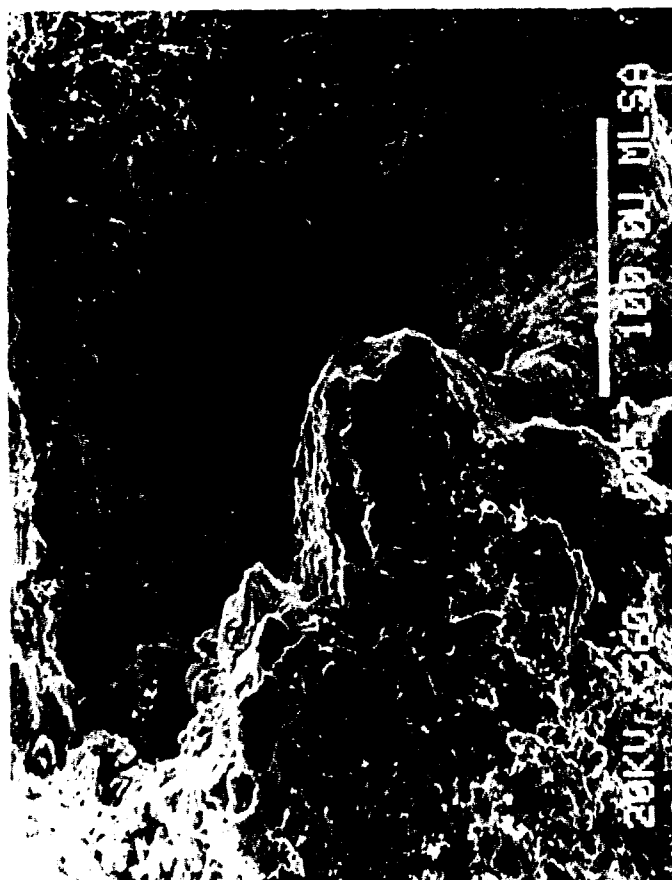
Figure 4.13c Galled Failure Zone

The tin, aluminum, silicon, and copper peaks are sharper than in 4.13b, particularly the silicon peak. Another of the pitted areas is shown in Figure 4.13d. Aluminum, silicon, and calcium are present, a definite indication of foreign particle contamination, but no foreign particle is visible. This area is clearly visible in Figure 4.12. Figure 4.13e shows a wear track produced during the test. The wear track is 0.0028 inch wide. This wear track can be seen at the bottom center of Figure 4.12. Tin is the primary elemental component, with the elements titanium, aluminum, silicon, and copper again present.

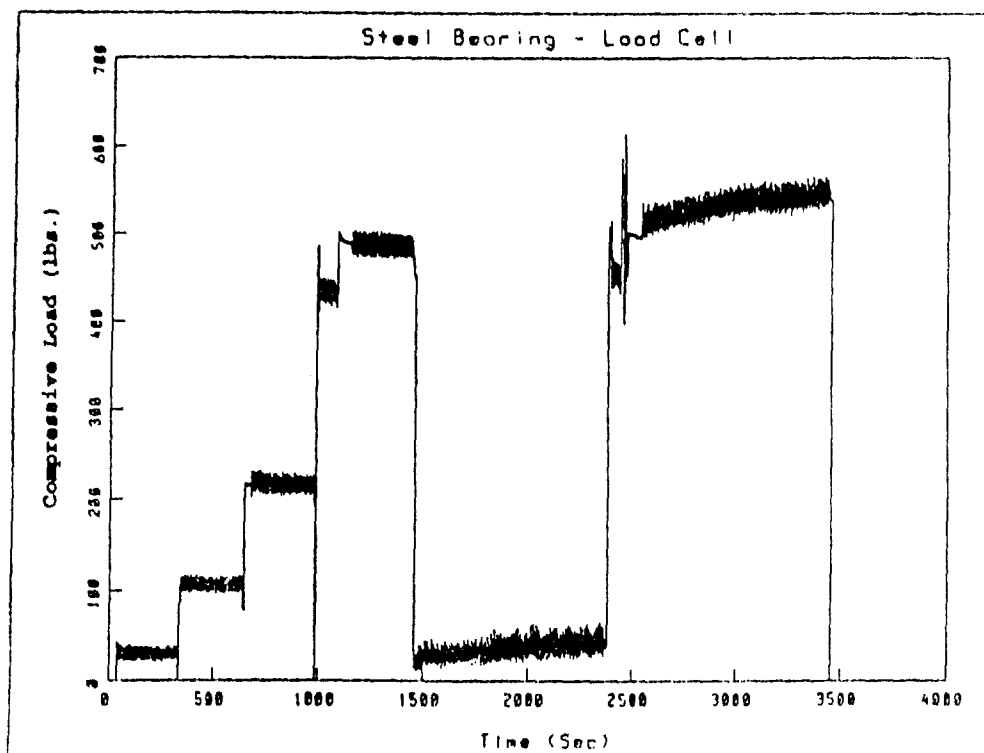
Figure 4.14 Load Cell Results - Bench Test 2

Load cell and thermocouple results are provided for comparison to the results of bench tests 1 and 3. Figure 4.14 shows the compressive load cell results. The buildup and the collapse of the compressive load that is due to lubricant film buildup can be seen in the Figure 4.15. Figure 4.16 provides the results of the thermocouples installed in the bearing pad. The sharp increases between test segments are noise spikes.

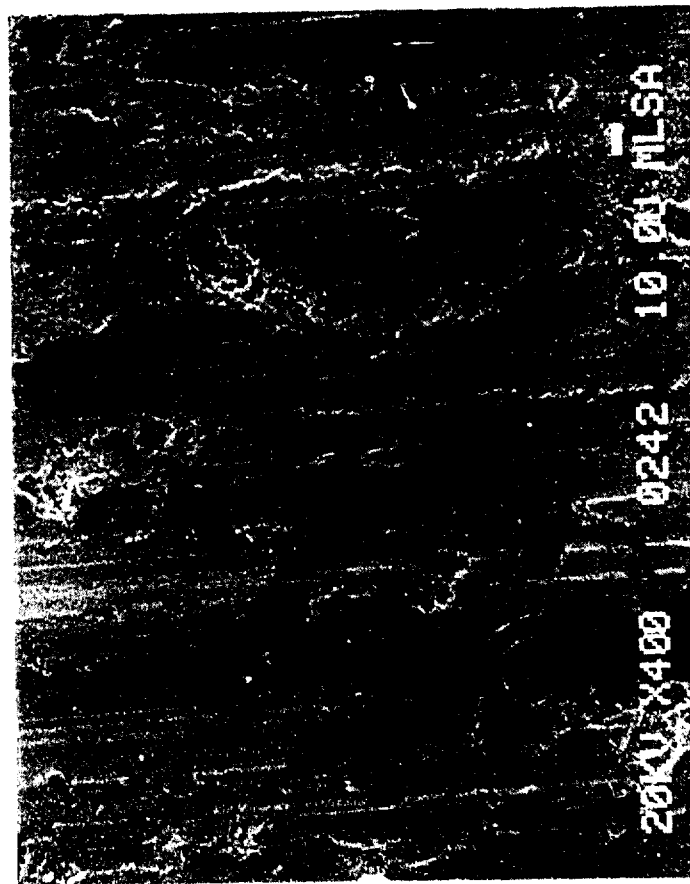
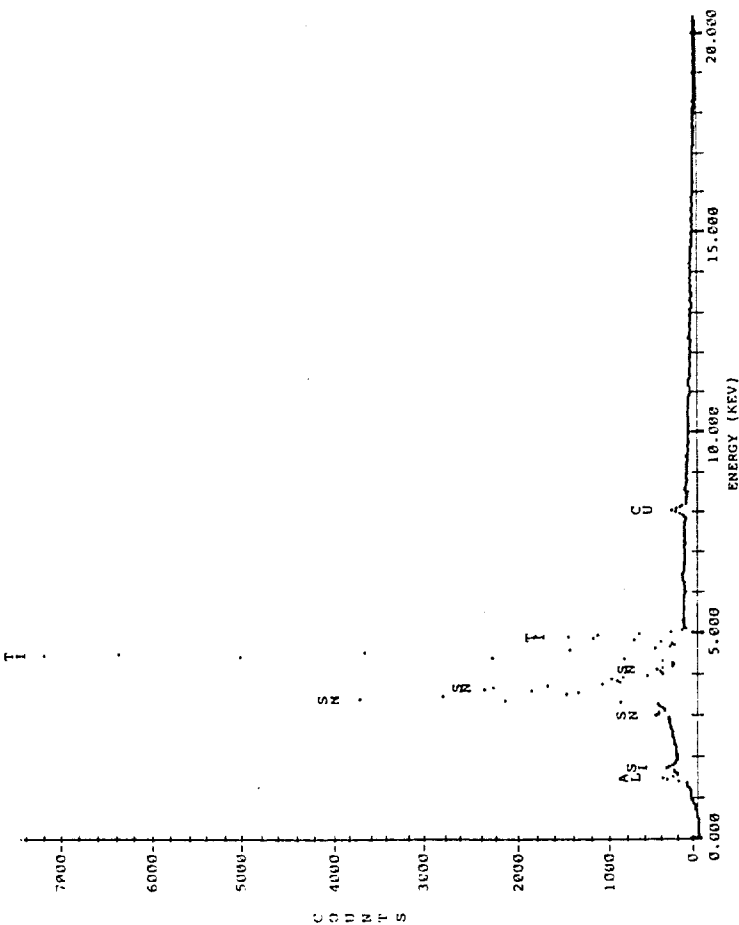
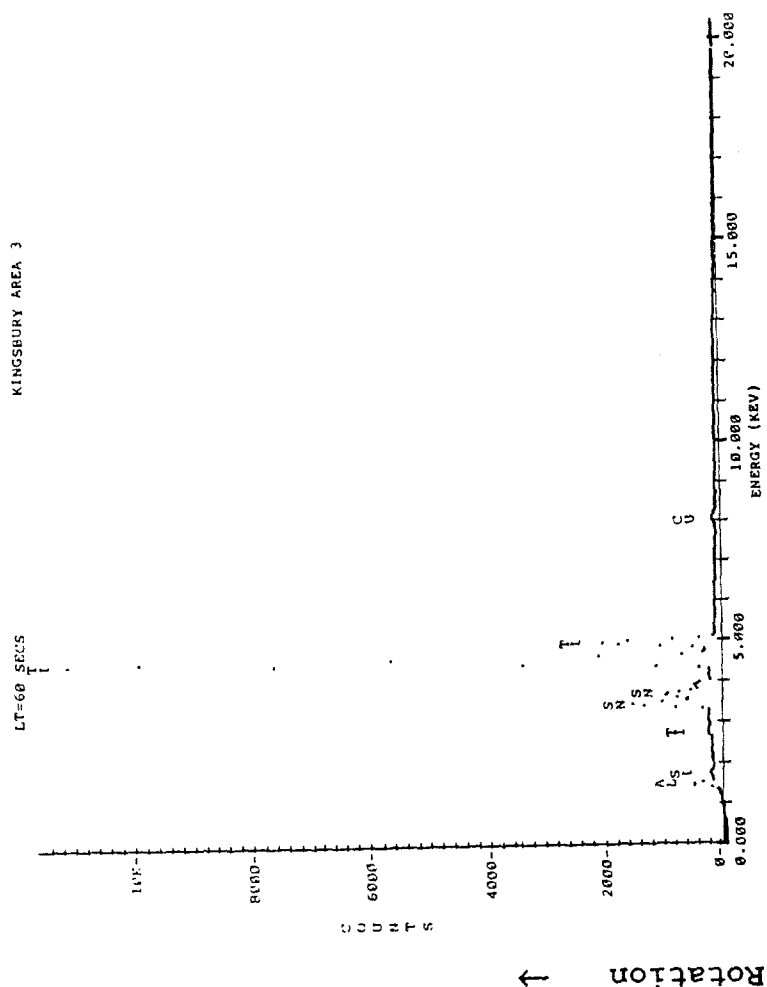
Figure 4.22c Wear Scar Beginning - Galled Zone

Figure 4.22 shows the SEM examination of the surface of a wear scar at its beginning and end and the corresponding elemental identification. Figure 4.22a shows the beginning of the wear scar. The direction of collar movement across the surface is upward. At the very bottom of the photograph, at the entrance to the wear scar, is a wear groove approximately 0.015 inches wide. This is indicative of a wear or foreign particle initiating the scar. Two zones are evident on the wear scar; a zone of smeared metal, followed by a zone of galling. Figure 4.22b shows a closeup of the smeared zone. Results of mass spectroscopy of the area are shown adjacent. High titanium and tin peaks are evident. Figure 4.22c shows a closeup of the galled zone. Titanium is more prevalent here than in the smeared zone. Figure 4.22d shows the scar end. There is not an exit groove for a wear particle indicating that the wear or foreign particle did not exit. No wear or foreign particle was found in the scar. The scar end is characterized primarily by galling. Figure 4.22e shows a closeup and the corresponding elemental identification. This area is identical in composition and structure to the galled zone at the scar entrance.
