# EXAMINATION OF PROTECTIVE COATINGS UTILIZED ON ARMY DS2 CONTAINERS

VICTOR K. CHAMPAGNE, Jr., MARC S. PEPI,  
CATHERINE M. ZOLLER, and SAUL ISSEROW  
MATERIALS TESTING AND EVALUATION BRANCH

June 1991

US ARMY  
LABORATORY COMMAND  
MATERIALS TECHNOLOGY LABORATORY

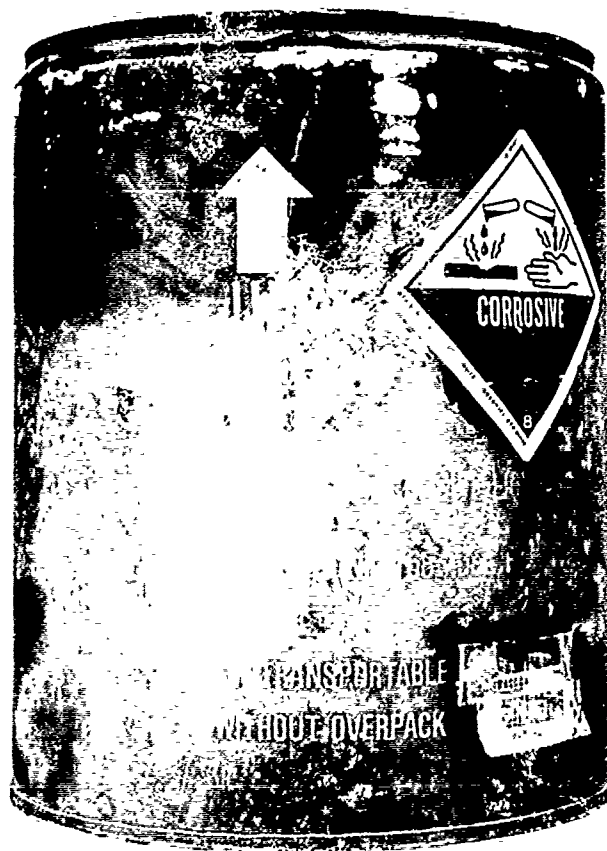
Figure 1. Five-gallon container in the as-received condition. Reduced 70%

Figure 1 shows the five-gallon container in the as-received condition. Overall, this container showed the least amount of corrosion when compared to the other two containers. Near the top, large areas of the green topcoat had been chipped away, as a result of mechanical

damage, leaving behind a bright white undercoat, as depicted in Figures 2 and 3. In addition, all three macrographs reveal a dull, matte finish on approximately 66% of the surface area of the container. This was most likely the result of weathering and exposure to adverse storage conditions. Figure 4 illustrates an area near the bottom weld chime where the topcoat had also been damaged. To the left of this region, a few isolated blisters and corrosion of the base metal occurred. The only significant evidence of corrosion was observed at welded seams which trapped moisture and allowed crevice corrosion to take place. Figure 5 shows the bottom weld chime which contains an example of crevice corrosion at the welded seam (top of micrograph). The bottom edge of the container had experienced some general corrosion where the external surface coating had been worn away. Figure 6 represents the corrosion observed along the side weld seam which also served as a site for water entrapment.

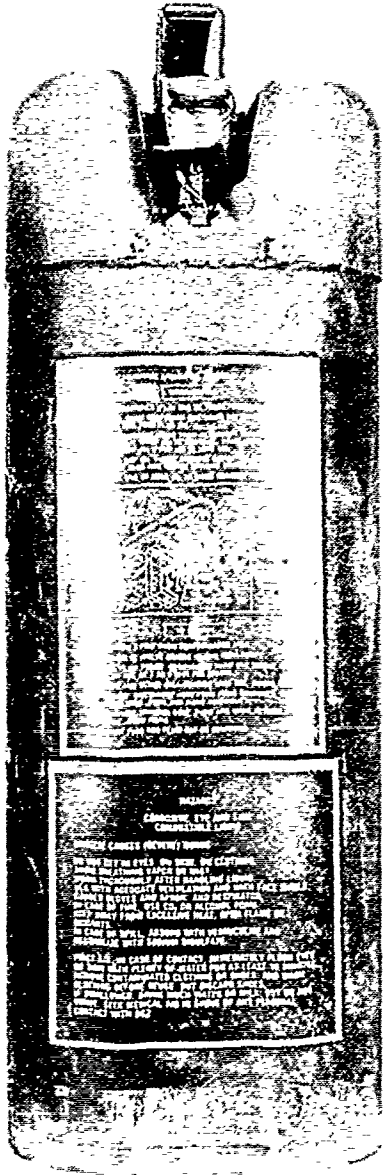
Figure 7. 14-liter container in the as-received condition.

Figures 7a and 7b show the 14-liter container in the as-received condition. This container consisted of various welded parts at the top and consequently numerous areas of corrosion were observed. On the top, general corrosion was prevalent on regions along the rounded surface, as shown in Figure 8. The protective coatings on these surfaces could easily be damaged during handling, exposing bare metal to the environment. Crevice corrosion occurred on both latches at regions which are welded to the container and support the handle. These latches did not have a continuous weld and consequently contained crevices where moisture could collect and cause corrosion, as revealed in Figures 9a and 9b. Corrosion was also noticed where the top containment latch came into contact with the surface of the container. General corrosion was observed on the handle itself, (refer to Figure 10) as its concave design allowed water to puddle. In addition, general corrosion occurred on the base of the container where it came in contact with the ground or another support, as Figure 11 illustrates. Here, the coating appeared to have been lifted away exposing the base metal. Overall, some of the design features of this container were conducive to corrosion.

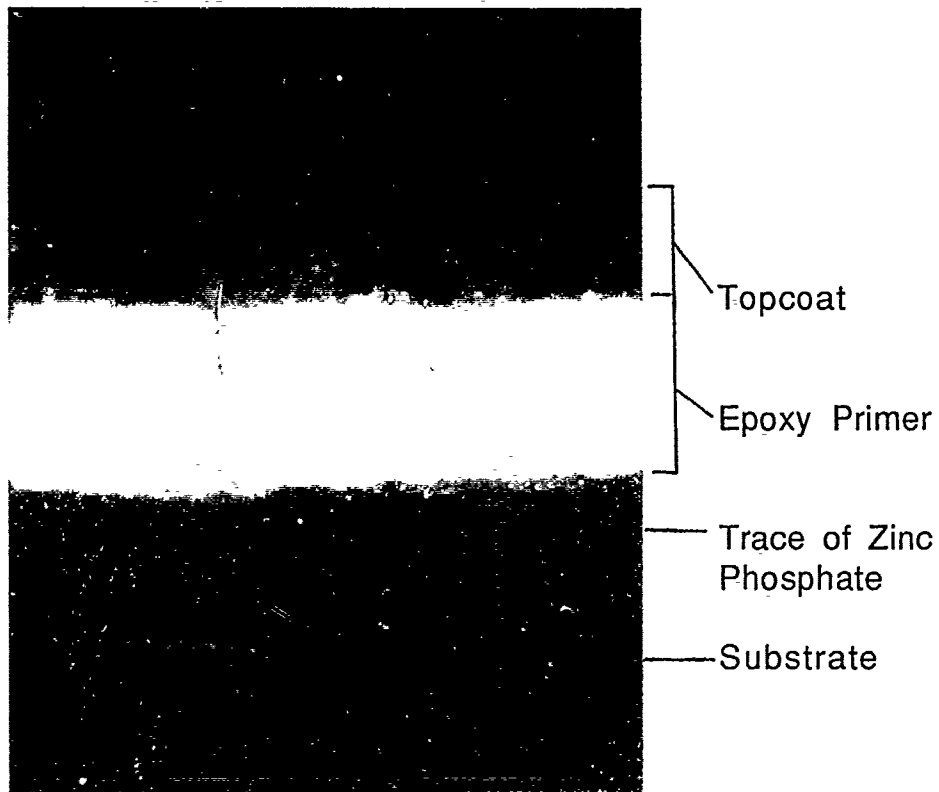
Figure 19 shows a representative cross section of the coating system of the five-gallon container taken from the side weld. This optical micrograph was exposed under polarized light in order to highlight the different coating layers.

In general, the coatings displayed good adherence and were uniform, except for the phosphate layer which appeared to be quite discontinuous. Figure 20 further illustrates this point as it shows a thick phosphate layer, in contrast to Figure 19 which revealed only trace

Figure 19. Representative cross section of the coating system of the five-gallon container taken from the side weld area. Mag. 500X

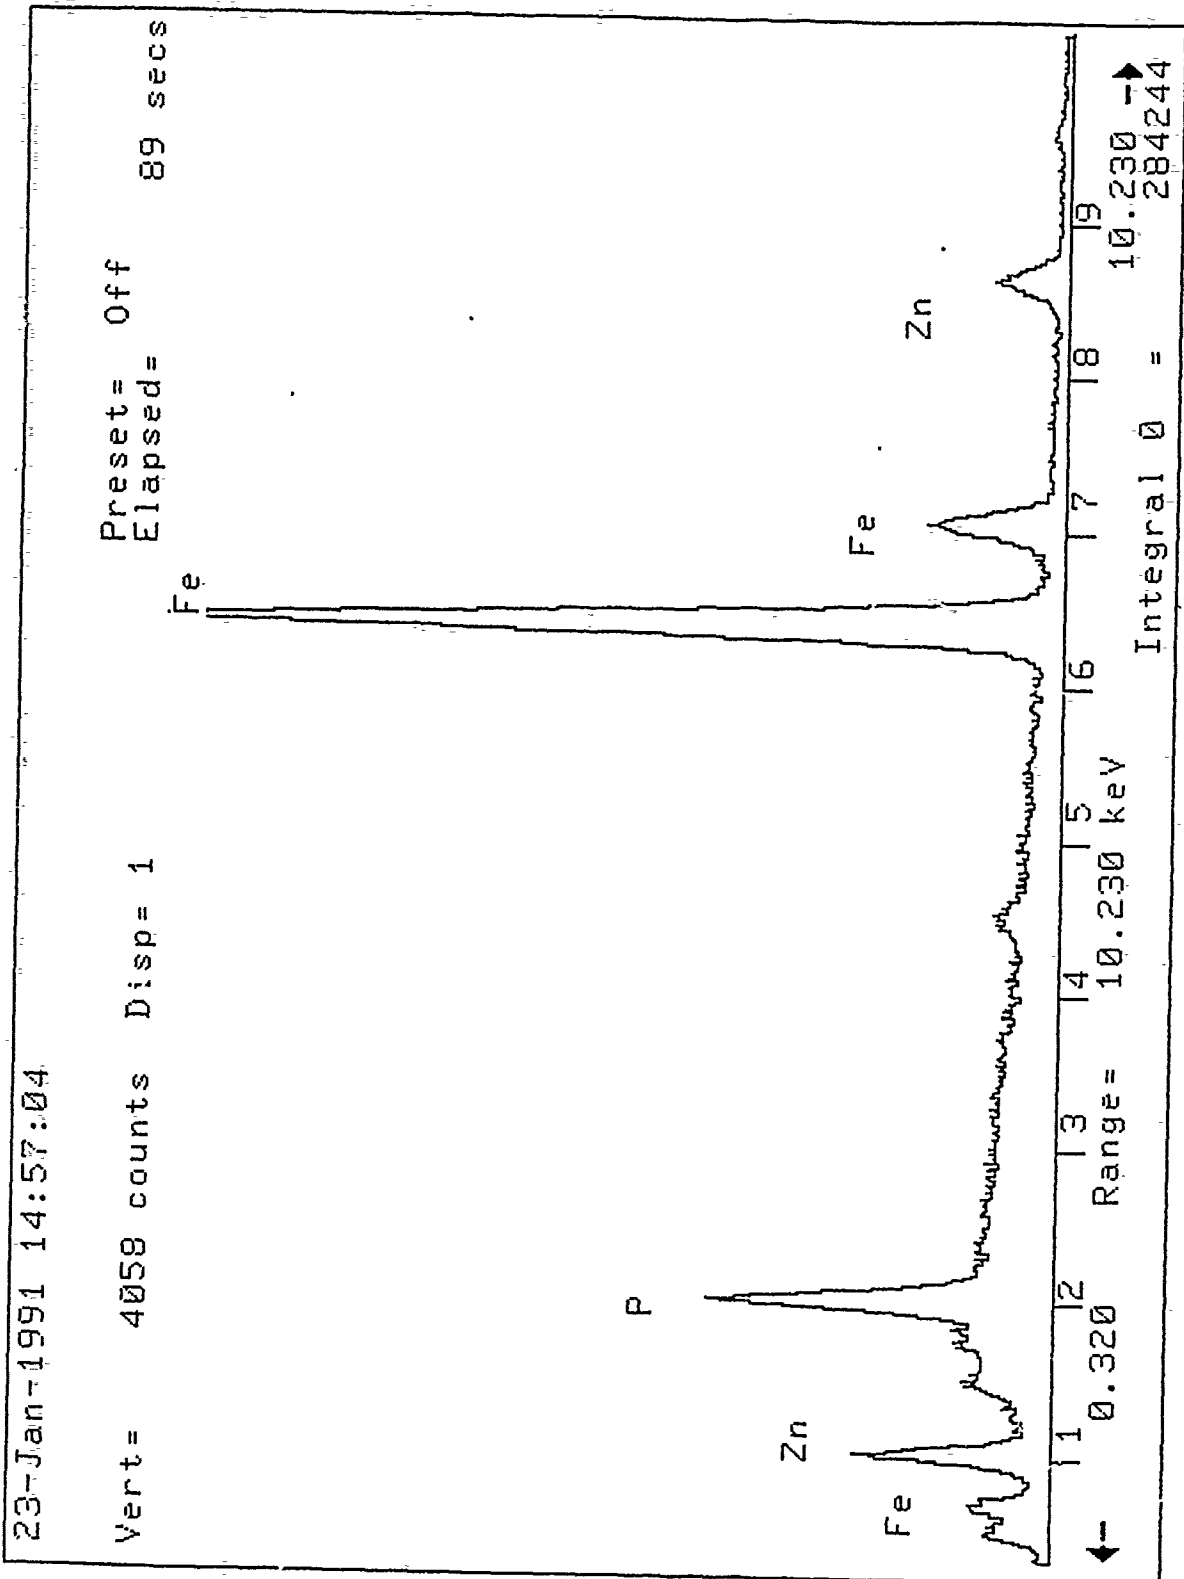
Figure 35. Energy Dispersive Spectroscopy of the exterior base metal of the five-gallon container. The zinc and phosphorous detected indicate the presence of a zinc phosphate pretreatment.

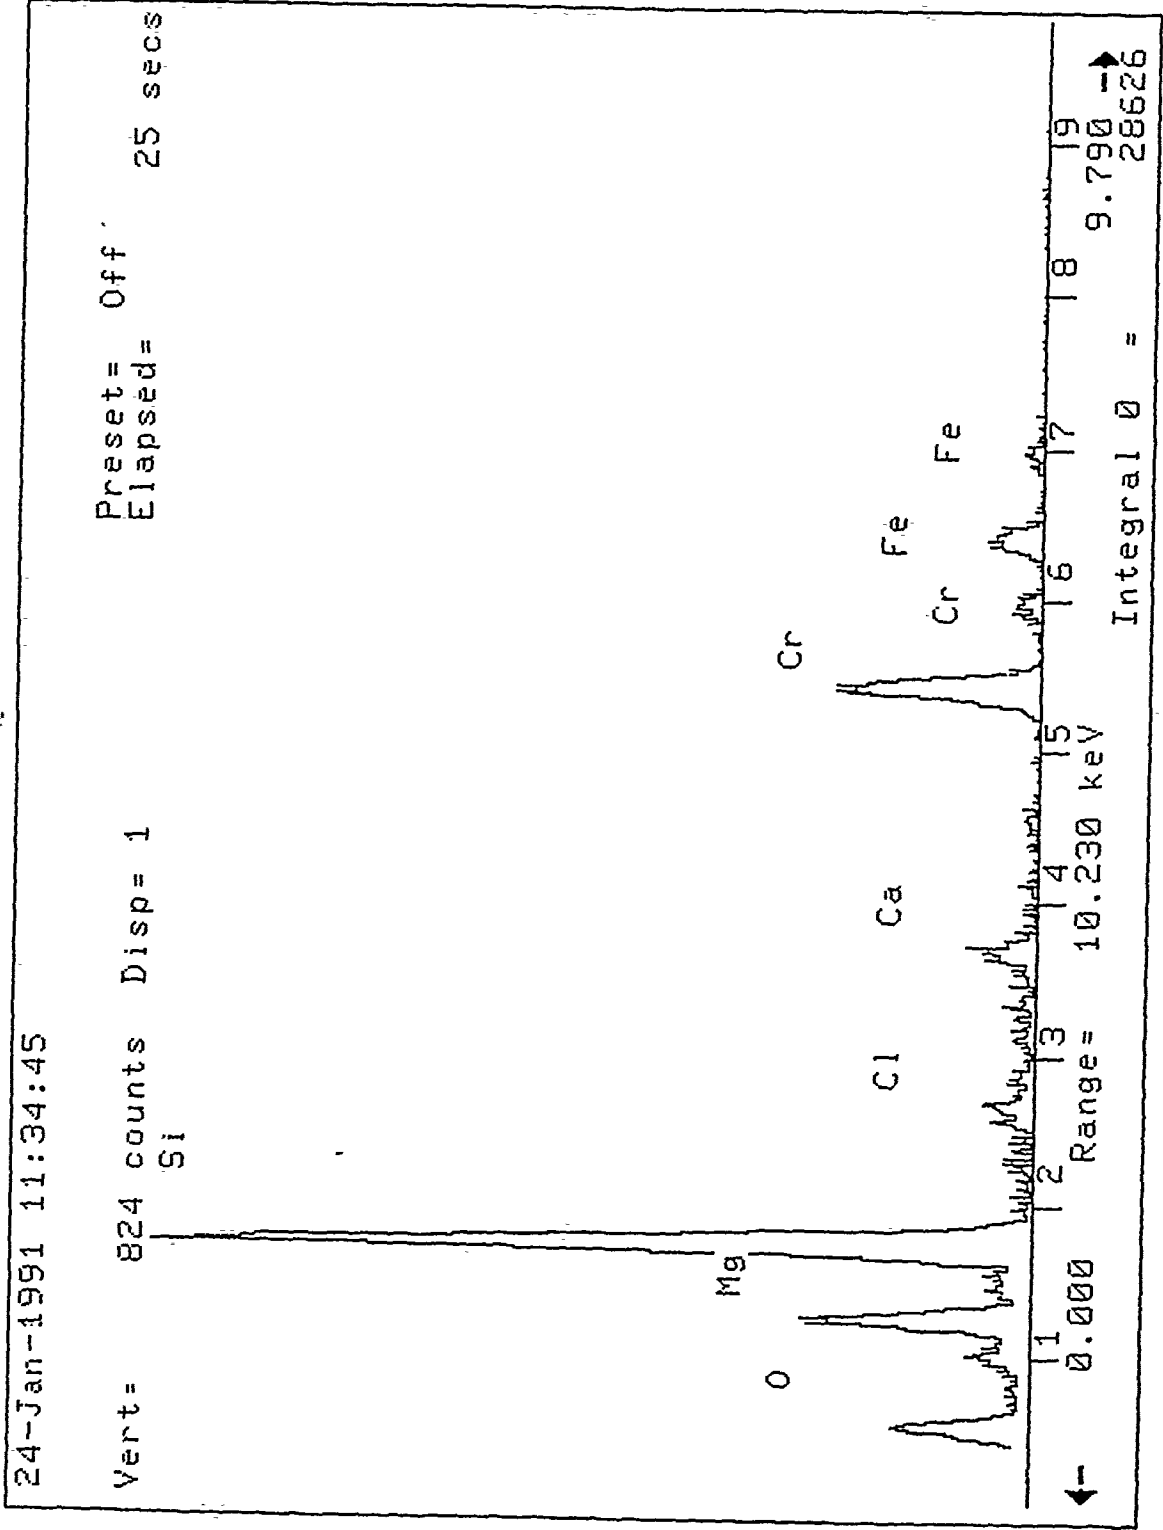
Figure 42. Energy dispersive spectroscopy of the exterior topcoat of the 14-liter container. Silicon, magnesium, oxygen, chromium, calcium, and iron are constituents of the pigments added to the topcoat. The presence of chlorine could indicate a contaminated sample surface.
