Supplement to a Report to  
Congressional Requesters

August 1991

# U.S.S. IOWA EXPLOSION

## Sandia National Laboratories' Final Technical Report

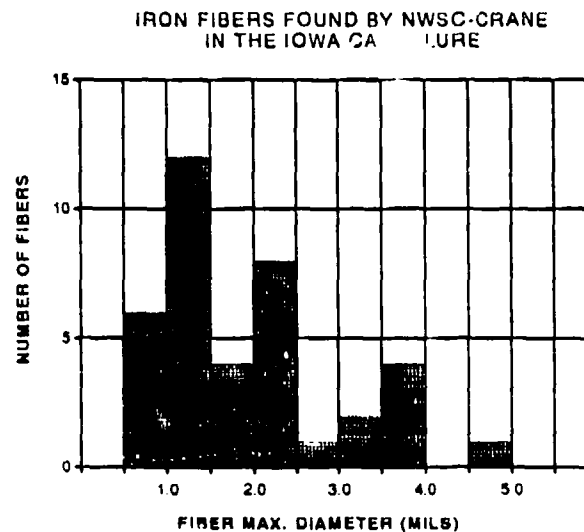
compared to the distribution of fiber sizes found in the IG-1 cannellure (Figure 3a). Within experimental uncertainty, these distributions are identical. Our conclusions from the fiber size data are that there is no difference in the sizes of the various fibers found in the cannellure and in the forward grooves of the IG-1 projectile.

Figure 3a. Size distribution of iron fibers found in the USS IOWA cannellure by NWSC-Crane.

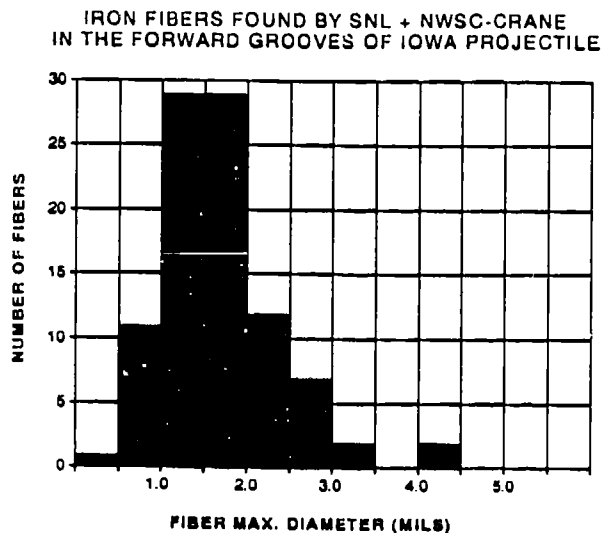
Figure 31. Size distribution of iron fibers found in the forward grooves of USS IOWA projectile (SNL + NWSC-Crane).

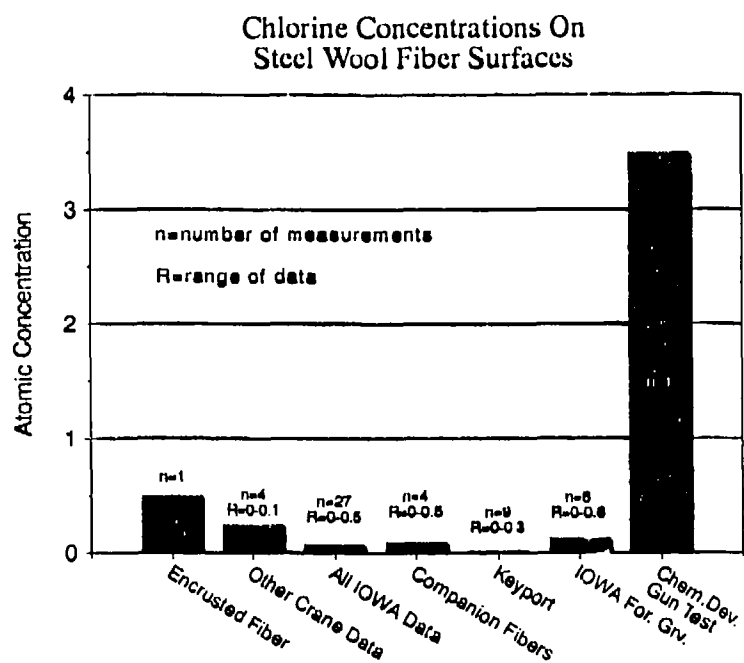
Figure 4. Calcium concentrations measured on steel wool fiber surfaces by Auger spectroscopy.

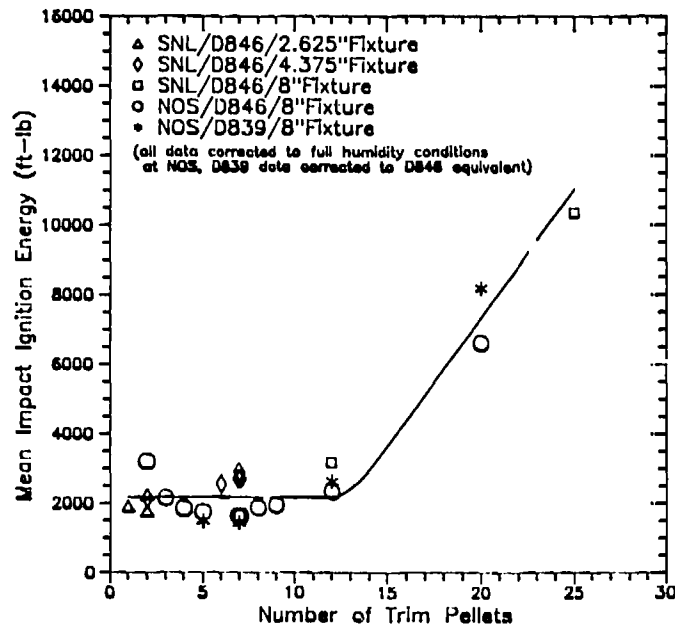
SNL thus compiled a fairly extensive set of data that could be correlated to establish the relationship between the mean impact ignition energy and the number of trim pellets. This is shown in Figure 10. The total mean ignition impact energy remains essentially constant over the approximate range of one to twelve trim pellets and then increases rapidly as the number of trim pellets increases.

Figure 10. Mean impact ignition energy versus number of trim pellets for all subscale tests at both SNL and NOS-Indian Head.

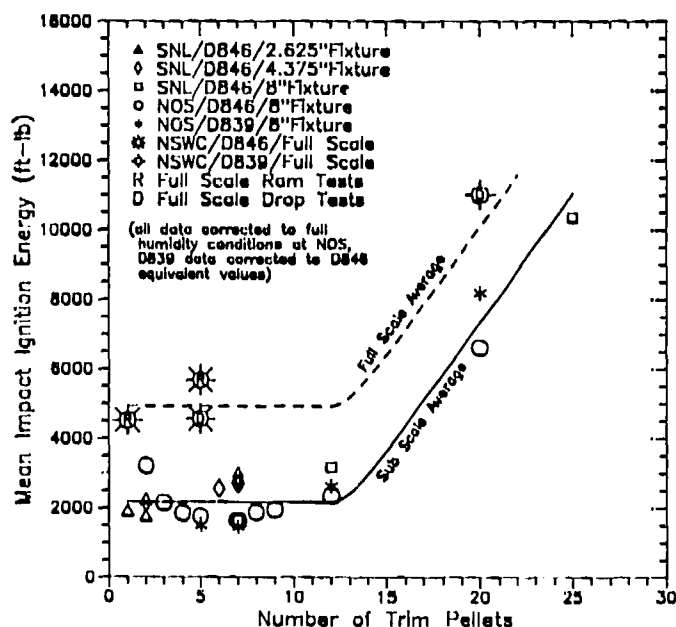
When the data in Figure 11 are analyzed, they show an approximately constant offset between the subscale and full-scale data. This offset is the energy that is lost in powder bag compression and swelling and subsequent mass pellet motion.

Figure 11. Full-scale ramming and drop test result compared to subscale test results.

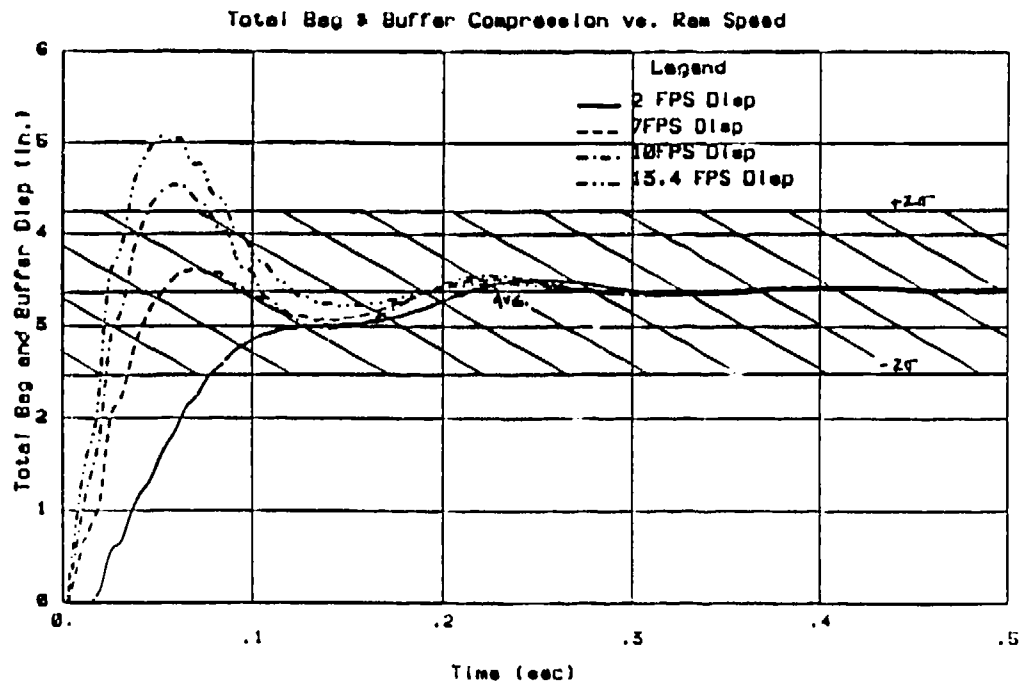
As indicated above, the buffer and bags must compress 3.33 in. in order for the rammerhead to be in the position that matches the gouges in the spanning tray. Figure 18 is a plot of the sum of the buffer and bag compression at four different rammer speeds as predicted by the model. For times greater than 0.3 sec., all four of the compression curves approach the static compression of the rammer, 3.33 in.

Figure 18. Predicted total powder bag and buffer compression for various ram speeds.

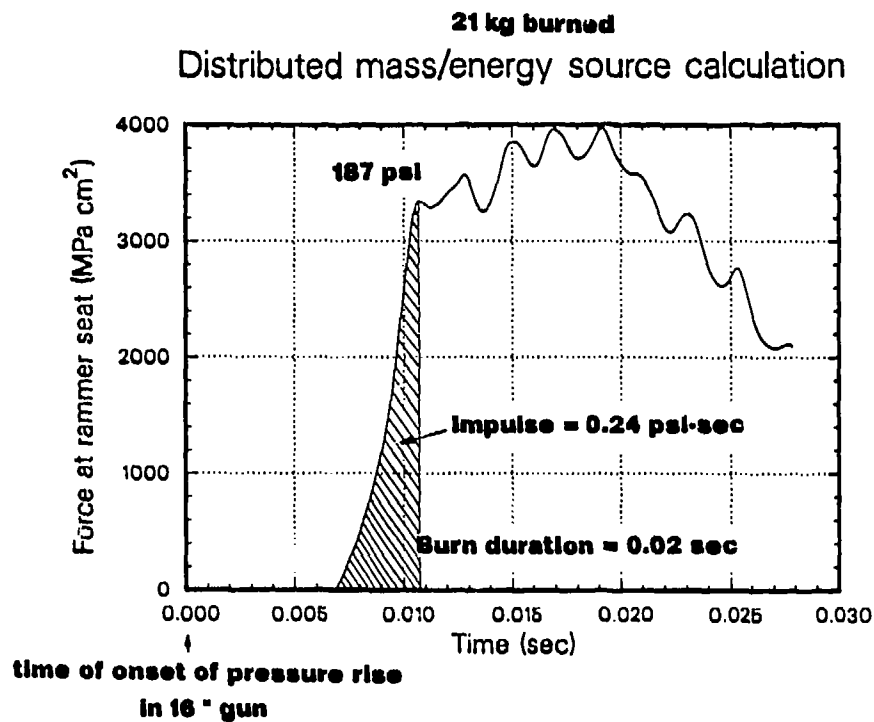
A plot of the pressure/history on the rammerman's seat is given in Figure 28. The peak pressure was estimated to be 187 psi, which occurred over 4 msec. of time. Because the pressure loading is due to gas flow impinging on the rammerman's seat, a loss of differential pressure occurs when the flow has arrived on the other side of the seat. It is thus assumed that no additional loading exists on the seat after this initial peak pressure of 187 psi.

Figure 28. Pressure at rammerman's seat predicted by distributed mass/energy source calculation. Note the absence of a pressure spike at the leading edge of the pulse.
