USACERL Technical Report E-91/08  
July 1991

# **Evaluation of Central Heating Plant at Rickenbacker Air National Guard Base**

by  
Martin J. Savoie  
John Gostich  
J.W. Chappell  
John Richards

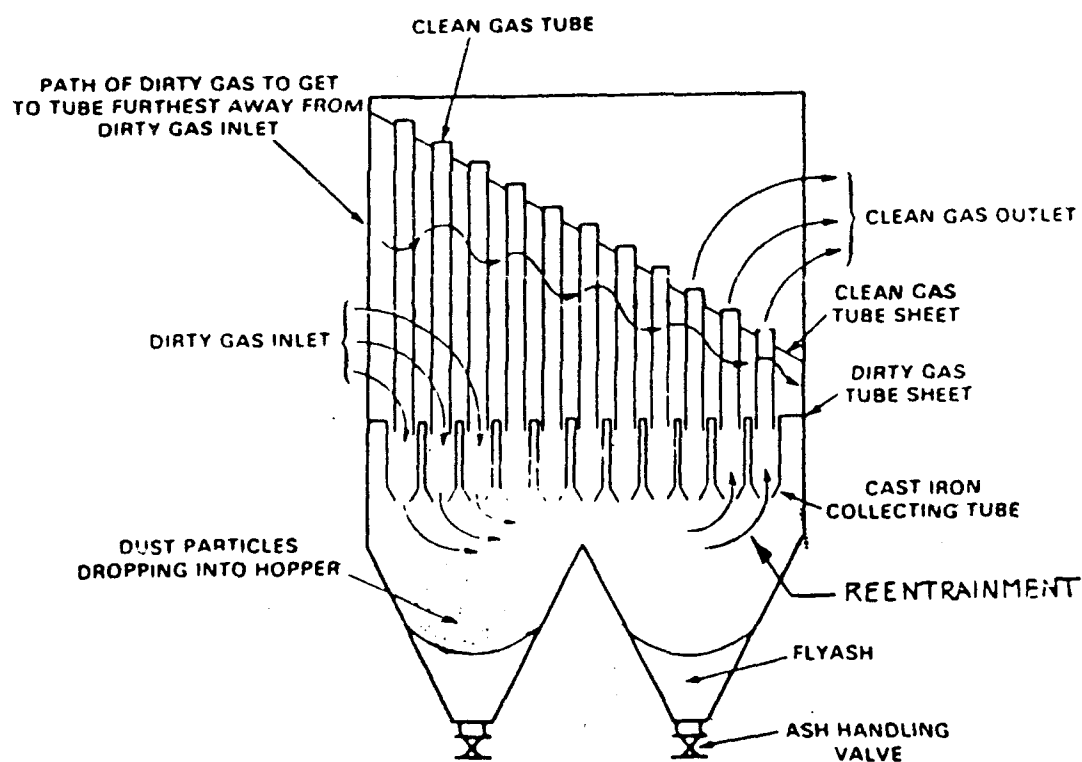
Figure 16. Multicyclone dust re-entrainment.

The thin layers of hard material also build up in the clean gas tube but, because of its large cross-sectional area, the hard material does not reduce its flow in proportion to the inlet vane, ramp, or spinner. This uneven flow then causes some flue gas to enter the tubes with less thick layers of hard material at the inlet vanes, flow down into the hopper area, across the hopper, re-entraining particulate in the flow and exiting the clean gas tube of those tubes with thick layers of hard material at inlet vanes (Figure 16). The reason the flue gas flow will exit the clean gas tubes with thick material at the inlet vanes is because the induced draft fan has the same suction of negative static pressure on all clean gas tubes.
