**MONITORING COMPLETED COASTAL PROJECTS PROGRAM**

MISCELLANEOUS PAPER CERC-91-5

**SPUD POINT MARINA BREAKWATER, BODEGA BAY  
SONOMA COUNTY, CALIFORNIA**

Final Report

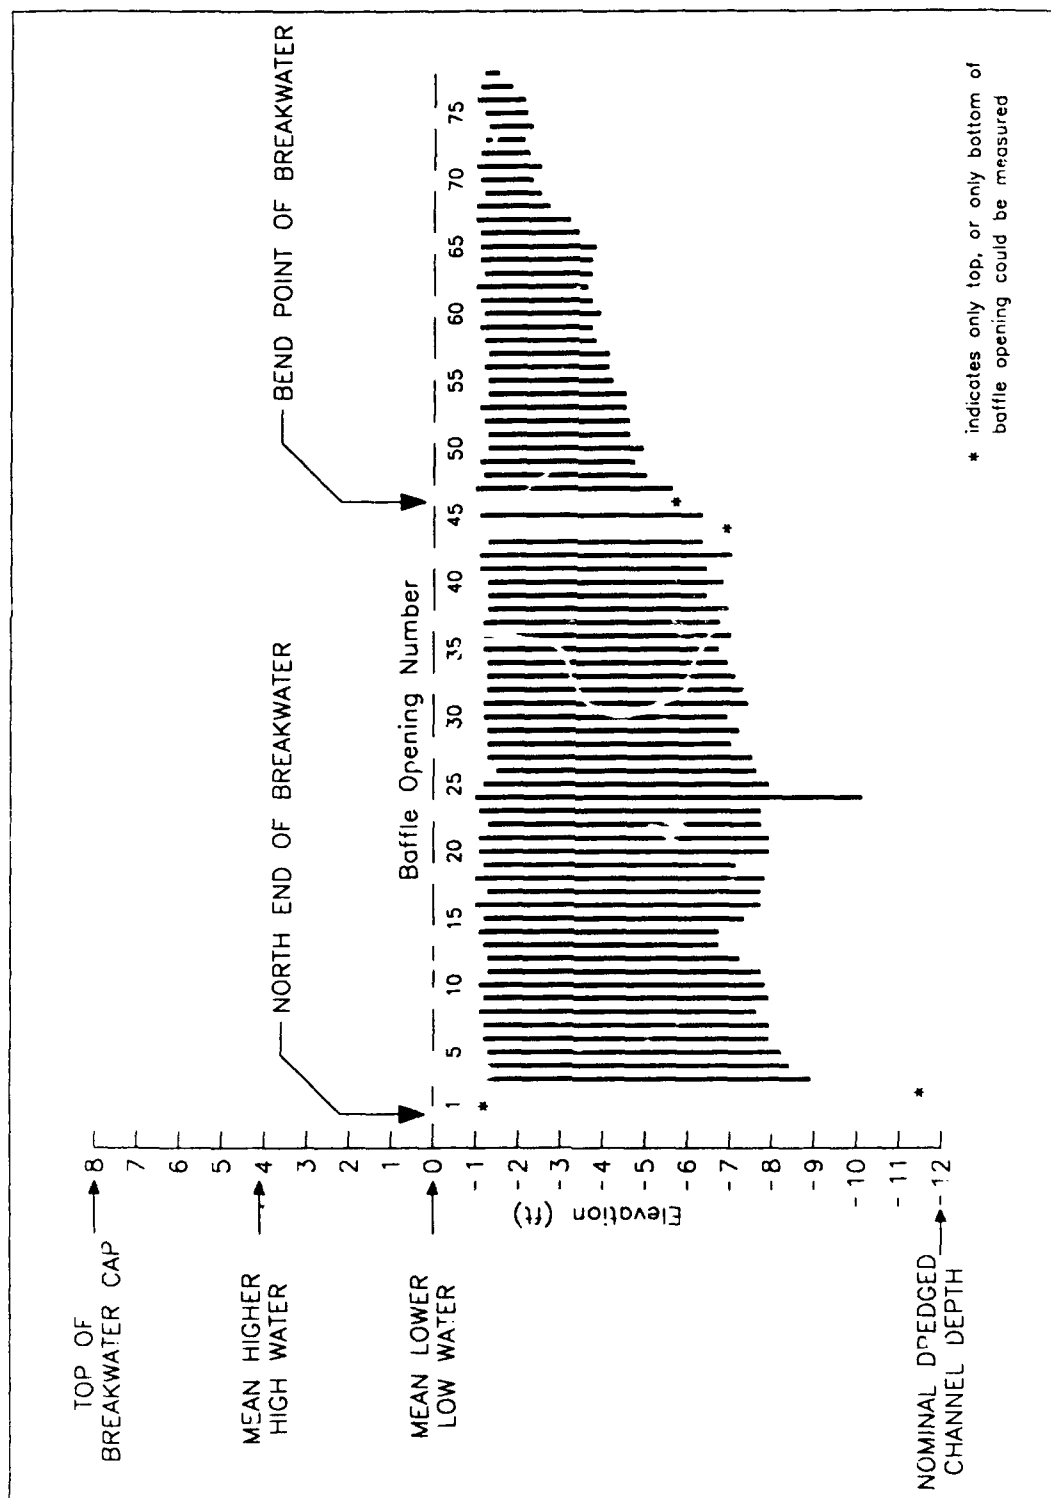
Figure 17. Vertical baffle opening dimensions

opening dimensions were also measured, by lowering an "L"-shaped graduated rod from the cap and hooking it under the bottom of each baffle panel, then lowering further until the rod touched bottom. These elevations were determined by reference to the top of the cap (assumed level at +8-ft elevation). Figure 17 shows a plot of the resulting baffle opening dimensions (dark vertical bars) versus horizontal position along the breakwater. The vertical dimensions are plotted to scale; the horizontal axis is only approximately scaled. The variation in the baffle panel bottom elevations was mostly due to varying accumulations of marine growth on the panels. The mudline elevation along the structure can be interpolated by connecting the bottoms of the baffle opening bars in Figure 17. Onsite observation found the mudline elevation to be deeper than -12 ft mllw at the seaward end and higher than -1 ft mllw at the landward end, where the baffle panel bottoms are buried. There is, however, a shallow gap at the landward end, between the end of the structure and the shore (see Figure 5b) which is open to flow during high tide. The relatively deep spot noted previously on the side-scan sonar image is seen on Figure 16 at baffle opening No. 24. The baffle opening data give no evidence of scour problems, but may be useful for comparison with future datasets. From the figure, the -7 ft mllw mudline elevation used in the wave transmission calculation seems to have been a reasonable choice for a working mudline elevation on the seaward leg of the breakwater.
