# Naval Research Laboratory

NRL Memorandum Report 6861

## High Pressure Turbine Blade Life Extension

August 28, 1991

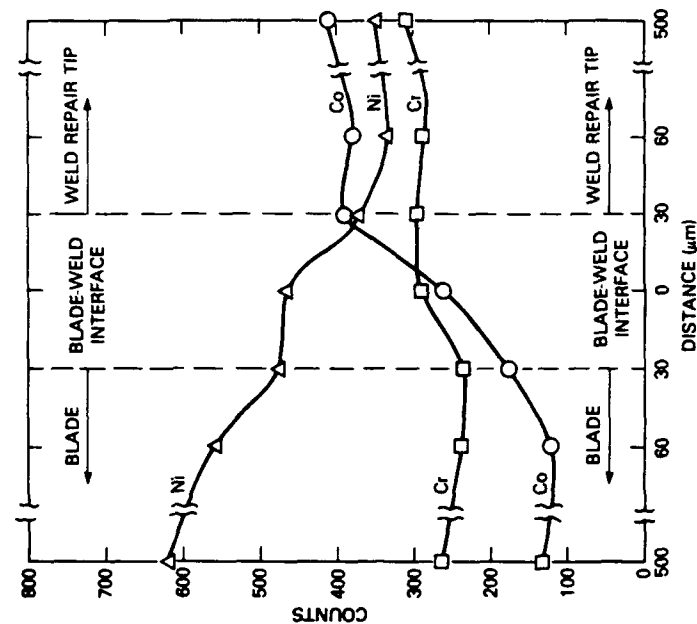
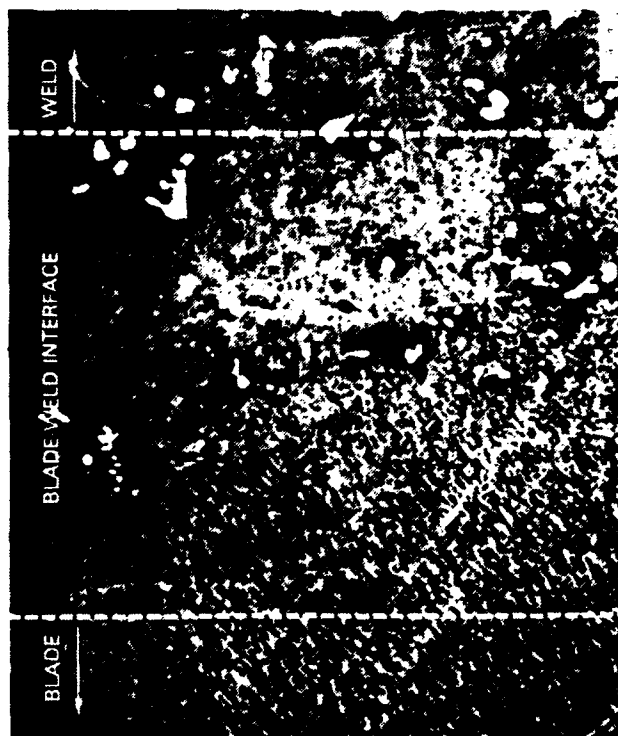
Figure 12. Microstructure of the blade-weld interface region and composition profiles detailing the Co, Ni and Cr gradients through the interface.

The composition profiles of nickel, chromium and cobalt through the blade-weld interface are shown in Figure 12. The profiles confirm that minimal intermixing of the blade and weld alloys occurred during the tip repair process. Additional detail of the microstructure of the blade/weld interface is illustrated by the TEM micrographs in Figure 13. The micrographs show the change in the microstructure from the blade alloy to the weld as the interface was traversed. The micrographs clearly show the minimal intermixing of the blade and weld alloys which occurred during the blade tip repair process.

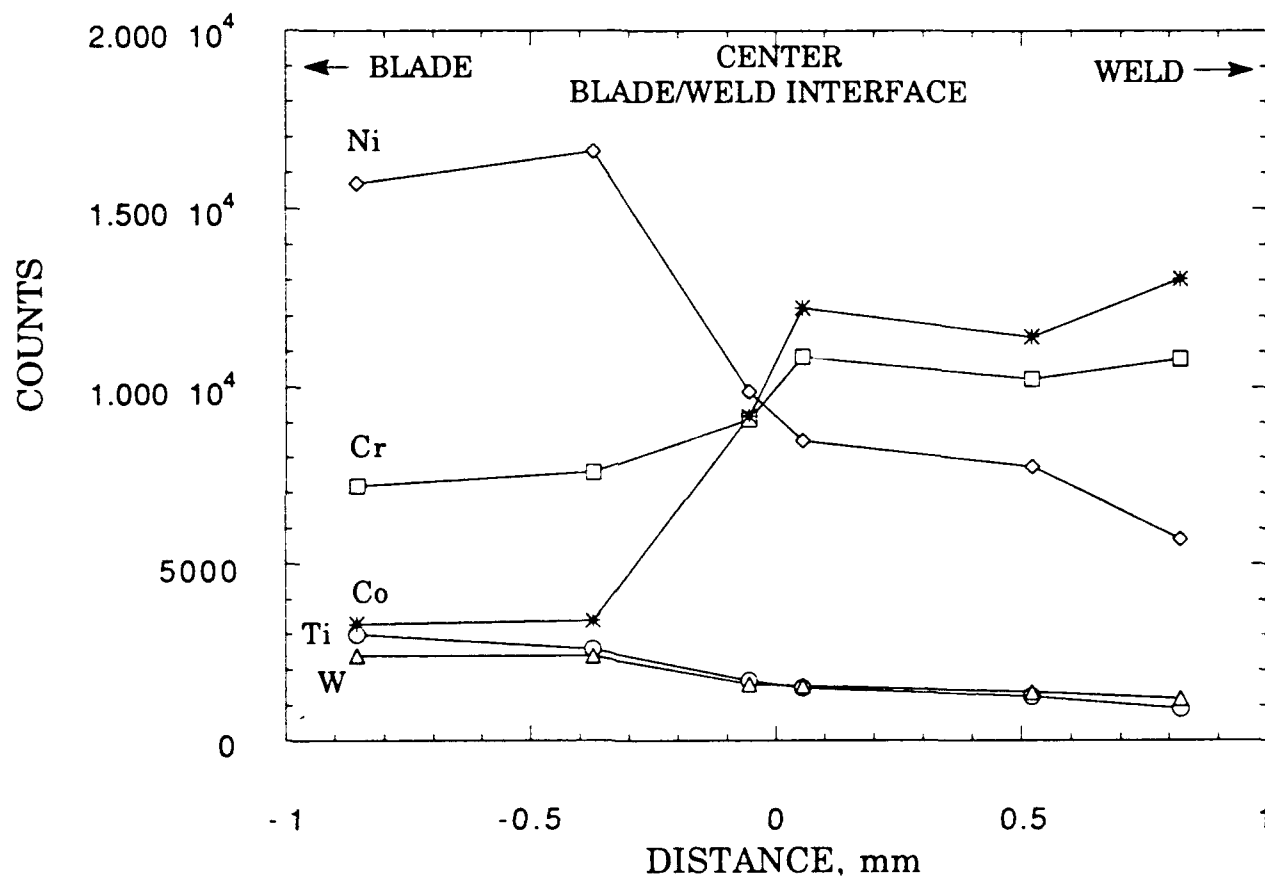
Figure 22. Semi-quantitative compositional analysis of the DS-R80H blade/MERL 72 weld interface region of an ASMET engine tested blade.

The ASMET engine tested blades showed no metallurgical weld defects, such as cracking or porosity. Weld metal dilution effects were examined using the SEM to conduct semi-quantitative energy dispersive x-ray analyses of the blade-weld interface region. Alloy composition profiles are shown in Figure 22 for the elements Ni, Cr, Co, Ti and W. The data indicate that elemental mixing at the interface of the repair was confined to a region approximately 1 mm or less in overall extent. These results are in agreement with those found for previously repaired blades, Figure 12, and suggest that the weld repair process can be expected to be repeated with considerable consistency.

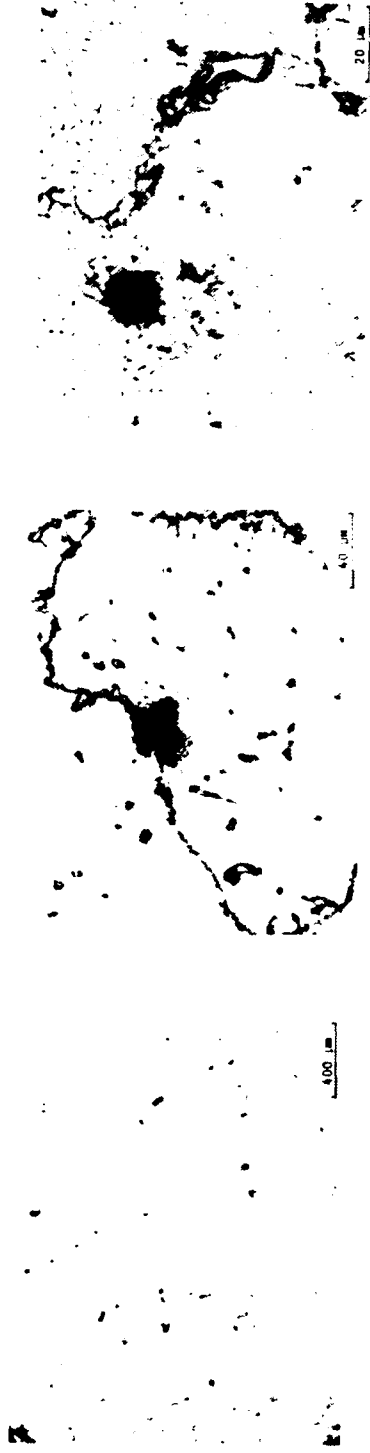
Figure 23. Optical microstructure of the not-HIP and HIP processed creep-rupture specimens.

The microstructure of the not-HIP and HIP processed, precipitation heat treated, untested creep-rupture test specimens is illustrated in Figure 23. For both material conditions, the microstructures are seen to be equivalent indicating that HIP processing produced no observable effect on the test specimen microstructure.

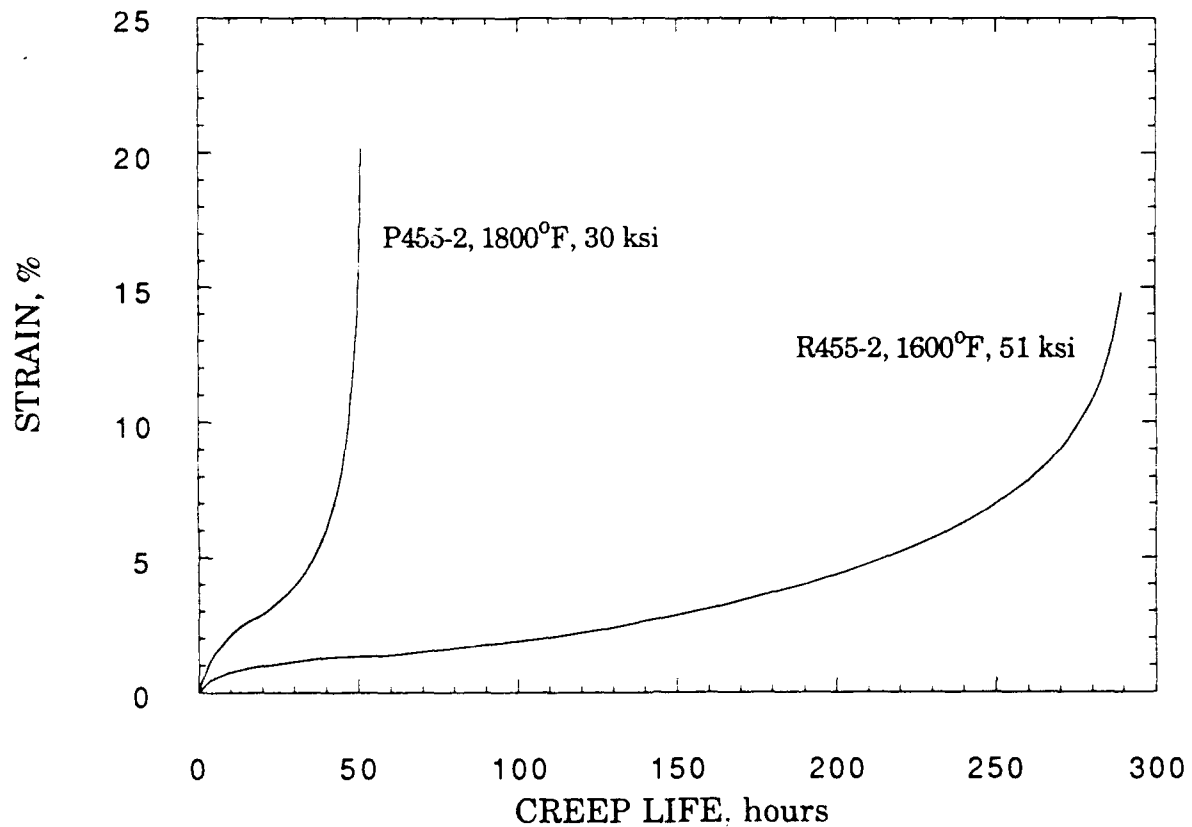
Figure 24. Creep-rupture results for not-HIP processed DS-R80H tested at 871 and 982°C.

The tensile and creep-rupture test results are summarized in Table 2. The results show that creep ductility increased with increasing test temperature. Typical creep-rupture test results from the DS-R80H specimens, heat treated to include the time at temperature of the coating cycle, are shown in Figure 24 for DS-

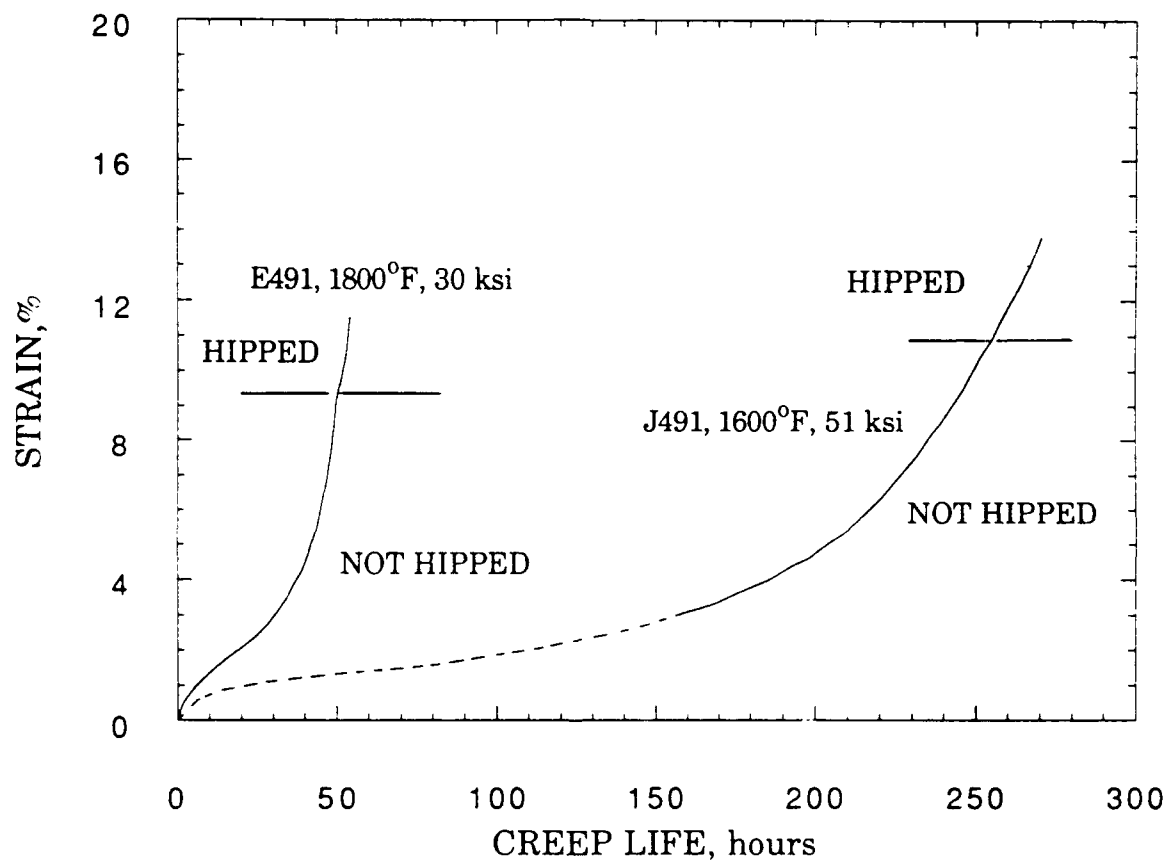
Figure 25. Creep-rupture results for not-HIP processed DS-R80H tested at 871 and 982°C.

To investigate the effects of HIP processing on the creep behavior of DS-R80H, creep tests of specimens from material 491 (Table 2) were interrupted during the tertiary creep stage. The specimens were then removed from the creep test machine, HIP processed and re-heat treated to the original conditions, including the time at temperature of the coating cycle. The specimens were then re-installed in the creep machines and the tests were continued to specimen failure. The results from these not-HIP/HIP processed tests at 871 and 982°C are shown in Figure 25. The horizontal lines in Figure 25 indicate the strain at which the tests were interrupted so that the specimens could be HIP processed. For the creep specimen tested at 871°C, the initial stress level was 40 ksi. At a strain level of 3%, the stress level was increased to 51 ksi. The dashed portion of the curve in Figure 25 represents the expected creep response of the specimen if the test had been conducted entirely at 51 ksi.

The results in Figure 25 show that the HIP processing provided little change to the creep response of the DS-R80H when compared with the results from the not-HIP processed creep specimens of material 491. As shown in Table 2, the combined not-HIP/HIP processed creep life of specimens of material 491 was slightly reduced from the life of the not-HIP processed specimens tested at both temperatures. In addition, the mid-test application of the HIP and heat treatment cycle reduced the specimen reduction in area and elongation values by approximately 50% when compared with the not-HIP processed condition.

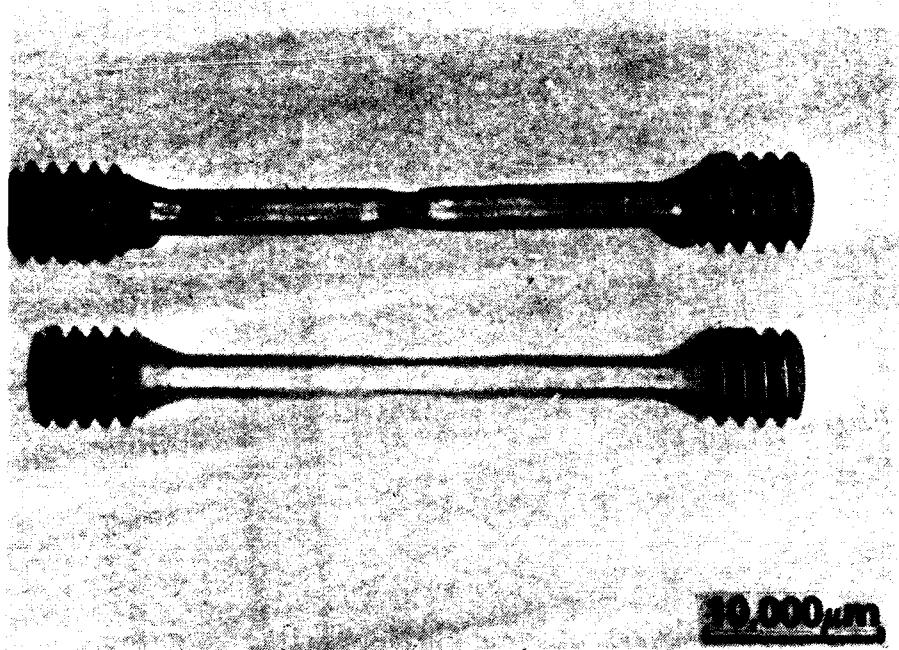
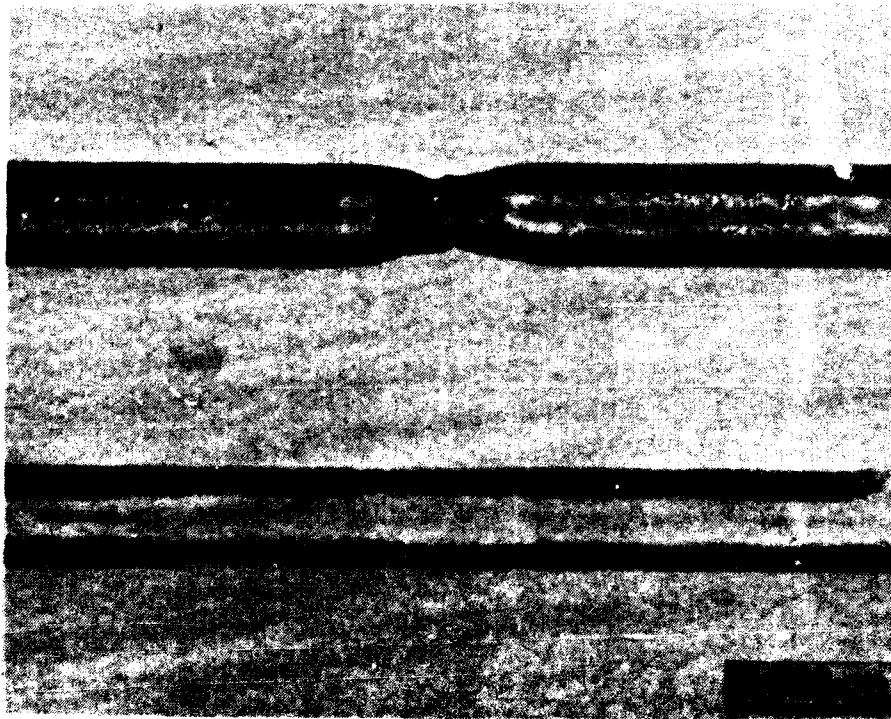
Figure 29. Creep-rupture results for DS-R80H/MERL 72/DS-R80H specimens tested at 871°C.

The creep-rupture results for the blade/weld specimens at 871°C are shown in Figure 29 and are given in Table 2. When compared with the results for the blade alloy, Figure 24 and Table 2, the results show that the creep life of the MERL 72 weld was drastically reduced from that exhibited by the DS-R80H. For example, the results show that at a stress level of 51 ksi, the

creep life of the MERL 72 was 1.3 hours compared with 289 hours for the DS-R80H. Similar reductions in the creep lives of the MERL 72 occurred at the lower stress levels. The appearance of the fracture surfaces of the MERL 72 creep-rupture specimens is shown in Figure 30. The micrographs show that the fracture surface exhibited microvoid coalescence which was consistent with the high level of ductility observed in the weld material. The results confirm that the weld material exhibited ductility levels consistent with the maintenance of the integrity of the blade/weld interface in the test specimens.
