**McGLELLAN AIR FORCE BASE**

# OPERABLE UNIT B PRELIMINARY ASSESSMENT SUMMARY REPORT

## VOLUME III: APPENDICES C, D & E

INSTALLATION RESTORATION PROGRAM (IRP)  
STAGE 3

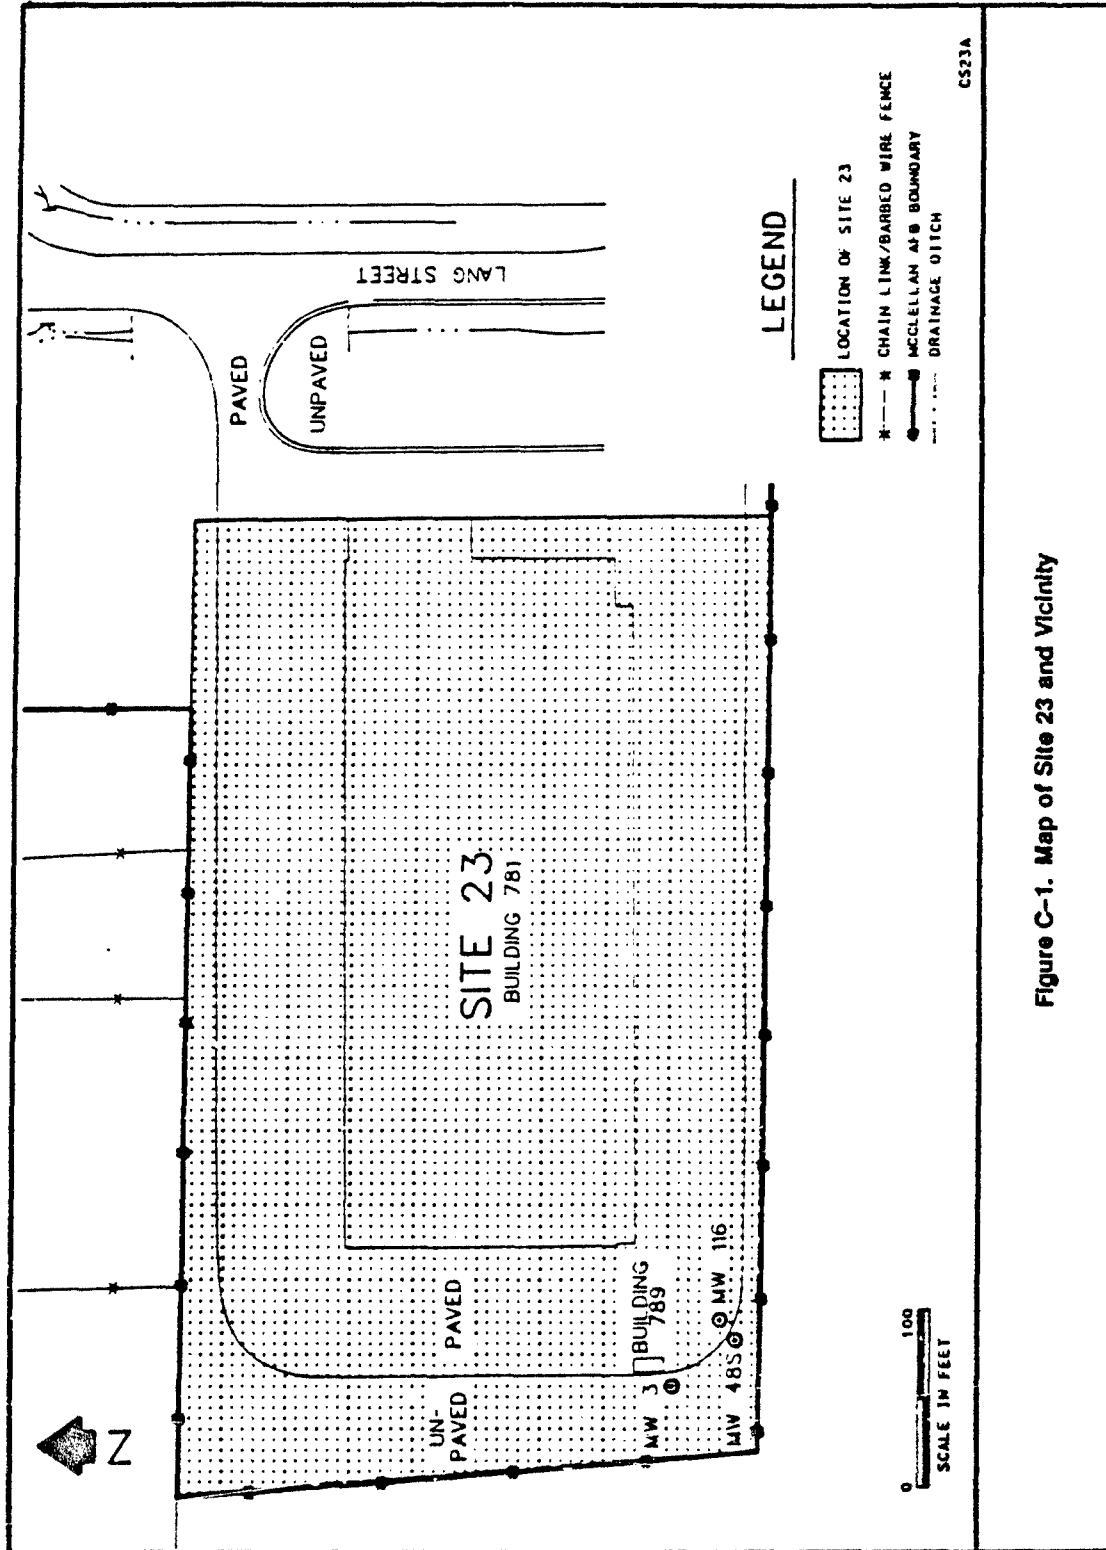
Figure C-1. Map of Site 23 and Vicinity

Odors, discolored soil, or buried debris were noted in 7 of the 10 borings. The odors were described as "slight solvent/sewage" odors. Debris and discolored soil was found to 24 feet BGS.

Inspect the water lines in the vicinity of Site 23 to determine if they are leaking. If leaks are found, they should be repaired to reduce further transport of contaminants in the soil. Collect and analyze additional soil samples to further characterize the extent of contamination.

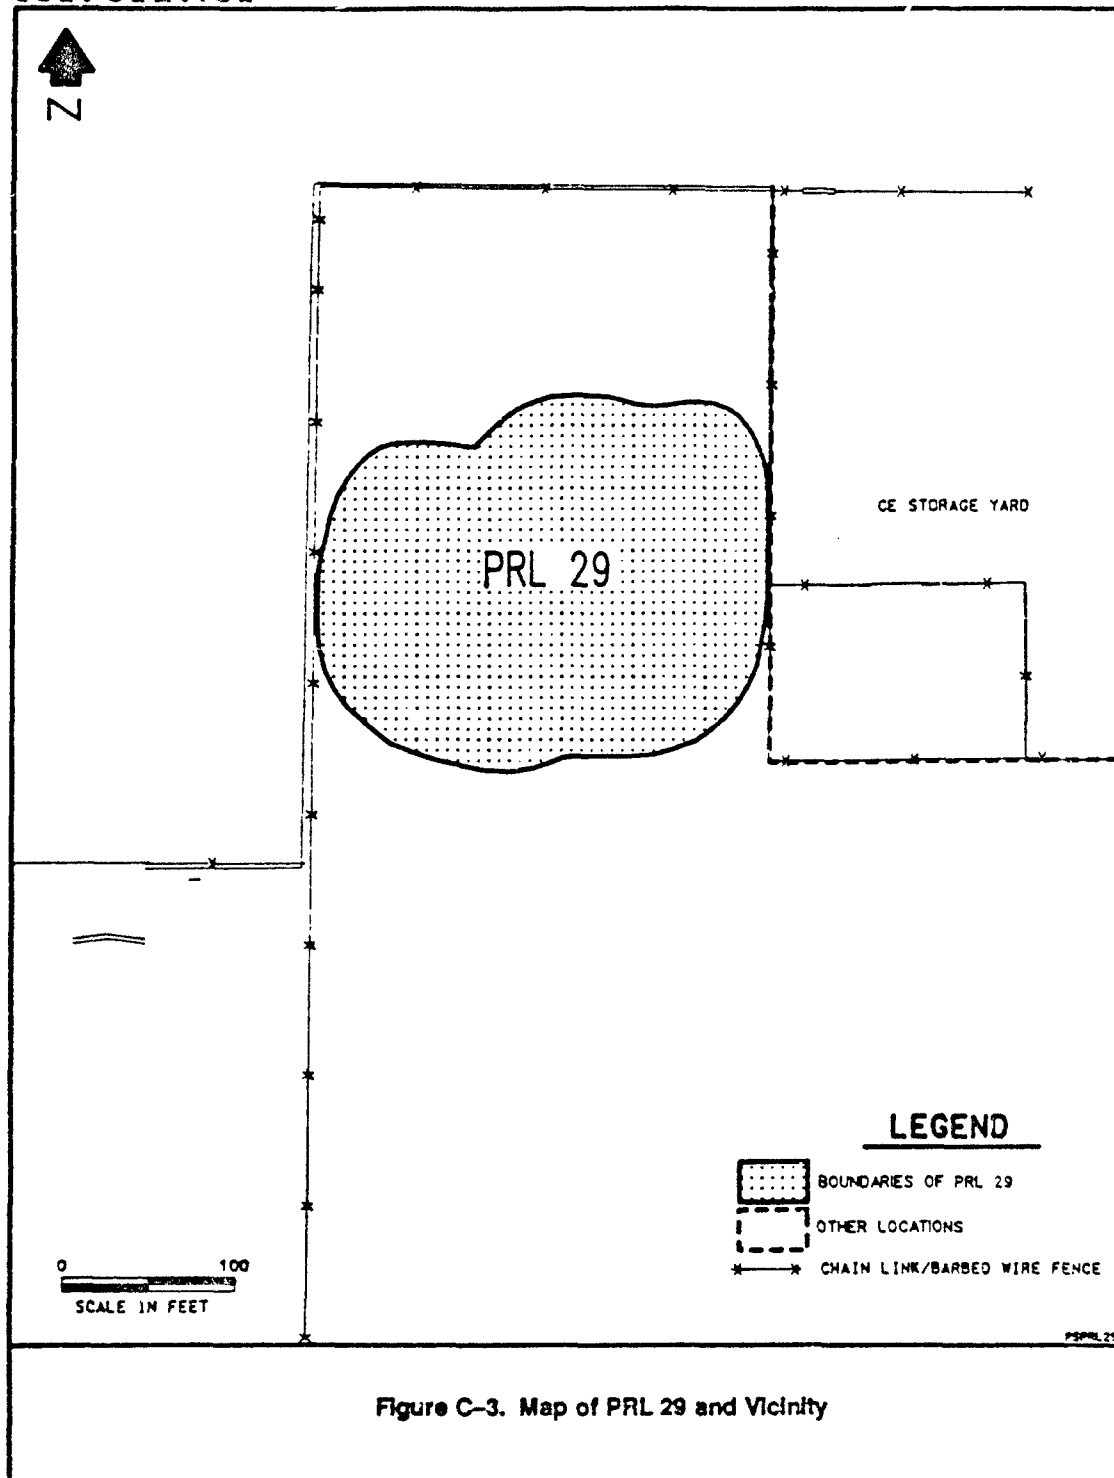
Figure C-3. Map of PRL 29 and Vicinity

Odors or visual evidence of contamination noted:  
None.

Collect and analyze soil samples to determine if contamination exists.

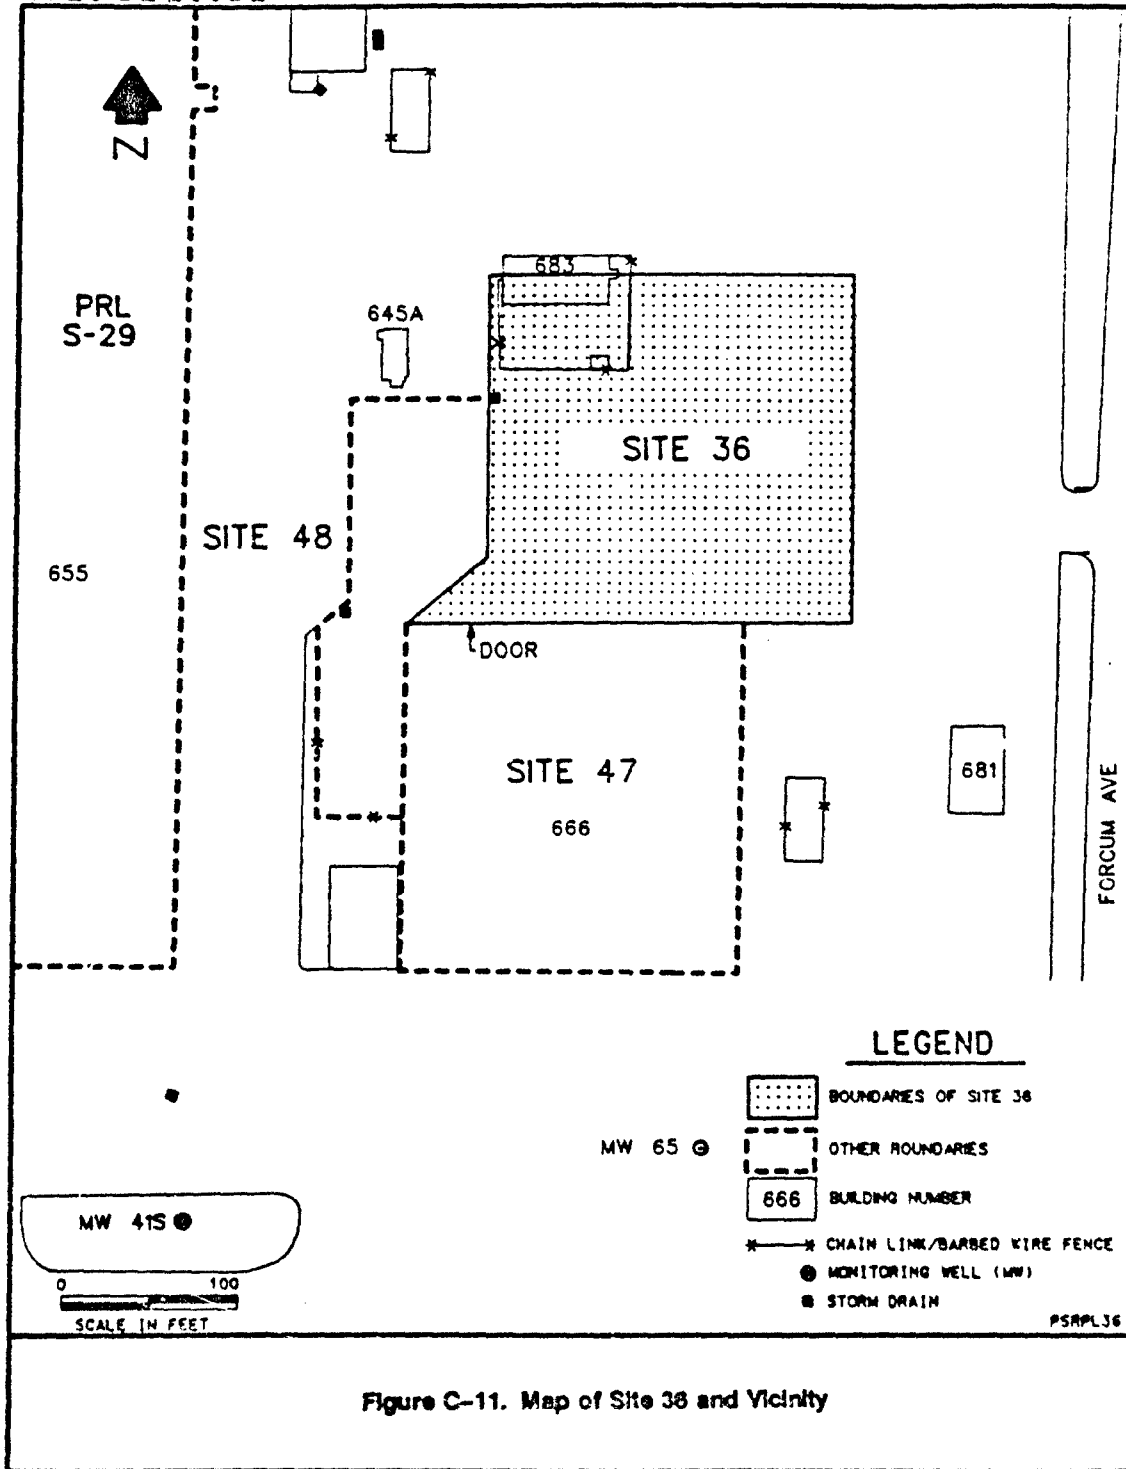
Figure C-11. Map of Site 36 and Vicinity

Discolored soil was noted between 3 and 7 feet BGS in Boring 48SAP03.

Collect and analyze near-surface soil samples for VOCs, semivolatile organic compounds, metals, and pH to further characterize the extent of contamination. Collect samples of the soil outside of the door on the north side of Building 666 to determine if contamination is present. Install an on-site monitoring well to determine if contaminants have migrated to groundwater. Conduct the RI of Site 36 and Sites 47 and 48 collectively.

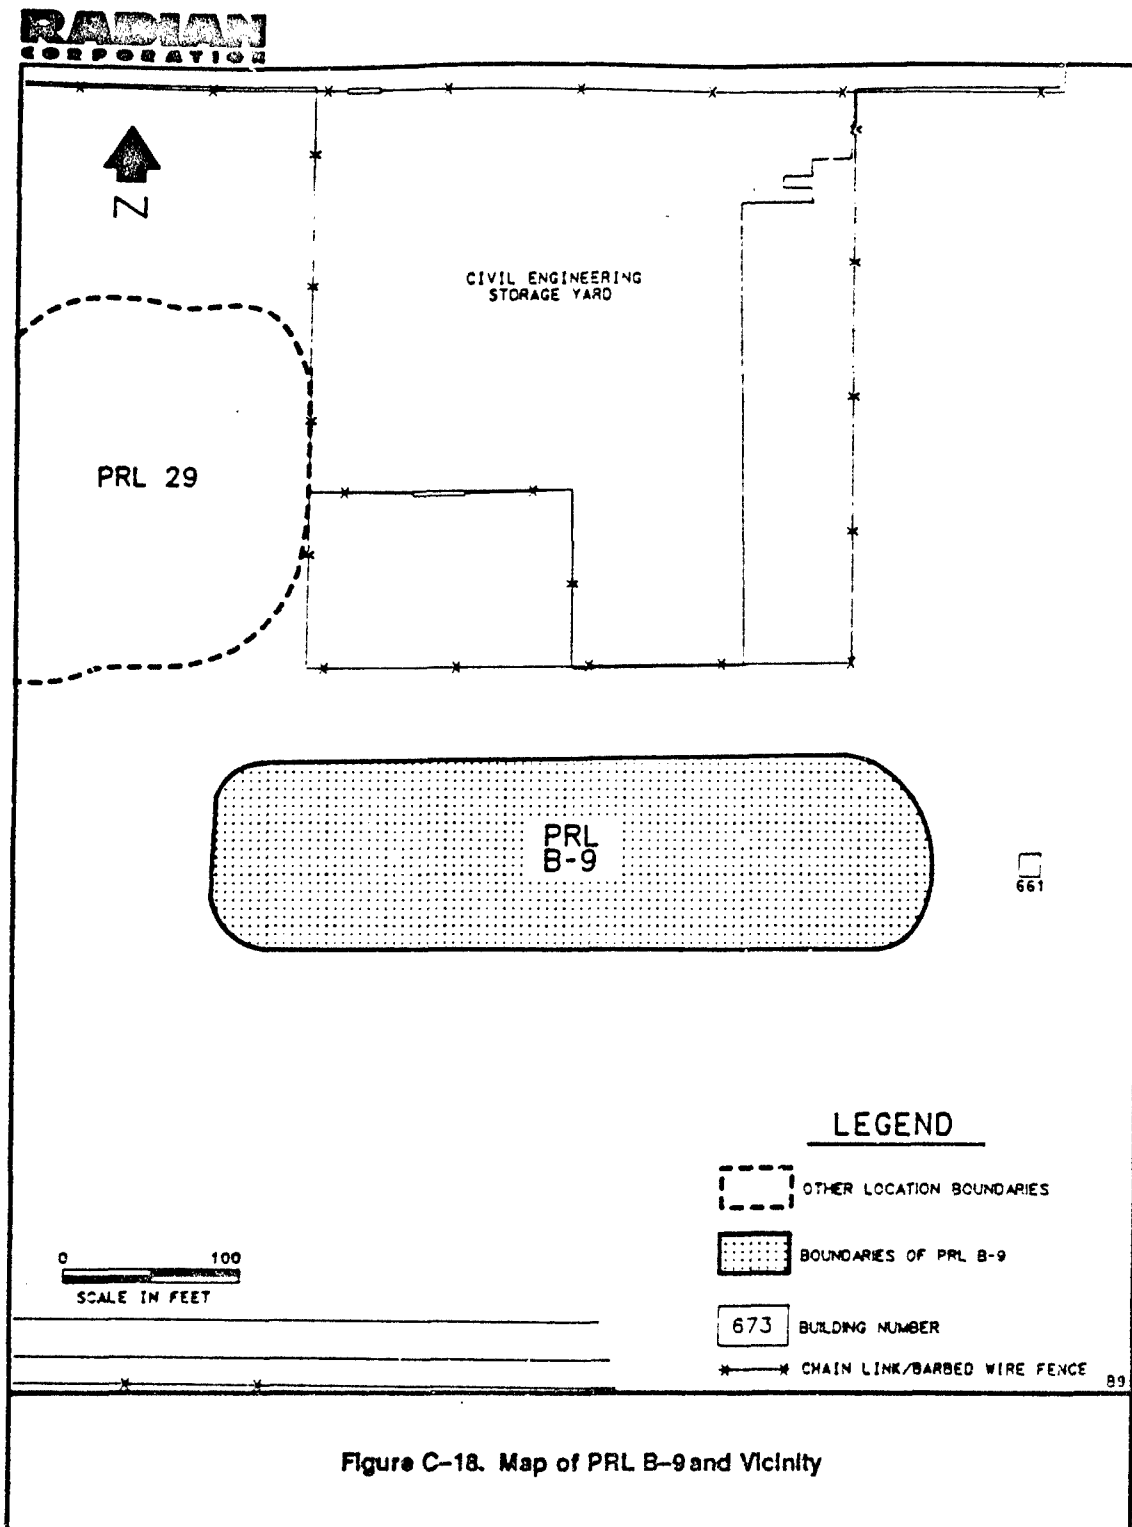
Odors or visual evidence of contamination noted:  
None.

No soil gas readings were taken.

Remove from list of Potential Release Locations. No further action is required because there is no evidence a burial pit existed at the location and there is no indication that hazardous materials have been handled at the location.
