NAVAL BIODYNAMICS LABORATORY  
NBDL-91R003

## HUMAN FACTORS ASSESSMENT OF USCG 47-FT MOTOR LIFEBOAT

Technical Report

October 1991

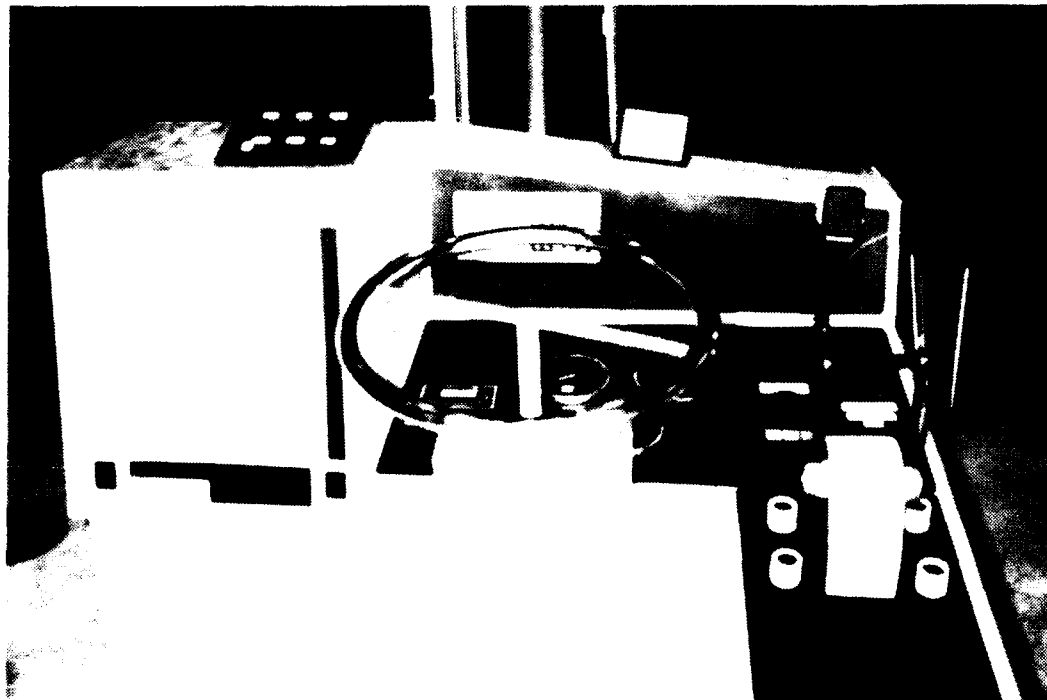
**Figure II.1b.** Proposed starboard steering station on open bridge.

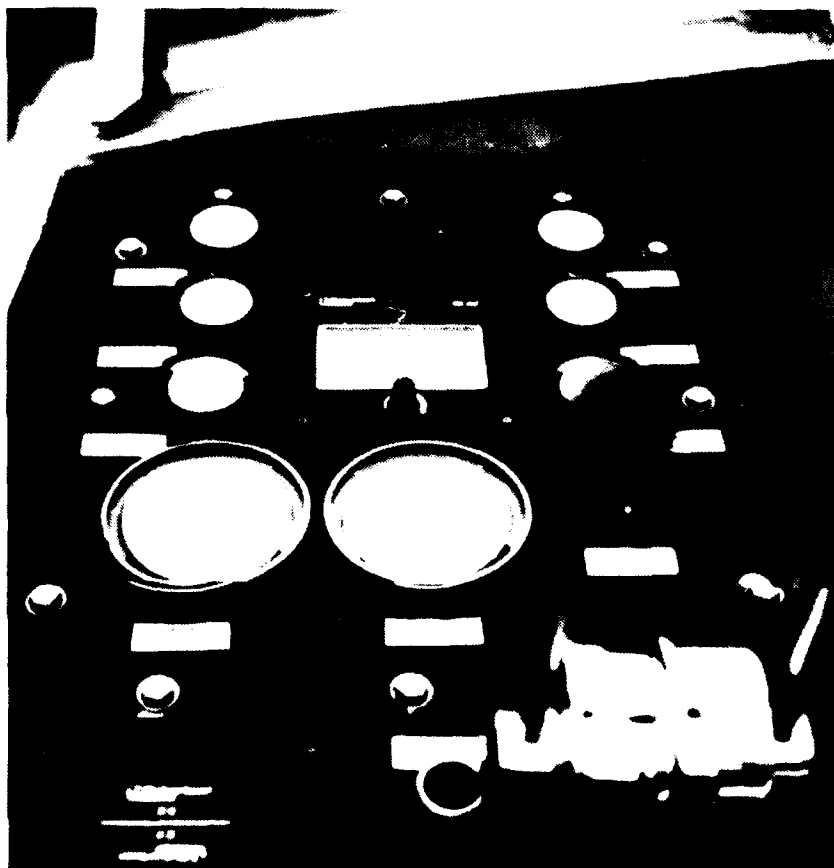
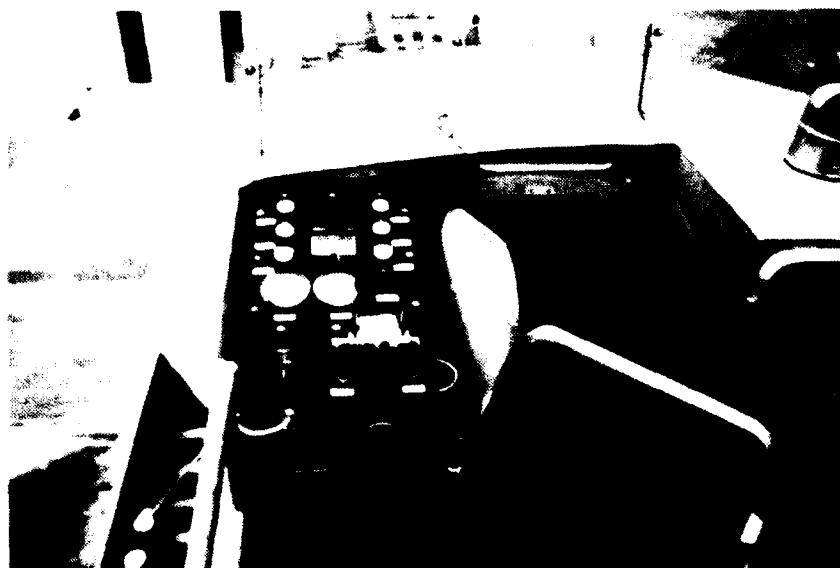
**Figure II.3.** Port steering station open bridge.

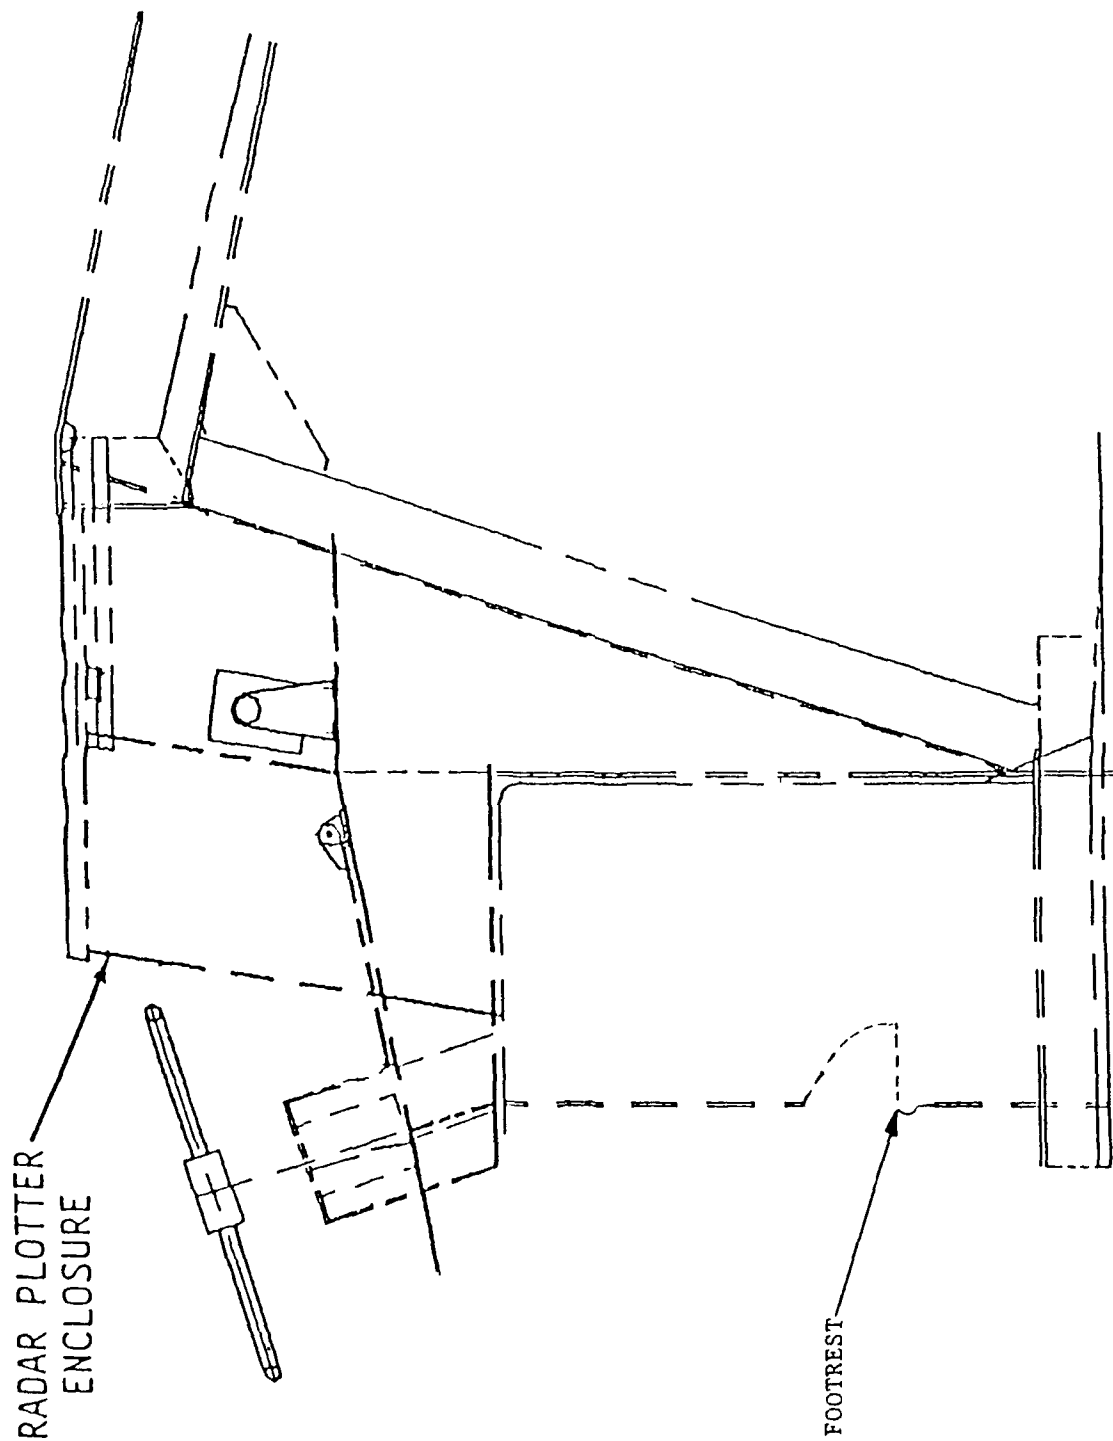
Figure II.8. Proposed footrest on open bridge starboard steering station.

- Footrests are required in order for crew personnel to brace themselves during rough sea conditions; footrests in two positions would increase the safety of the members in the OB. In addition, providing footrests would decrease overall fatigue.
- Firmer padding is required, similar to the padding needed in the EB chairs.
- The bench-like seat located starboard and aft of the coxswain chair appears to be adequate for crewmembers. However, in rough seas, handholds are necessary for crew to brace themselves.

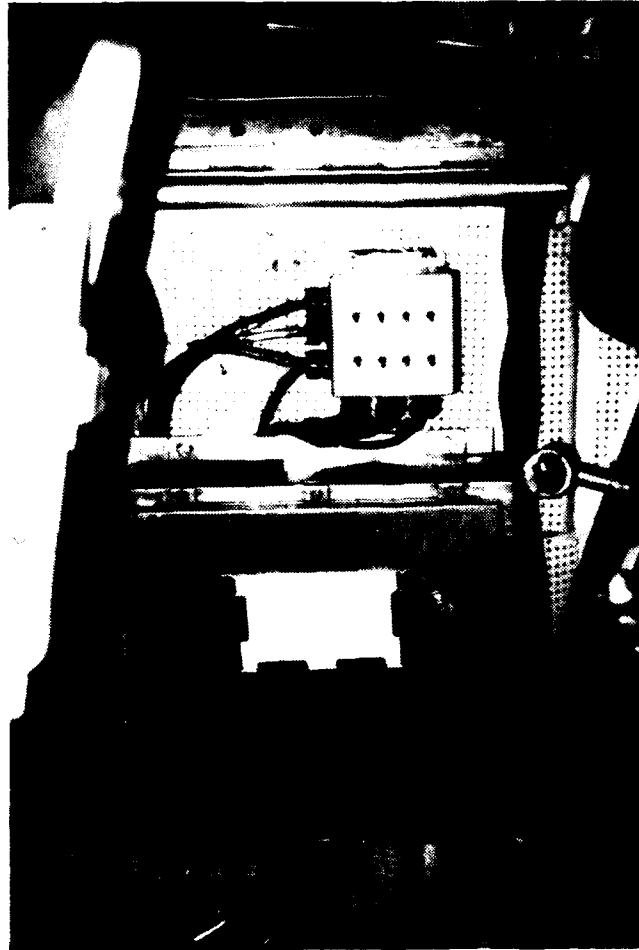
- The jump seats as presently configured are inadequate for crew use. They are in an unsatisfactory location and block the movement of the two coxswain chairs. The starboard jump seat, for example, must be stowed in order for the coxswain to exit the chair.

**Figure II.13.** 12 volt DC panel starboard bulkhead of enclosed bridge and starboard jump seat.

- Problem:**
- The seats are only marginally serviceable. The hinge brackets on the seats do not allow passengers and crew to lie across the seats.
- Approach:**
- Replace jump seats with fold-down type benches.
  - Assure that standard anthropometric measurements are utilized in the design of the replacement benches.

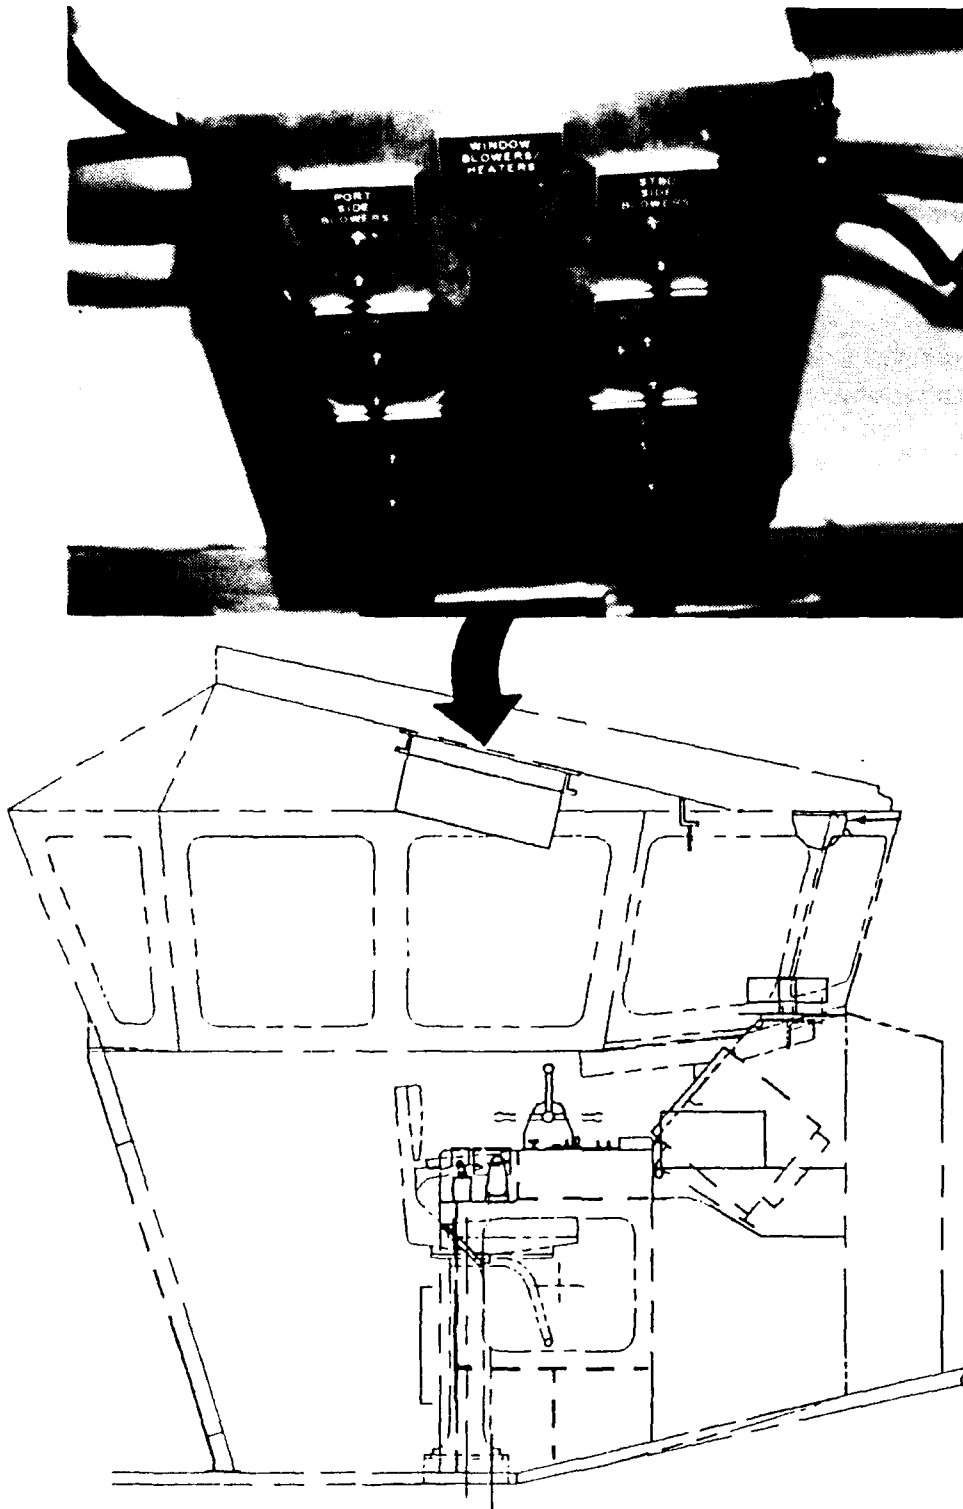
Figure II.22. Window/heaters junction box in enclosed bridge overhead.

- Provide a locking mechanism on the hinged windows that is shock and vibration resistant. Remove the plate covering the lower window frame. Redesign the window latching mechanism to ease the operation of the window and label the correct movement of the latch handle to open and close the window.

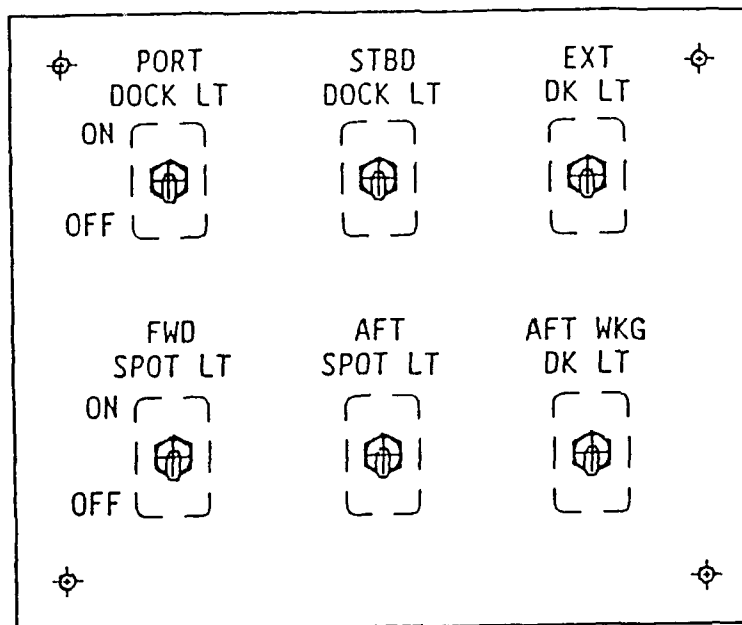
**Figure II.24a.** Current navigation and lighting switch panels on open bridge

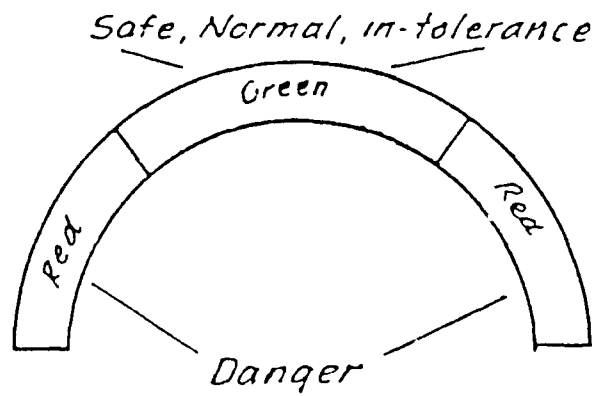
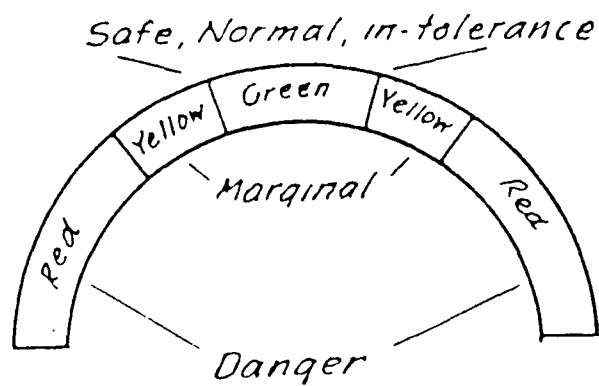
- The green-red combination used on the current tachometer gauge is adequate in discriminating between the safe and unsafe rpm limits of the engine. However, it may be recommended that a third color be used in the gauge display. For example, the color yellow can be used to indicate marginal operating parameters. Figure II.26 illustrates both the current and the proposed color coding configurations for the tachometer gauges. The standard colors can be used for both round and half round gauges (discussed above).
- Situational factors (low ambient light/illumination, inclement weather, operator workload) will have negligible effects on the reading of the color coded tachometer gauges.

Figure II.26. Color codes for engine indicators.

- The color coding of the tachometers gauges should be painted on the face (interior) of the gauge once the tolerance limits have been determined by test crew engineers. This would protect the color coding from inclement weather, water, moisture, and conditions of extreme heat or cold. The use of plastic colored strips is not recommended.
