| 4. TITLE AND SUBTITLE<br><br>Human Factors Assessment of USCG | | | | 5. FUNDING NUMBERS<br><br>69X0243 | |
| 7. PERFORMING ORGANIZATION NAME(S) AND ADDRESS(ES)<br><br>Naval Biodynamics Laboratory<br>P. O. Box 29407<br>New Orleans, LA 70189-0407 | | | | 8. PERFORMING ORGANIZATION<br>REPORT NUMBER<br><br>NBDL-91R003 | |

This report documents the ergonomic and safety deficiencies noted 14-16 November 1990 during an on-site familiarization and inspection of the prototype USCG 47-ft motor lifeboat (MLB). The following human factors problem areas are addressed: steps, platforms, and railings (including ladders); doors, hatches, and passageways; controls; instruments and displays; workspace; and habitability considerations (including chairs).

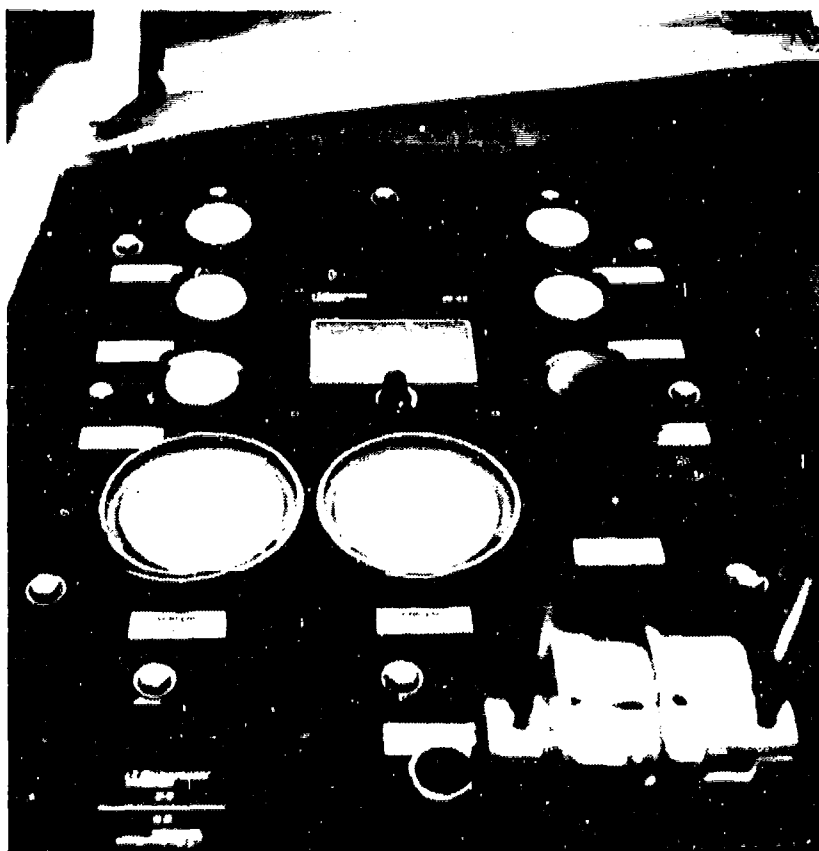
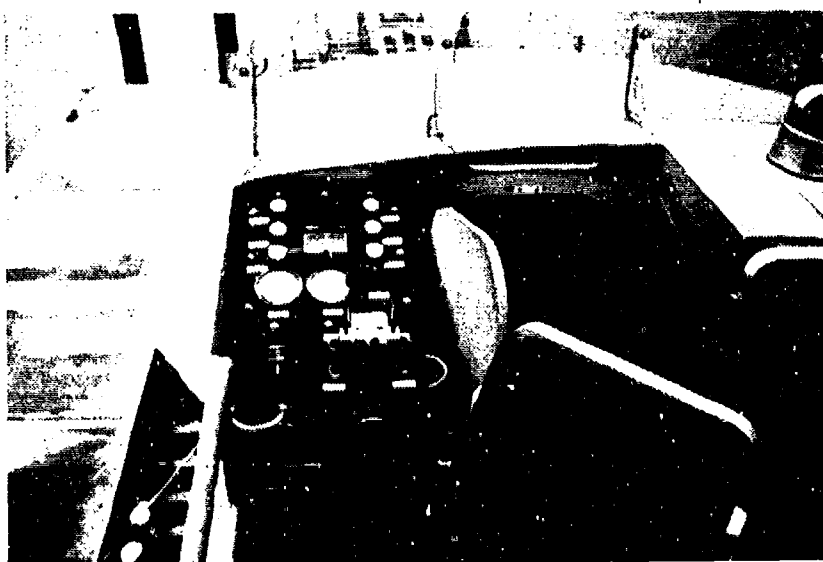
Figure II.3. Port steering station open bridge.

- For example, the throttle control in its proposed position is on the same side as the engine indicators and the tachometers. Obviously, the throttle control is related to the indicators and the tachometers. Related functions should be arranged together so that their association is readily apparent to the operator. It is recommended that when a panel display is affected by a particular control, the display and control should be located near each other.

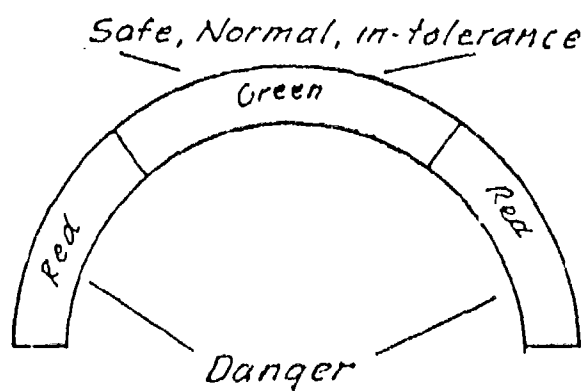
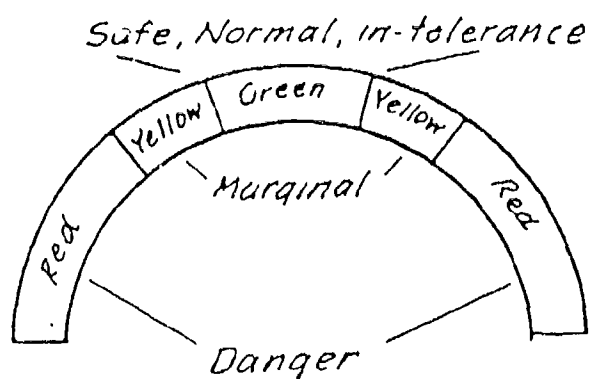
Figure II.26. Color codes for engine indicators.

- The green-red combination used on the current tachometer gauge is adequate in discriminating between the safe and unsafe rpm limits of the engine. However, it may be recommended that a third color be used in the gauge display. For example, the color yellow can be used to indicate marginal operating parameters. Figure II.26 illustrates both the current and the proposed color coding configurations for the tachometer gauges. The standard colors can be used for both round and half round gauges (discussed above).
- Situational factors (low ambient light/illumination, inclement weather, operator workload) will have negligible effects on the reading of the color coded tachometer gauges.

- The color coding of the tachometers gauges should be painted on the face (interior) of the gauge once the tolerance limits have been determined by test crew engineers. This would protect the color coding from inclement weather, water, moisture, and conditions of extreme heat or cold. The use of plastic colored strips is not recommended.
