DOT/FAA/RD-91/1

**Composite Profiles of  
Helicopter Mishaps at  
Heliports and Airports**

January 1992

Final Report

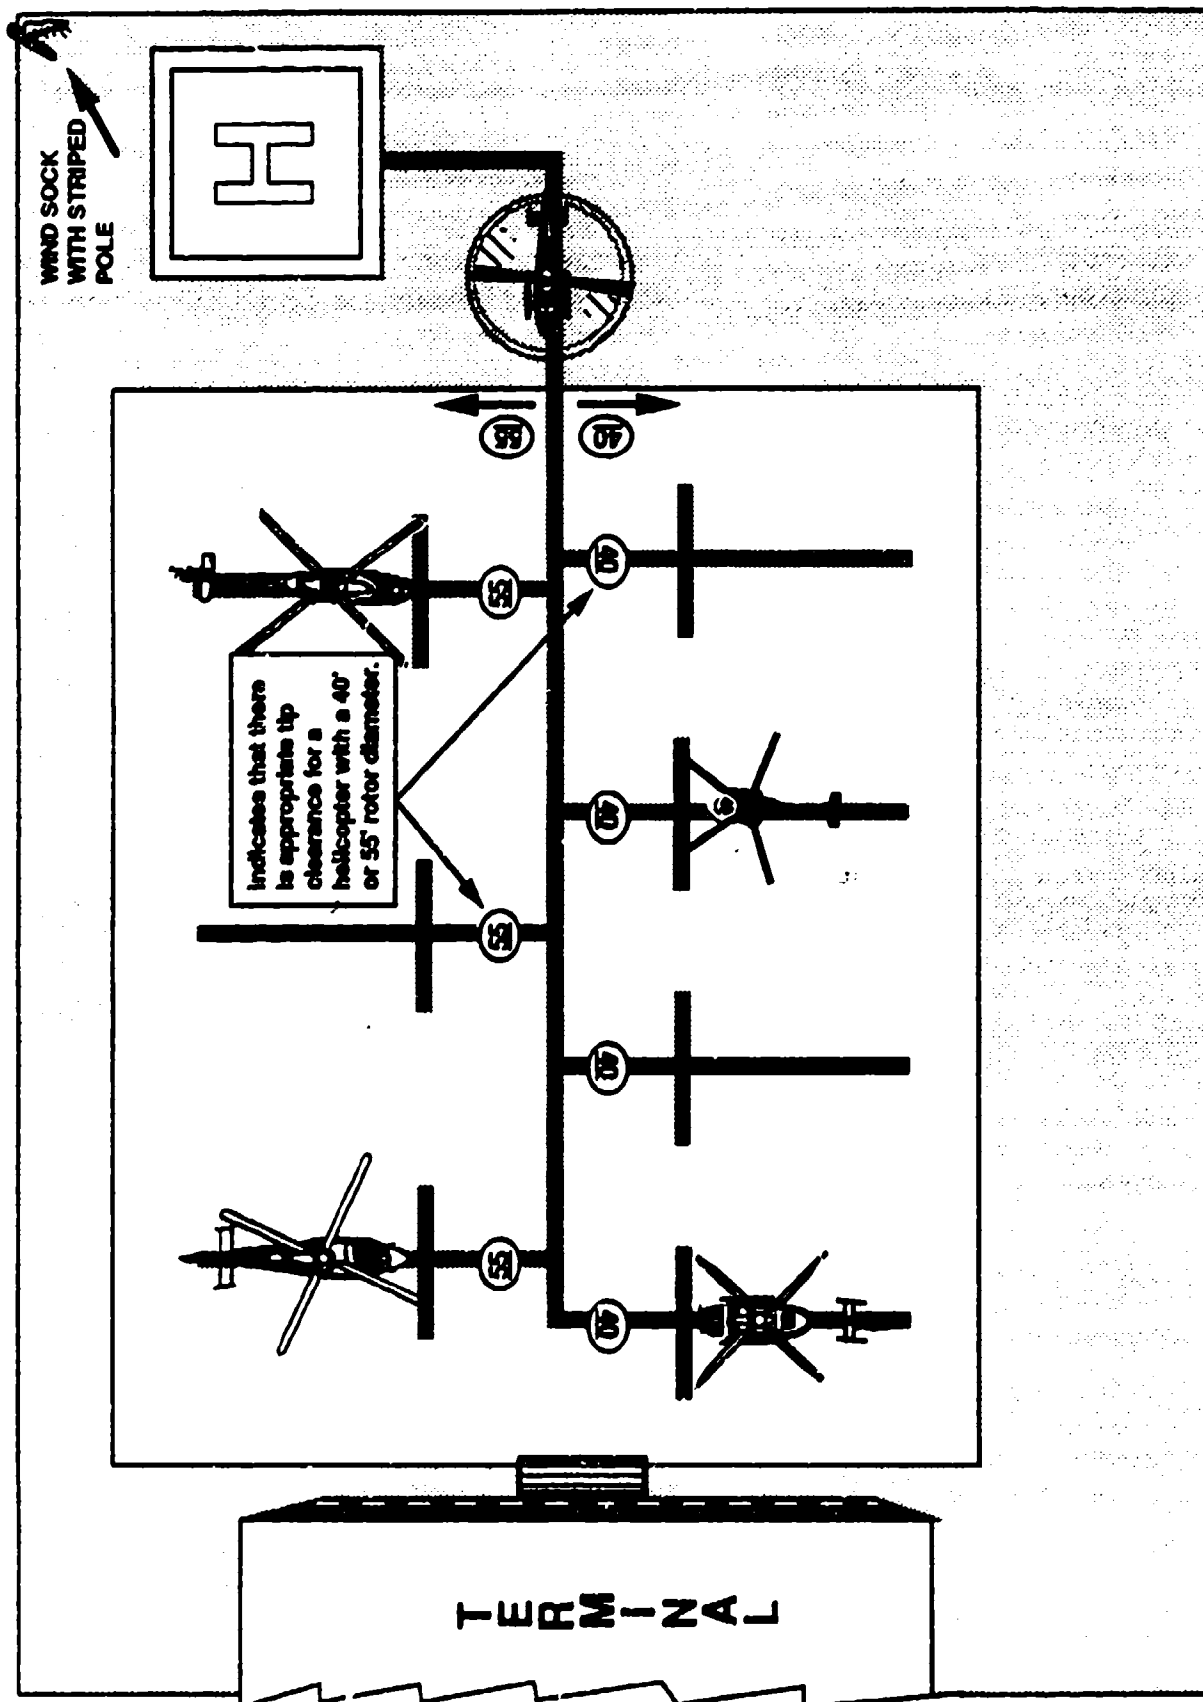
FIGURE 17 IMPROVED HELIPORT DESIGN - ADEQUATE PARKING AREA SIZE

Complacency/Vigilance - The fact that the UNICOM operator had the approved parking space diagram and appropriate designation at his disposal, and that he admitted familiarity with the maximum sizes and helicopter types specified but did not use them may indicate either a lack of professionalism, a certain degree of complacency, or that he may have been distracted at the time of the mishap. The mishap investigation did not indicate distraction as a possibility. Therefore, it is assumed that the "inadvertent" assignment of two large, multi-engine helicopters to the wrong parking spots was due to complacency or an inadequate appreciation of the situation. This may have been caused by a lack of training or vigilance regarding the specified parking procedures.

Communications - Even when radio communications are used, UNICOM operators are not certificated as air traffic controllers, and their information is considered advisory in nature. However, the rather casual suggestion of "spot 3 or 4" and the lack of more specific phraseology by both the helicopter crews and the UNICOM operator may have contributed to the use of non-standard parking procedures. Fixed based operators (FBO's) should consider providing basic parking information to the pilot such as the parking space designator and what diameter rotor system can be accommodated in that spot. This information should be adjacent to the parking space and painted so that it can be clearly seen under all light conditions.

Marking - The fact that both helicopters parked off the parking space centerline contributed to the cause of the accident. To facilitate placement of the aircraft at the center of the parking space, centerlines and cross lines need to be clearly marked and visible to the pilot of a taxiing helicopter. Figure 17 depicts the heliport with design improvements that enhance safety.

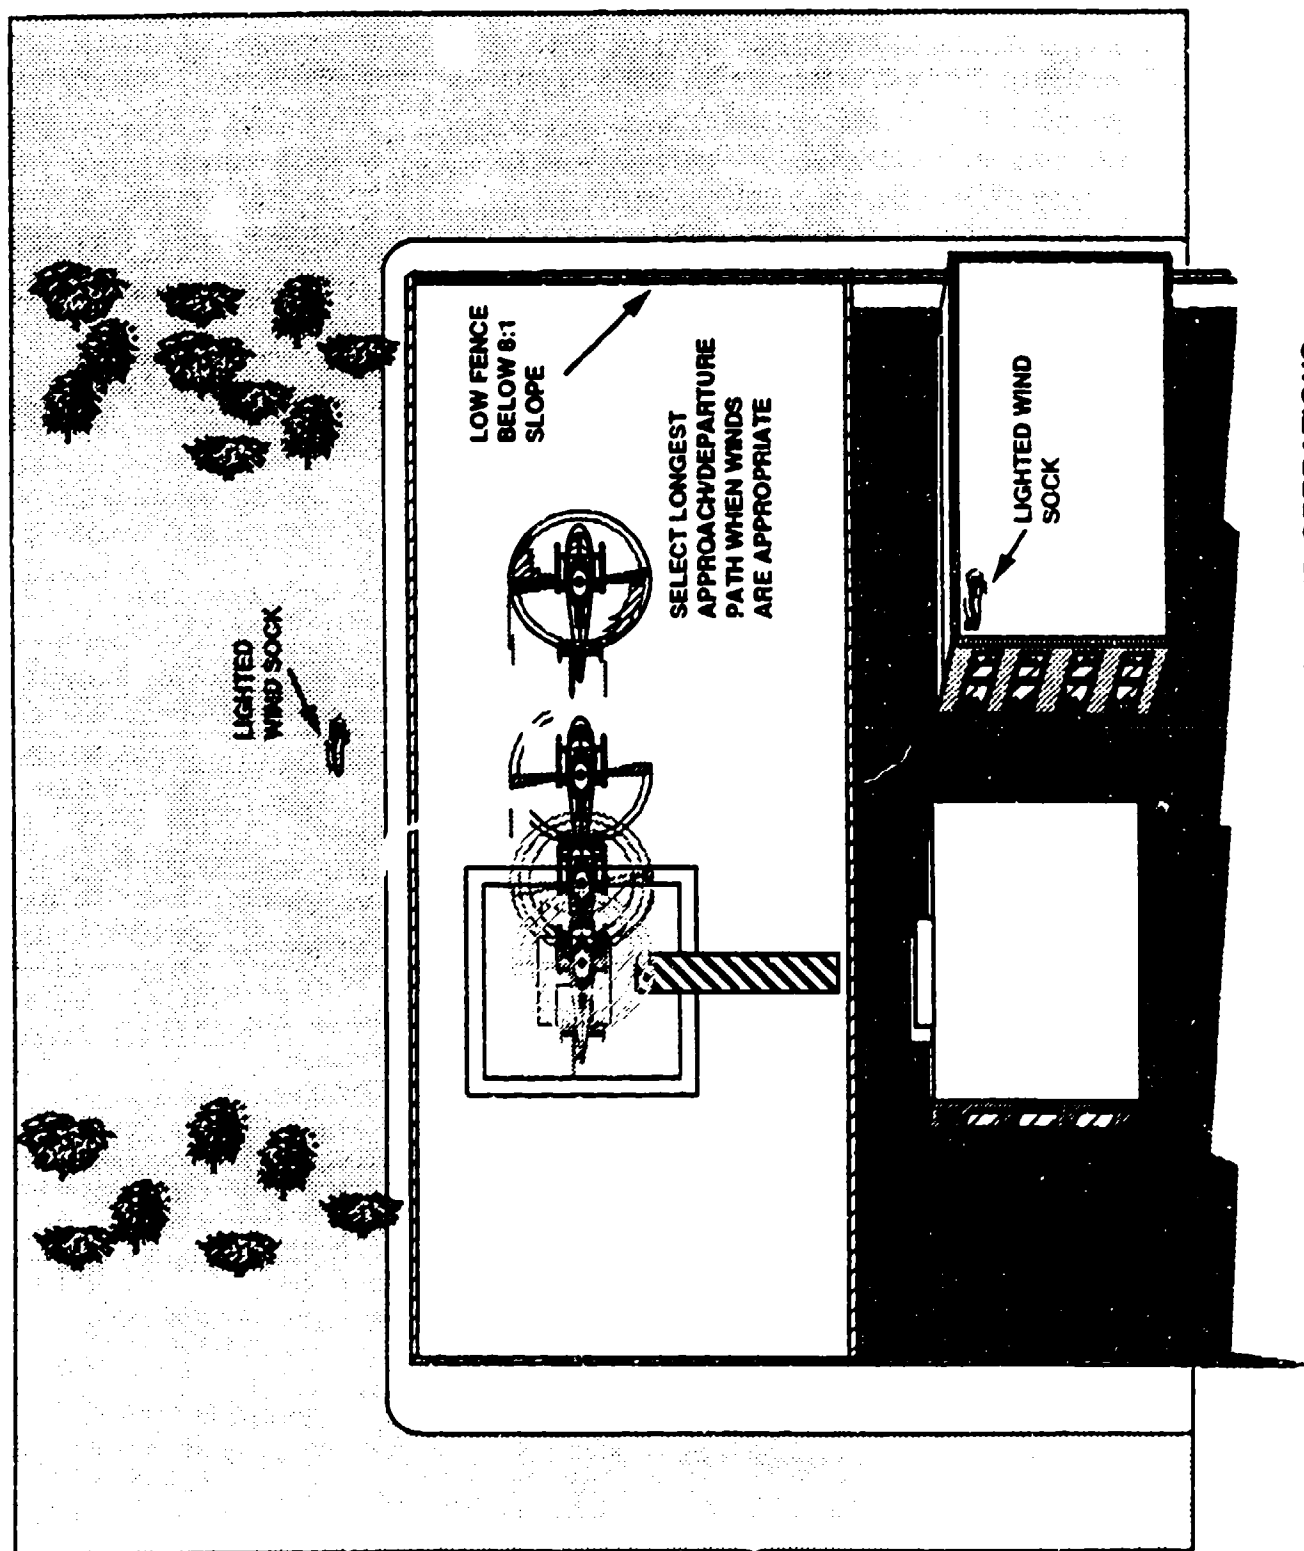
FIGURE 23 IMPROVED HELIPORT DESIGN AND OPERATIONS

Mechanical Failure - Catastrophic engine failures, fuel control malfunctions, bearing failures, and compressor mount fractures have contributed to engine failure/malfunction during takeoff. Since these events are generally survivable, it is important to consider the possibility of their occurrence during heliport design.

Approach/Departure Path - At first glance, the takeoff flight path chosen by the pilot and depicted in figure 22 seems unreasonable. Even though a departure path perpendicular to that flown would have given the pilot more room, mishap data shows that pilots do not always choose the most appropriate approach/departure path. The obvious lesson here is that pilots should give themselves as much leeway as possible in all situations. A good rule of thumb to remember is that "short cuts generally short cut safety."

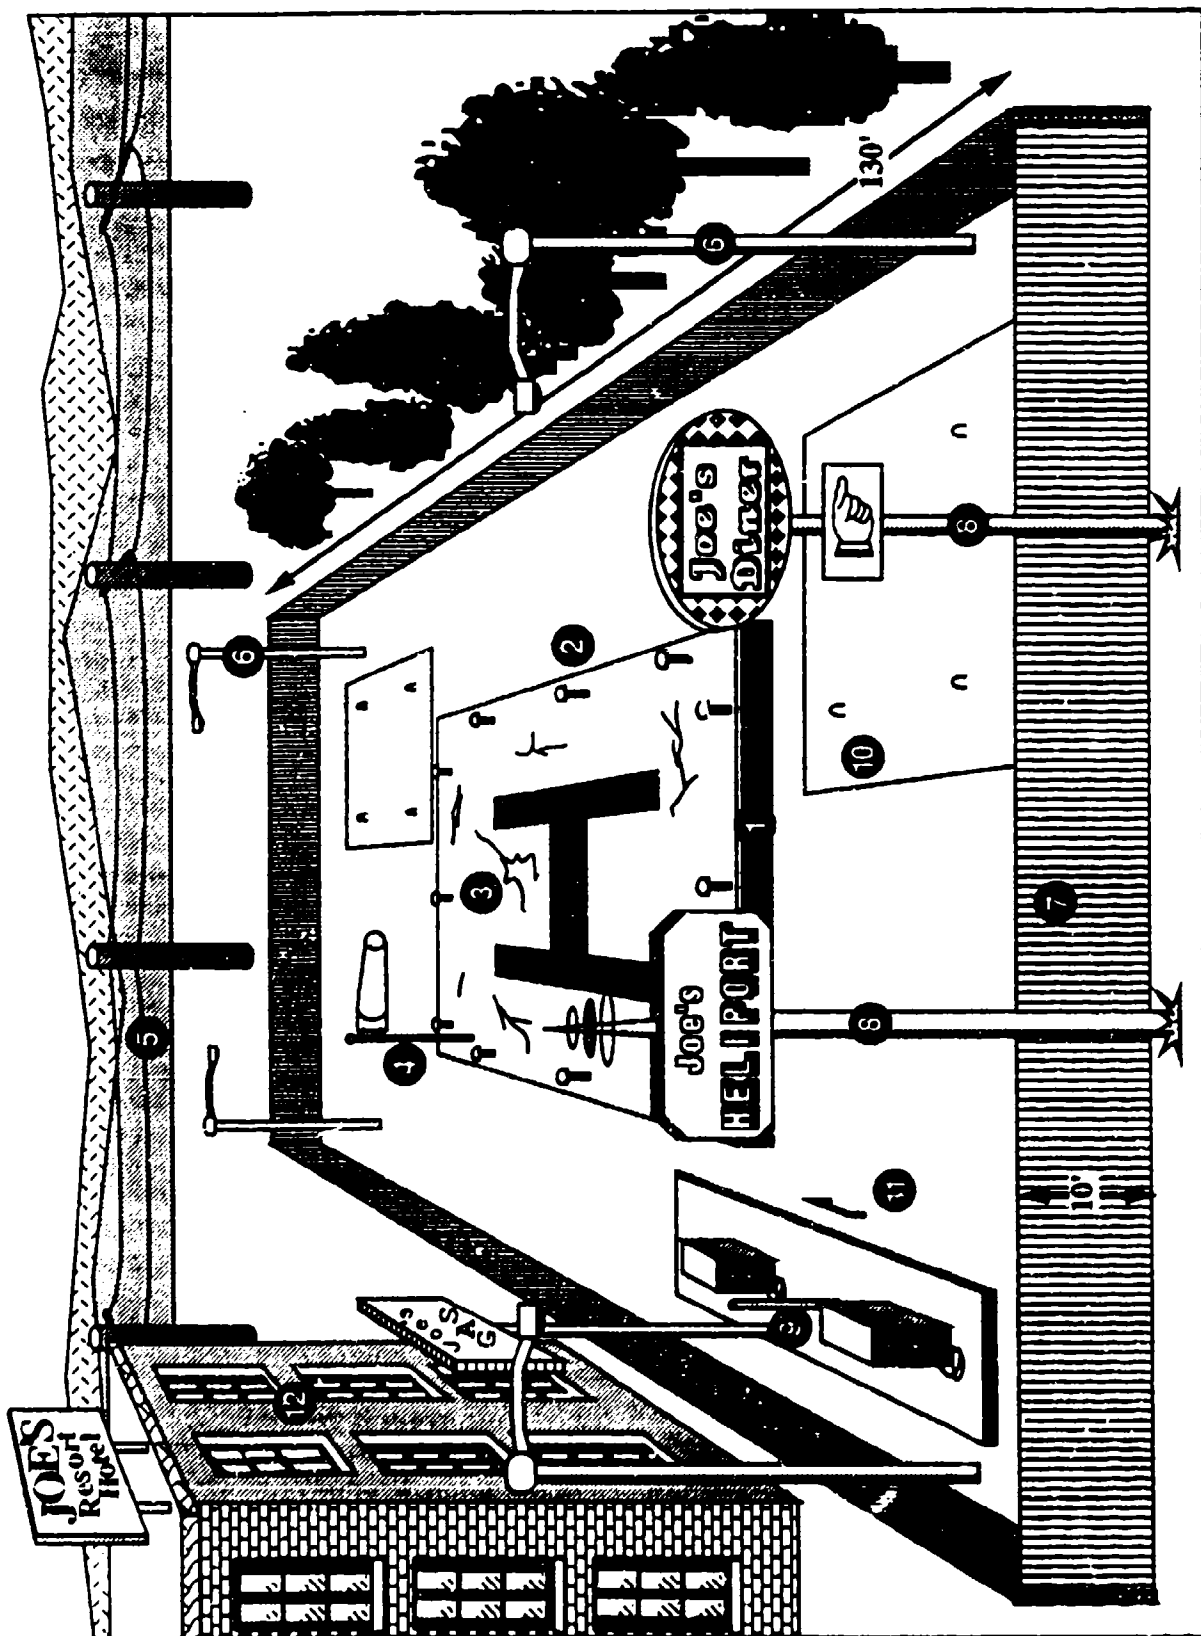
FIGURE 35 PROPOSED HELIPORT DESIGN

Figure 35 is a diagram that was submitted with the heliport approval application. Your assistant has numbered the design features that she thinks may be safety hazards. She also developed table 2 which includes the corresponding number of the items, as well as the items themselves that are of concern to her. Your task is to fill in the description column in table 2 for those items that you feel represent safety hazards. You must also fill out the recommendation letter (figure 36) that your company will send to the county commission. The correct answers are provided in appendix A and appendix B. Good luck!!
