WL-TR-91-4032  
DOT/FAA/CT-91/23  
VOL II, Part 3

COMPOSITE FAILURE ANALYSIS HANDBOOK  
VOLUME II - TECHNICAL HANDBOOK  
PART 3 - CASE HISTORIES

R.J. Kar  
Northrop Corporation  
One Northrop Avenue  
Hawthorne, California 90250-3277

February 1992

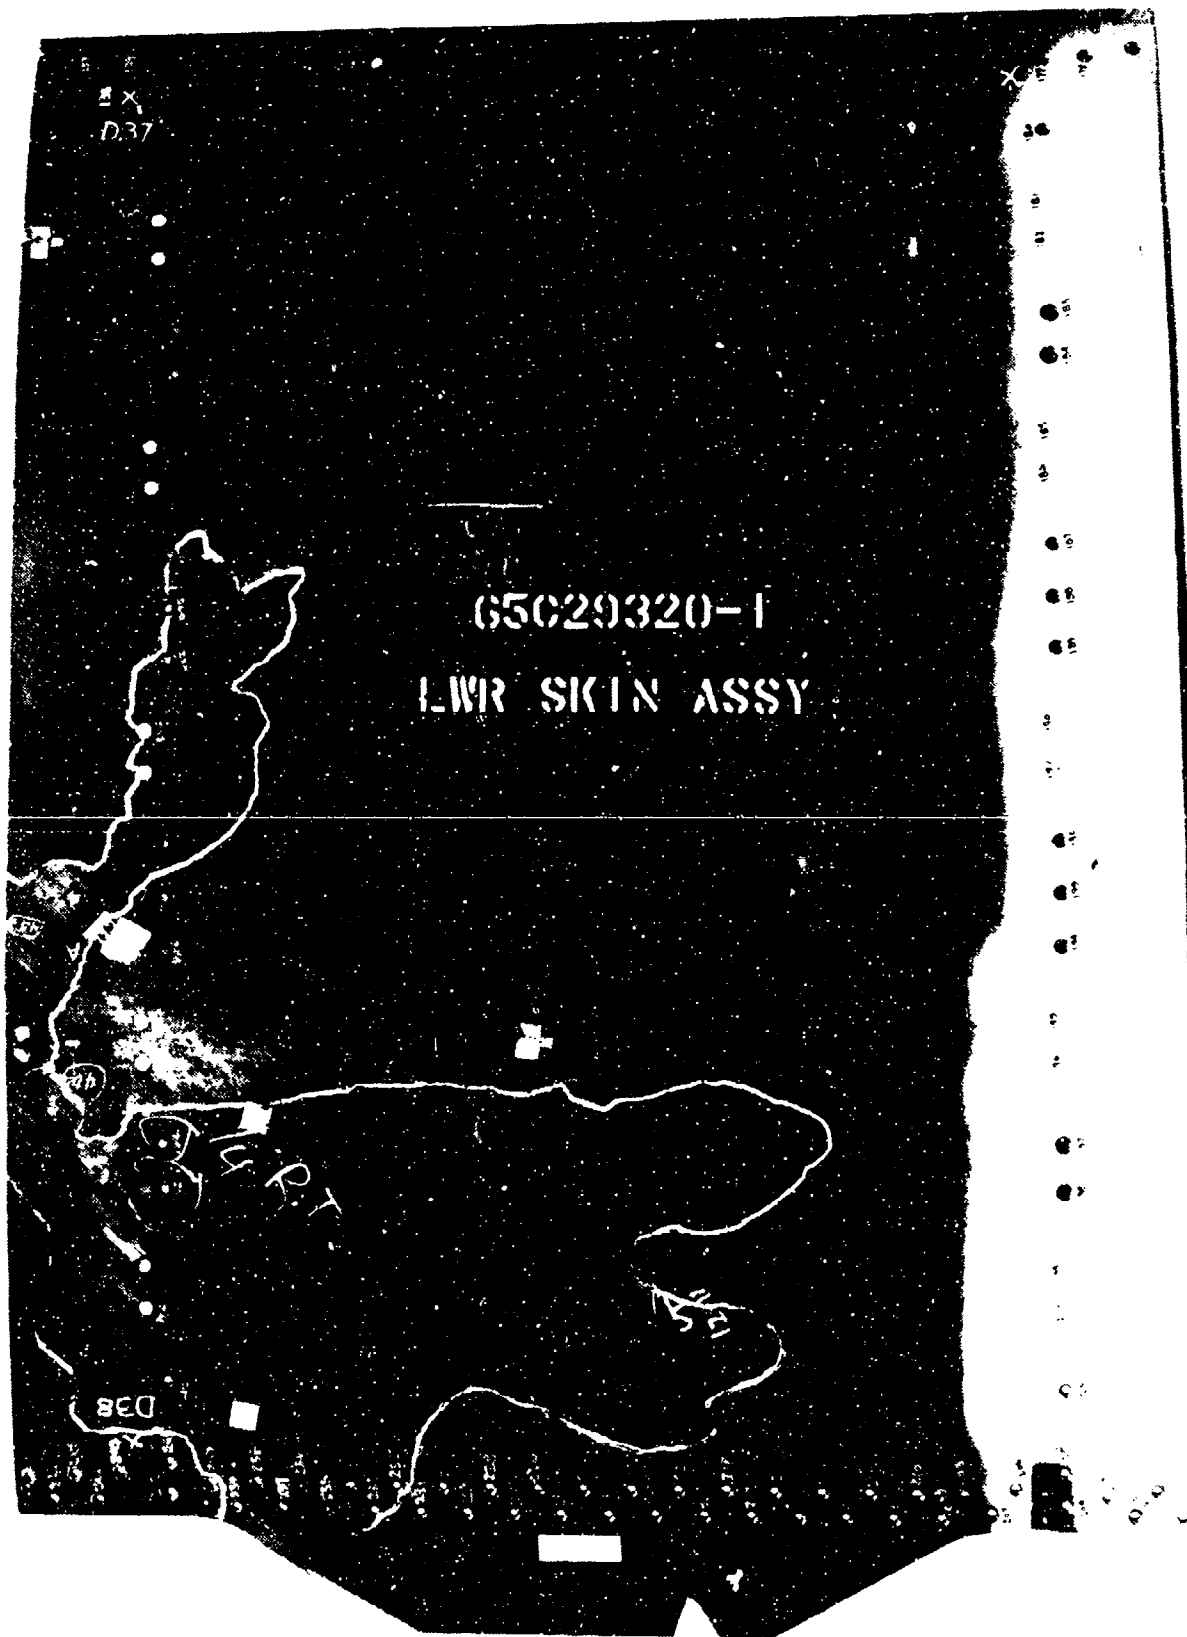
Figure 2-6. J4X Wing Test Box Lower Skin Surface

The lower skin surface, shown in Figure 2-6, was damaged in a similar manner to the upper skin, although to a lesser extent. The skin buckling also indicated a compressive loading. Since the stress prior to fracture was supposed to be tensile, the neutral axis between tension and compression must have shifted to below the lower skin surface during the failure process. As a result of these visual observations, it appeared that damage in the upper skin and spars occurred prior to cracking in the lower skin.

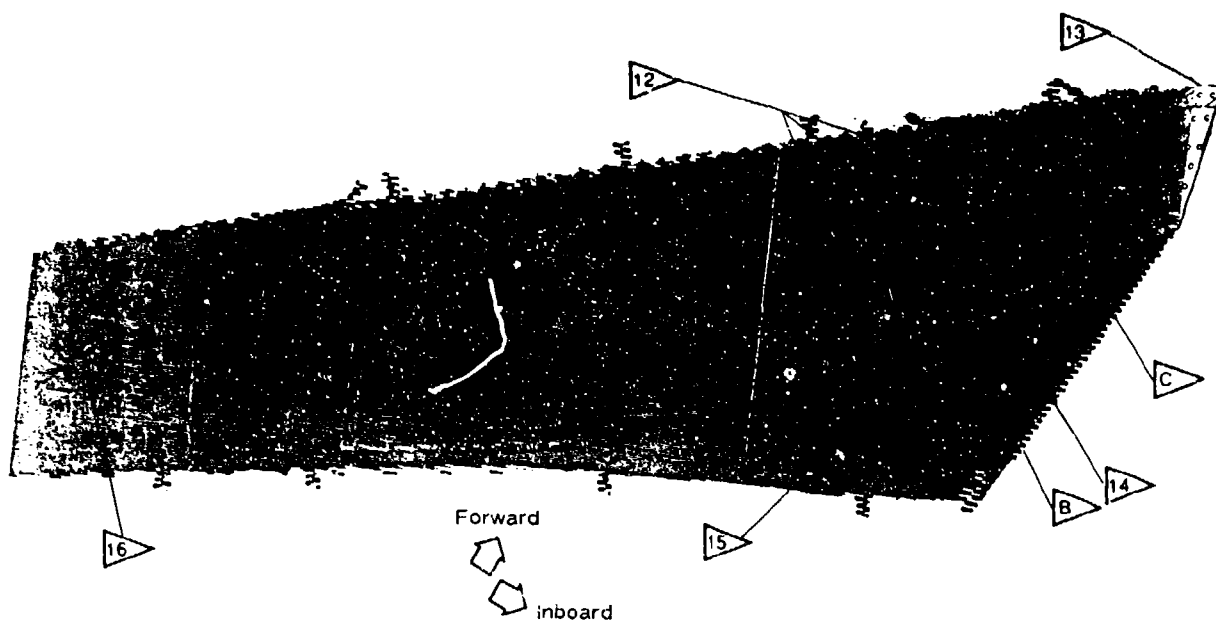
Figure 2-12. NDE Results of the Upper Surface

TTU analysis provided a through scan of the discontinuities along the upper and lower skins. The major delaminations and disbonds occurred along the inboard edge of the wing, with the exception of one donut-shaped delamination at the center of the wing. Figures 2-11 and 2-12 show

the TTU hard copy printout. The areas indicated by alphabetical flagnotes were delaminations or disbonds which were crack mapped during subsequent fractographic examinations. However, the areas shown with numerical flagnotes were defects indicated by X-ray, such as core to skin disbonds, core crush, and water in the core cells.

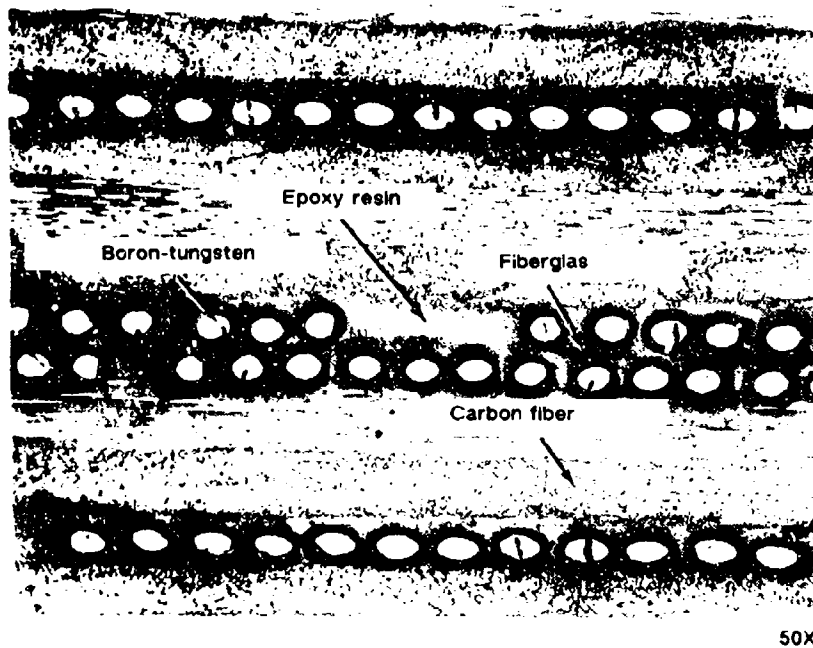
Figure 2-14. Photomicrograph of Zone B Cross-Section

The materials used to construct the wing were found to be carbon, boron-tungsten, and fiberglass fibers in an epoxy resin. These material constituents were identified by the following techniques: scanning electron microscopy, optical microscopy, electron probe microanalysis, and electron scattering for chemical analysis (ESCA). The fibers were identified by SEM, ESCA (Figure 2-13), and optical microscopy (Figure 2-14). The novalac based epoxy resin was identified by infrared spectroscopy.

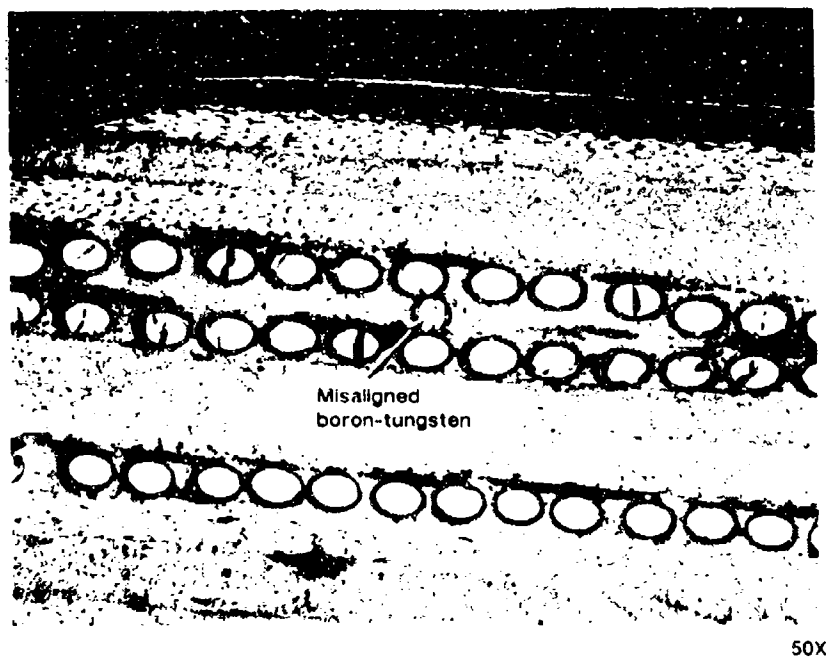
Figure 2-15. Cross-Section Illustrating Boron Fiber Misalignment Resulting in Resin-Rich Adjacent Regions

The ply orientation and number of plies were found to be consistent with engineering drawing specifications. Localized discontinuities such as resin-rich and resin-starved regions (Figure 2-15) were usually caused by misalignments of the extremely large boron fibers. A small amount of porosity was seen in the graphite/epoxy plies between the 0 and 90 degree plies. These discontinuities were not found to be associated with the delamination regions and therefore were not considered as contributory factors to the cause of part failure.

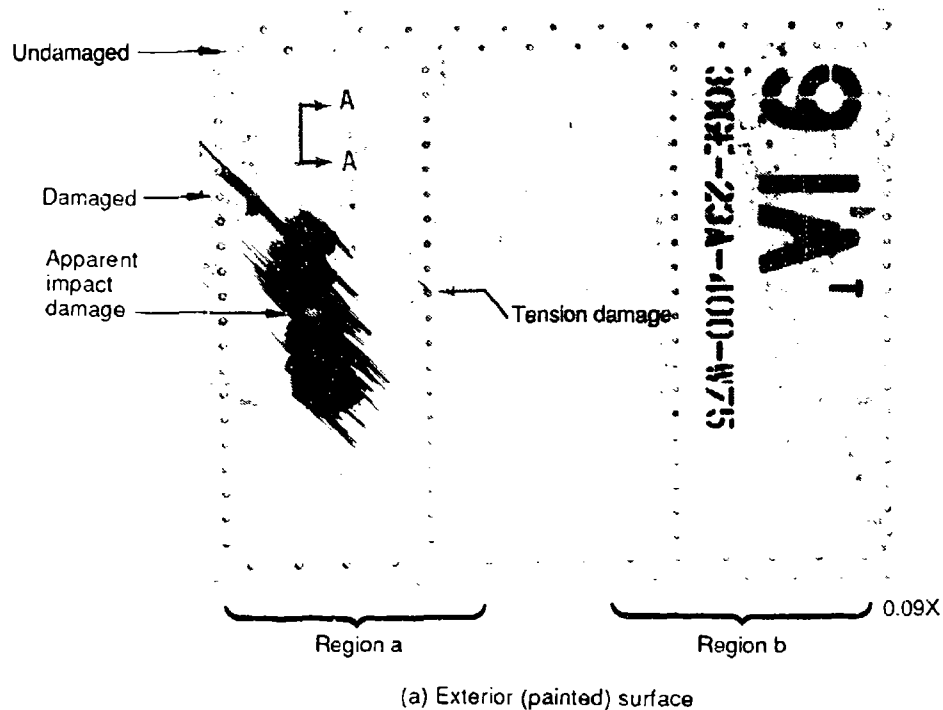
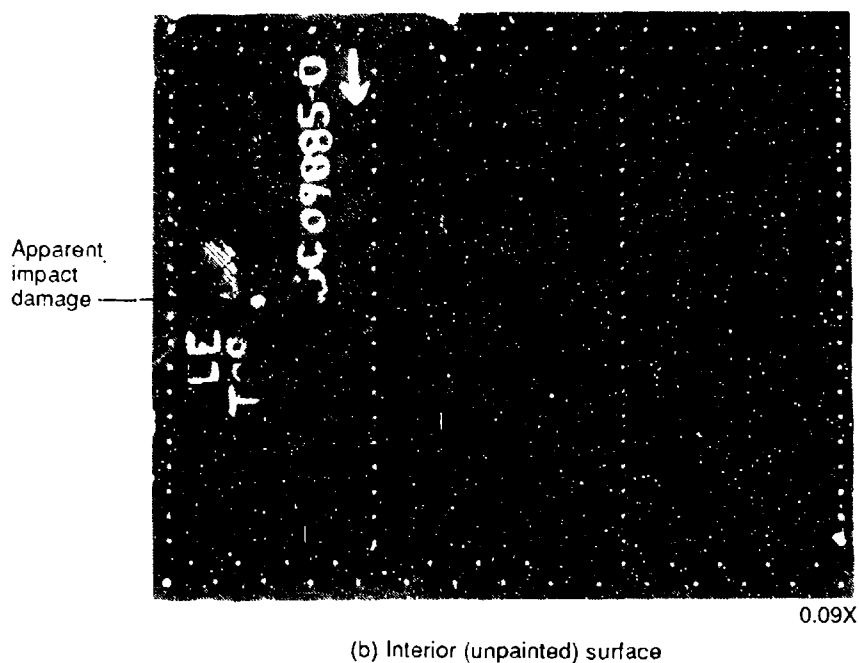
Figure 2-24. Photomicrographs of the Component As-Received

Figure 2-24 shows the fractured test panel in its as-received condition. The rectangular panel, with a dimension of 43 by 36 inches, appeared to have been fastened to one or more fixed structures during testing. Due to limited background information, the emphasis was placed on the visual examination. At the time of the part's receipt, it was speculated that the part had been fractured via impact loading. This speculation was made due to the appearance of the damage which was typical of that observed in impact loaded structures.

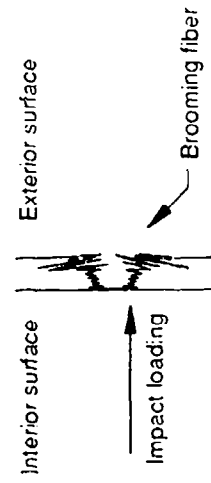
Figure 2-25. Apparent Impact Damage

As shown in Figure 2-25, the damage appeared to have been caused by an object penetrating through the panel from the interior surface (Figure 2-25a), as evidenced by the brooming fibers on the exterior surface (Figure 2-25b). These damage features are commonly observed in an impacted specimen.

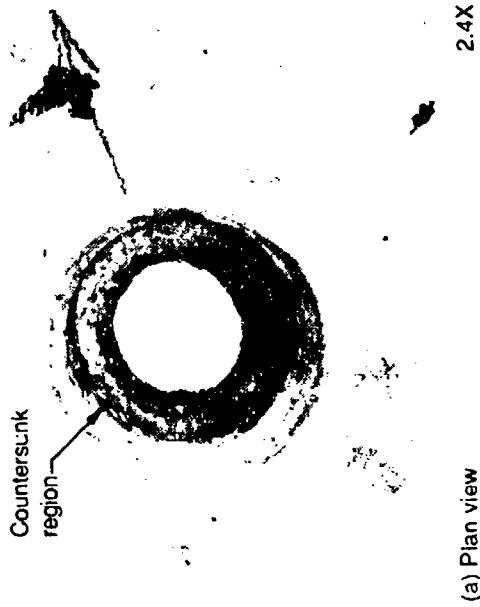
Figure 2-26. Damage in Fastener Hole Loaded Under Shear

In conjunction with stress analysis, visual examination was performed using fastener hole damage as evidence to determine the loading condition experienced by the panel during the test. The key evidence was the depth and elongation of the hole. In general, hole elongation indicates shear-type loading in which the head and the shank of the fastener tilt at an angle to the hole. Figure 2-26 illustrates the damage of a typical shear loaded fastener hole. The damage seen in the countersunk region of the fastener hole was created by the fastener head which dug into the laminate due to the test load. In contrast, tension loaded fastener holes did not show any sign of elongation, retaining their circular shape (Figure 2-27). The fastener head dug beyond the countersunk region causing severe delamination near the inner edge of the hole. Figure 2-28 shows the mapping of the fastener hole damage. From the mapping, it was determined that Region A of the panel was loaded under tension and shear. However, Region B seemed to have been securely fastened to a fixed structure as evidenced by the lack of fastener hole damage in that portion of the panel.

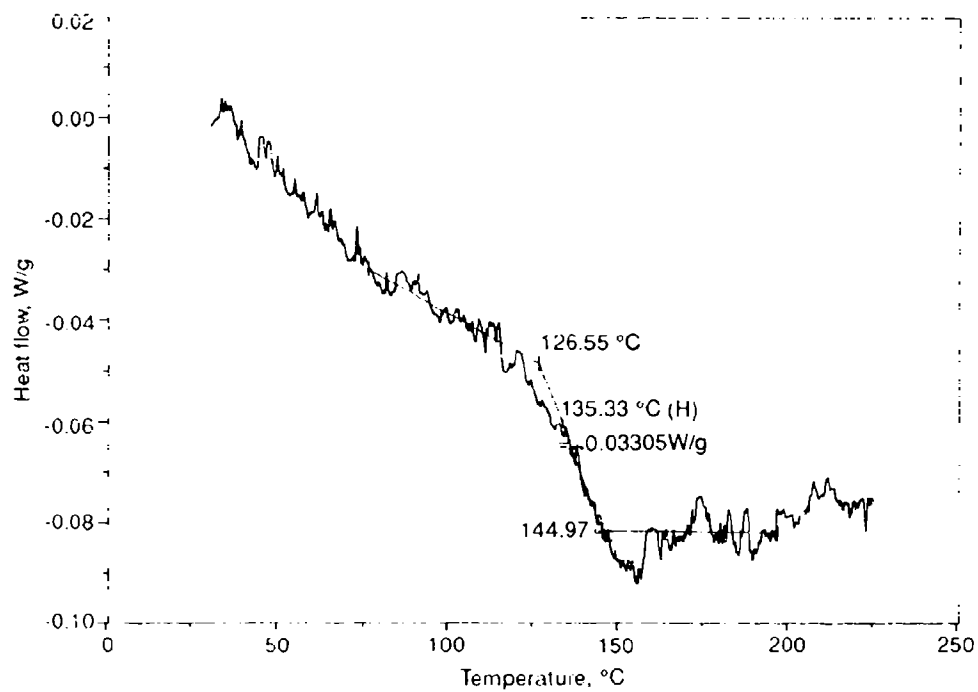
Nearly identical results were obtained from the glass transition temperature measurements by TMA and DSC (see Figure 2-43). These values were 133°C (271°F) and 135°C (275°F), respectively. These are typical values for a 121°C (250°F) epoxy resin. A metallographic section was taken through a bulged area (see Figures 2-44 and 2-45), found adjacent to a bolthole, which was apparently the result of constraint by the bolt. This section revealed microbuckling of fibers in a crack-like formation extending from the delamination toward the lower surface. Fiber and matrix details were difficult to discern from the prepared section, but the overall condition of the laminate appeared to be good.

Figure 2-43. TMA and DSC Thermograms of Strut

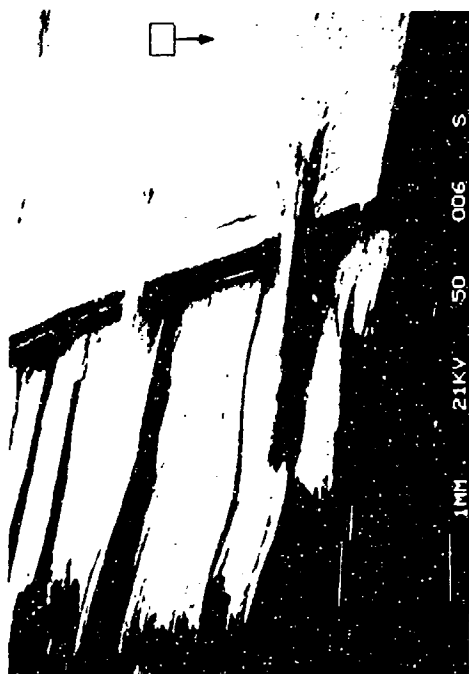
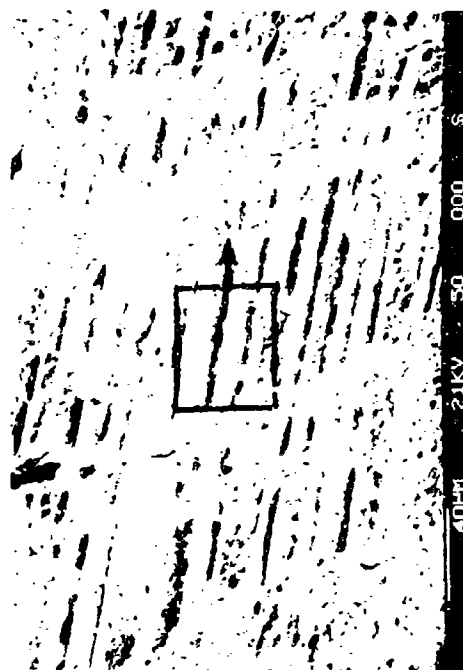
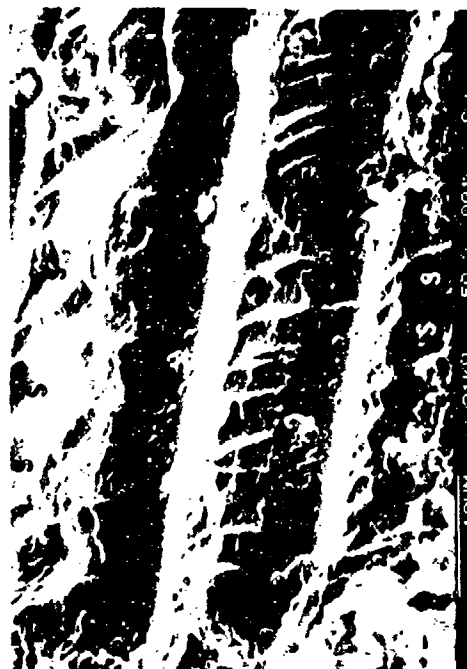
SEM examination was performed on the single delamination of the small piece. Evidence of shear fracture (scallop and hackles) was observed on the laboratory-exposed surface of this delamination (see Figures 2-46 and 2-47). The propagation direction was oriented axially along the length of the strut, but the exact direction could not be determined. Examination of the tensile half of the translaminar fracture revealed radial patterns on fiber end fractures (see Figure 2-48). The resultant direction of crack-propagation, determined by mapping the directions in which the lines radiate in the individual fiber fractures, was from the lower surface (tension) toward the delamination. Examination of the compressive half of the translaminar fracture revealed buckled fibers displaying chop marks (see Figure 2-49), typical of compressive failures. Although SEM examination of the translaminar fracture was conducted around the bolthole region, the non-conducting surfaces encountered produced images which were not of sufficient quality to include in this report. SEM examination of the translaminar fracture was difficult to perform, due to the extreme depth of this fracture. This prevented adequate application of gold (even after multiple sputter applications) to get a uniformly covered surface. Therefore, charging of uncoated areas during SEM examination made the location of suitably informative, fiber fractures difficult to perform.

Figure 2-46. SEM Fractographs of Delamination at the Translamellar Fracture Surface of the Small Piece  
Scallops indicate shear fracture. The orientation of these scallops indicates propagation of the delamination axially along the strut.

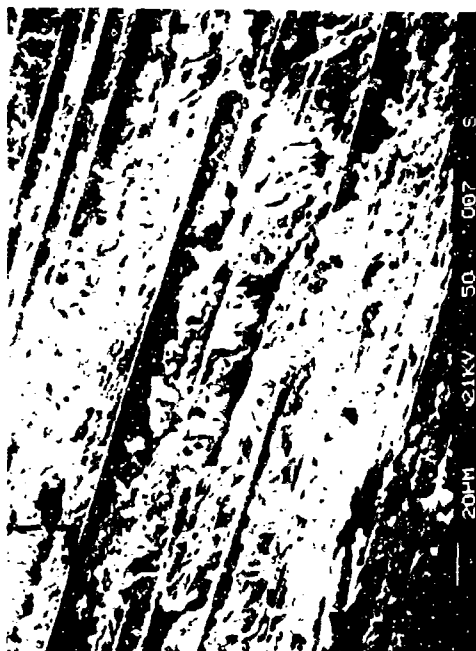
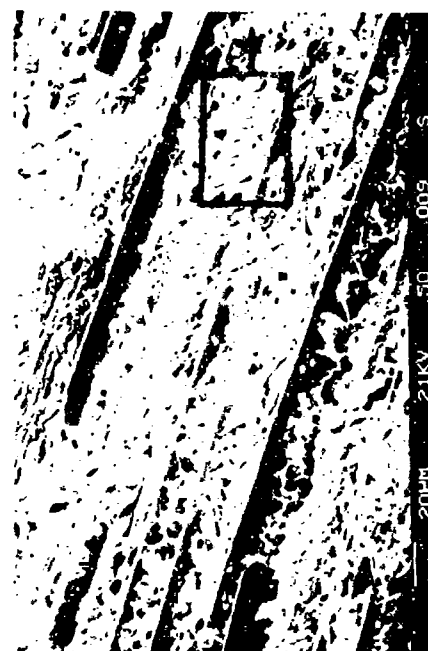
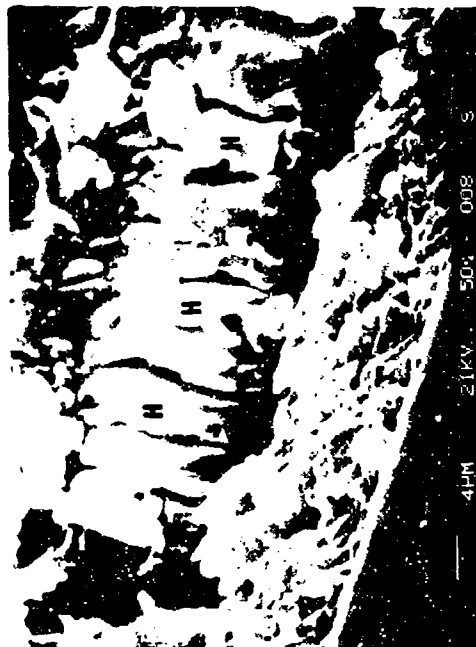
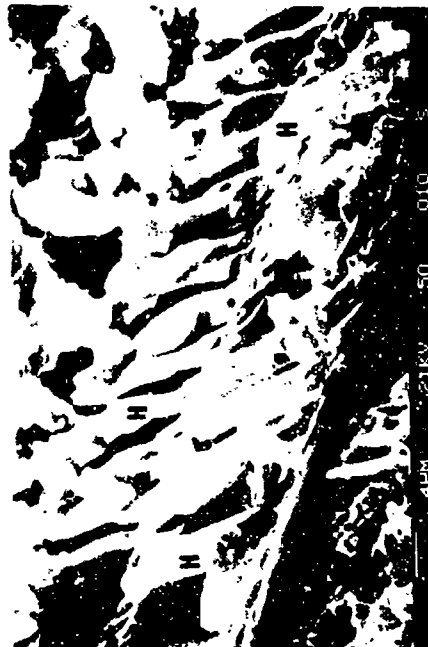
Figure 2-47. SEM Fractographs of Delamination Adjacent to Translaminar Fracture  
Hackles indicate shear fracture and propagation of the delamination axially along the strut.

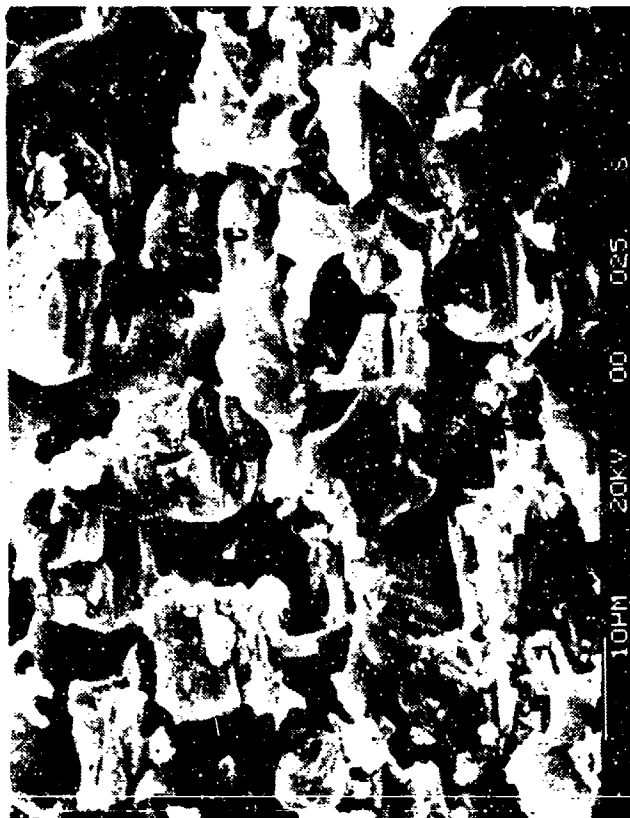
**Figure 2-49. SEM Fractographs of the Compressive Half of the Translaminal Fracture**  
These fractographs exhibit compressively loaded fiber fractures, as indicated by the presence of both tensile and compressive fracture morphology.

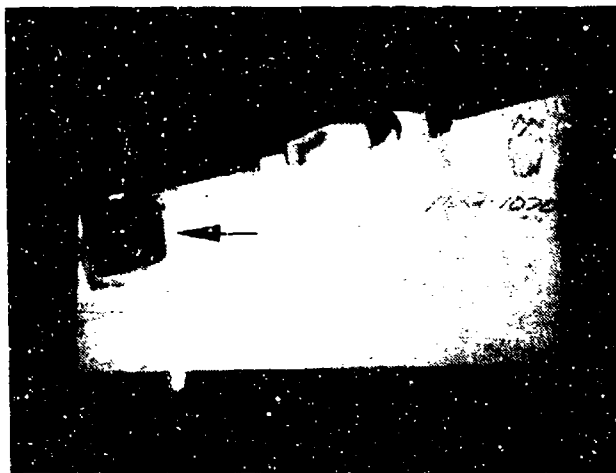
Initial examination of the parts in the as-received condition showed that the rudder labeled P/N 76301-68G240001-1003 was relatively intact, whereas P/N 68A240001-1013, A221070 was the part that had been repaired. Further testing was accordingly concentrated on the latter part. Figure 2-51 shows photographs of the repaired part in the as-received condition. As shown, one of the skins (arbitrarily labeled as the inboard side) had a repair patch close to the leading edge of the assembly. The outboard skin had a localized region of damage as determined by simple coin tap tests, in a region immediately opposite the patch.

Figure 2-51. As-Received Photographs of Rudder

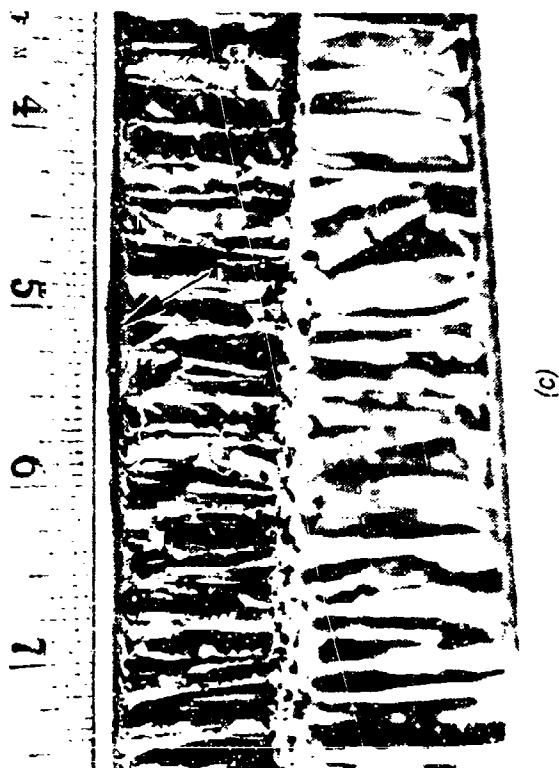
In order to perform fractographic examination, a rectangular coupon was sectioned from the rudder containing the damaged region in the outboard skin, and the repaired region in the inboard skin. The coupon was obtained by sectioning the rudder well away from the regions of interest using a flood-cooled carbide saw. The defect surface associated with the primary delamination was exposed by means of a controlled saw cut and gentle peel loads in the laboratory. Figure 2-55 shows macrophotographs of the coupon after exposing the fracture. As shown in Figure 2-55a and 2-55b, the fracture surface associated with the delamination was highly reflective and had a colored ridge of epoxy traversing the surface, approximately 3 inches away from the center of the delamination. Also of interest was the observation that the damage indications were not due to core disbond (see Figure 2-55c).

Figure 2-55. Macrophotographs of Delamination Fracture in Coupon From Damaged Area

(c) Lateral View of Assembly Showing Absence of Core Disbond

Note damage (at arrow)

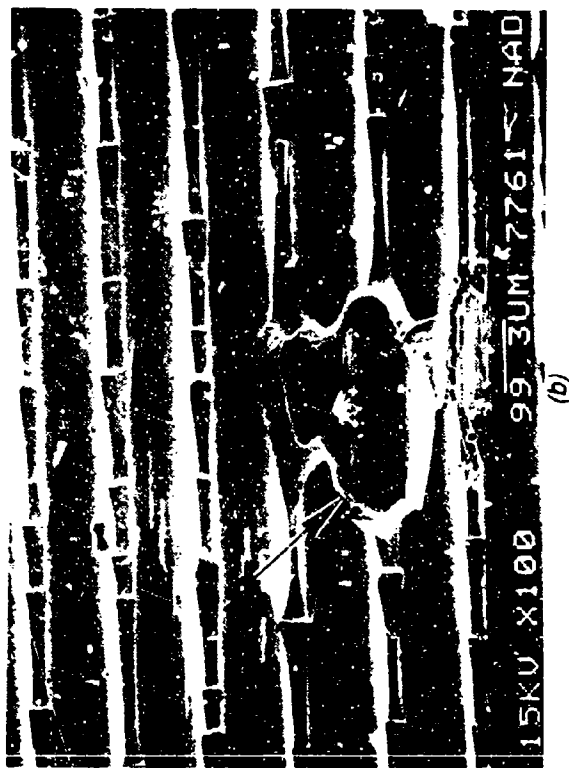
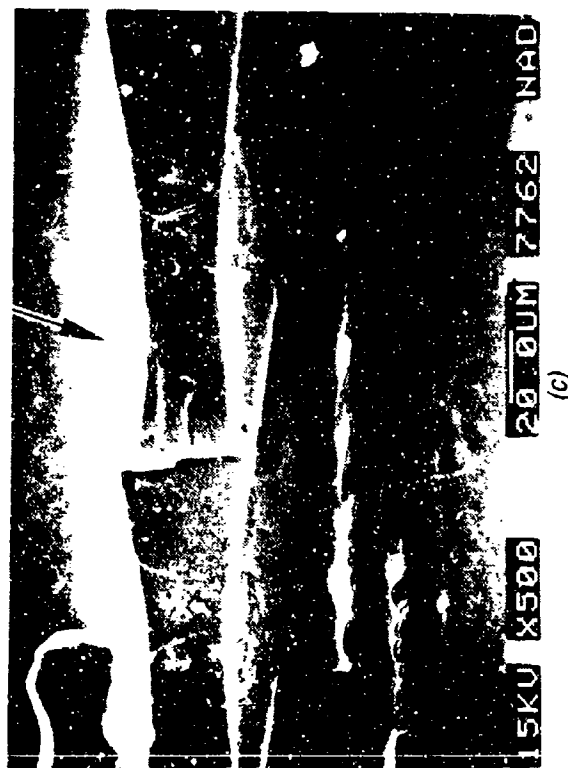
Figures 2-56 and 2-57 show SEM photographs of fracture features observed in the delamination region and in regions adjacent to the delamination. In the region of the delamination, the fracture surface exhibited a "resin-starved" condition, with very little evidence of fracture. As shown in Figure 2-56, stray hackles could be observed; however these were associated with very fine porosity. The epoxy ridge shown in Figure 2-55 was also associated with fine porosity (see Figure 2-57b). The laboratory fracture regions, in contrast, were associated with peel fracture characteristics in the form of river patterns in fractured epoxy (Figure 2-57c).

Figure 2-56. SEM Photographs of Delaminated Surface  
 (a) Low Magnification  
 (b) Intermediate Magnification Showing  
 Resin-Starved Condition (Arrow)  
 (c) High Magnification Showing Porosity (Arrow)

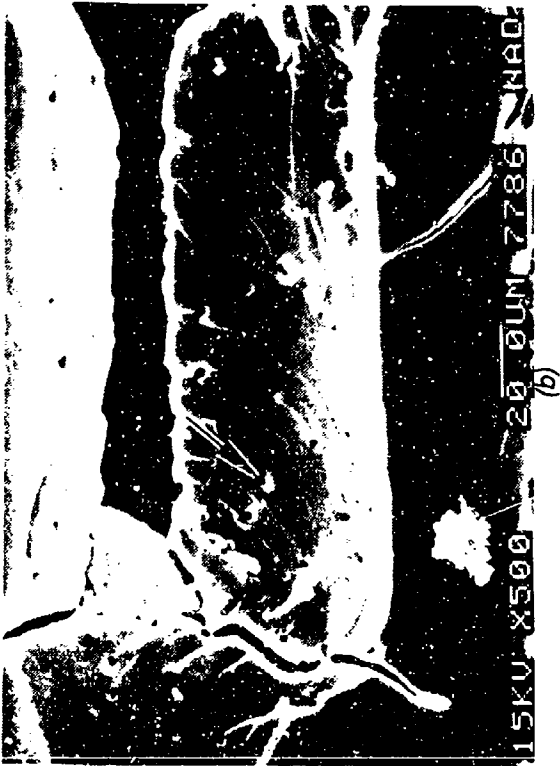
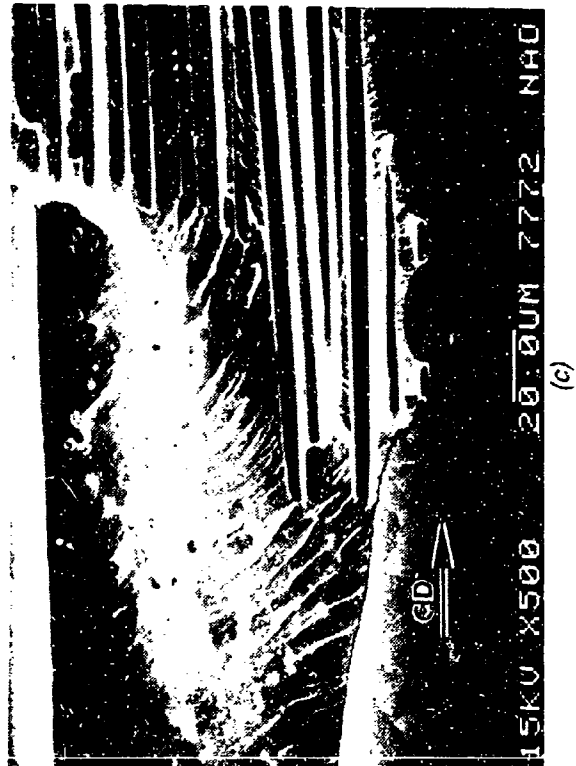
Figure 2-57. SEM Photographs Showing Fracture Details in Delamination  
 (a) Low Magnification Showing Epoxy Ridge (Arrows)  
 (b) Porosity in Epoxy Ridge (Arrow)  
 (c) Peel Fracture in Laboratory Overload Region  
 CD = Crack propagation direction

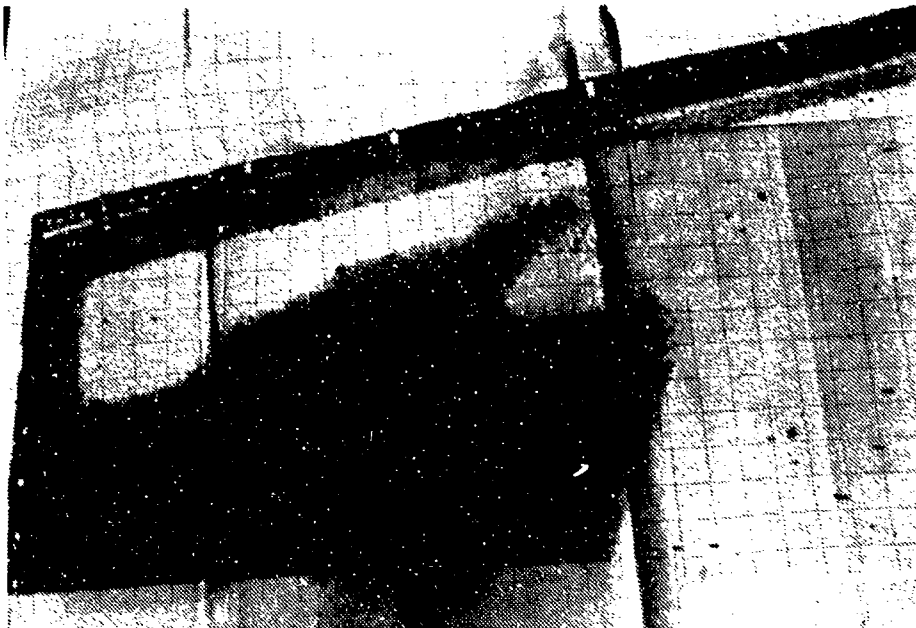
Initial nondestructive testing of the part consisted of conventional through-transmission ultrasonic (TTU) C-scan testing of the assembly. Figure 2-62 shows photographs of the C-scan plots. Damage in stabilizer #2 consisted of two zones, 1) damage at the outboard end of the stabilizer adjacent to the trailing edge (Figure 2-62a), and 2) mid-section damage extending approximately 9 inches span-wise, and approximately 10 inches chord-wise, starting from the trailing edge (Figure 2-62b).

Figure 2-62. TTJ C-Scans of Horizontal Stabilizer  
 (a) Damage on Outboard Location Near Trailing Edge (Zone A in Figure 2-61b)  
 (b) Mid-Spar Damage (Zone B in Figure 2-61b)

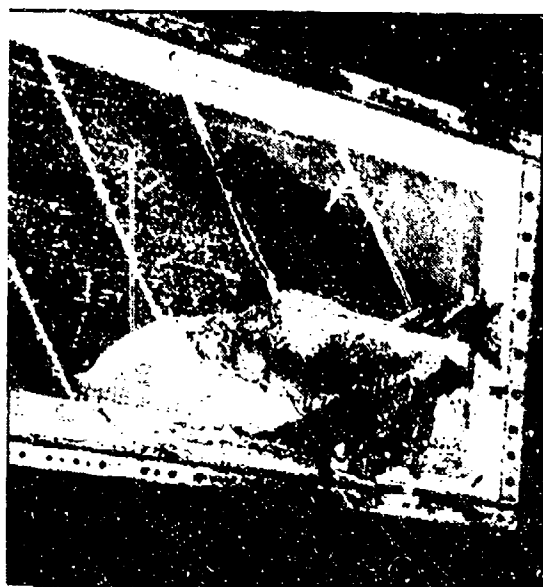
Detailed 2-D and 3-D pulse echo ultrasonic imaging was concentrated on these two zones of damage. Figure 2-63 shows pulse-echo images of the damage at the outboard end. Orthogonal cross-sections of the 2-D image (Figure 2-63a) revealed that the damage in this zone (hereafter referred to as zone A) consisted of two principal regions of delamination (Figure 2-63b) with one close to the outer skin, and the second closer to the back face of the skin. Damage in the mid-section location (hereafter referred to as zone B) started at or very close to the top face, and extended across the flight surface and into the interior (Figure 2-64).

Figure 2-63. Pulse-Echo Images of Damage at the Outboard End of the Stabilizer (Zone A)  
 (a) 2-D Image Showing Delamination  
 (b) Orthogonal Section Showing Two Zones of Delamination

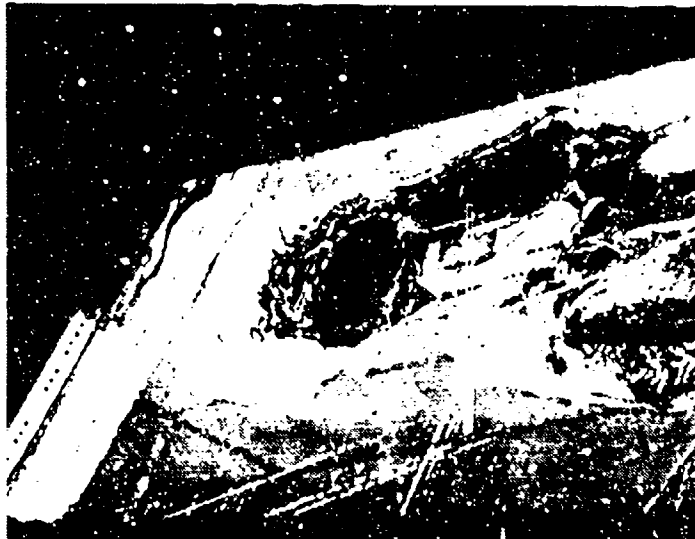
Figure 2-64 Pulse-Echo Images of Damage at the Mid-Section of the Stabilizer (Zone B)  
(a) 2-D Image  
(b) 3-D Image

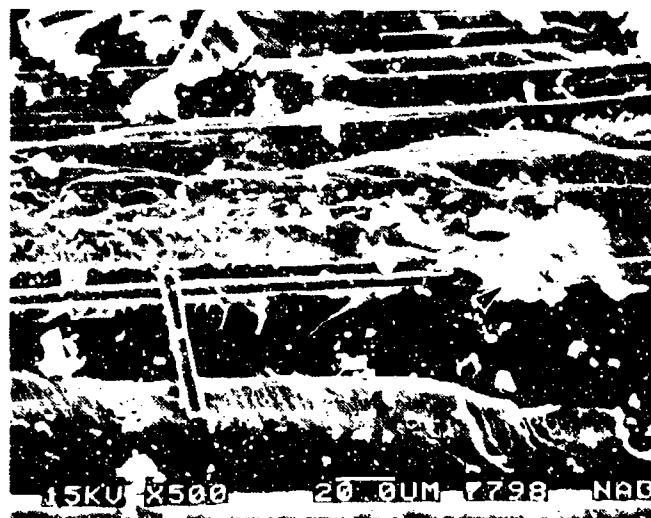
Figure 2-66. SEM Photographs of Delamination in Zone A (Top Layer Removed)  
 (a) Low Magnification Showing Component Debris  
 (b) High Magnification Showing Peel Characteristics in Delamination  
 Note debris at arrow

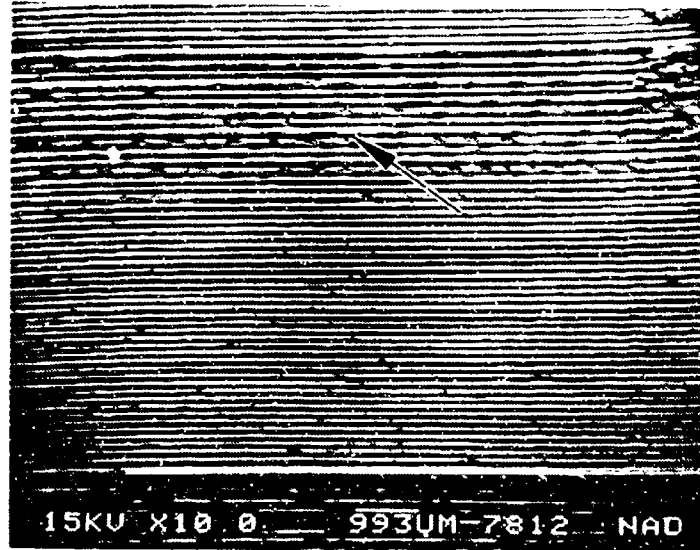
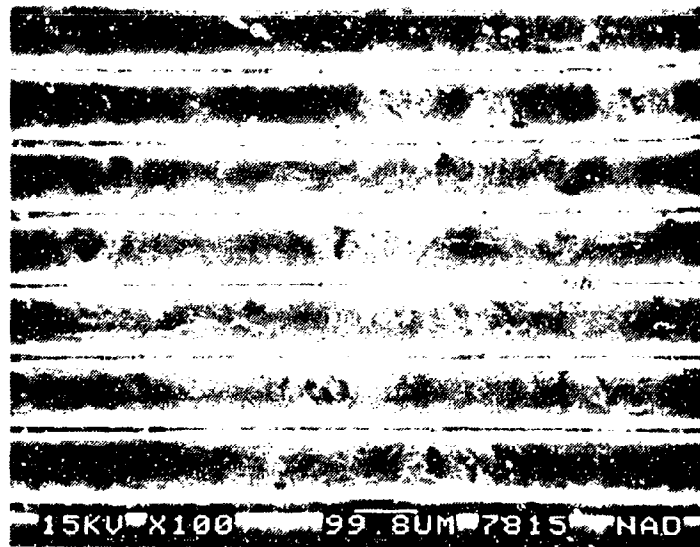
Figure 2-67. SEM Photographs of Delamination in Zone A (Second Layer Removed)  
 (a) Central Region of Resin Starved Fibers (Arrow)  
 (b) High Magnification Photograph Showing Detail in Central Region

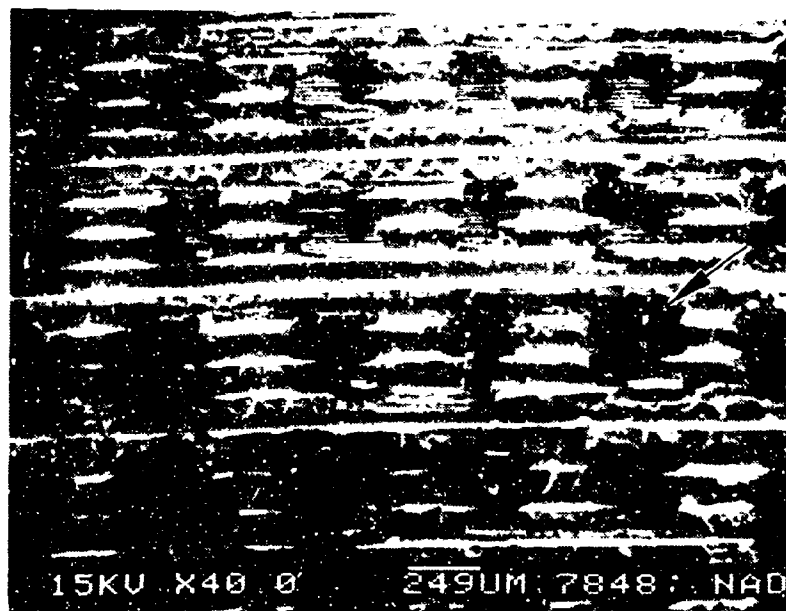
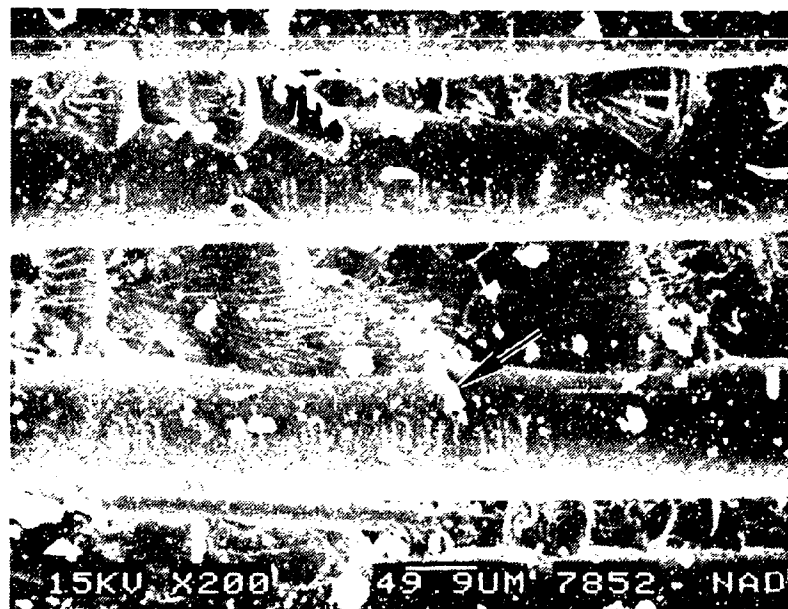
Figure 2-69 shows SEM photographs of the delaminated layer in zone B. Again mapping of the rivers indicated local fracture propagating by peel radially across the surface with key-holing (Figure 2-69a) and an abundance of compression debris.

Figure 2-69. SEM Photographs of Zone B Delamination (Top Layer Removed)  
 (a) Low Magnification Showing Key-Holing (Arrow)  
 (b) High Magnification Showing Compression Debris (Arrow)

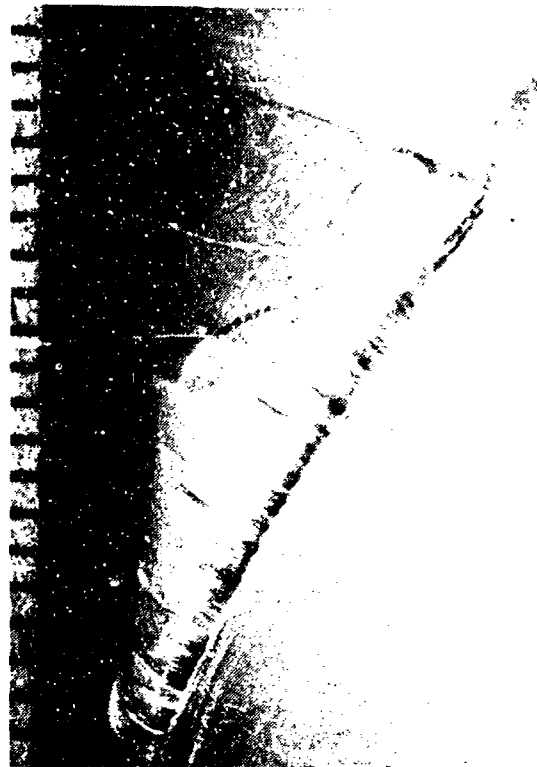
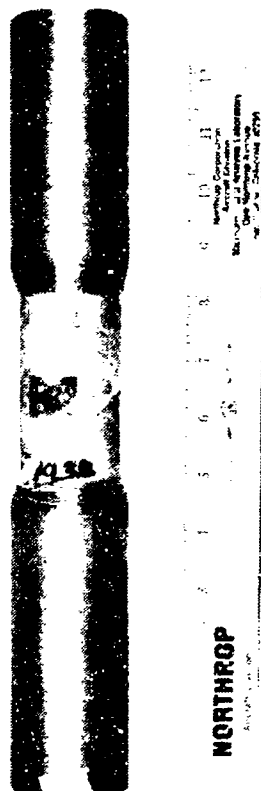
Figure 2-70a shows the component in the as-received condition. Visual examination of the component revealed that the part was filament wound and that it exhibited a surface condition in the form of a diagonal bulge (shown in Figures 2-70b and 2-70c) present around the outer periphery of the gage section of the cylinder.

Conventional ultrasonic testing of the component was unsuccessful because of the non-availability of a transducer with a cylindrical contour. X-ray radiography was carried out and revealed indications in the area of the bulge previously detected by visual examination. No other areas of damage were detected in the hollow cylinder.

Figure 2-70. As-Received Documentation of Failed Cylindrical Specimen  
 (a) Overall Specimen  
 (b), (c) Surface Bulge on Periphery of Cylinder

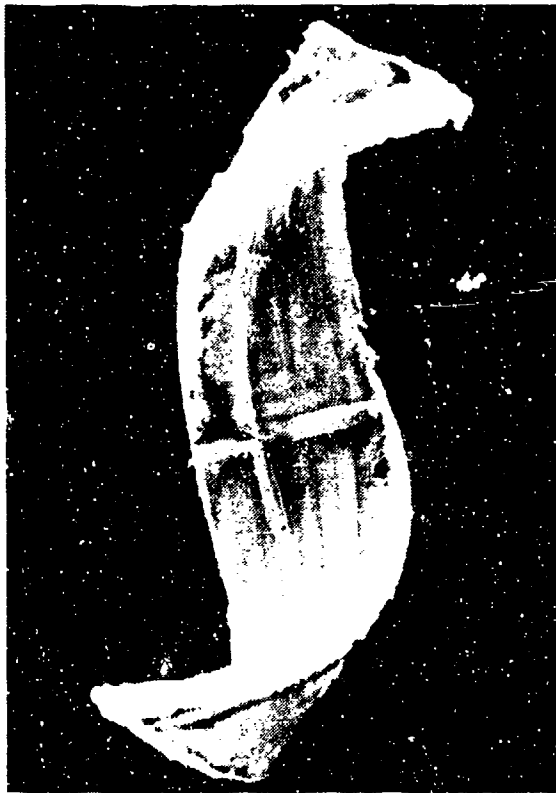
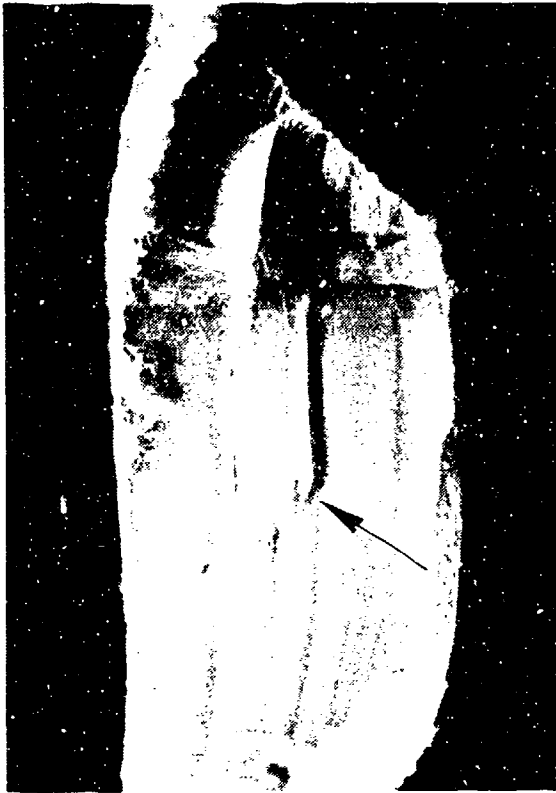
Figure 2-72 presents photographs of fragment B as viewed from various angles. Examination of the inner surface of the fragment revealed internal displacements (Figure 2-72a) which correspond to the external bulge. The contour of the interior defect was identical to that present on the exterior, indicating that these areas of damage had possibly been caused by the same load event.

Figure 2-72 Photographs Showing Damage in Fragment B of Cylinder  
 (a) 1X Photo Shows Interior Damage  
 (b) 2X Photo of Interior Damage (Bulge at Arrow)  
 (c) 2X Photo Showing Mating Damage on Exterior

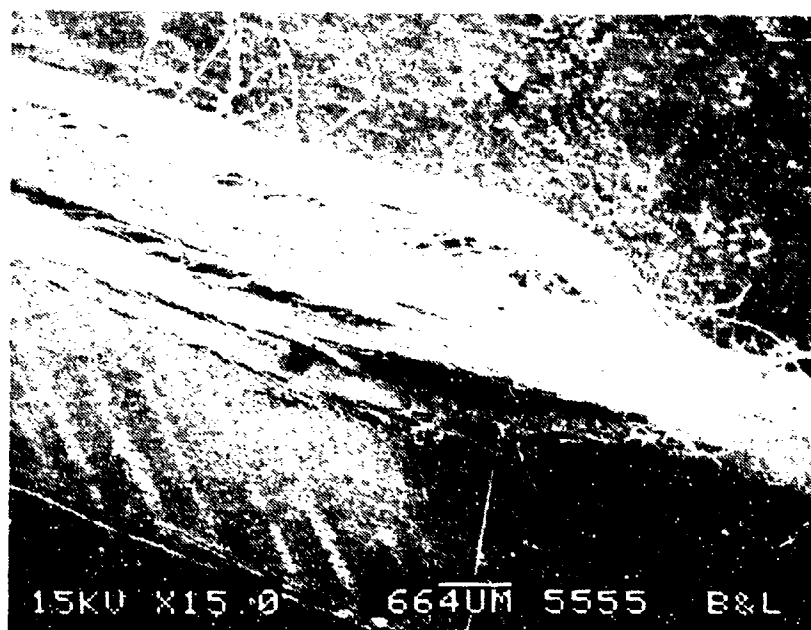
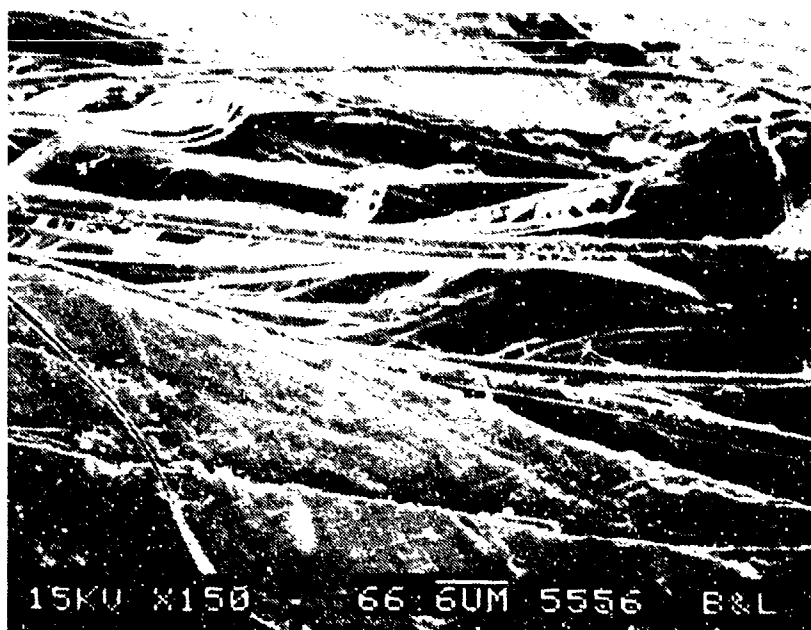
SEM examination was carried out on the outer and inner surfaces of the cylinder. Figures 2-73, 2-74, and 2-75 present SEM photographs of fracture present on the outer and inner surfaces. As shown in Figure 2-73a, the region of damage on the outer surface consisted of localized displacement of fiber bundles, splitting of fibers, and defibrillation of fiber ends. Figure 2-74 presents SEM photographs of the outer surface with the cluster of fibrils removed. As can be seen in Figure 2-74a, the fractured resin exhibited hackles, and the fibers appeared to be bending under shear loads (Figure 2-74b). Such fracture characteristics are typical of failure due to localized in-plane shear stresses caused by torsional loads. Figure 2-75 presents SEM photographs of the inner surface of the cylinder. The failure in this region was also characterized by fiber splits, and bending of fiber ends.

Figure 2-75. SEM Photographs of Damage on Inner Surface of Cylinder  
 (a) Low Magnification Showing Splitting  
 (b) High Magnification Showing Splits and Bending of Fibers

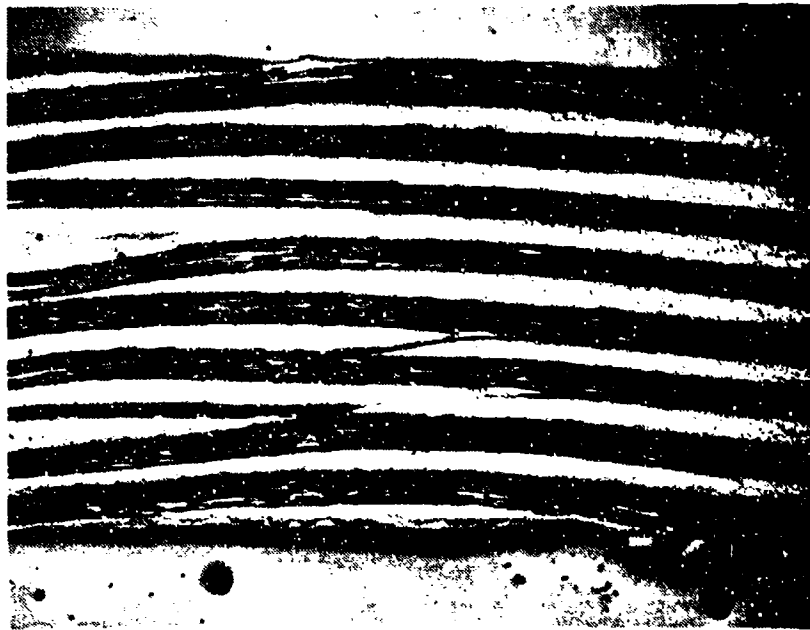
Radial sections were taken through the cylinder in the region of the defect, and the sections were oriented so that the fractures were in profile. Figure 2-76 shows optical micrographs of the cross-sections taken through the failed regions. In these areas, no material defects such as porosity or contaminants were detected. Chemical identification of the resin was not carried out due to lack of material specifications. However, the general appearance of the fracture locations and morphologies suggested that failure was not related to material discrepancies.

Elementary stress analysis indicated that torsional loading of the cylinder would lead to localized in-plane shear conditions in elements of the cylinder. This would lead to delaminations caused by in-plane shear stresses. Bending of the fiber bundles would occur due to the critically resolved tensile components associated with the torsional loads.

Failure of the hollow cylinder occurred under torsional overload. The localized failures were caused by in-plane shear stresses associated with the torsional loads.

Figure 2-76. Optical Photomicrographs of Cross-Section Taken Through Defects in Cylinder  
(a) Magnification = 20X  
(b) Magnification = 50X

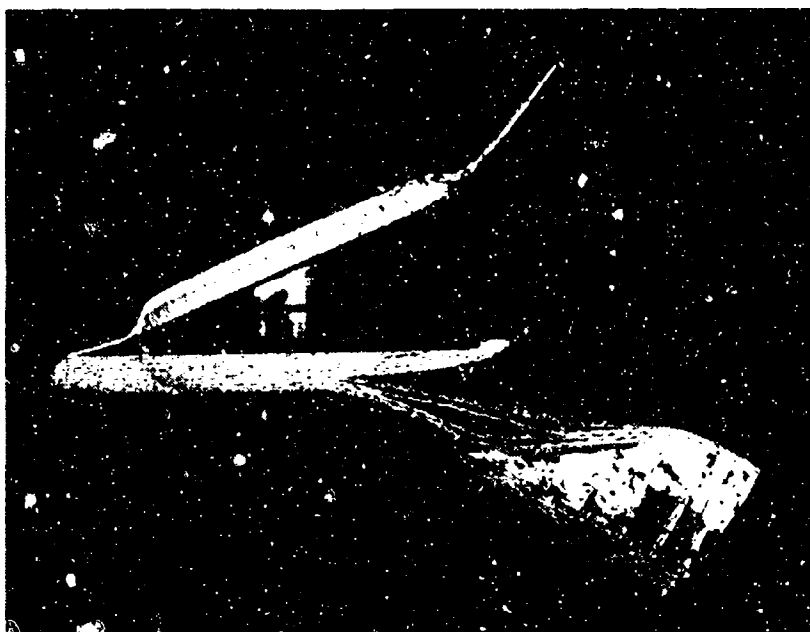
Several zones of delaminated fracture were apparent by visual evaluation. X-ray testing of the assembly failed to reveal any additional regions of delamination.

Figure 2-77. As-Received Documentation of Compound Plate and Fastener Assembly  
 (a) Lateral View of Assembly  
 (b) Top Surface of Plate
