WL-TR-91-4032  
DOT/FAA/CT-91/23  
VOL II, Part 3

COMPOSITE FAILURE ANALYSIS HANDBOOK  
VOLUME II - TECHNICAL HANDBOOK  
PART 3 - CASE HISTORIES

R.J. Kar  
Northrop Corporation  
One Northrop Avenue  
Hawthorne, California 90250-3277

February 1992

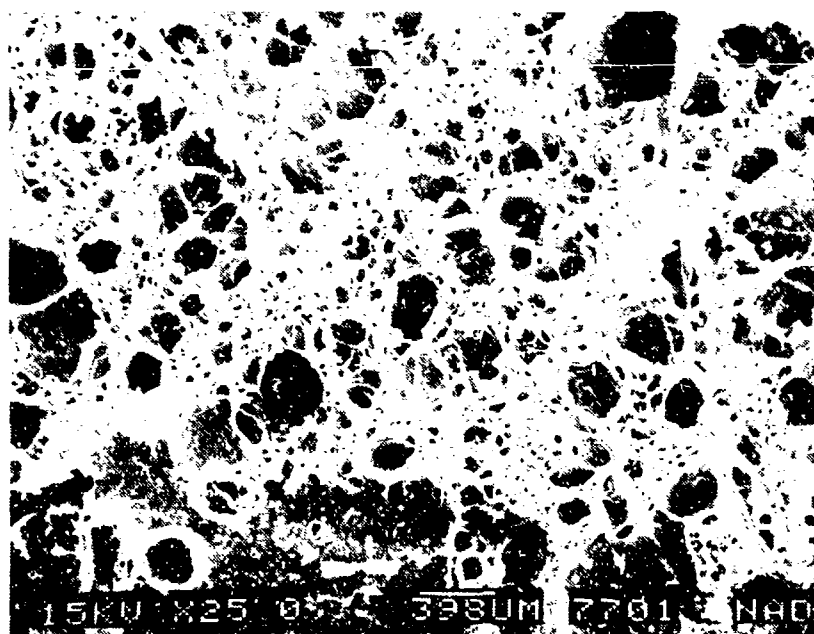
The top surface of the compound plate was also examined. The section was extremely brittle and delaminated upon gentle handling with a tweezer (Figure 2-82). Evaluation of the fragment, which appeared to be ceramic in nature, revealed evidence of overheating as suggested by the bent contour (Figure 2-83a) and voids observed during SEM examination (Figure 2-83b).

Figure 2-83. Optical and SEM Photographs of Delaminated Fragment of Top Surface of Compound Plate  
 (a) Oblique View Showing Bent Contour of Fragment  
 (b) Voids on Top Surface

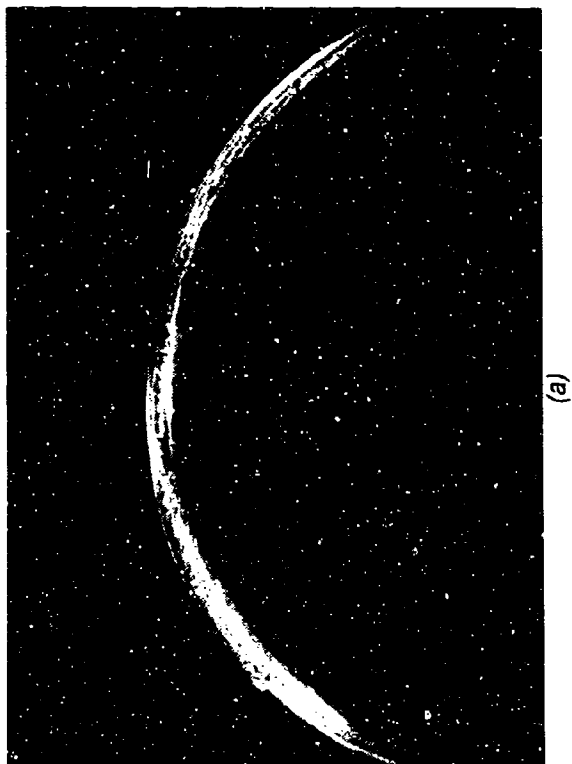
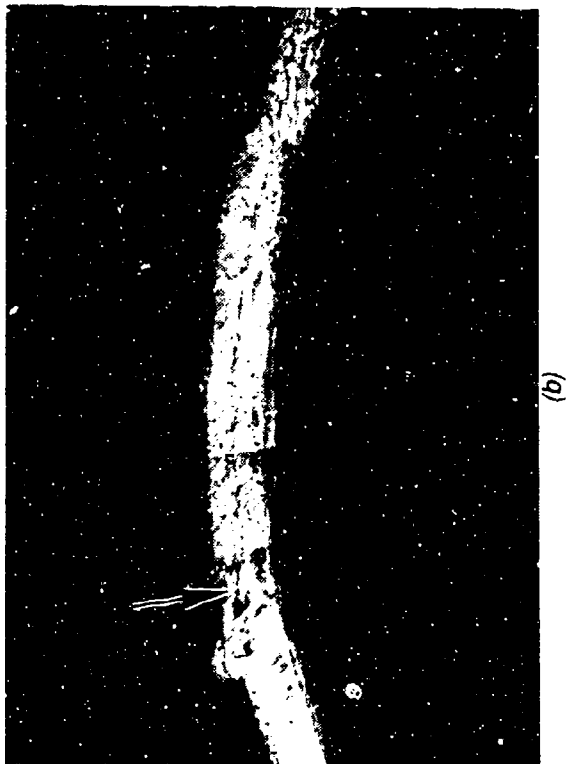
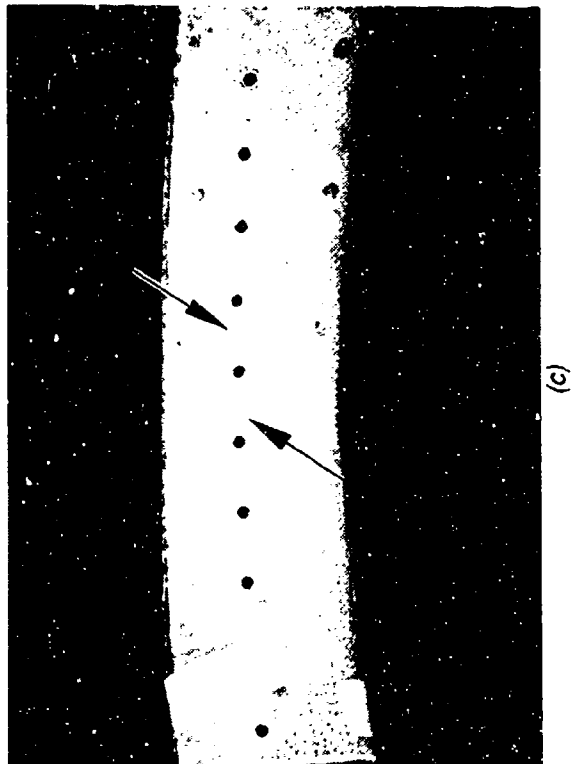
Figure 2-84 shows a collage of the part in the as-received condition. Close examination of the part indicated that the component consisted of a thin woven sheath (believed to be Kevlar/epoxy) enclosing a laminated bow (believed to be filament wound Kevlar/epoxy and glass/epoxy). The part was associated with extensive cracking all around the outer periphery (see Figure 2-84b); and along the inner diameter in mid-section regions containing fastener holes (see Figure 2-84c, and Figure 2-85a). When viewed obliquely, the sheath appeared torn in several areas (see Figure 2-85b). The entire sheath appeared loose and disbonded, and barely held in place by the ends. In addition the bow was associated with extensive delaminations (see Figure 2-85c), as determined by simple visual examination of the part.

Figure 2-84. As-Received Documentation of Composite Arch Reinforcement  
 (a) Overall View  
 (b) Cracking in Outer Periphery of Sheath (Arrow)  
 (c) Cracks in Mid-Section Fastener Holes (Arrows)

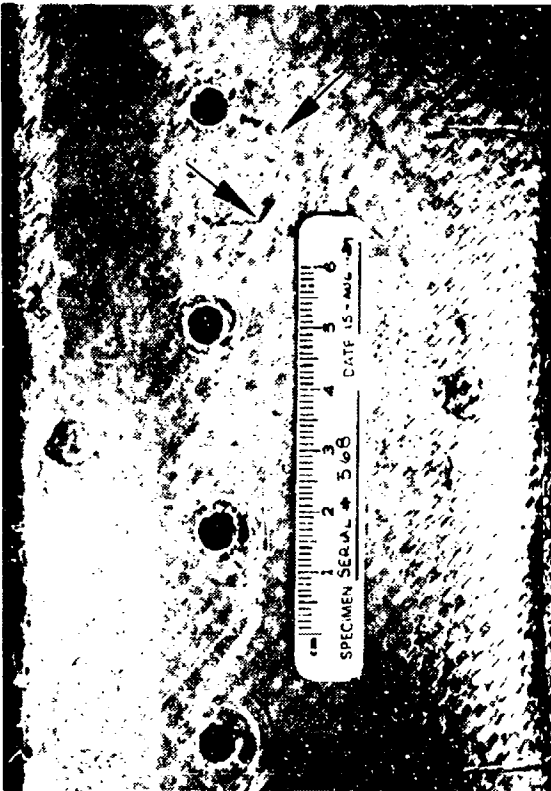
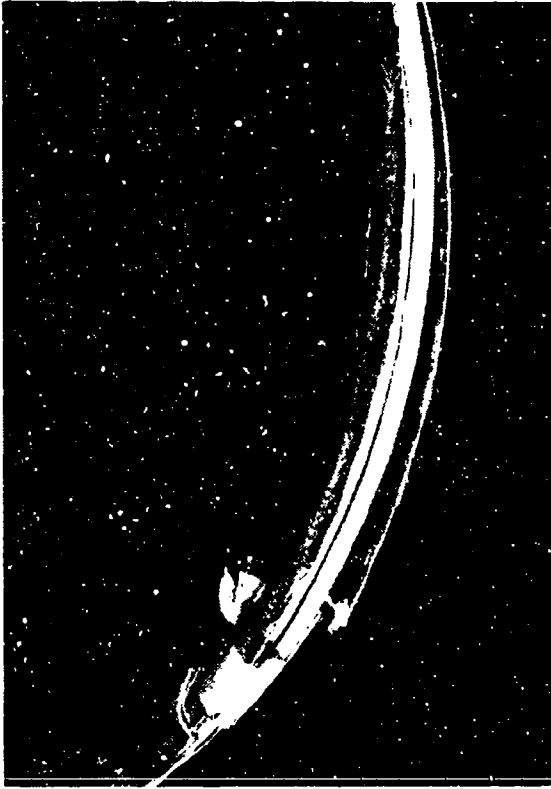
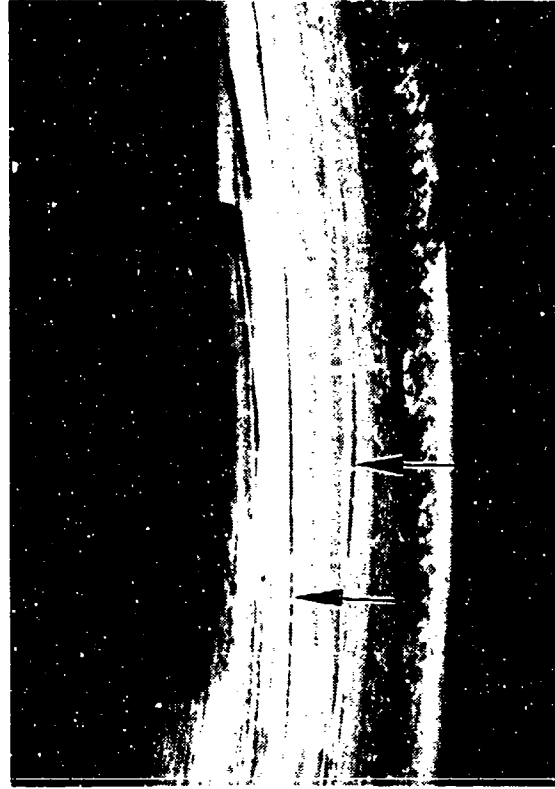
Figure 2-85. Documentation of Cracks in Part  
 (a) Shear Cracks in Fastener Holes (Arrows)  
 (b) Oblique View Showing Tearing of Sheath  
 (c) Delaminations in Bow Contained by Sheath (Arrows)

Initial examination was concentrated on the cracks observed in the sheath and bow around fastener holes (refer to Figure 2-85a). The general appearance of these cracks suggested that these were shear cracks, rather than tensile cracks. Figure 2-87 presents fracture features observed in the sheath in the region of a fastener crack. The fracture was characterized by dense tangles of fibrils (Figure 2-87b), as would be expected in translaminar failures in Kevlar/Epoxy. Examination of the regions below the fibrils revealed a delaminated surface associated with hackles, as is shown in Figure 2-87c, indicating that the fastener cracks were shear cracks. The orientation and morphology of the fibrils suggested that cracking in this region occurred under in-plane shear loads, resulting in tensile failures of the Kevlar fibers. Figure 2-88 presents a delaminated region in the bow in the vicinity of a crack. The fracture was once again characterized by shear failure characteristics, namely the occurrence of hackles in the resin (Figure 2-88a). The glass fibers, and Kevlar fibrils (Figure 2-88b) were characterized by tensile fracture characteristics.

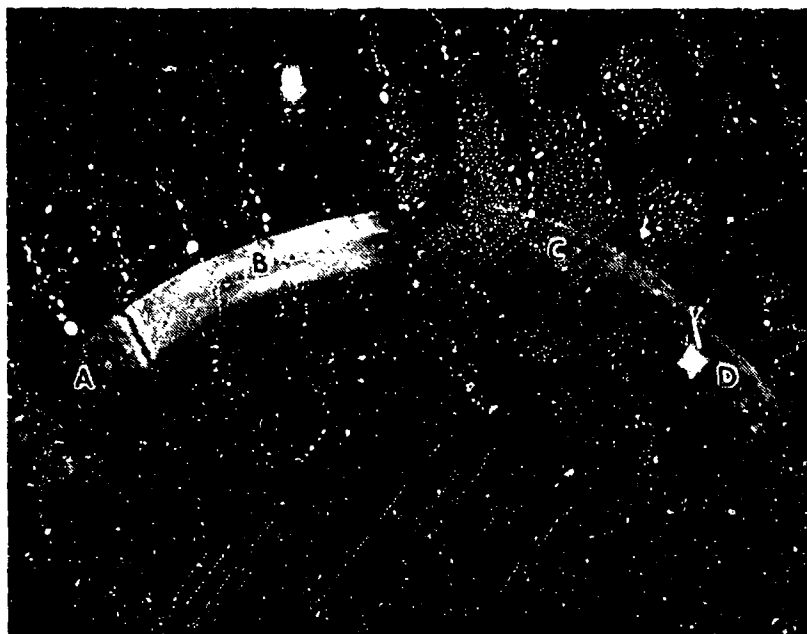
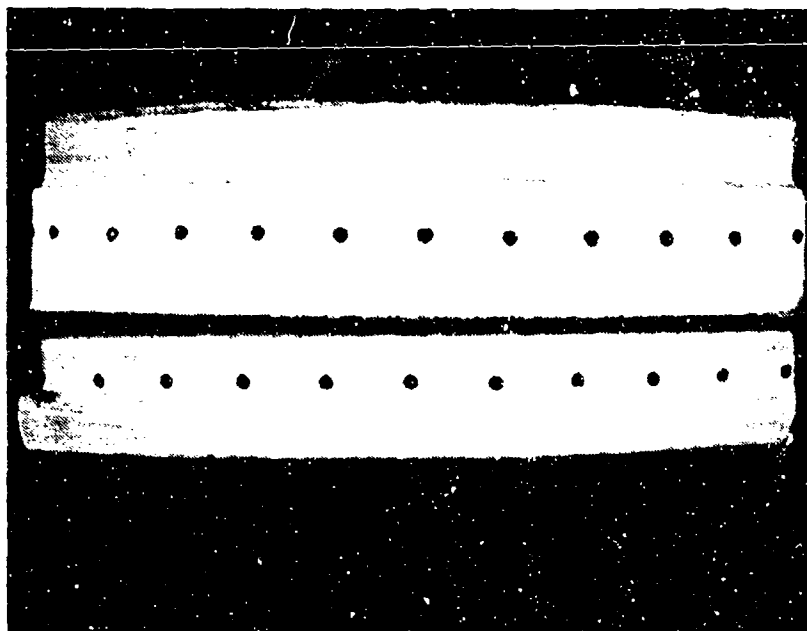
Figure 2-86. Documentation of Ply Removal and Sectioning  
(a) Sectioning of Part

arbitrarily labeled as A, B, C, and D in Figure 2-86a. Upon sectioning, the sheath totally separated from the bow in the sections labeled B, and C. In addition the bow delaminated into two fragments in the section labeled C, as is illustrated in Figure 2-86b.

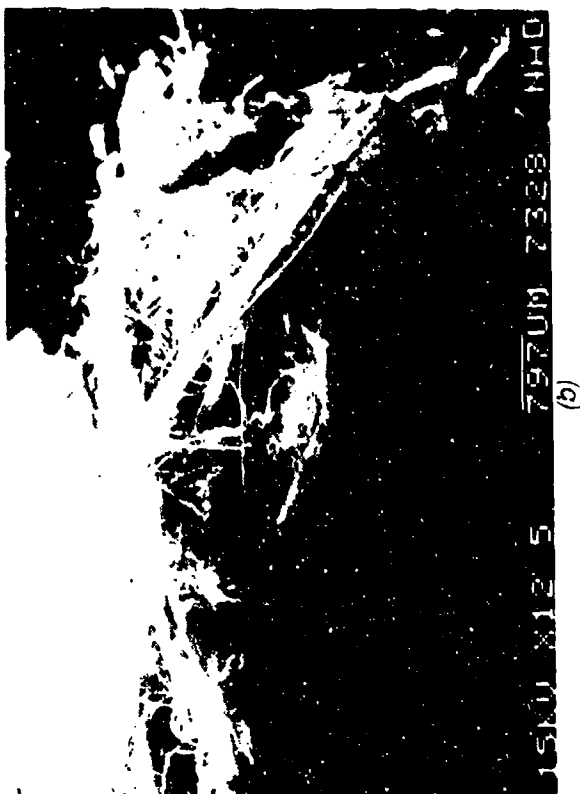
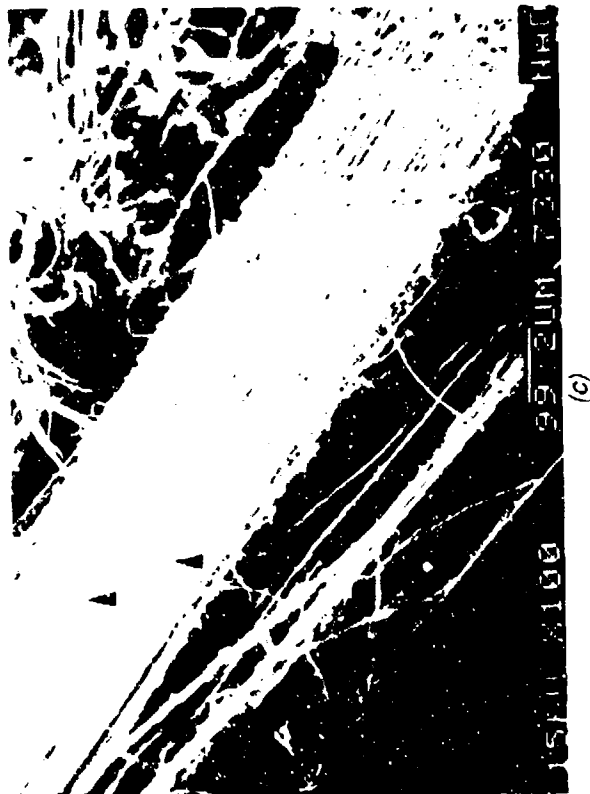
Elementary stress computations indicated that the delaminations in the sheath and bow were caused by the part being subjected to bending and torsional loads. The occurrence of shear cracks in mid-region fastener holes suggests that one or more of the fasteners may have been loose in these regions introducing localized bending and buffeting. Shear cracks formed in these regions, and with the resultant change in loading, the sheath and bow delaminated. The sheath was very poorly bonded to the bow and the bow exhibited severe porosity. It is believed that these material defects resulted in enhanced delamination of the bow.

Figure 2-87. Optical and SEM Photographs of Shear Fracture at Fastener Hole  
 (a) Macro photograph of Crack  
 (b) SEM Photograph Showing Kevlar Fibrils in Crack Viewed End On  
 (c) Delamination Surface Containing Hackles (Arrows)

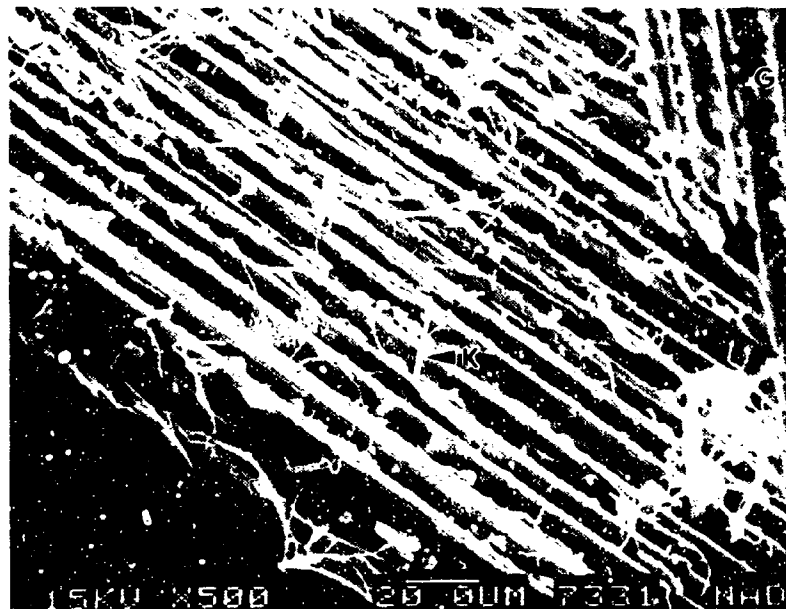
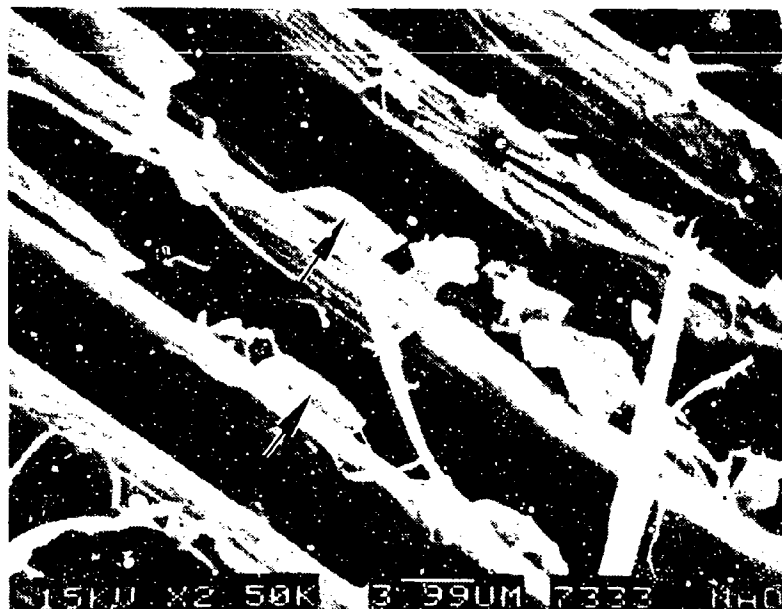
Figure 2-88. SEM Characterization of Fastener Hole Crack in Bow  
 (a) Glass (G) and Kevlar Fibrils (K)  
 (b) Hackles in Resin (Arrows)

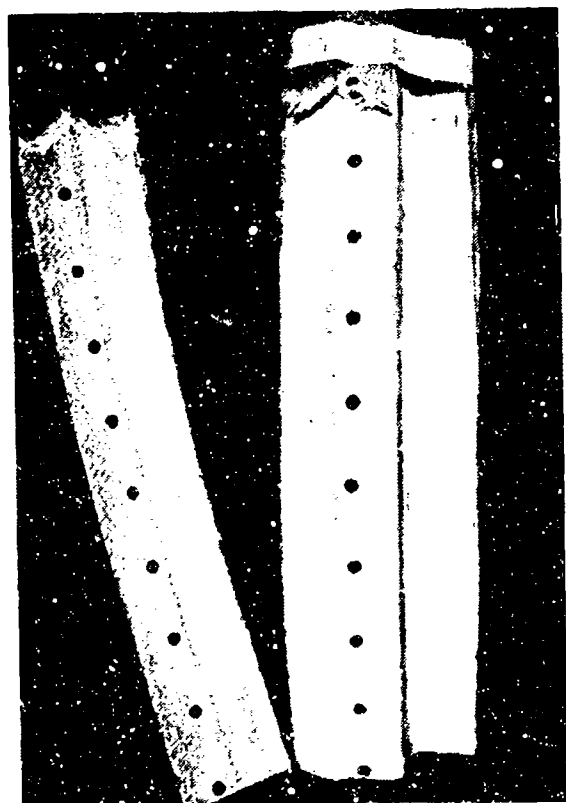
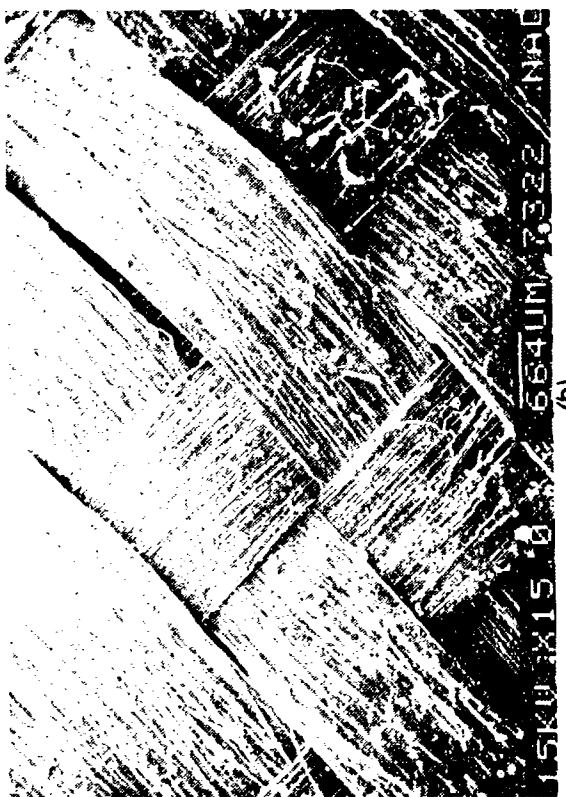
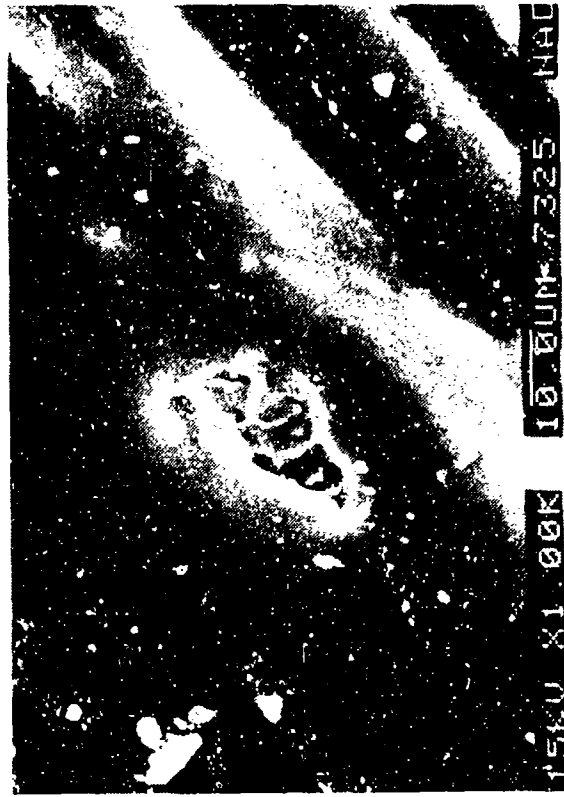
Figure 2-89 shows features observed on the bottom surface of the sheath that had separated from the bow. As can be seen in Figures 2-89b and 2-89c, there was practically no evidence of bonding of the sheath to the bow. Figure 2-90 shows optical and SEM photographs of the mating surface where the sheath should have been bonded. Again there was practically no evidence of fracture, with the surface appearing to be in the original unbonded state, and with occurrence of porosity.

Figure 2-89. Characterization of Sheath Surface  
 (a) Macro photograph Showing Separation From Bow  
 (b) Macro photograph of Sheath Surface  
 (c) Absence of Bonding With Bow

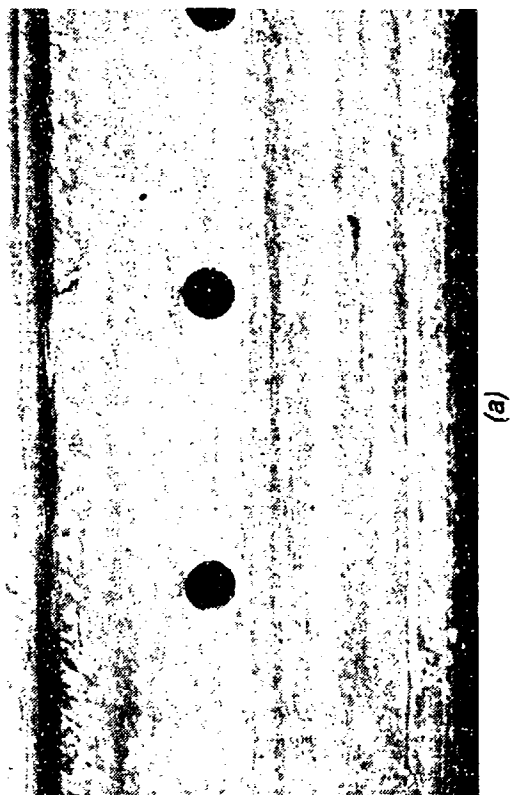
Figure 2-90. Evaluation of Bow Surface  
 (a) Macrophoto of Surface Where Sheath Separated  
 (b) Higher Magnification Photo Showing Traces of  
 Glass Scrim (Arrows)  
 (c) SEM Photograph Showing Unbonded Surface  
 With Porosity (Arrows)

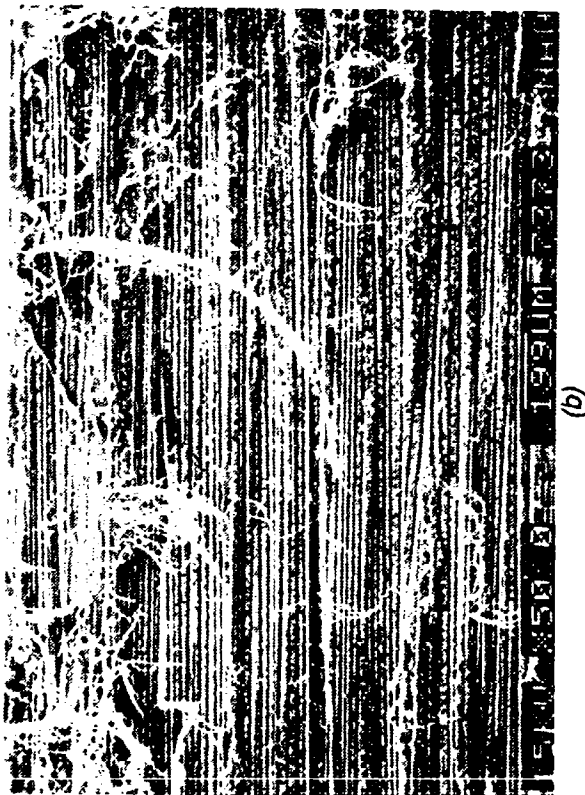
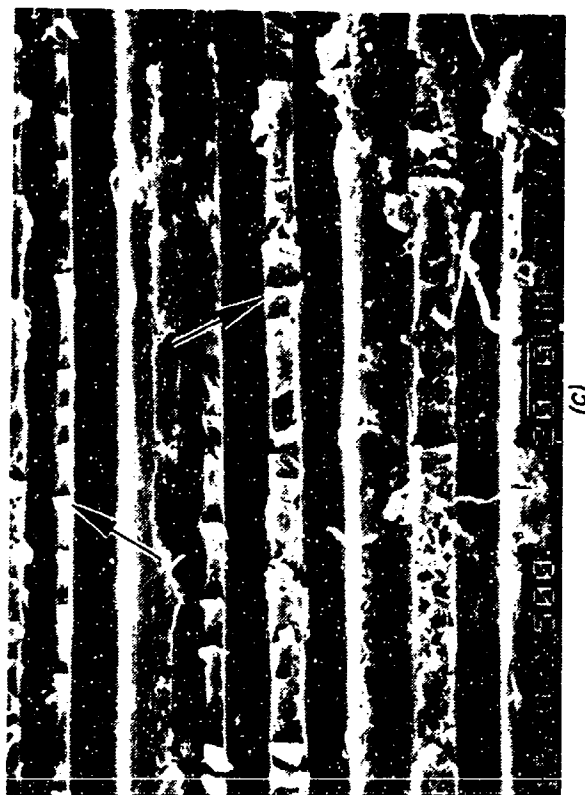
SEM examination was also carried out on the delaminations in the bow (refer to Figure 2-86b). Figure 2-91 presents optical and SEM fractographs of fracture features observed in a principal delamination in the bow mid-section. Fracture was characterized by in-plane shear failure characteristics, namely translaminar tensile fracture in the glass and Kevlar fibers (Figure 2-91b), and hackles in the fractured resin (Figure 2-91c).

Figure 2-91. SEM Characterization of Bow Delamination  
 (a), (b) Tensile Failure of Kevlar and Glass Fibers  
 (c) Hackles (Arrows) in Resin

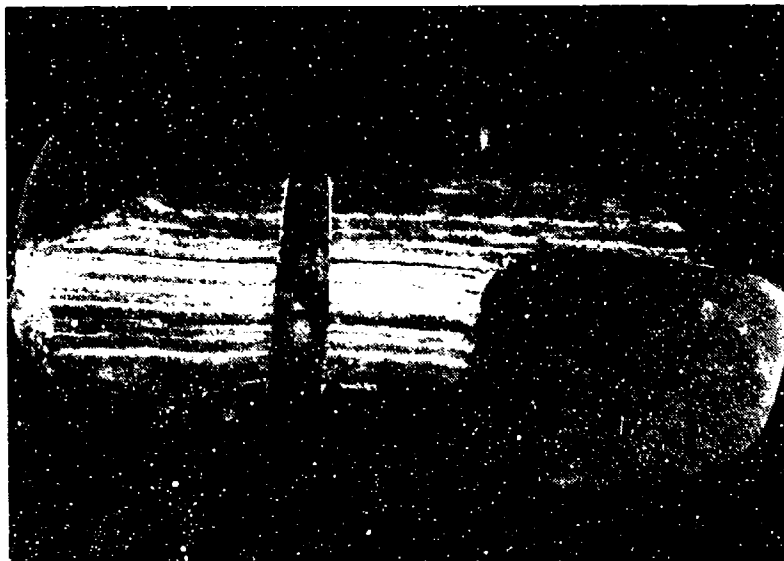
Microstructural examination was carried out on sections taken through the part in a region of fastener holes. As can be seen in Figures 2-92 and 2-93, extensive delaminations were present in the bow, with the sheath totally separated from the bow. The glass and Kevlar plies were characterized by extensive porosity, indicating that the part may have been of poor quality.

*Figure 2-92. Macro photograph of Cross-Section Taken Through Fastener Hole*

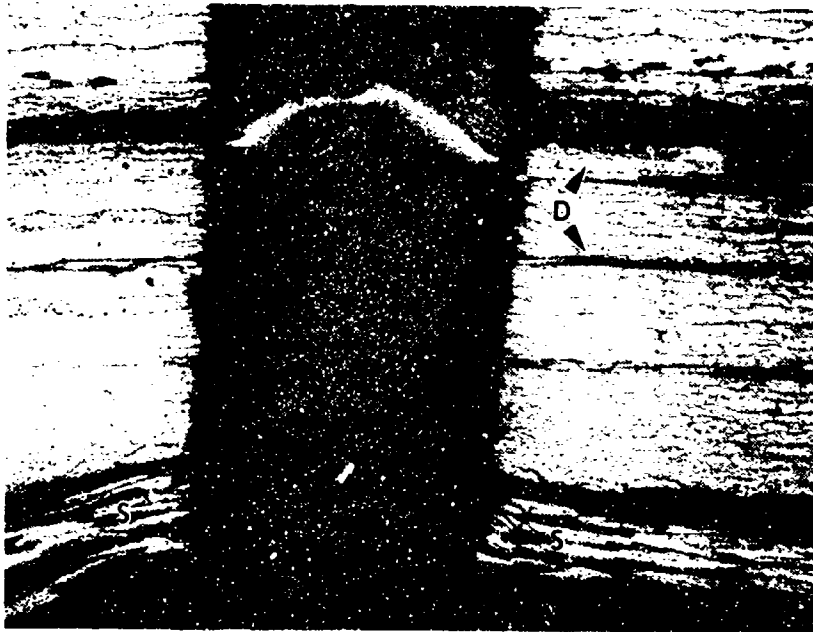
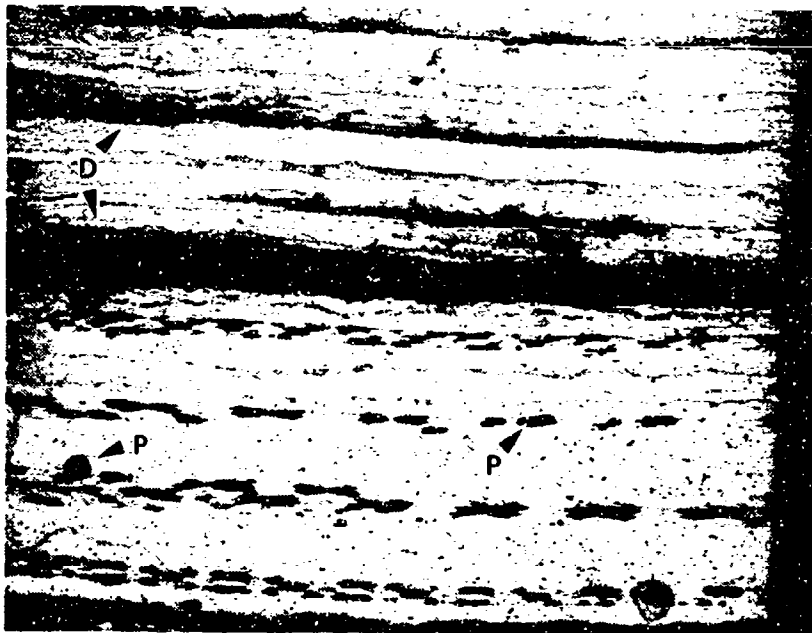
Figure 2-93. Optical Photomicrographs of Cross-Section Through Fastener Hole  
 (a) Separation of Sheath (S) and Delaminations (D) in Bow  
 (b) Delaminations (D) and Porosity (P) in Bow
