## NONDESTRUCTIVE EVALUATION OF A GRAPHITE ALUMINUM COMPOSITE SPACE RADIATOR PANEL

BY NEIL M. FELDMAN AND JOHN V. FOLTZ

RESEARCH AND TECHNOLOGY DEPARTMENT

DECEMBER 1991

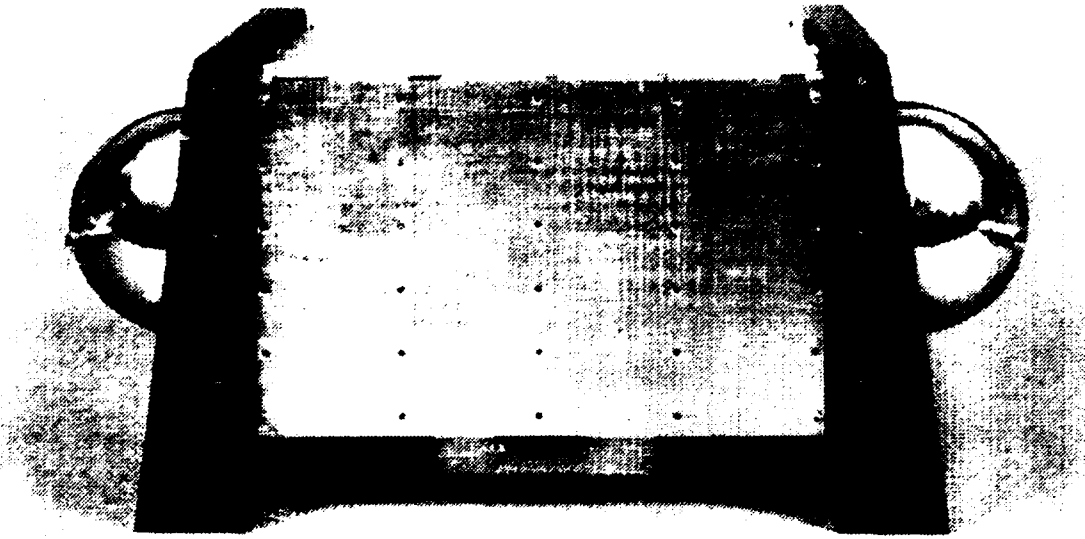
FIGURE 1. GR/AL COMPOSITE RADIATOR PANELS PROTECTING THE COMMON PRESSURE VESSEL BATTERY

tests conducted were a vibration test and a thermal conductivity test. The vibration tests were conducted with thermal control mirrors glued to the panel and the panel attached to the common pressure vessel (CPV) battery as seen in Figure 1. The vibration qualification test frequencies for the CPV battery were between 20 Hz to 2 kHz for a duration of 120 seconds. The vibration tests were conducted for the axial and each of the two lateral directions. The vibration tests had two objectives. The first was to learn if the graphite aluminum radiator would survive the vibration tests with no visible deterioration. The second objective was to assure that the mirrors glued to the panel survived the vibration tests with no visible damage and the mirrors were still intact with the panel.

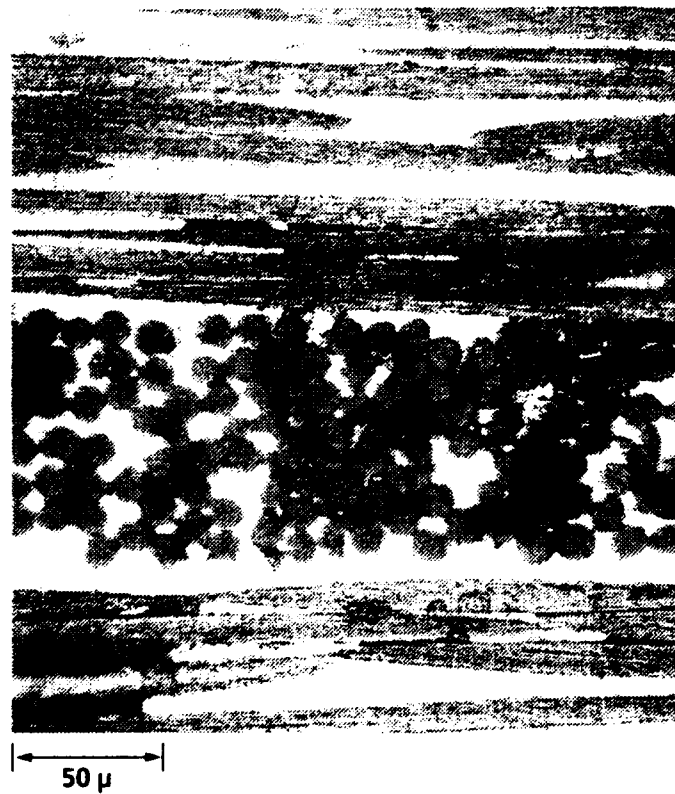
FIGURE 4. MICROGRAPH OF GR/AL PANEL

defined in Figure 2. Initial consideration went to using a unidirectional layup to bias the fiber arrangement in the 12-inch direction and provide the high  $0^\circ$  thermal conductivity needed. However, the radiator design incorporated bolt holes within one bolt diameter of the panel free edge so the composite architecture was modified to increase the strength in the  $90^\circ$  direction and reduce the possibility of edge tearout during machining. The configuration chosen was a  $[0_2/90/0_2]_2$ , ten-ply stack as seen in Figure 3. A 3-mil aluminum foil was added on each surface to minimize fiber print-through. This resulted in a laminate with nominal 50 mil total thickness and nominal unit ply thickness of 4.4 mil. The requested fiber fraction was  $42 \pm 2$  percent by volume. A photomicrograph of the layup configuration can be seen in Figure 4. The white areas in the figure are the aluminum layers in the configuration. The fibers in the transverse direction are the  $0^\circ$  fibers used to dissipate the heat. The cross sectional fibers in the center of the micrograph are the  $90^\circ$  fibers which add strength to the radiator around the bolt holes.

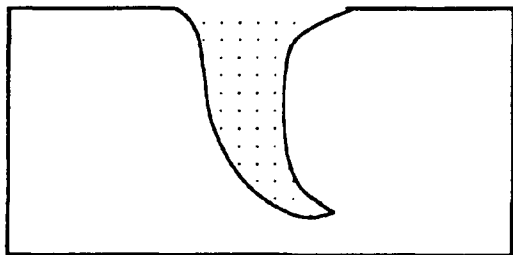
FIGURE 6. CROSS SECTION OF AN OPEN DEFECT OR IRREGULARITY

One of the most important steps of the dye penetrant procedure is the thorough cleaning of the surface area of the panel. The surface to be evaluated has to be cleaned of all scale, grease, dirt, and other foreign matter. Also, the panel should not be cleaned with much force as this would close cracks or pores that exist on the surface skin of the panel (Figure 6).

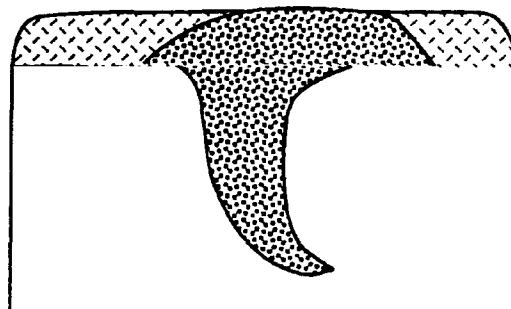
FIGURE 9. DETECTION OF THE DEFECT

because of the diffusion of the penetrant in the developer, is always larger than the discontinuity (Figure 9).

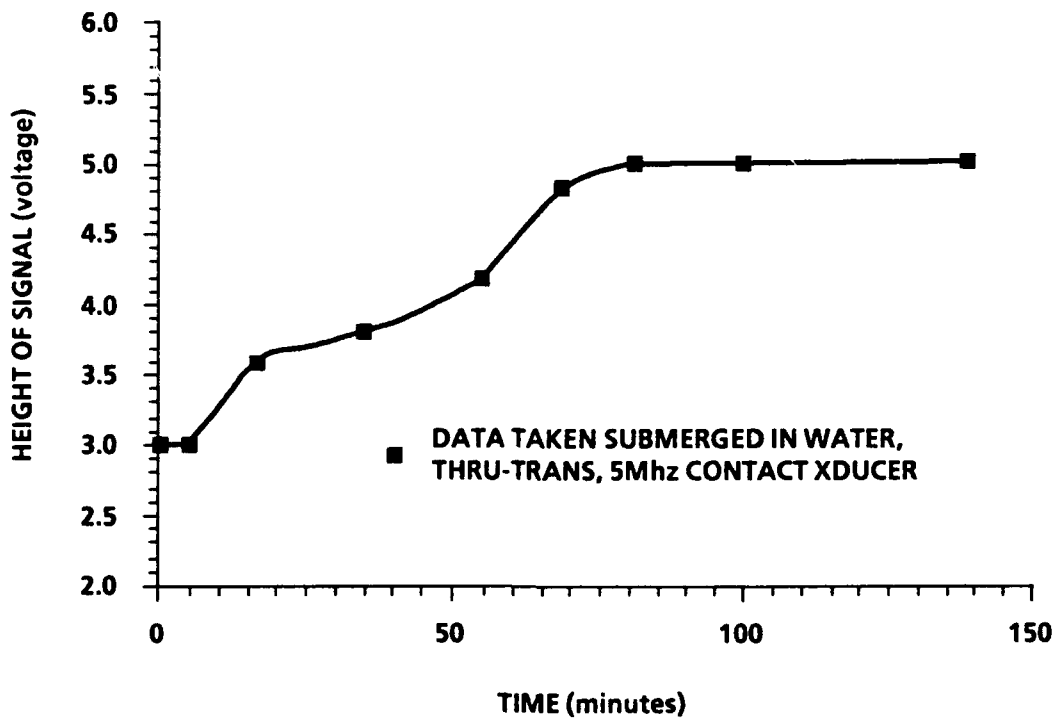
**FIGURE A-1. PLOT OF WATER DIFFUSION VERSUS SIGNAL ATTENUATION**

A graphite aluminum composite panel with known gross delaminations was submerged into the ultrasound tank without the silicone adhesive. The signal attenuation of a particular spot within the delamination was observed and recorded. As time elapsed water entered the delamination, hence water replaces air giving a path for the ultrasound signal to travel. This would give a false C-scan for the delamination because the signal is no longer being attenuated by air. The plot of water diffusion versus signal attenuation can be seen in Figure A-1.

A method of water proofing or sealing these exposed edges of the composite is achieved by a silicone adhesive (RTV). The adhesive is applied to the edges by a fine tip brush and takes approximately 24 hours to setup and cure. Once the adhesive has been cured it seals the surface from moisture. The silicone adhesive will highly attenuate the ultrasound waves as seen on the outer edges and the holes in the C-scans in Figure 19. Therefore, special care must be taken not to spread the adhesive on unexposed areas. When the ultrasound tests are completed the silicone adhesive can be peeled away from the composite with no left over residue.
