**THREE CASE HISTORIES OF CRACKING PROBLEMS  
ASSOCIATED WITH  
STEEL BRIDGE FLOOR BEAMS**

A Report on a Research Project  
Sponsored by the  
STATE OF ILLINOIS  
DEPARTMENT OF TRANSPORTATION and the  
U. S. DEPARTMENT OF TRANSPORTATION  
Federal Highway Administration

DEPARTMENT OF CIVIL ENGINEERING  
UNIVERSITY OF ILLINOIS AT  
URBANA-CHAMPAIGN  
URBANA, ILLINOIS  
JUNE 1992

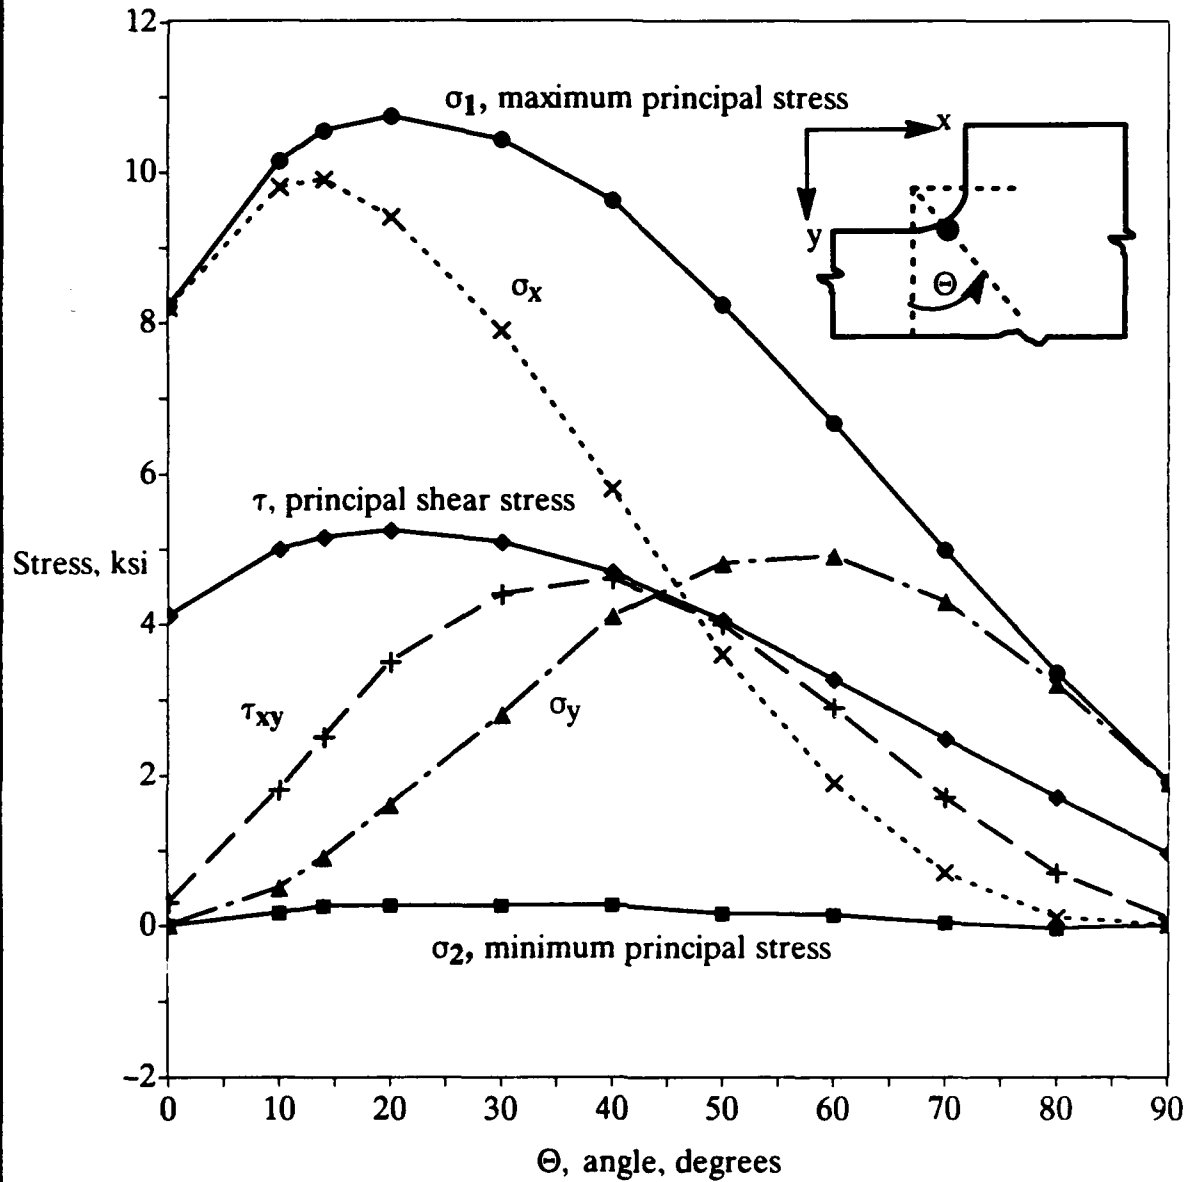
Fig. 5.5 FEM Study of Stresses Adjacent to Beam Cope

The results from the analysis are reasonably good considering that there are an infinite number of possible loading conditions and that a small two-dimensional mesh is being used to model a complex three-dimensional structure. The applied shear in the finite-element model ( $V = 1.60$  kips) is very close to the resulting shear in the floor beam when the space
