DOT/FAA/RD-92/8

Performance of Insulated Pavements at Newton Field, Jackman, Maine

Maureen A. Kestler
Richard L. Berg

May 1992

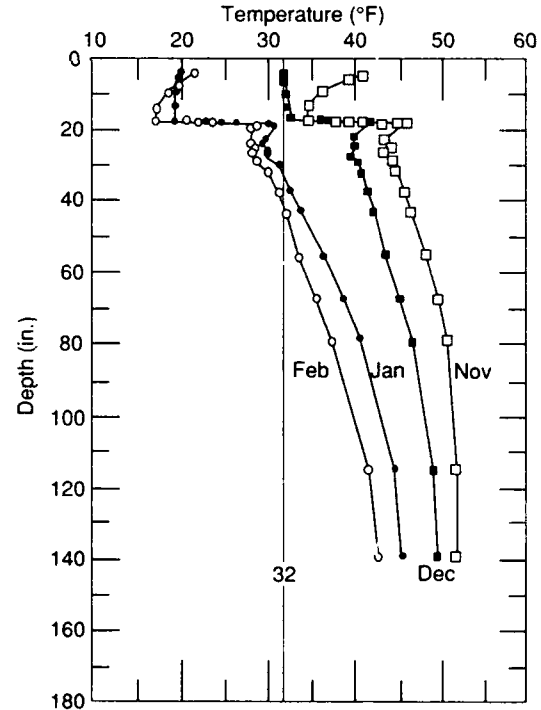
d. Subsurface temperatures at Newton Field, station 4+50, winter 1987-1988.

A distinct temperature discontinuity occurs immediately beneath the insulation on the runway (Fig. 13d). Two vertical thermocouple assemblies, one located both in and above the insulation and the second located entirely below the insulation, are separated horizontally by approximately 5 ft. It is believed that the temperature discontinuity between the thermocouple assemblies is caused either by damage to the insulation or by the horizontal separation of the insulation panels. The problem probably occurred during construction. Evidence of this problem was encountered during construction near stations 4+50 and 8+00. At both locations, trucks, bulldozers, and other construction traffic caused a large subgrade "flow" that in turn raised the insulation. Under

direction of the resident engineer, the insulation was removed, the subgrade was removed to the desired depth, and the geotextile, insulation, and base course were all replaced.

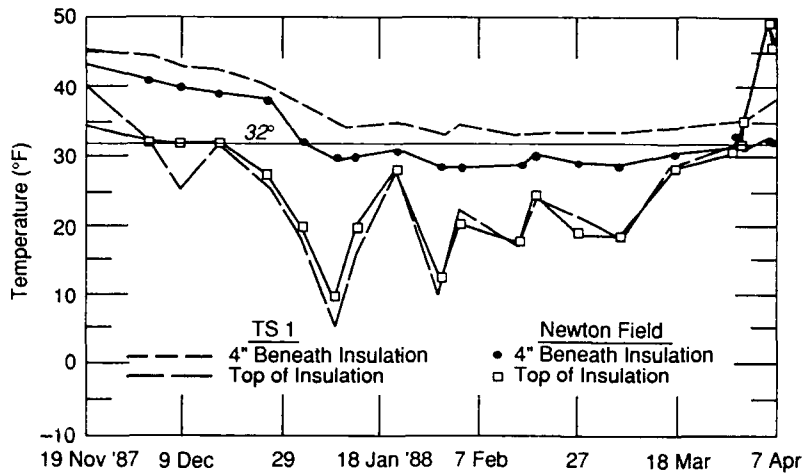
Figure 14. Comparison of temperatures above and beneath the insulation at Newton Field and in test section 1.

The difference in insulating ability of the insulation at the two pavement sites is also seen in Figure 14. Although the temperatures at the top of the insulation at each site are comparable, 4 in. beneath the insulation the temperatures differ substantially and fairly consistently over time. For winter 1987–1988, the 32°F isotherm never penetrated to this depth at the test sections, but at a comparable depth at the runway, the temperature remained below 32°F for nearly three months. This performance was the same for all three winters during which subsurface temperatures were obtained at both sites.

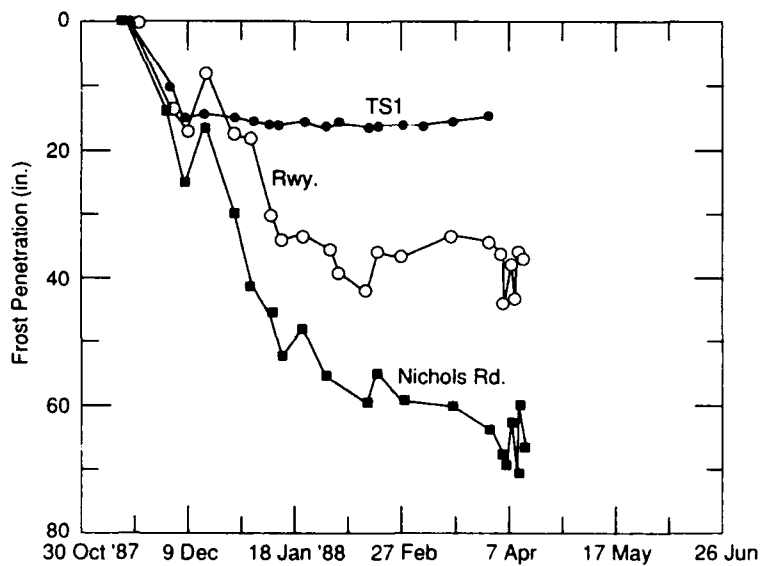
Figure 15. Progression of frost penetration with time, winter 1987–1988.

The progression of frost penetration with time is shown in Figure 15. For the 1987–1988 winter, the insulated pavement at the runway (station 4+50) allowed approximately 2 ft of frost penetration beneath the insulation. Although appreciably less than at noninsulated Nichols Road, the actual frost depth far exceeded all estimates. The unexpected frost penetration beneath the insulation on the runway during winter 1986–1987 constituted the primary reason for installation of the test sections in 1987. In contrast to the limited effectiveness of the insulation at the runway, the insulation at test section 1 prevented frost from penetrating into the subgrade. While Figure 15 is based upon 1987–1988 data, the curves are representative of each year; frost never

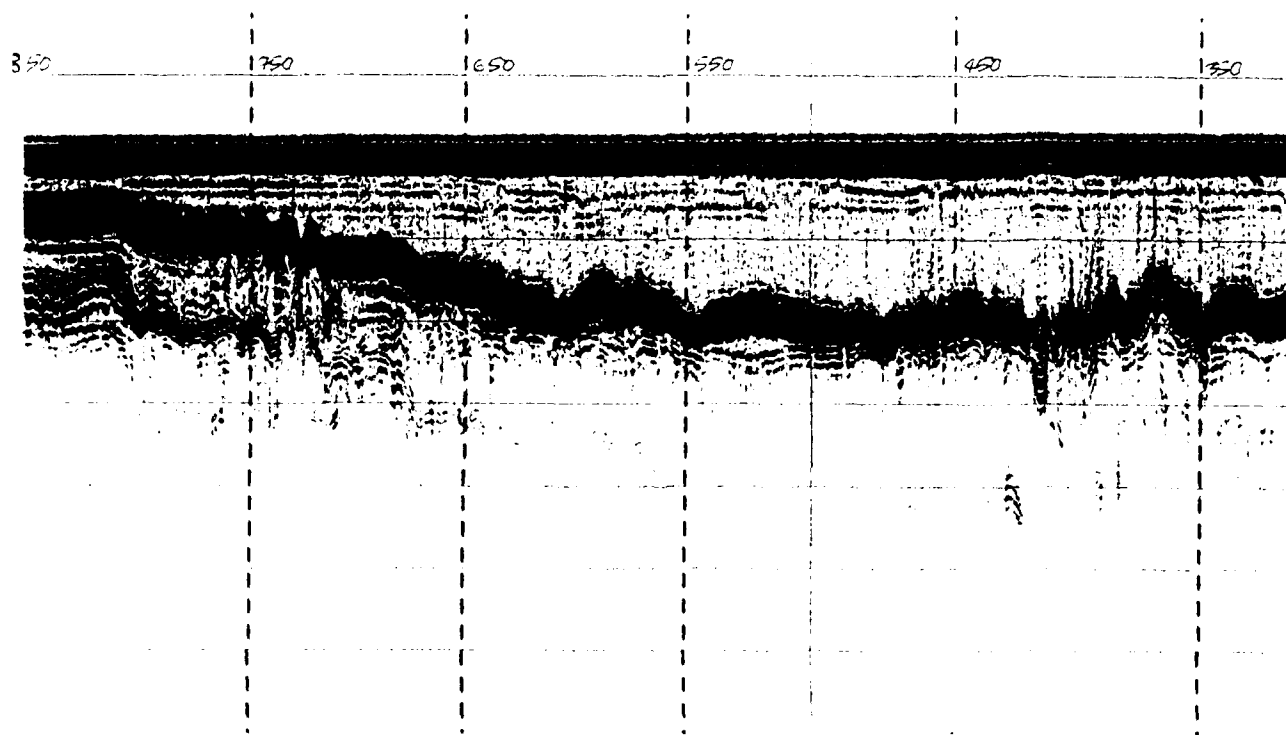
b. Centerline profile at west end of Newton Field, station 3+50 to station 8+50.

In contrast to the relatively uniform depth of the insulation panels at the test sections, Figures 22b and c show the irregular base course thickness and corresponding nonuniform depth of the insulation panels along the centerline at the two ends of the runway. For the insulation panels at shallow depths, the vertical stresses imposed by the design single-wheel load of 30 psi exceed the panels' 40 psi compressive strength. It is possible that this could lead to crushing of the insulation and ultimately lower the efficiency of the insulating layer. In Figure 22d, the individual 2-ft wide panels can be identified and are indicated on the figure.
