MTL TR 92-26

# **LAV ARMOR PLATE STUDY**

**US ARMY  
LABORATORY COMMAND  
MATERIALS TECHNOLOGY LABORATORY**

This study was undertaken to determine the cause of cracking in high hard armor steel plates used in the manufacture of light armored vehicles (LAVs) and to make recommendations to alleviate the problem. Cracks in several components from fielded vehicles were analyzed. In many cases the cracking was found to be caused by improper edge preparation in cutting the steel which resulted in environmentally-assisted cracking. Cracks were also observed starting from welds which were attributed to a number of possible causes: stress-corrosion cracking, hydrogen-assisted cold cracking, and cracking due to extremely harsh vehicle use. Base metal mechanical properties, including hardness, tensile strength, and Charpy V-notch impact energy were measured from room temperature to  $-40^{\circ}\text{F}$  ( $-40^{\circ}\text{C}$ ). Ballistic properties were measured and the propensity of the steel to crack under ballistic impact conditions was also evaluated. Additionally, the study involved a review of MIL-A-46100 and the new Canadian Material Specification, CMS-18.

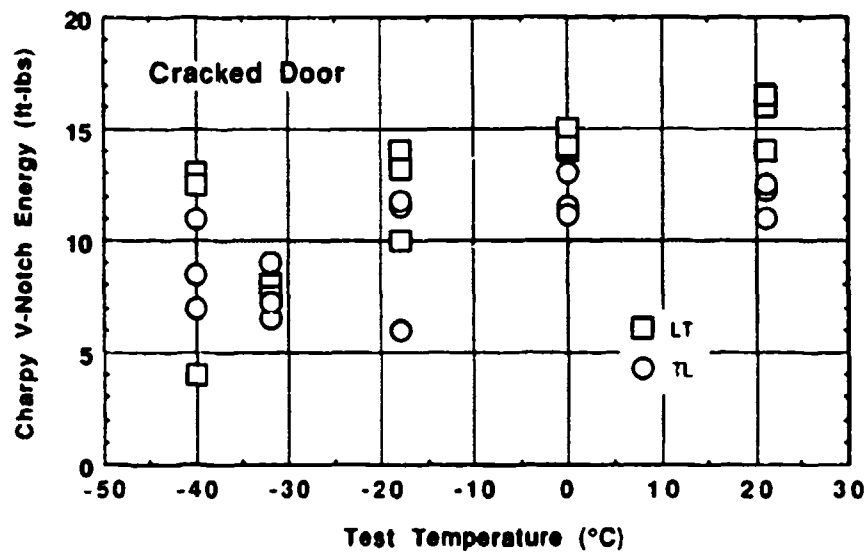
(3/4 size specimens) from room temperature (72°F) to -40°F. No sharp transition temperature was observed (see Figure 4). The shape of the curve is typical for very high strength steels.<sup>3</sup>

Figure 4. CVN energy (3/4-size specimens) versus test temperature; cracked door.

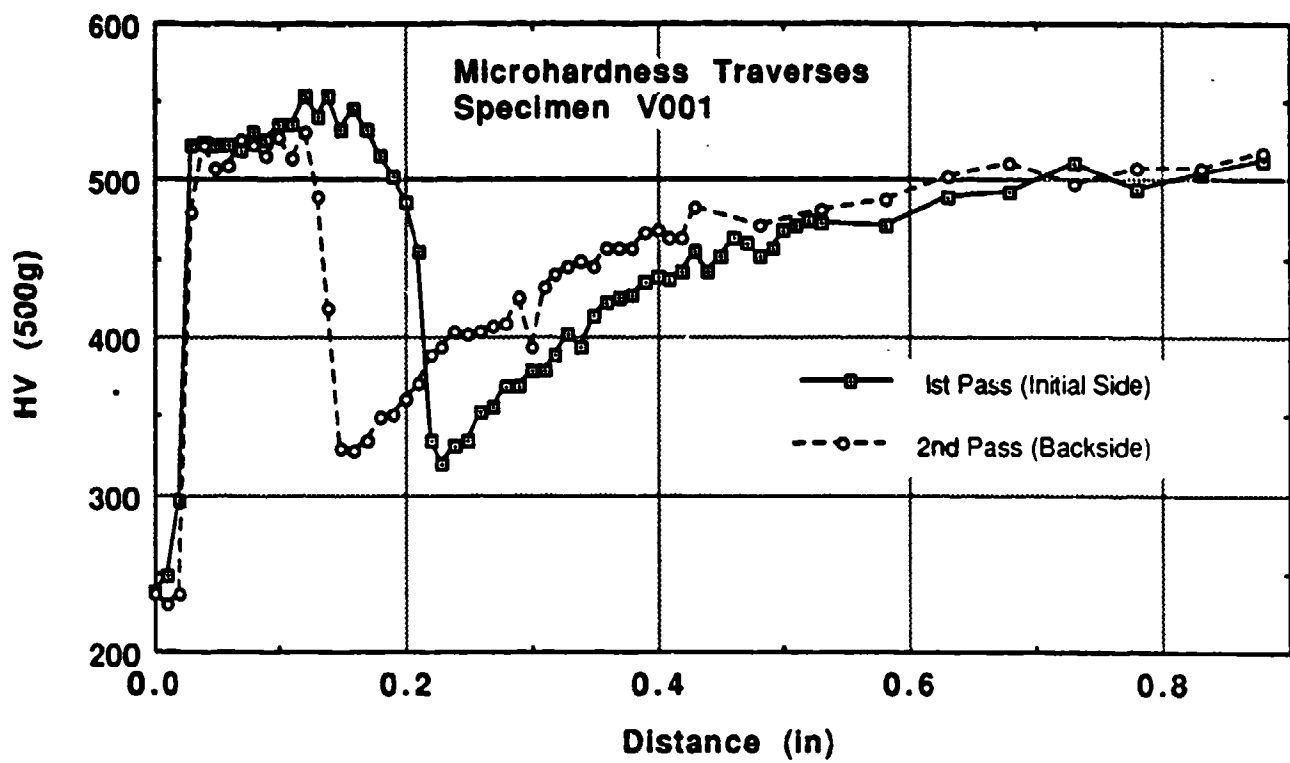
Figure 8. Microhardness tranverses across a weld from dropped LAV.

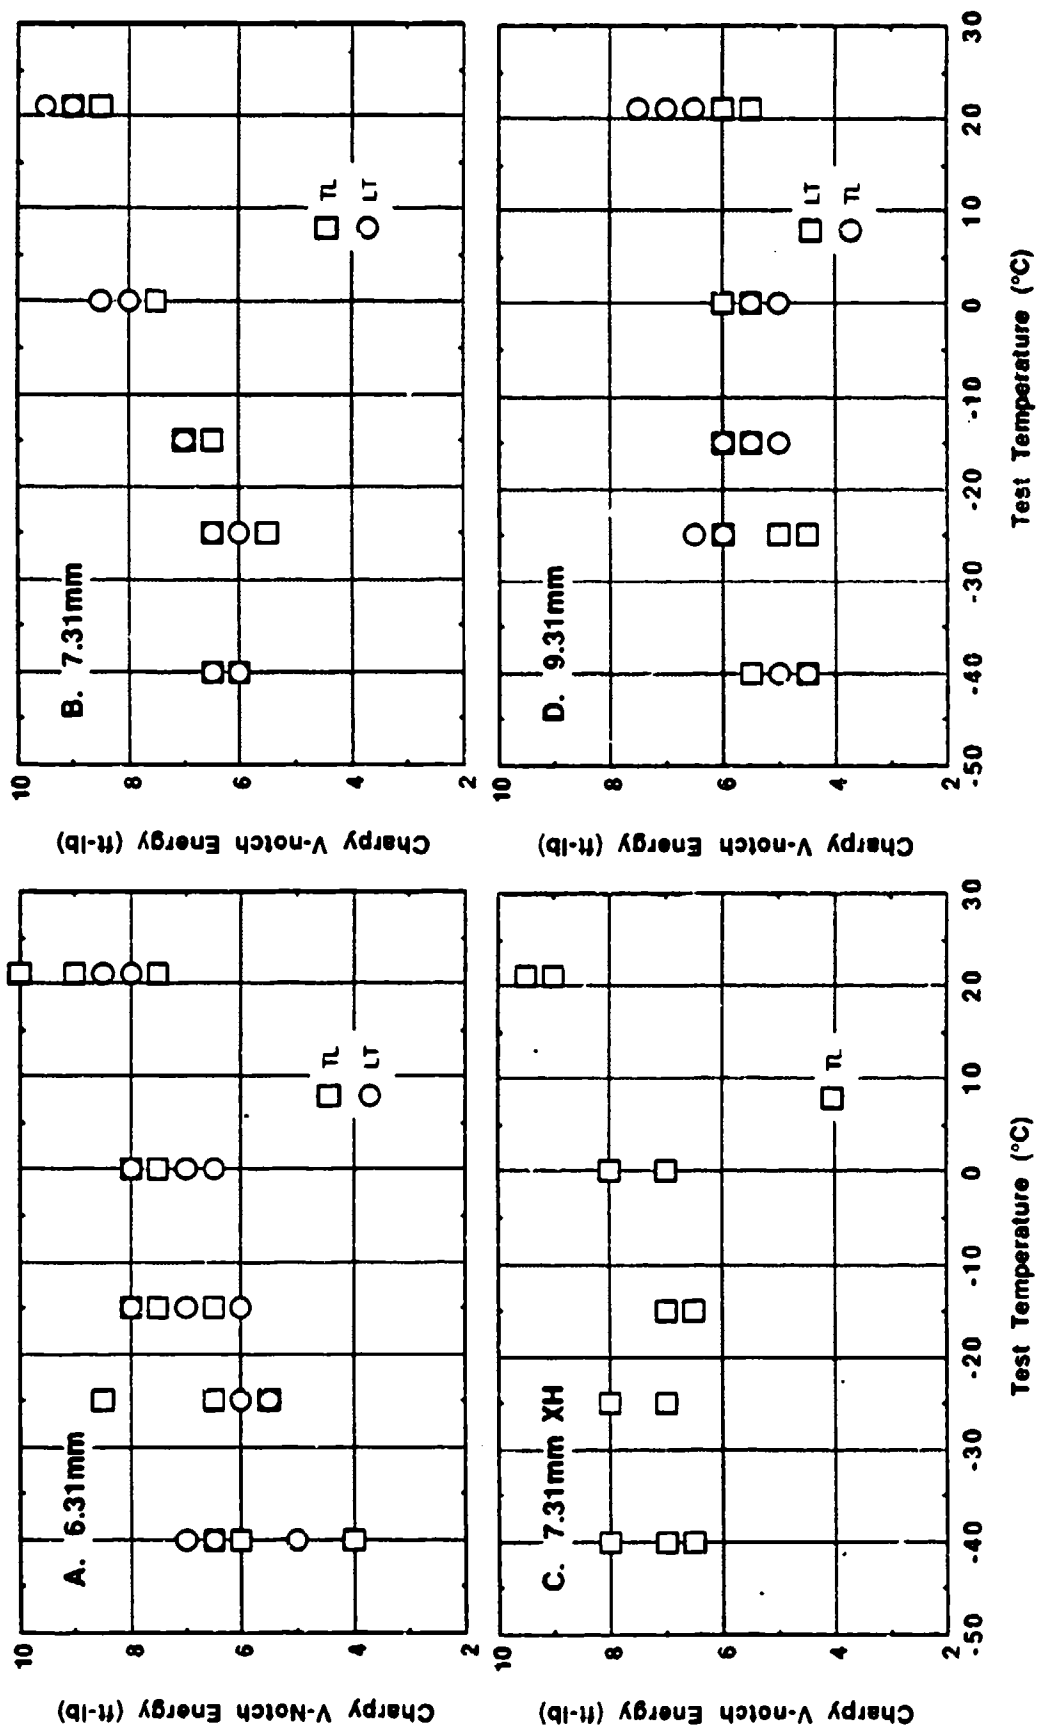
The Charpy impact toughness was measured on the four plates in both the longitudinal and transverse directions over a test temperature range from  $-40^{\circ}\text{F}$  to the room temperature of  $72^{\circ}\text{F}$ . The results are given in Figures 9a through 9d for the four plates tested. It should be noted that there is no abrupt change in toughness values at any point over this temperature range. The toughness decreases gradually from room temperature ( $72^{\circ}\text{F}$ ) to  $-40^{\circ}\text{F}$ . The Charpy values exceeded the requirements of MIL-A-46100 for three of the plates, while the 9.71-mm thick material had values slightly lower than specified; i.e., longitudinal 10 ft-lbs measured versus 12 ft-lbs specified, and transverse 9.5 ft-lbs measured versus 10 ft-lbs specified.

Figure 9. Charpy impact energy (1/2 size specimens) versus temperature for (a) 6.31-mm plate, (b) 7.31-mm plate, (c) 7.31-mm XH plate, and (d) 9.71-mm plate.
