Aircraft Structures Report 449

**DAMAGE TOLERANCE ASSESSMENT OF BORON/EPOXY  
REPAIRS TO FUSELAGE LAP JOINTS**

D. REES  
L. MOLENT  
R. JONES

AUGUST 1992

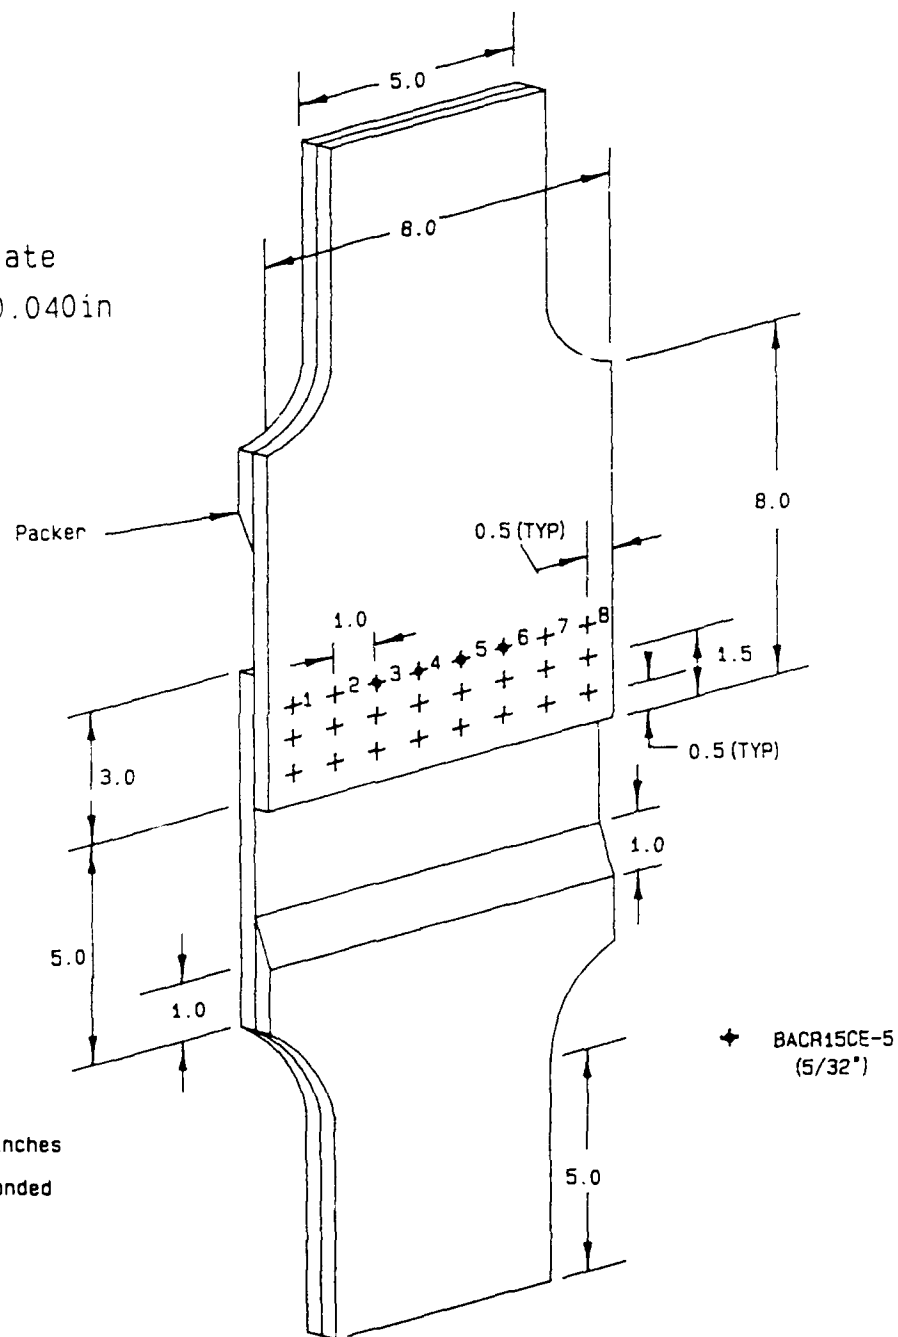
Figure 1. Fuselage Lap Joint Specimen

The lap joint specimens consisted of two 1.016mm thick 2024-T3 aluminium sheets fastened with three rows of 3.97mm diameter BACR15CE-5 100° shear head counter sink rivets. Specimen dimensions are shown in Figure 1. To reproduce crack growth rates in agreement with fleet measurements [2], the specimens were assembled in pairs by bonding back to back on a 12.5mm thick honeycomb core. Multiple cracks in the upper row of rivets were initiated and grown under a tensile fatigue loading. The specimens were then repaired using a 203mm long by 203mm wide unidirectional boron/epoxy doubler. Details of specimen manufacture, crack initiation, crack growth rates and further details of the repair can be found in previous reports [1,2].

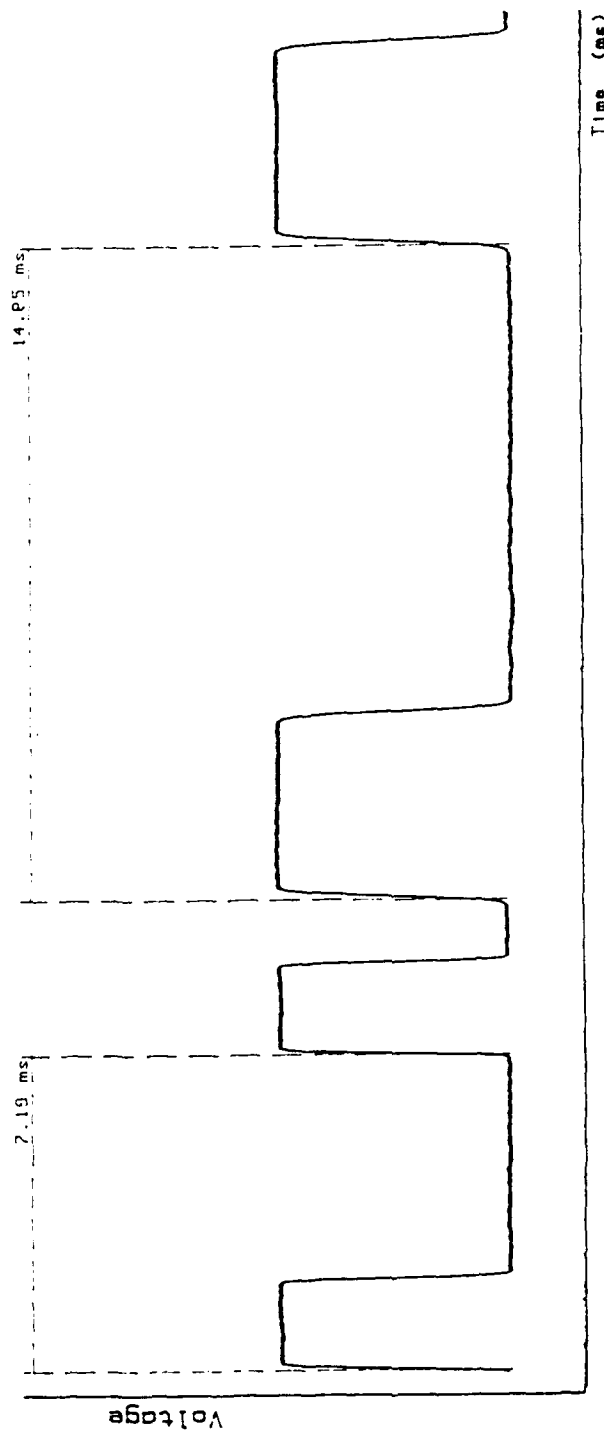
Figure 5. Typical Impact Test Result

A typical impact test result is shown in Figure 5. The impact site locations are shown in Figure 6, and the impact energies are summarised in Table 2.

Absorbed Energy = 3.6524 Joules.
