TECHNICAL REPORT REMR-GT-18

EVALUATION OF THE REHABILITATION PROGRAM  
FOR RELIEF WELLS AT LEESVILLE DAM, OHIO

September 1992

Final Report

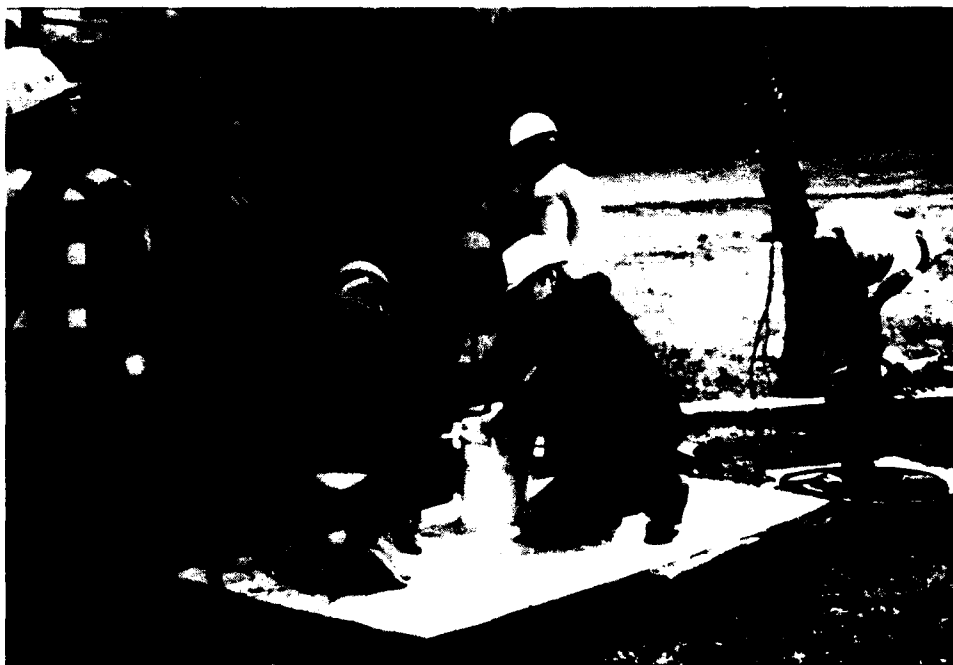
Photo 16. Vertical support for PVC riser  
pipe; plywood platform placed over the  
relief well housing

22. Prior to conducting the chemical treatment program in each relief well, a temporary 5- to 6-ft length of casing had to be added to the well to maintain a static water level inside the casing, above the floor of the relief well housing. Maintaining the static water level inside the casing was necessary in order to properly introduce, contain, and surge the chemicals in the well. A 10-in.-diam PVC well casing was used for the temporary casing extension. A neoprene sleeve was used to join the PVC riser pipe to the fiberglass relief well casing (Photos 14 and 15). The neoprene sleeve was secured to each pipe with stainless steel bands. Vertical support for the PVC riser pipe was provided by extending the PVC pipe through a plywood platform placed over the relief well housing (Photo 16).

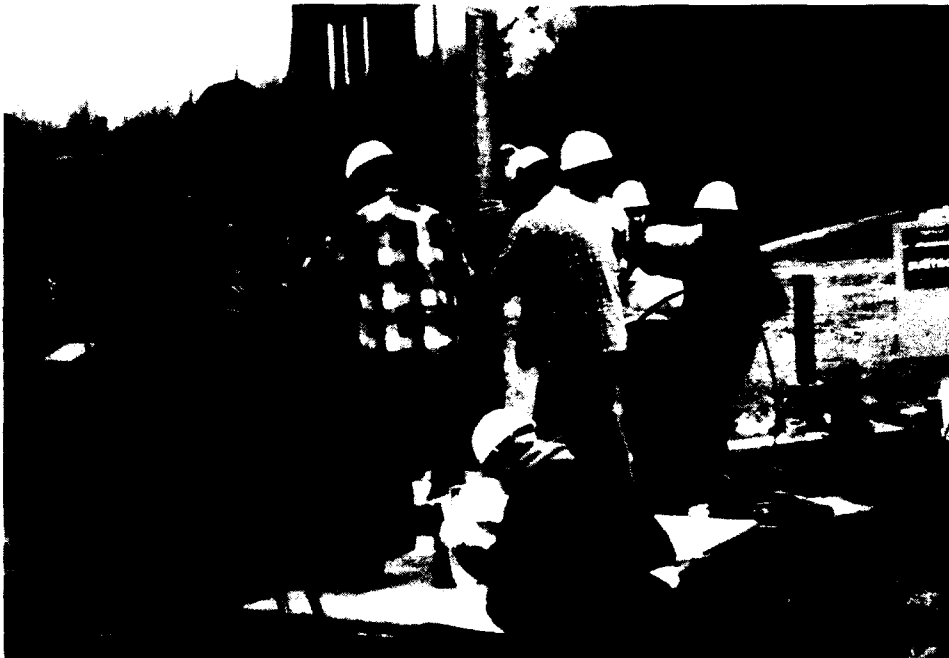
Photo 17. Pump test conducted using a submersible turbine pump and pumping at three different rates (Continued)

24. A step-drawdown pumping test was performed on the relief wells. The test was conducted by setting a submersible turbine pump in the well and pumping the well at three different rates, where possible, for a period of 2 hr at each rate (Photo 17). Riser pipe extensions were added to the wells prior to the pumping tests allowing an initial static water level to be measured for use as a basis for computing drawdowns. That some of the wells were flowing prior to the rehabilitation pumping tests is evident from the fact that water levels in the riser pipe extensions, except for wells W-1, -3, -11, and -12, were higher than the tops of the well risers without the extension. The elevations of the tops of risers for wells W-1, -2, -3, -11, and -12, at the ends of the well line, are about a foot or so higher than that of the remaining wells. Thus, in addition to the fact that W-1, -2, -3, and -12 are low-producing wells, this increase in the elevations may account for the absence of flow before the extensions. The scope of this study, however,

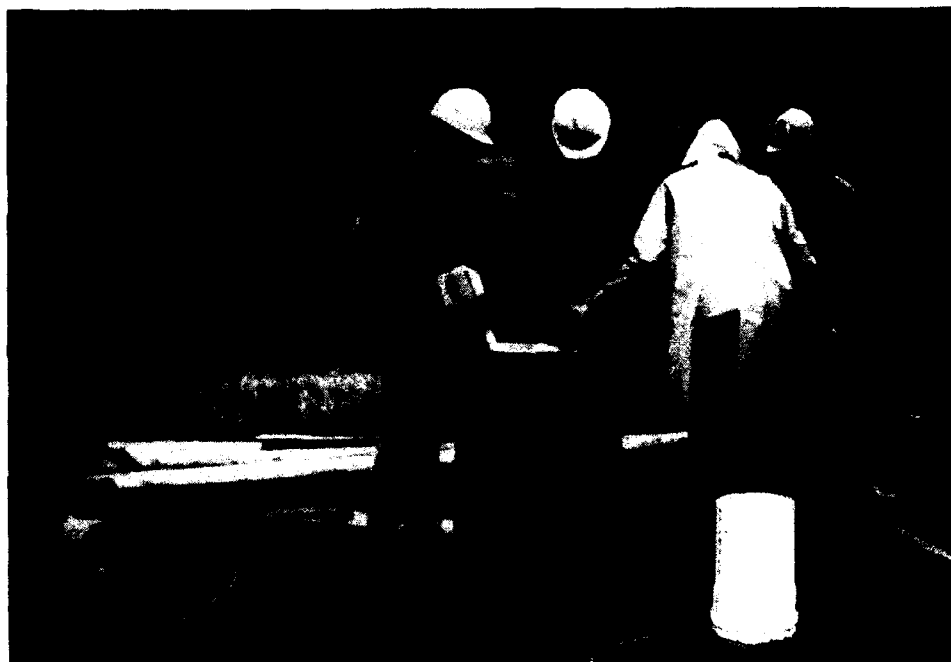
Photo 20. Chemical mixing operation - small electrical, metering pump

42. A commercially available long-linear phosphate solution, known as Aqua-Mag™, was obtained in 55-gal drums (Photo 19). A small electrical, metering pump was used to measure and dispense a predetermined volume of the phosphate solution into an empty 55-gal drum (Photos 20, 21, and 22). The predetermined volume of phosphate solution was equivalent to 3 percent of the well volume. The well volume was calculated as the volume inside the casing and intake plus the volume in the filter pack (using a porosity value of 40 percent), multiplied by an empirical factor of 1.5. The premeasured volume of phosphate solution was then pumped from the 55-gal drum, through a flexible 1-1/2-in.-diam hose, into the relief well (Photo 23). The discharge end of the flexible hose was initially positioned at the bottom of the well screen and was slowly raised to the top of the well screen as the phosphate solution was pumped into the well. Immediately after adding the long-linear phosphates to the well, the phosphates were surged in the well using a mechanical surge block (Photos 24 and 25). Surging started at the top of the well intake and continued downward to the bottom of the intake, at a rate of 15 ft/hr. The length of the stroke of the surge block was approximately 36 in., and the measured rate of fall of the surge block was about 3 ft/sec. The phosphates were surged in the well for a period of 2 to 4 hr. (Note: An initial attempt was made to surge the wells by hand using a cathead as shown in Photo 26. This technique was found to be inadequate for sustaining the required surging action over the prescribed period of 2 to 4 hr. A mechanically powered drill rig was subsequently used to surge the relief wells throughout the chemical treatment program). As surging progressed, each well was periodically bailed to remove accumulated sediment in the well (Photo 27).

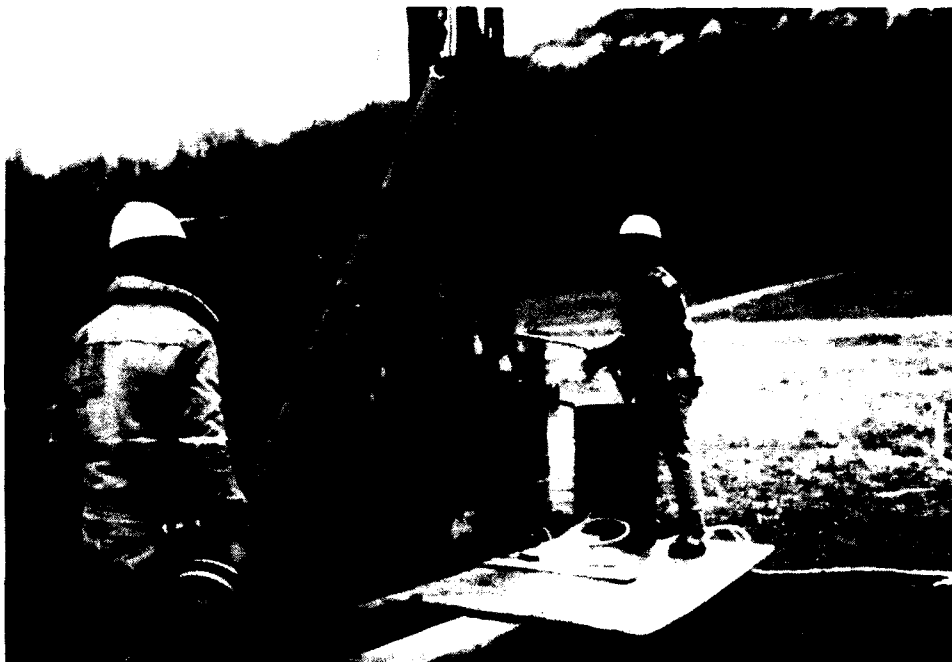
Photo 25. Surge block
