Technical Report SL-93-5  
April 1993

## Investigation of Probable Causes of Cracking, Aircraft Weather Shelters, Kadena Air Base, Okinawa

Prepared for U.S. Army Engineer District, Japan  
Camp Zama, Japan

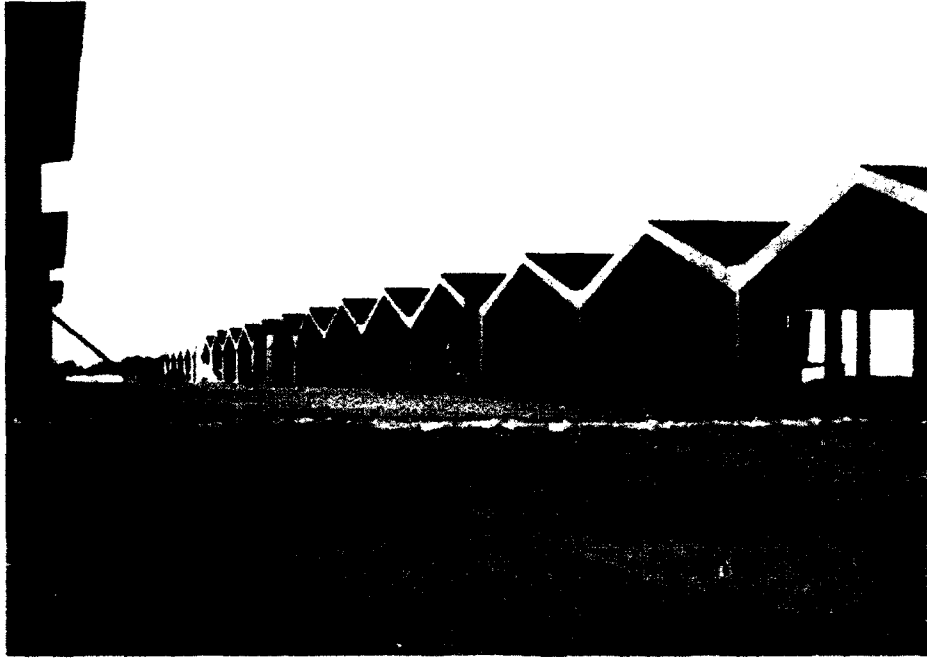
Figure 1. Kadena Air Base aircraft shelters

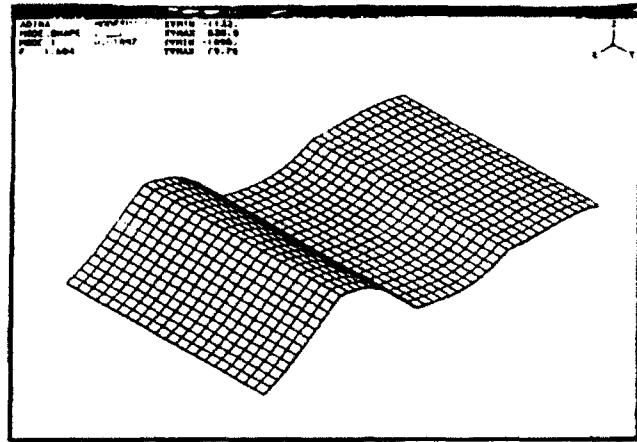
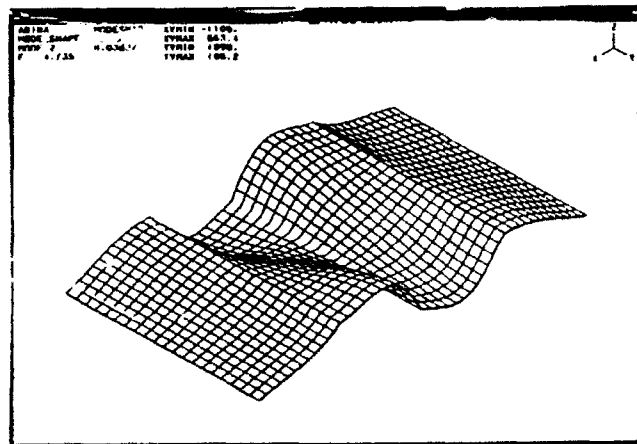
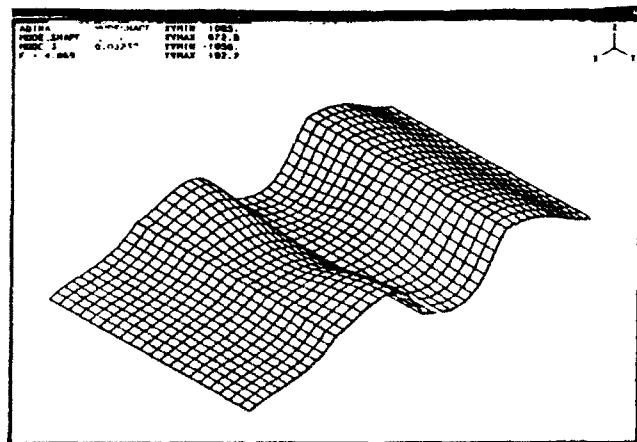
Figure 12. First three calculated mode shapes for global two-bay model

Calculated fundamental frequencies for the global model are relatively small. Figure 12 shows the lowest three calculated frequencies. Since it was not practical to collect data for the entire two-bay structure corresponding to the global model during our site visit to Kadena, the dynamic investigation concentrated on the local response for individual slab panels. Thus, the frequency range of interest was higher than would have been investigated for the entire structure.

There was evidence of one or more of the lower global modes present in some of the local data collected from a single slab, as is indicated in the low-frequency portion of the power spectrum shown in Figure 13. Excitation of the first global mode of response (Figure 12a) could result in cracking patterns similar to those observed in the structure. Cracking parallel to the valleys and at the underside of the girders near the peaks could be attributed to excitation of this fundamental global mode, as might be affected by wind loads. Unfortunately, the resolution for the lower frequency ranges was not adequate to determine if these global modes were being excited by ambient conditions. Also, the frequency range of interest for these global modes is at the low end of the effective range for the accelerometers used in the investigation. Therefore, the evidence for excitation of these global modes is inconclusive.

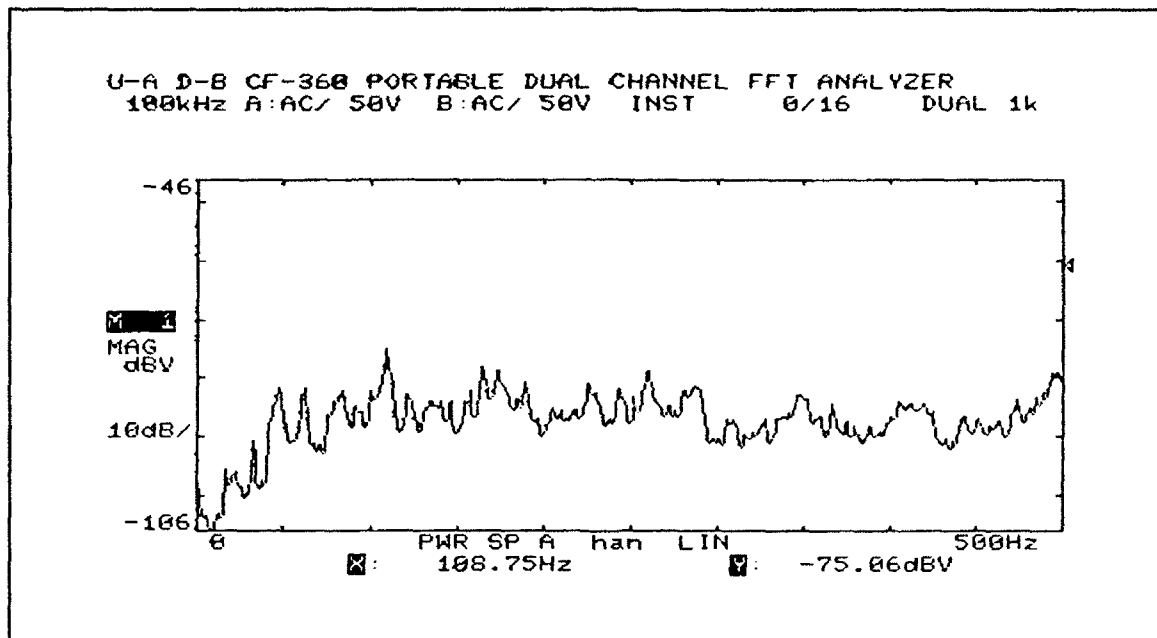
Figure 13. Power spectrum showing evidence of lower global modes in local data (peaks at frequencies less than 40 Hz)

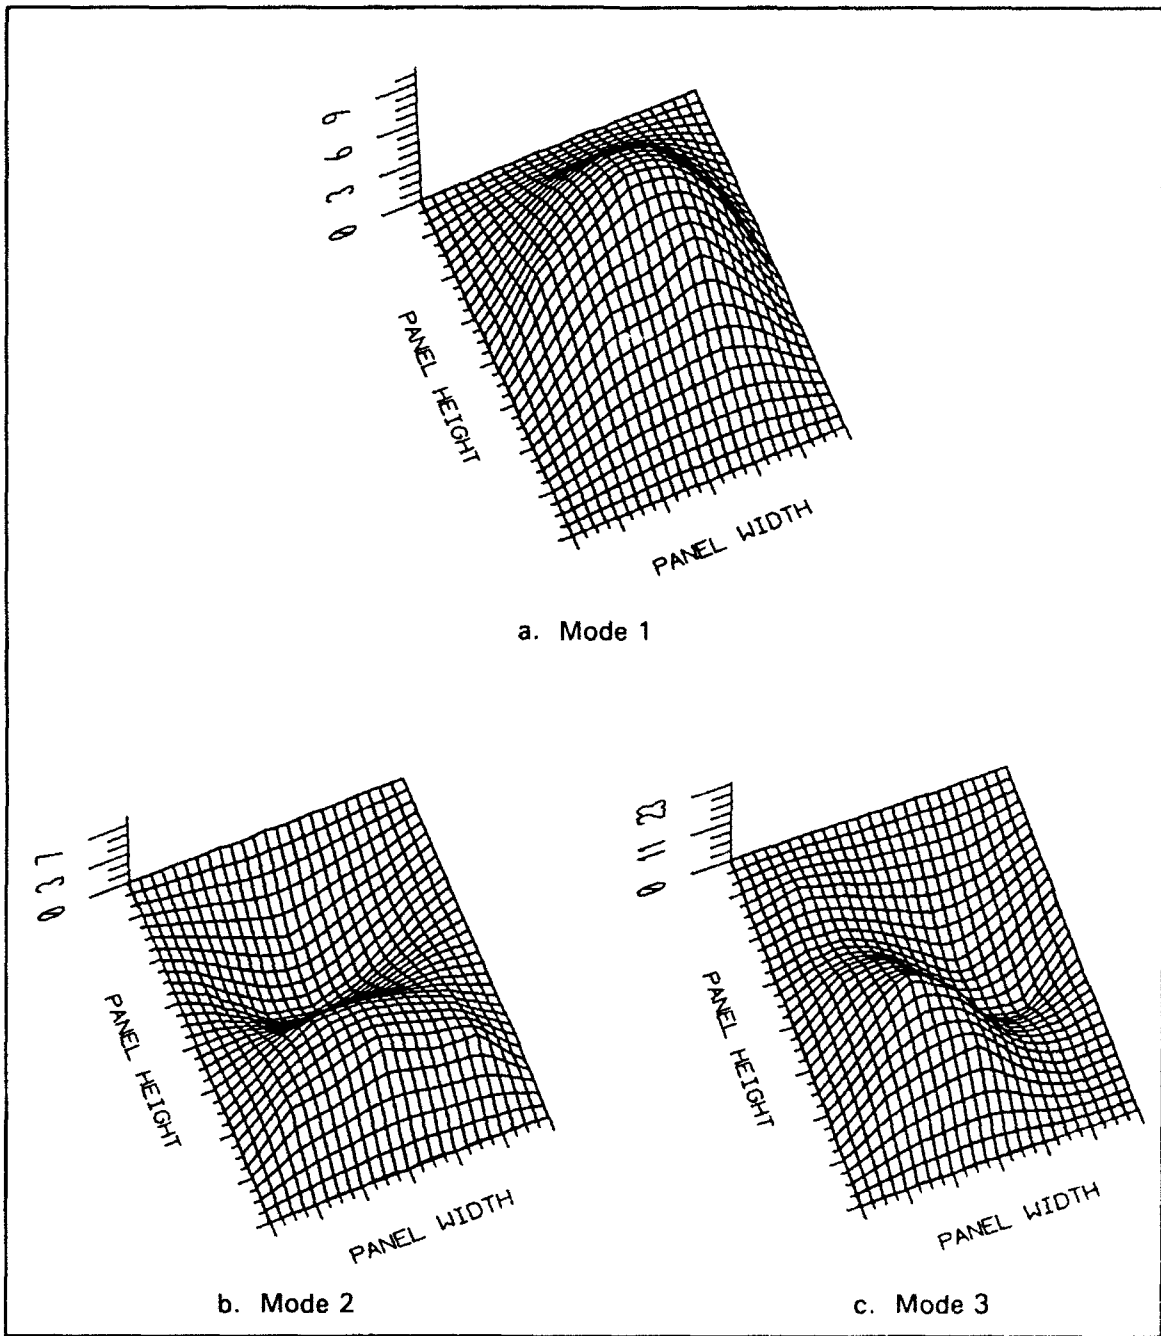
An undamaged panel (UP1) was selected to provide baseline data. Figure 17 displays the experimental fundamental vibration mode for this panel. The shape of the fundamental mode derived experimentally is strikingly similar to the calculated mode (Figure 14b). The fundamental frequency determined from test results was 46.25 Hz, compared to a calculated fundamental frequency of 45.65 Hz. Experimental results from modes 2 and 3 are shown in Figures 17b and 17c. The frequency values are not as close to the calculated values as they were for mode 1 (Table 5), but the patterns are still notably similar.

Figure 17. First three modes for UP1 as determined by impact tests

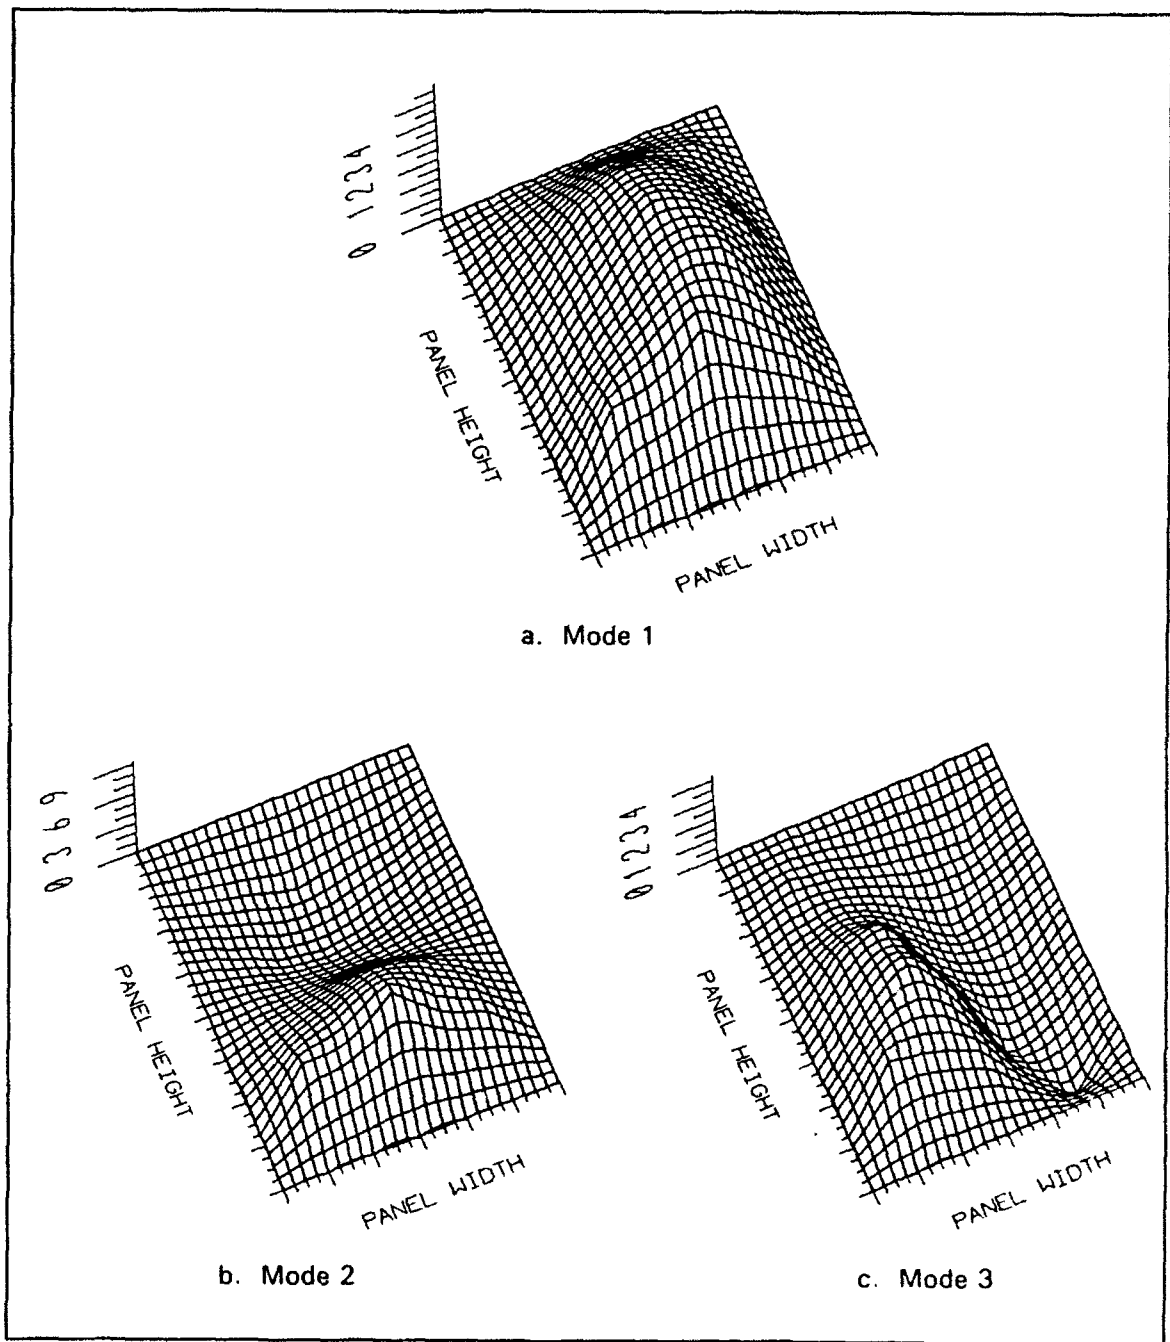
The damaged panels (DP1 and DP2) chosen for impact tests represented two of the more common crack configurations. One panel (DP1 in Figure 15) had a diagonal crack across one corner and penetrating the full depth of the slab. The same procedures were used for this panel as were used for the undamaged panel to define the mode shape. Figure 18 shows the first three experimentally derived modes for DP1. The results for this mode of DP1 appear to be identical to those of the undamaged panel. A minimal effect of the crack on structural behavior is indicated. The second and third modes for this panel compare very well visually with experimental results for UP1 and with calculated results.

Figure 18. First three modes for DP1 as determined by impact tests

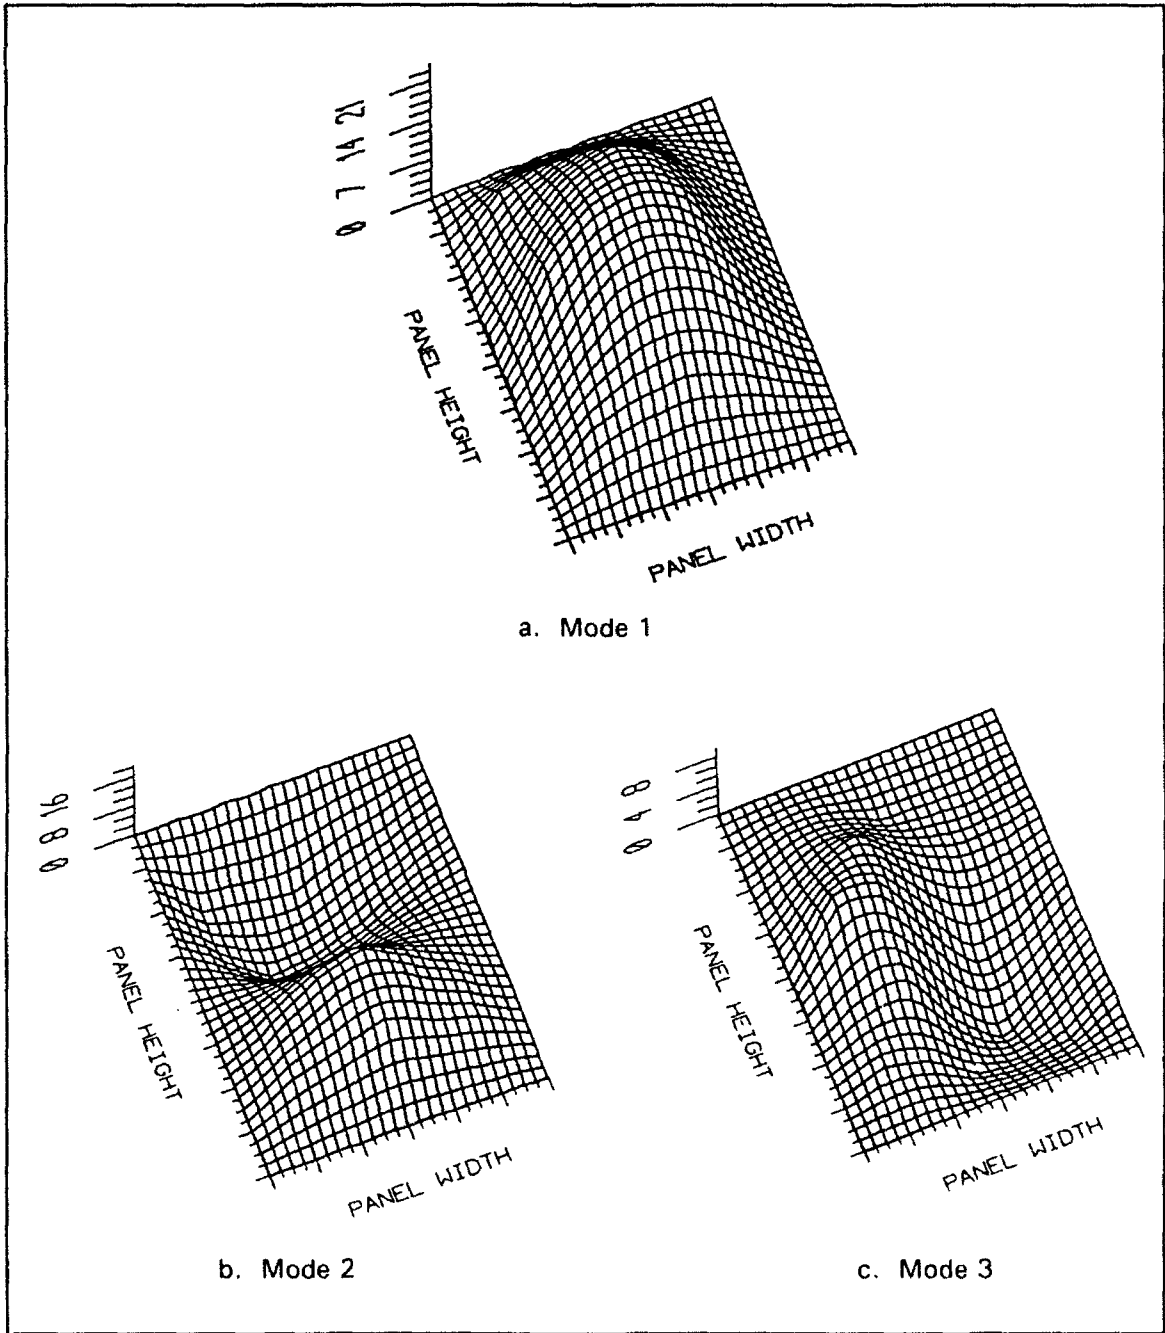
DP2 is located as indicated in Figure 15. Damage to this panel consisted of a longitudinal crack running parallel to the long dimension of the slab and approximately 1.5 m from the valley edge of the panel. The experimental fundamental frequency for the first mode was 46.25 Hz, the same as it was for the other two panels. The first three mode shapes are presented in Figure 19. Table 5 gives a comparison of the first three frequencies for the calculations and test results.

Figure 19. First three modes for DP2 as determined by impact tests

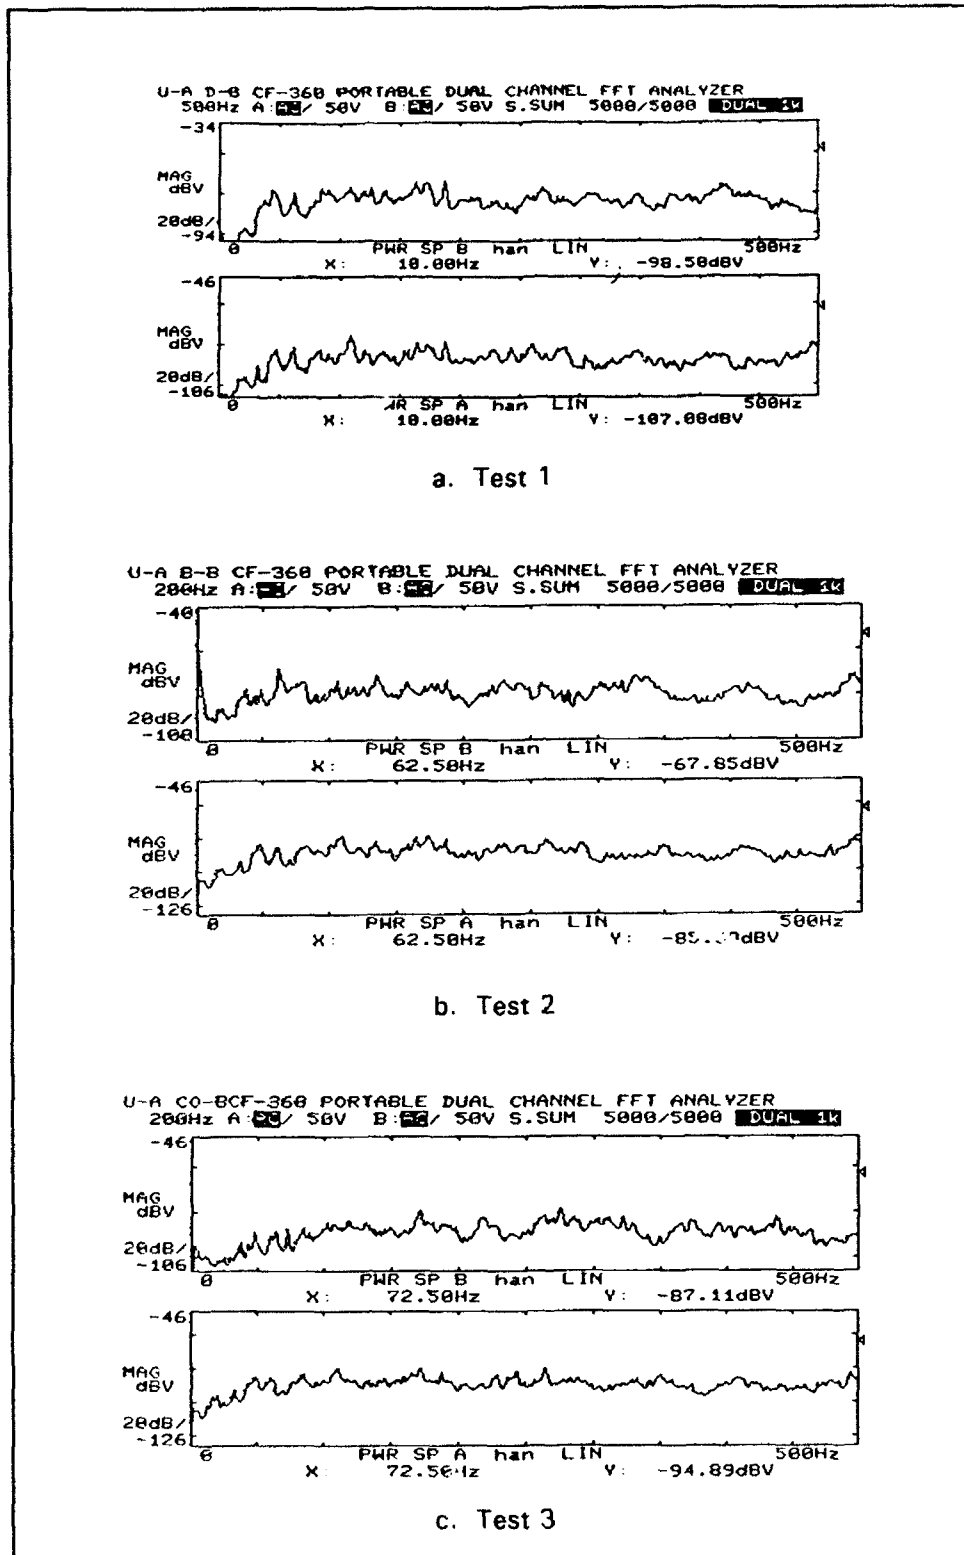
Figure 20 shows the power spectra for each of these three stationary tests, with data from the two channels open for that test (reference values plus test data). Each curve represents the averaging of 5,000 time segments of data, which reduces random noise significantly. As was true of results from the impact tests, these data indicate very similar dynamic properties for the damaged and undamaged slab panels and imply minimal effect of the crack on structural performance during everyday operating conditions.

Figure 20. Power spectra from three stationary tests (F-15, under power, parked in structure); data averaged from 5,000 time segments

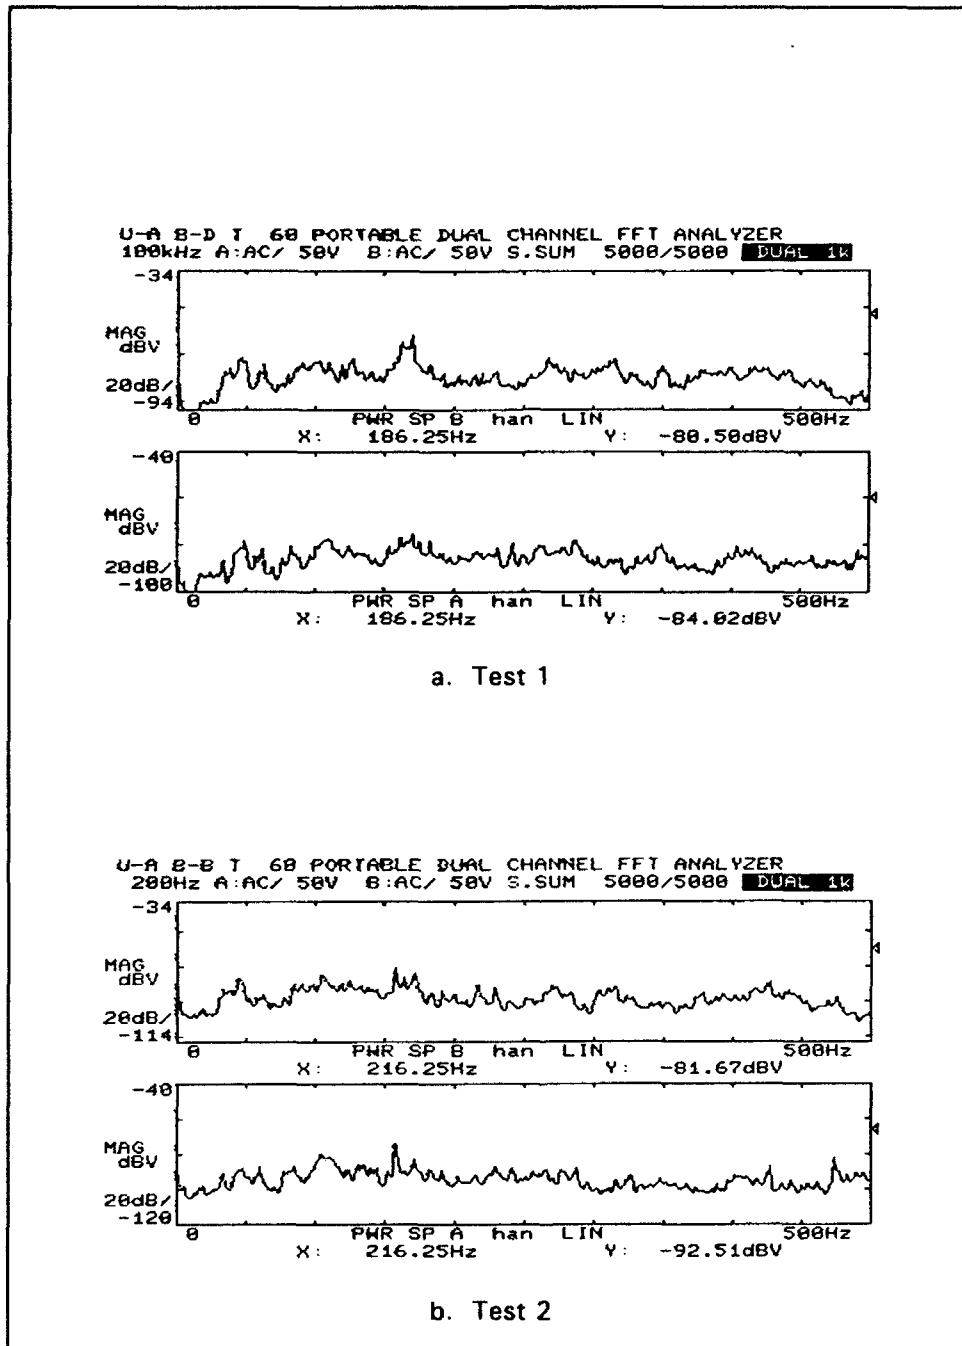
The two taxiing tests compared UP1 first with DP1 and then with the beam separating UP1 and DP1. Power spectra are plotted in Figure 21, again comparing data from pairs of channels. The results are consistent with those of the previous tests: (a) very similar dynamic properties for all members and conditions tested; and (b) the expectation of structural performance from cracked slabs similar to that of the intact portions of the shelter-roof panels.

Figure 21. Power spectra from two taxiing tests (F-15 moving through shelter); data averaged from 5,000 time segments
