Miscellaneous Paper CERC-93-5  
July 1993

## Monitoring of East Breakwater Rehabilitation at Cleveland Harbor, Ohio

by *Joan Pope, Robert R. Bottin, Jr.*  
*Coastal Engineering Research Center*

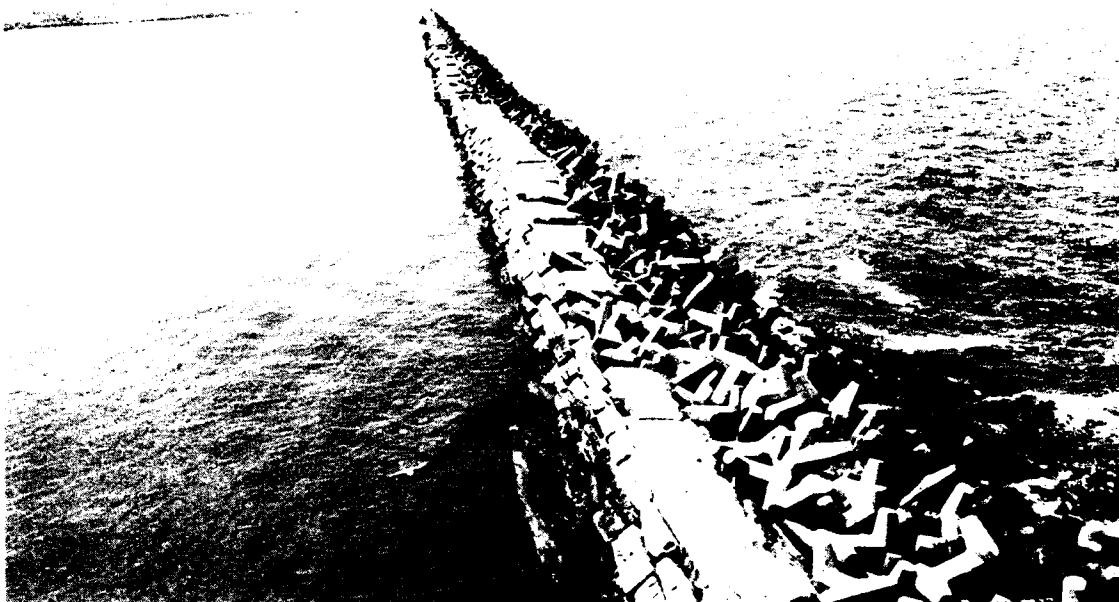
A typical section of the rehabilitated breakwater trunk is shown in Figure 7 and a view of the structure is shown in Figure 8. The slope, and in some cases the crest, were rebuilt using 2-ton dolos concrete armor units placed on a 1V:2H slope. The layer thickness is equivalent to the average measured thickness of two layers of dolosse randomly placed. Underlying the dolosse, an underlayer stone (Type "C," ranging in weight between 600 and 1,300 lb) was placed to provide an even surface with proper gradation on which the dolosse could be placed. The pre-rehab breakwater stone did not infringe in the concrete armor units layer area as the existing structure slope was simply buried.

Figure 8. View of dolos-rehabilitated east breakwater trunk (dolosse installed on lakeside of structure)

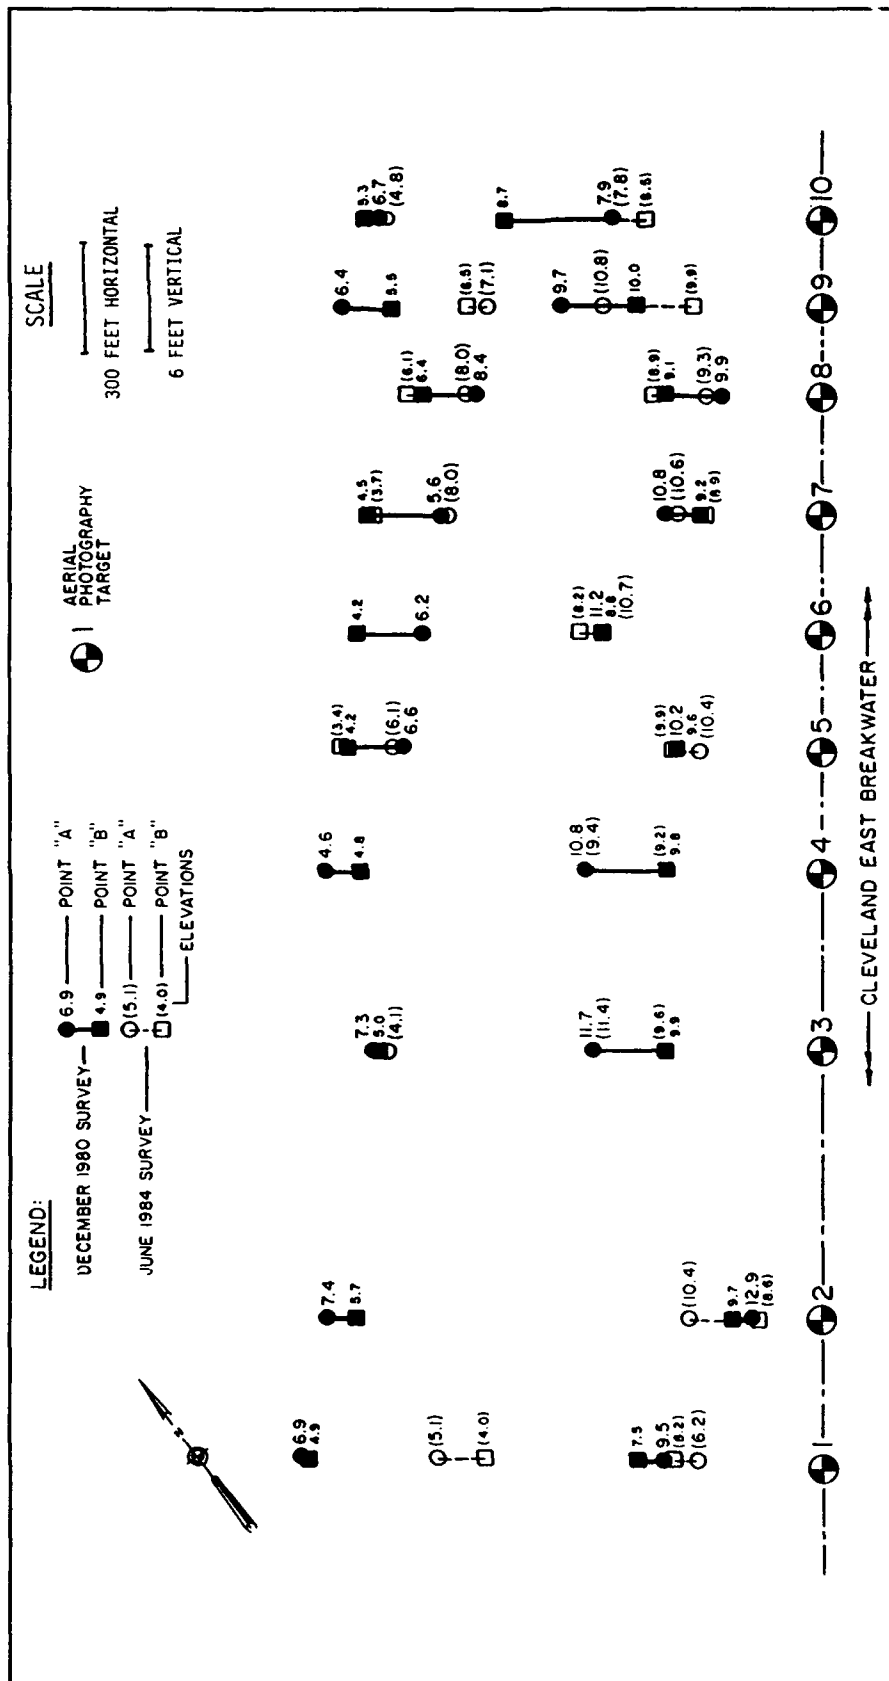
Of the 20 target dolosse established initially along the breakwater trunk, data were collected for 12 units over the entire monitoring program. The other eight dolosse were either lost, broken, or inaccessible. Three of these missing armor units were replaced by new target dolosse between the November 1982 and March 1983 surveys. The dolosse at the crest of the breakwater proved to be considerably more stable than those at the waterline. Of the ten target dolosse at the waterline, four were missing, two were broken, and one was inaccessible at the end of the monitoring period. The remaining three settled into the structure. One of the crest dolos was lost, and the others settled into the structure.

Figure 17. Net movement of targeted dolosse along breakwater trunk section between December 1980 and June 1984

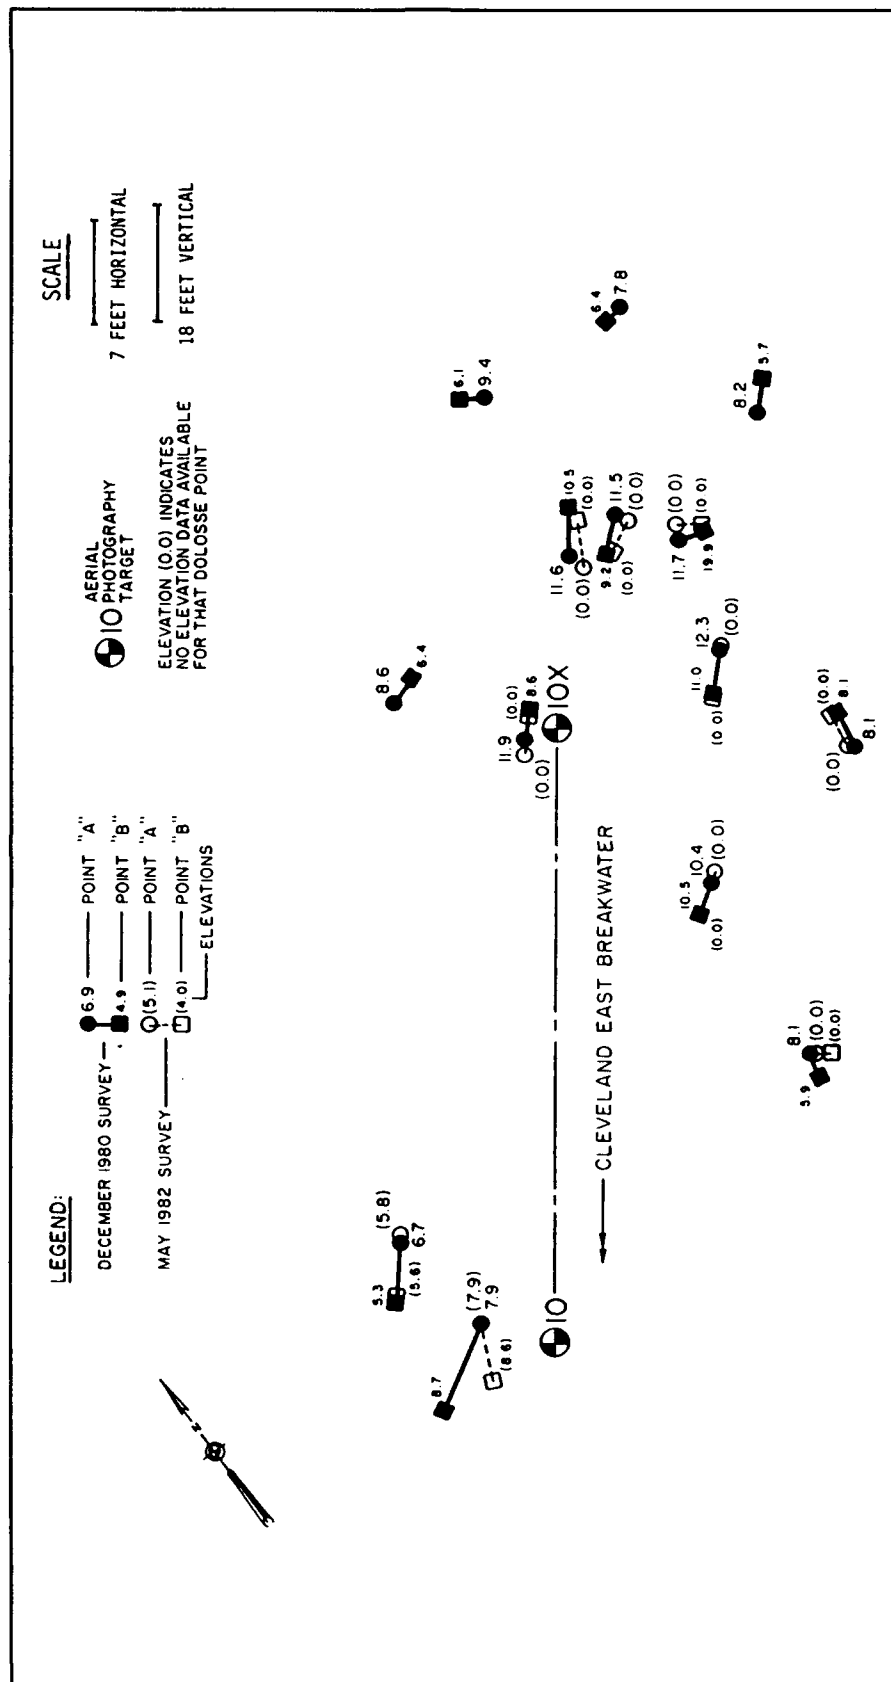
The April 1982 storm resulted in movement and breakage of some dolosse along the breakwater trunk and removal of nearly all the dolosse above low water over a 20-ft-wide section at the breakwater head. Observations and scrape marks along the concrete cap of the trunk also indicate that some units slid, flipped, or were thrown to the harbor side of the structure during the storm. About 65 dolosse were "popped" away from the impermeable, vertical-faced lighthouse concrete block base and strewn downslope as broken fragments. As a result of the storm, 200 additional dolosse were placed on the head section in October 1982 to repair the damage zone and widen the head section crest (from a two-dolos width to a three-dolos width). New target dolosse were identified and monitored. Target dolos density and the number of inspections for the head section were increased. Twenty-one new dolosse were designated for survey following the April 1982 storm. During the October repair, displaced dolosse along the trunk section also were repositioned and additional units were placed as necessary.

**Figure 18. Net movement of targeted dolosse at breakwater head section between December 1980 and May 1982**

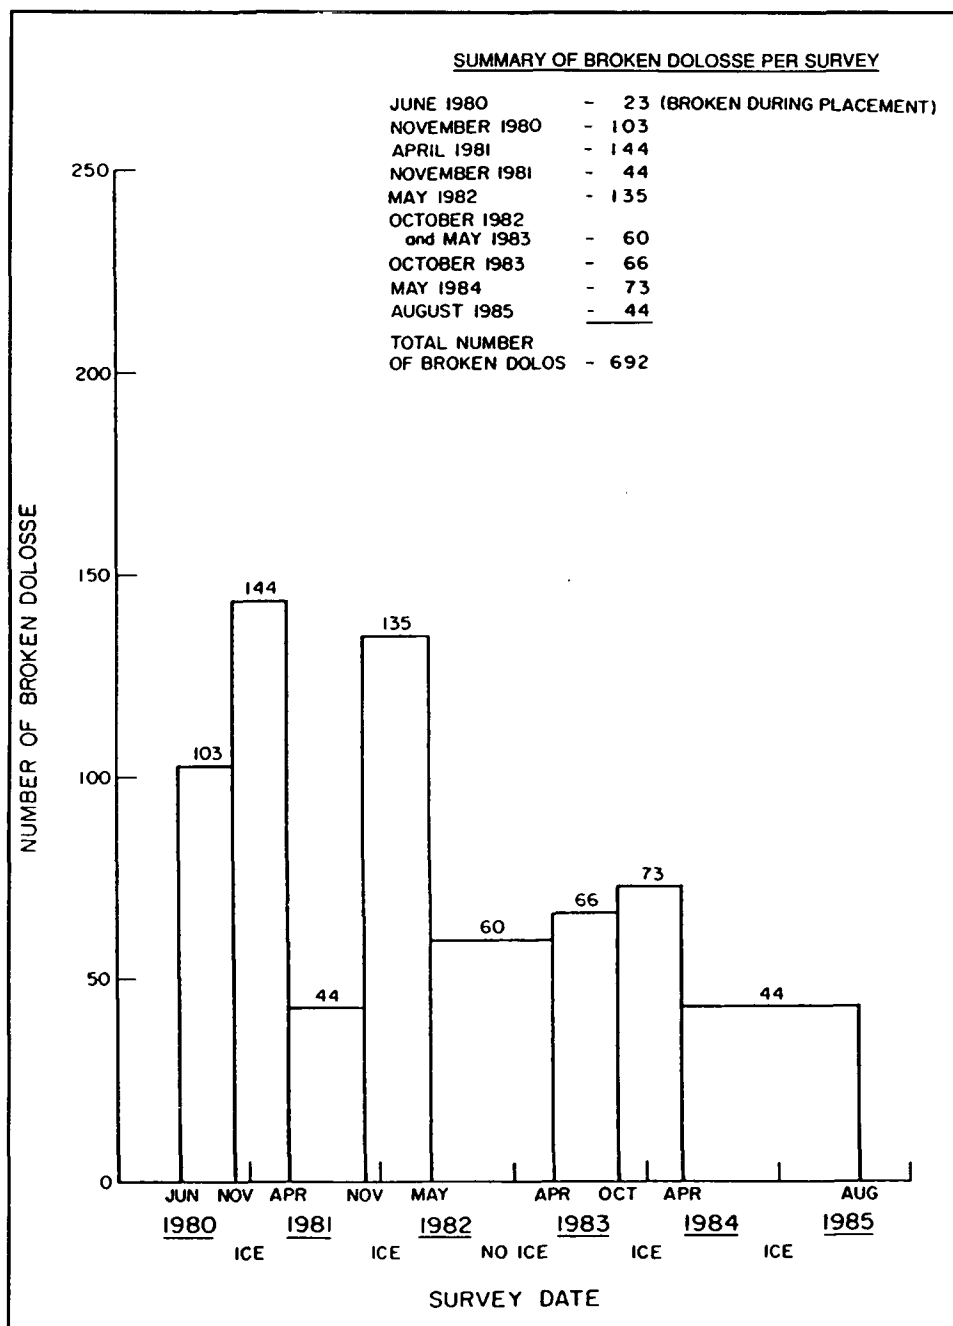
Evaluation of the broken dolos survey results from April 1980 to September 1985 indicates a total of 692 broken units above the waterline. The number of newly inventoried broken dolosse per individual survey is shown in Figure 19. The rate of new breakage appears to have decreased with time as shown by the cumulative number of broken units during the monitoring period (Figure 20).

Figure 19. Number of broken dolosse identified in individual surveys

Approximately 30 percent of the dolosse were placed above the average annual mean lake level during construction. Therefore, about 8,972 dolosse of the total 29,741 were placed above the waterline within the primary wave impact zone. With 692 units broken, this yields approximately an 8-percent breakage rate over the monitoring period ignoring below-water breakage.

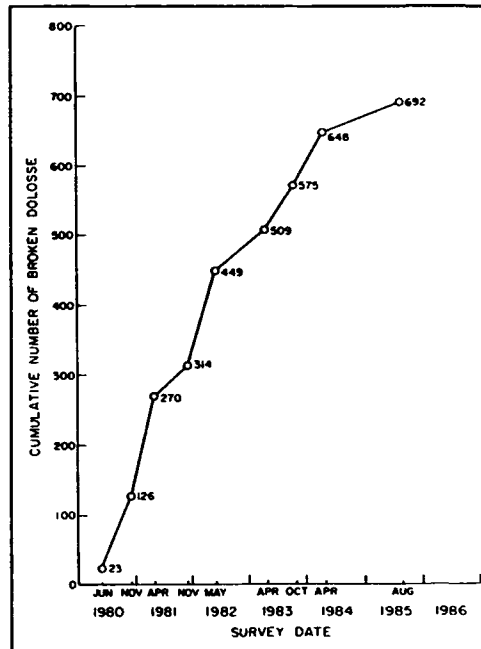
Figure 20. Cumulative number of broken dolosse during the monitoring period

winter months. Breakage was considerably greater from November to April than from the period April to November. A combination of increased storm activity and the effect of ice on the structure during the winter months probably contributed to the greater breakage rate.
