**A CASE STUDY: DAMAGE TO THE METROPOLITAN  
OAKLAND INTERNATIONAL AIRPORT CAUSED BY  
THE LOMA PRIETA EARTHQUAKE**

Barney A. Vallergera

William P. Grogan

Final Report

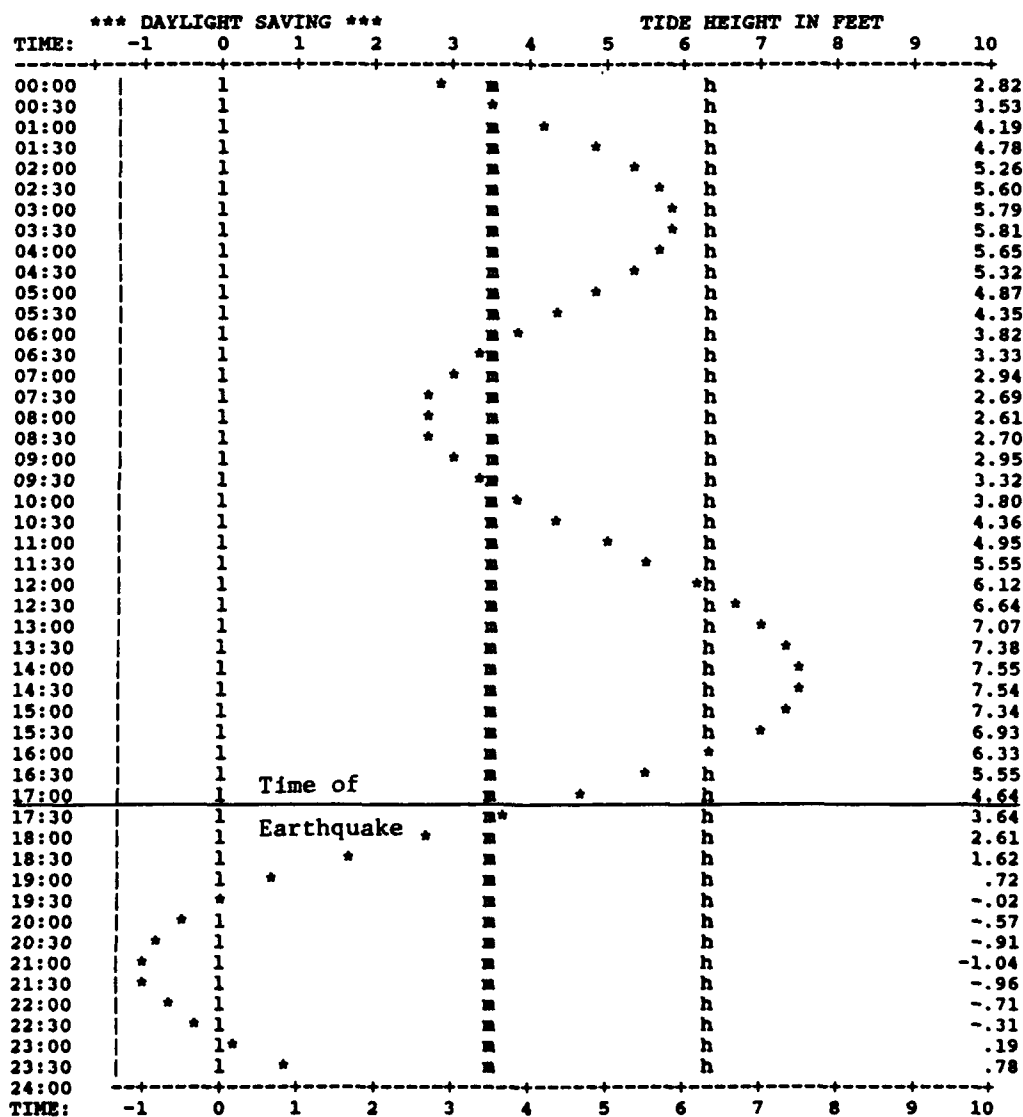
tide of 6.97 ft at 1400 hr. Figure 14 shows the recorded rise and fall of the tide on 17 October 1989.

Figure 14. Tide data for 17 October 1987
