Technical Report HL-93-7  
August 1993

# **Scour Protection for Dam No. 2, Arkansas River, Arkansas**

## **Hydraulic Model Investigation**

*by John E. Hite, Jr.  
Hydraulics Laboratory*

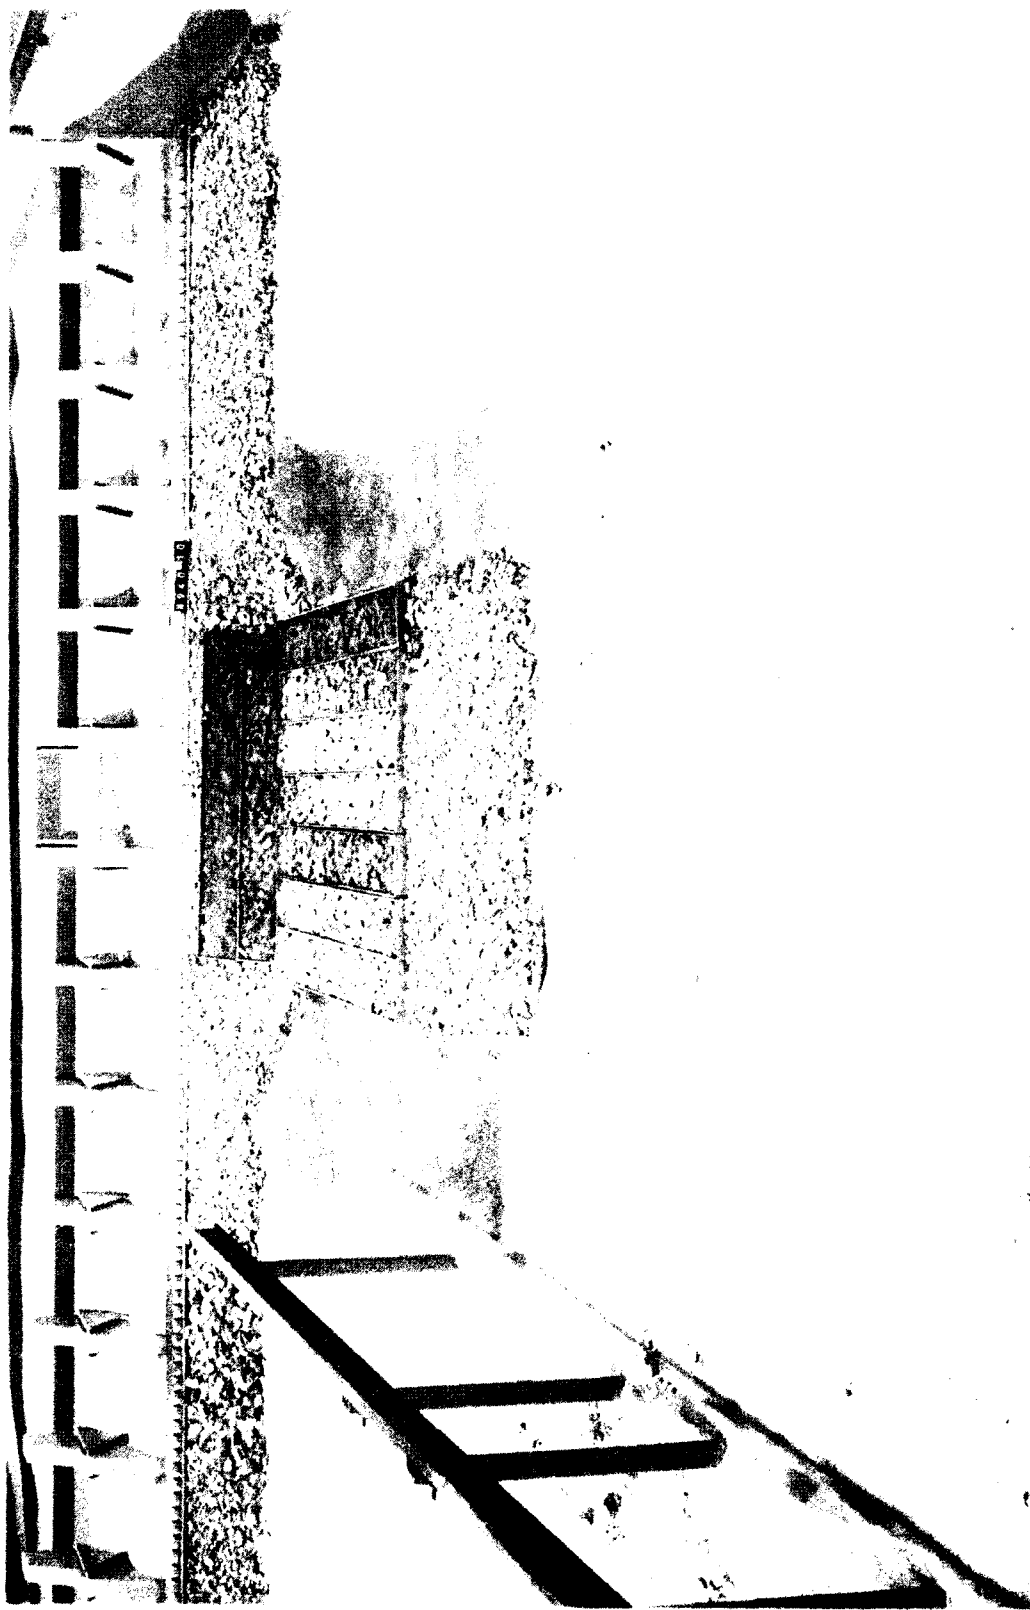
Since failure of the type 2 scour protection occurred with tailwater elevations much higher than the minimum tailwater anticipated at the project, structural modifications were made downstream from the existing stilling basin. The type 3 design shown in Photo 6 consisted of barges, 175 ft long by 26 ft wide by 12 feet deep, filled with grouted rock and placed downstream from the existing stilling basin. This design was tested in an attempt to provide a secondary stilling basin. The basin extended 220 ft downstream as shown in Plate 5 and contained a 6-ft-thick blanket of Riprap No. 7 offset 4.5 ft below the top of the barge for a distance of 125 ft downstream from the end of the barges. The type 3 scour protection design remained stable when tested for 8 hr with one gate fully open, normal upper pool elevation, and tailwater el 118.

Photo 6. Type 3 scour protection design

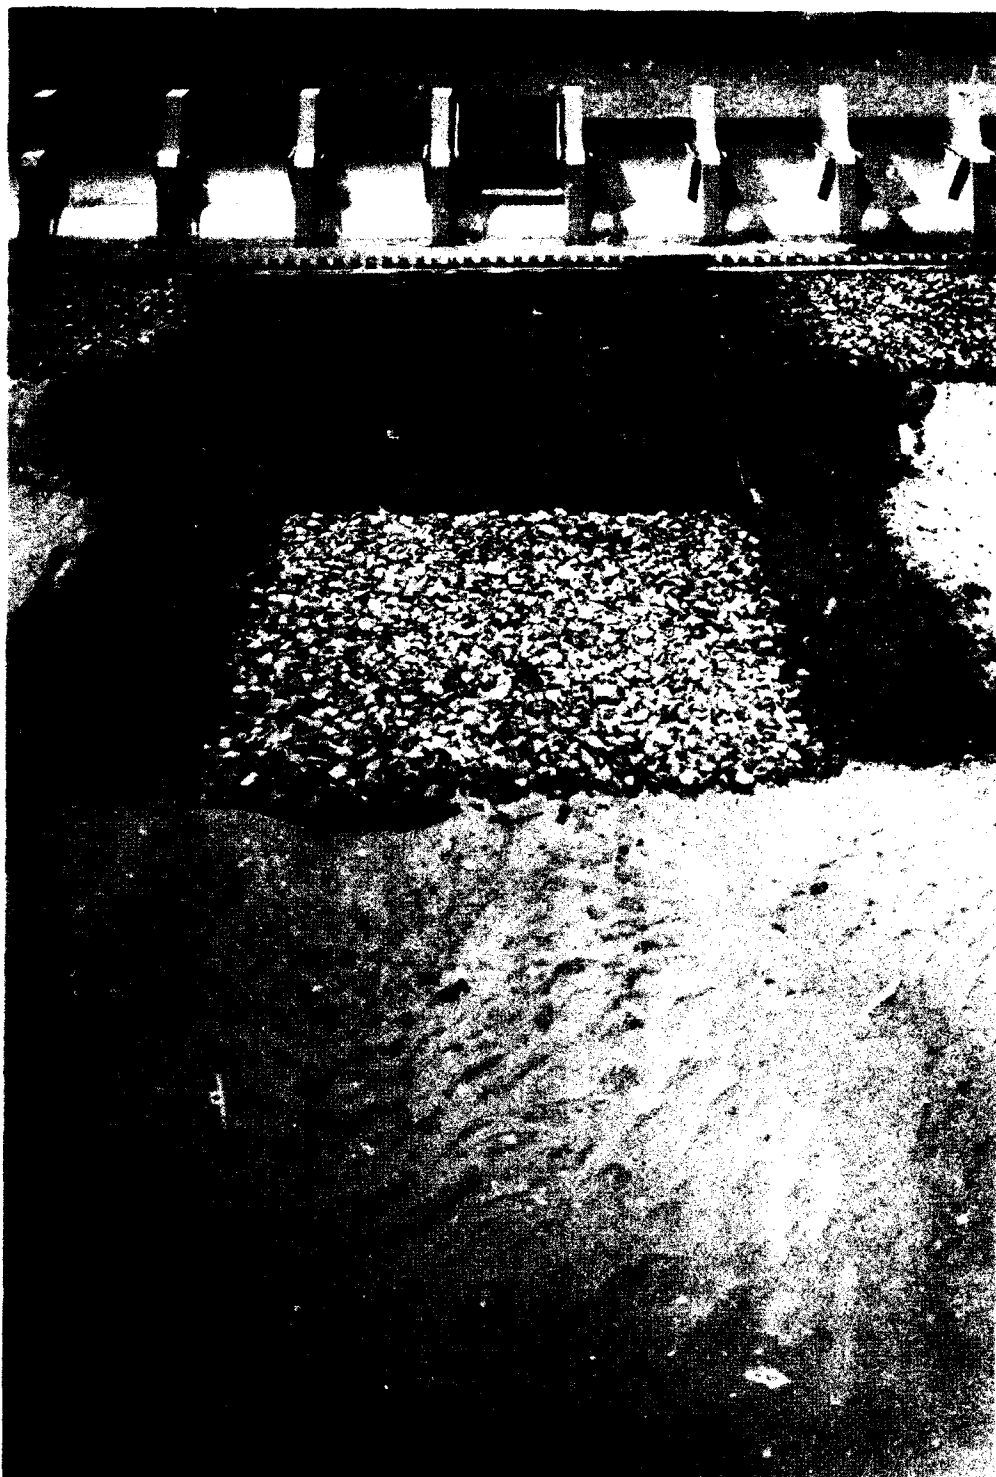
Because the constructibility of the type 3 design was questionable, the type 4 scour protection design, shown in Photo 7, was tested next. This design was considered more feasible, and details of the plan are shown in Plate 5. The design consisted of the same size barges used in the type 3 design placed on a 1V on 6H downward slope beginning immediately downstream from the end of the existing basin at el 119 and terminating at el 90. A 6-ft-thick layer of Riprap No. 7 was placed horizontally for 182 ft downstream. The type 4 scour protection design remained stable when tested for 8 hr with gate 6 fully open, normal upper pool, and tailwater el 118. Flow conditions during the test are shown in Photo 8. Supercritical flow exited the original basin, and a hydraulic jump formed in the secondary stilling basin. Adequate energy dissipation occurred in the secondary stilling basin, and scour in the exit channel

Photo 7. Type 4 scour protection design

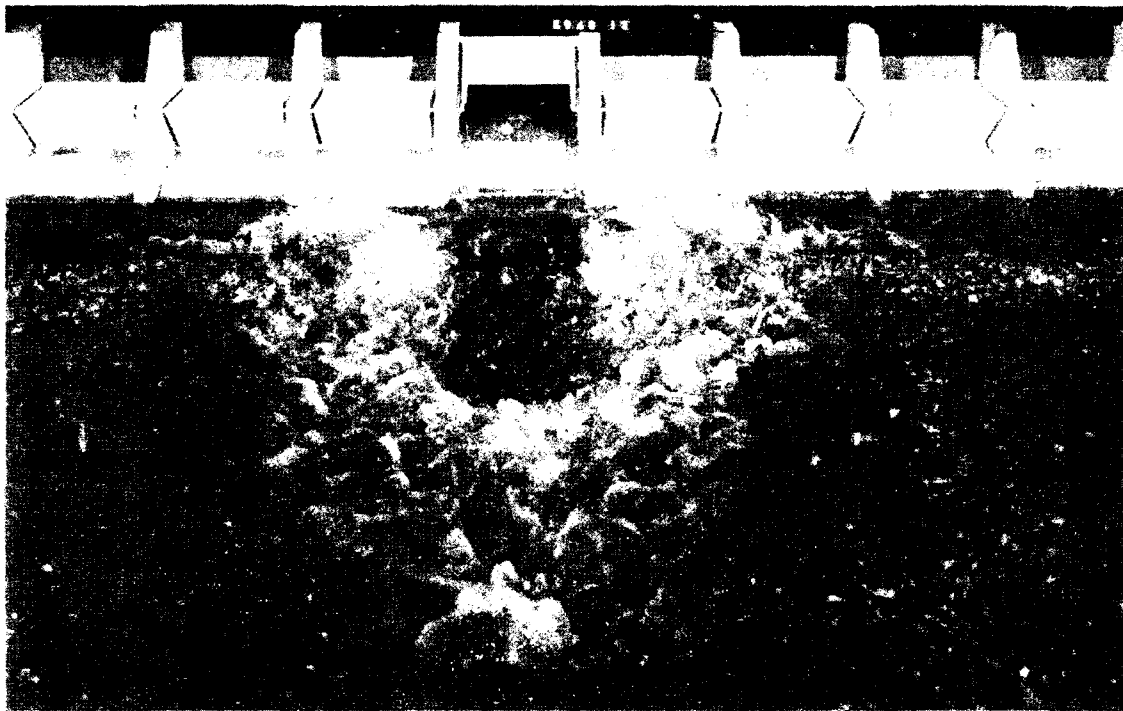
Photo 8. Flow conditions with type 4 scour protection design, normal upper pool, gate 6 fully open, tailwater el 118

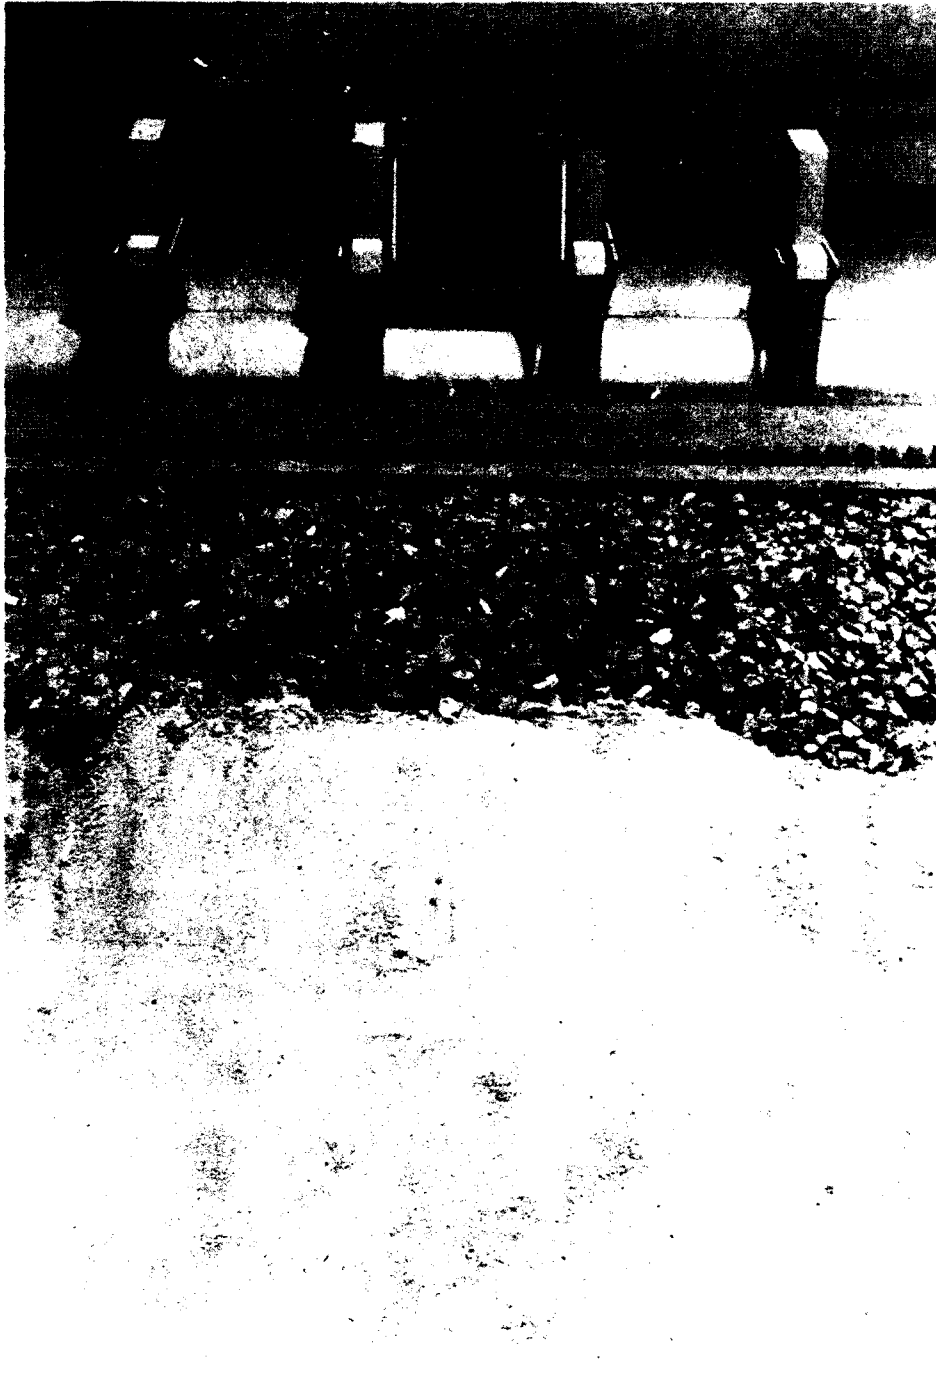
A test was requested by Little Rock District with additional larger riprap placed on top of Riprap No. 7, which had been tested previously and found to be unstable with one gate fully opened and tailwater elevations below 150. This plan, designated the type 5 scour protection design, shown in Photo 9, consisted of 4- to 6-ft-diam stones placed on top of the existing Riprap No. 7 beginning approximately 30 ft downstream from the end sill and terminating approximately 90 ft downstream from the end sill. The plan was tested using gate bay 4, and was found to be unstable for tailwater elevations equal to or less than 135 with the normal upper pool and gate 4 open fully.

Photo 9. Type 5 scour protection design

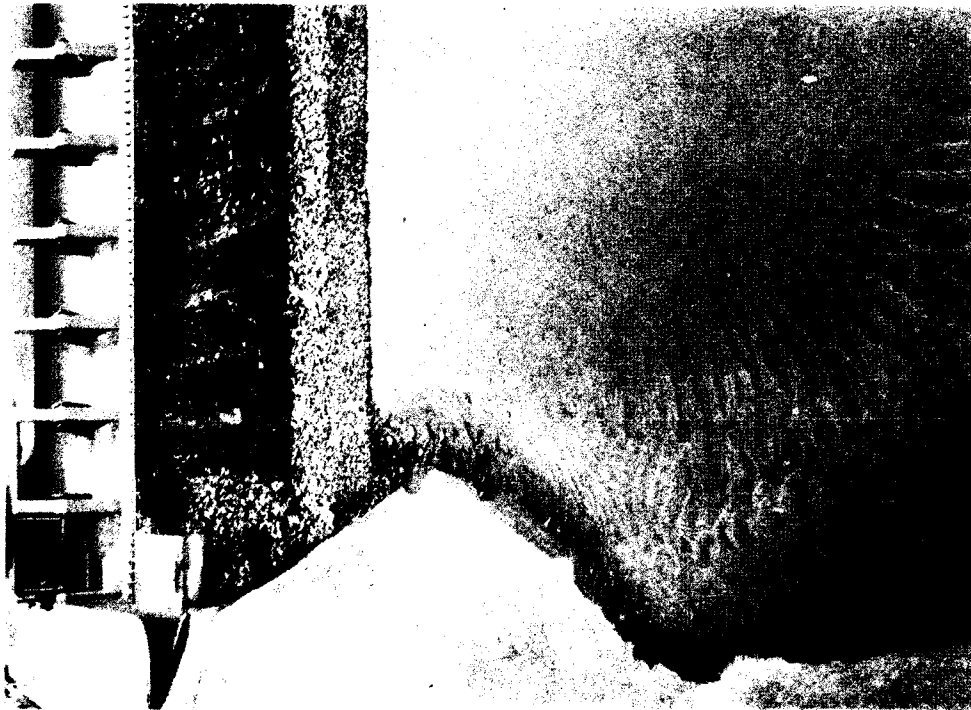
Photo 14. Type 9 scour protection design after 8 hr (prototype) of operation with gate 16 opened fully to the normal pool and tailwater  
el 113

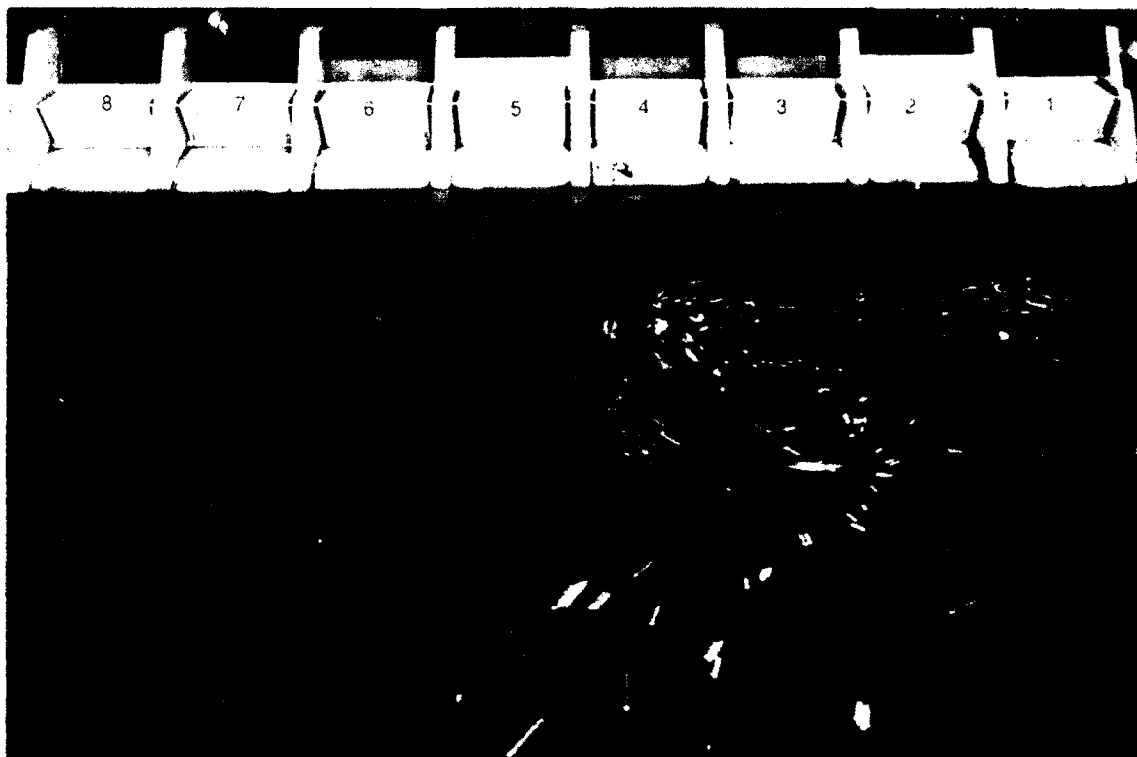
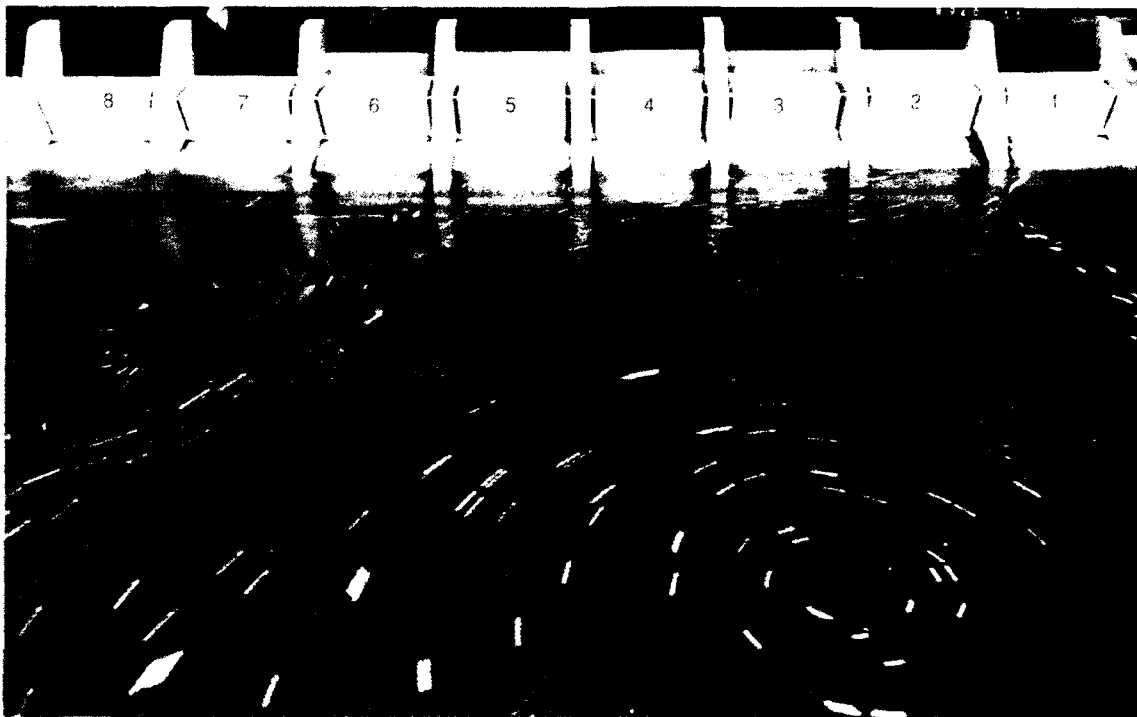
Photo 24. Flow conditions with gates 2-6 closed, a discharge of 15,000 cfs, and pool el 162

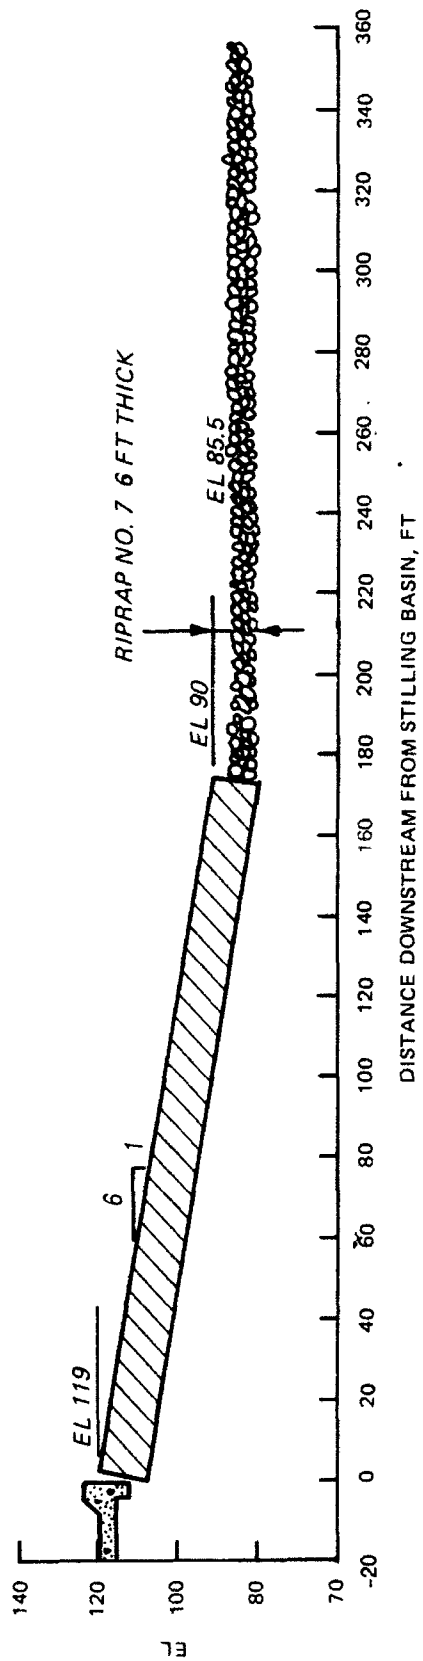
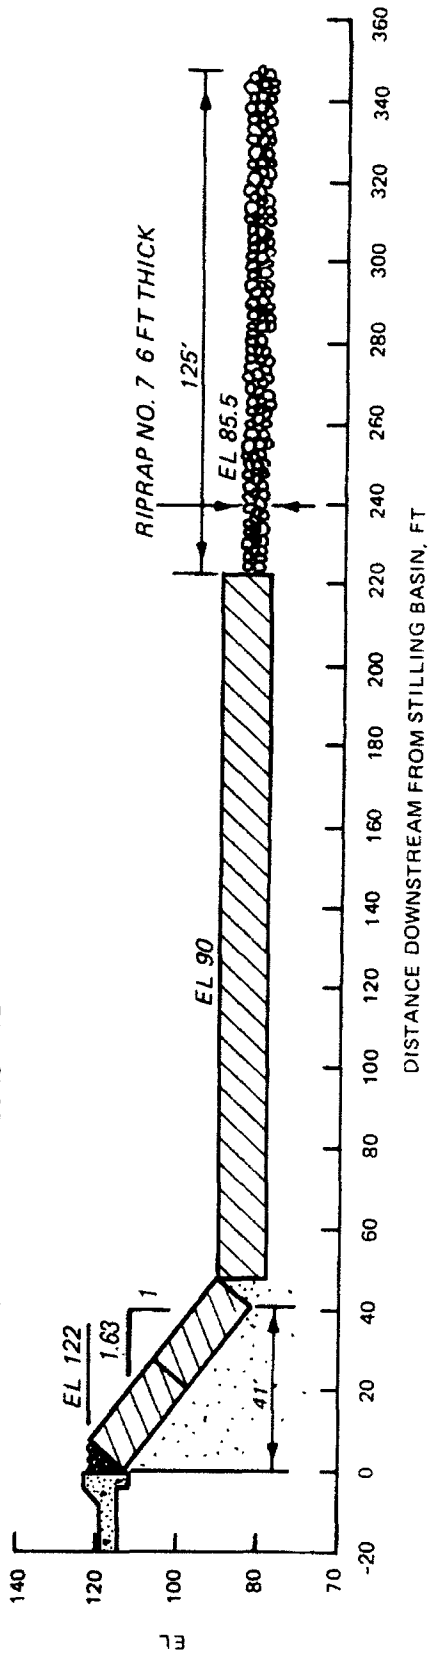
# SCOUR PROTECTION DESIGN

NOTE: BARGES ARE 12 FT BY 26 FT BY 175 FT  
FILLED WITH RIPRAP AND TREMIE CONCRETE
