**DOT/FAA/CT-93/1**

## **Vertical Drop Test of a Metro III Aircraft**

June 1993

Final Report

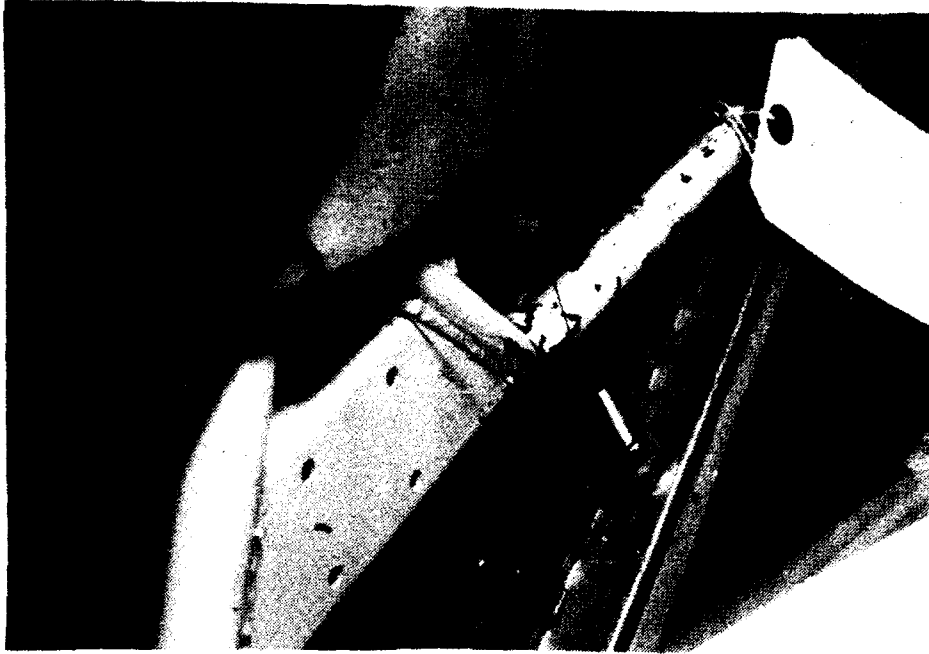
FIGURE 34. POST TEST SEAT 7, INBOARD AFT LEG

Figure 33 shows seat 6 (on the left) and seat 7. Figure 34 shows the damage to the inboard aft leg of seat 7, and figure 35 shows the damage to the seat track under seat 7.
