ARMY AIRCRAFT FIRE-DETECTION SYSTEMS OPERATION AND RELIABILITY.

**ARMY  
AIRCRAFT  
FIRE-DETECTION  
SYSTEMS  
OPERATION  
AND RELIABILITY**

This report evaluates the results of a July 1993 study of fire indications on board Army aircraft. Although the focus was the aircraft fire-detection system, other areas involving "potential" fire, such as smoke and sparks, were included and evaluated.

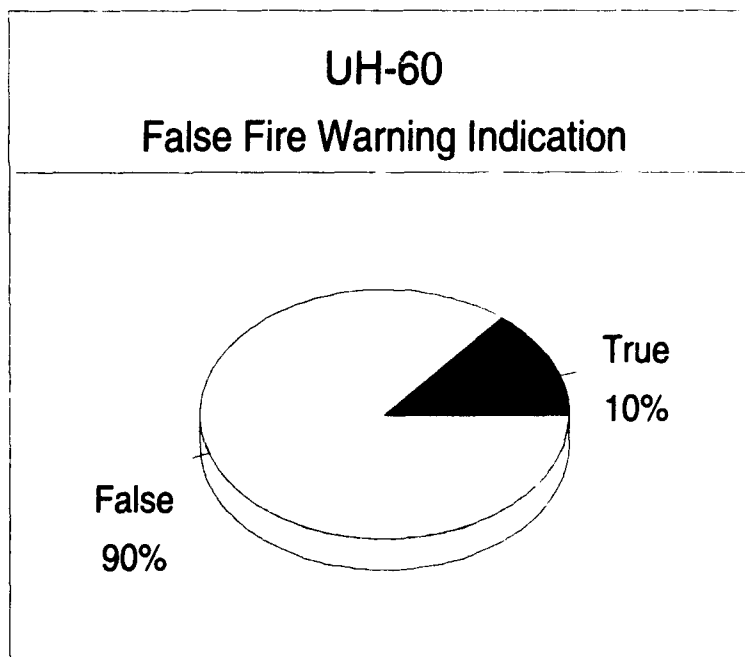
The causes of the fire indications could be broken down as shown in the chart below.

An assessment could not be drawn from shorts related to the overhead panel because part numbers and specific items of failure were not reported and the information referred only to the general area.

Compass failures accounted for 7 fire indications (8%) during flight and, although seemingly insignificant, in one case the pilot was executing an instrument approach during night IMC. Contending with a primary instrument at such a critical time can increase the crew's workload in several regards. Pilots must isolate the failure, execute the emergency procedure, and, while performing these tasks, fly the aircraft effectively. Weather conditions, illumination, crew rest, and training can adversely impact the crew's effectiveness.

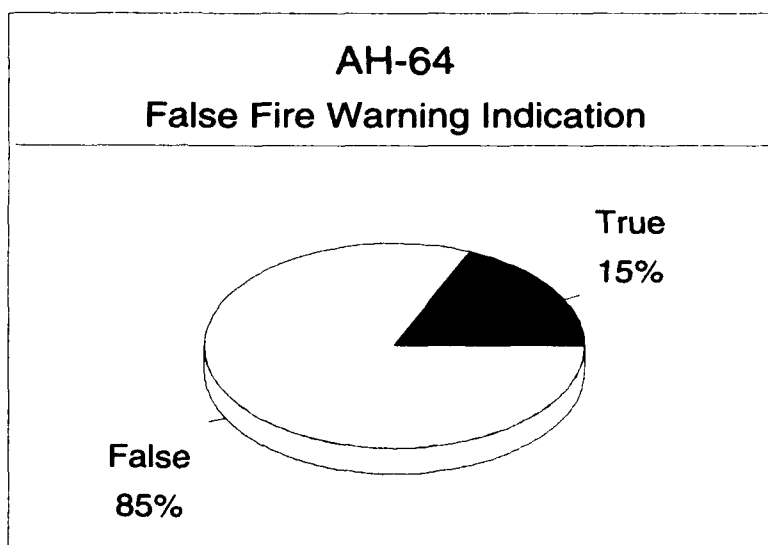
The study concentrated on three areas: fire-warning activations, shaft-driven-compressor failure, and the environmental control unit (ENCU).

The Apache has by far the most complex fire-detection system. It uses optical infrared flame detectors, pneumatic overheat-detection elements, and an overheat sensor.

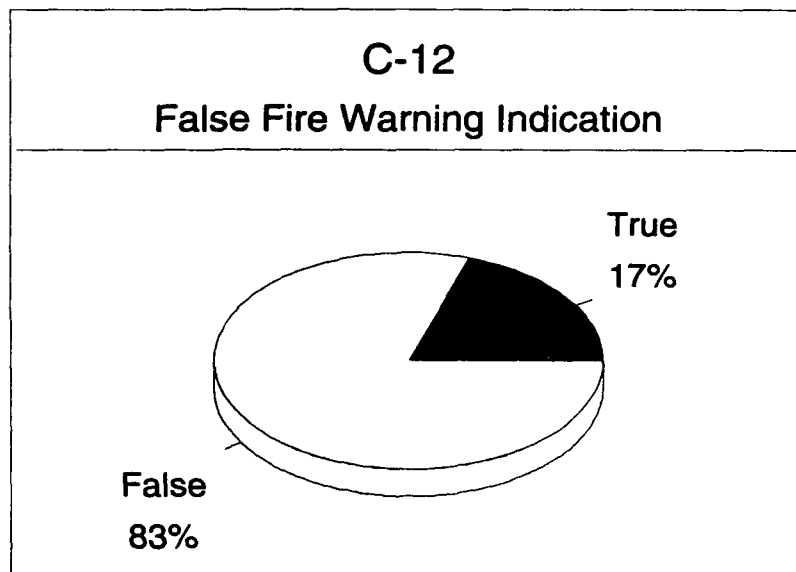
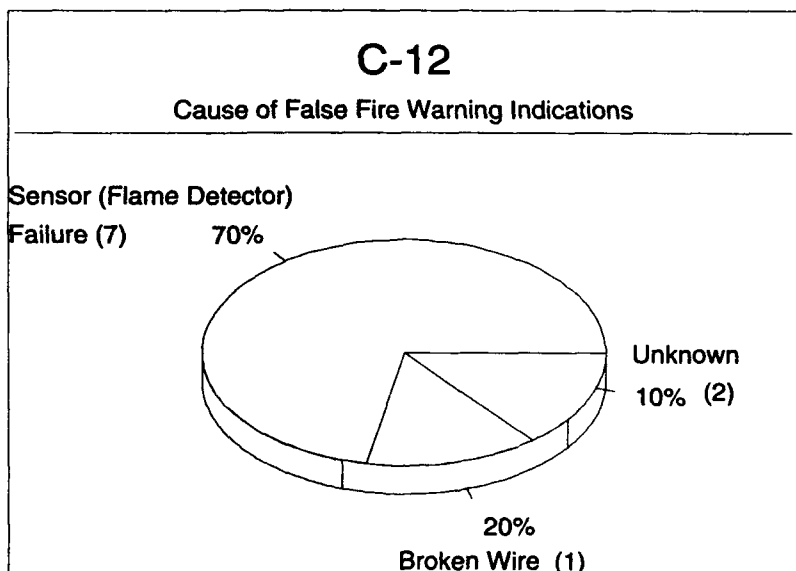
The C-12 has flame detectors made by Pyrotector. Each engine has three. They operate on viewing infrared light from the fire. Of the 12 fire-warning indications, two were true (one oil and the other a burned-out starter generator) while the remaining 10 (83%) were false.

The forward blower motor/fan is a weak link for the Army C-12. Unfortunately, its failure results in smoke and fumes into the cabin and cockpit. It is not considered a critical failure as on the AH-64 and AH-1 in that the C-12 offers a much more stable and thereby manageable platform from which to work.
