**NORWAY/UNITED STATES DESIGN PROTECTIVE  
AIRCRAFT SHELTER (PAS) QUANTITY-DISTANCE  
PROGRAM 1/3-SCALE TEST SERIES**

**Volume I of V  
PAS 1-4 Summary**

**August 1993**

**Final Report**

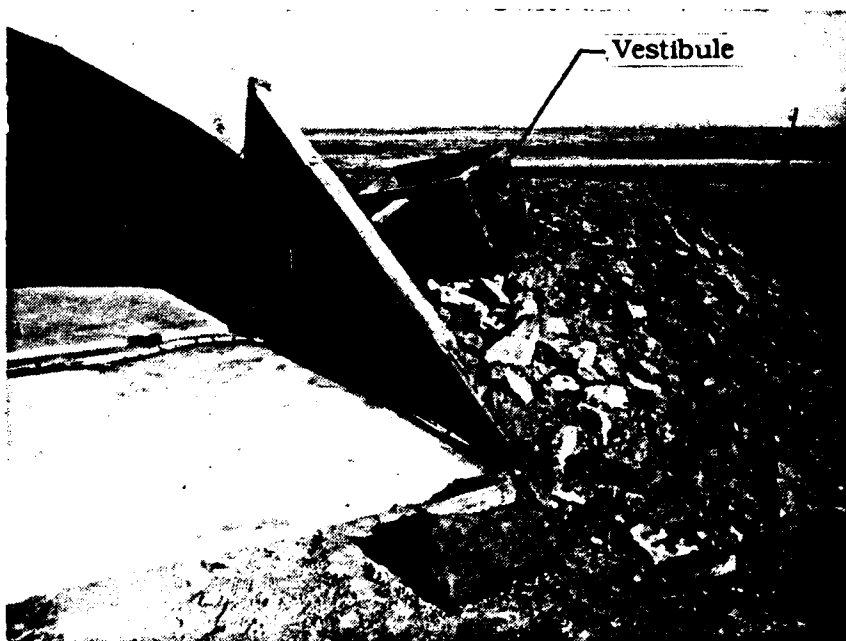
The personnel vestibule was found lying on the rock rubble berm within 1 m of its original position (Fig. 27). The personnel door that had been located in a frame installed in the opening in the left front wall was found inside the vestibule. The door had been bent outward about its vertical centerline, and the welds simulating the hinges and latches had all been broken. The door frame remained intact in the opening.

Figure 27. Posttest location of vestibule, PAS-1.

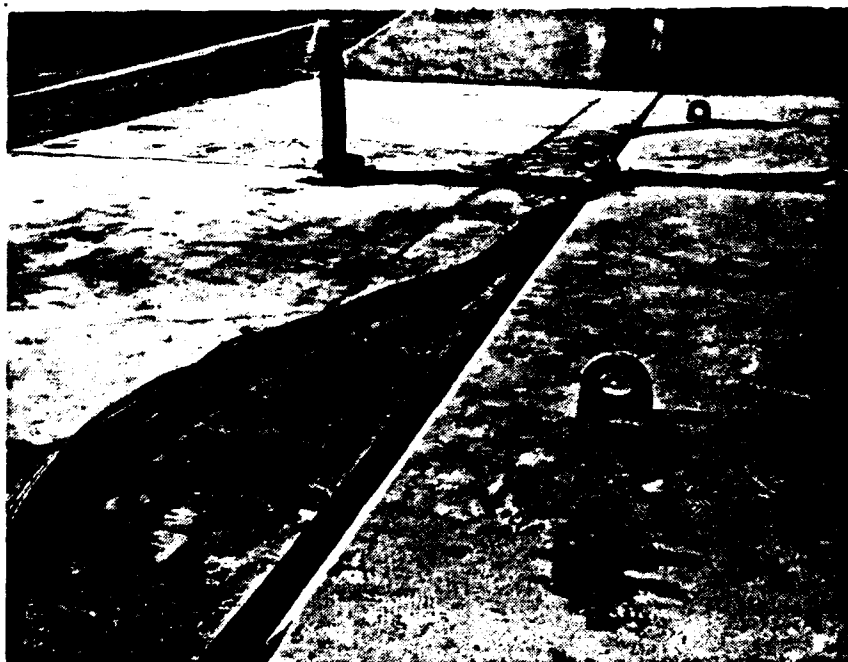
The front door was found lying inside the shelter in the door pit area (Fig. 33). The right side hinge bracket was still on the hinge pin near the correct position for operation. However, the left hinge bracket had moved off the pin (Fig. 34). The top edge of the door was resting on the steel angle at the edge of the door pit (Fig. 21). No damage to the steel angle was noted. The right support post was found in the door pit area near its original position. The left support post was never found despite an extensive search in front of the shelter. It was assumed that it was blown through the personnel door opening and was buried among the rock rubble and soil.

Figure 33. Posttest location of front door, PAS-1.

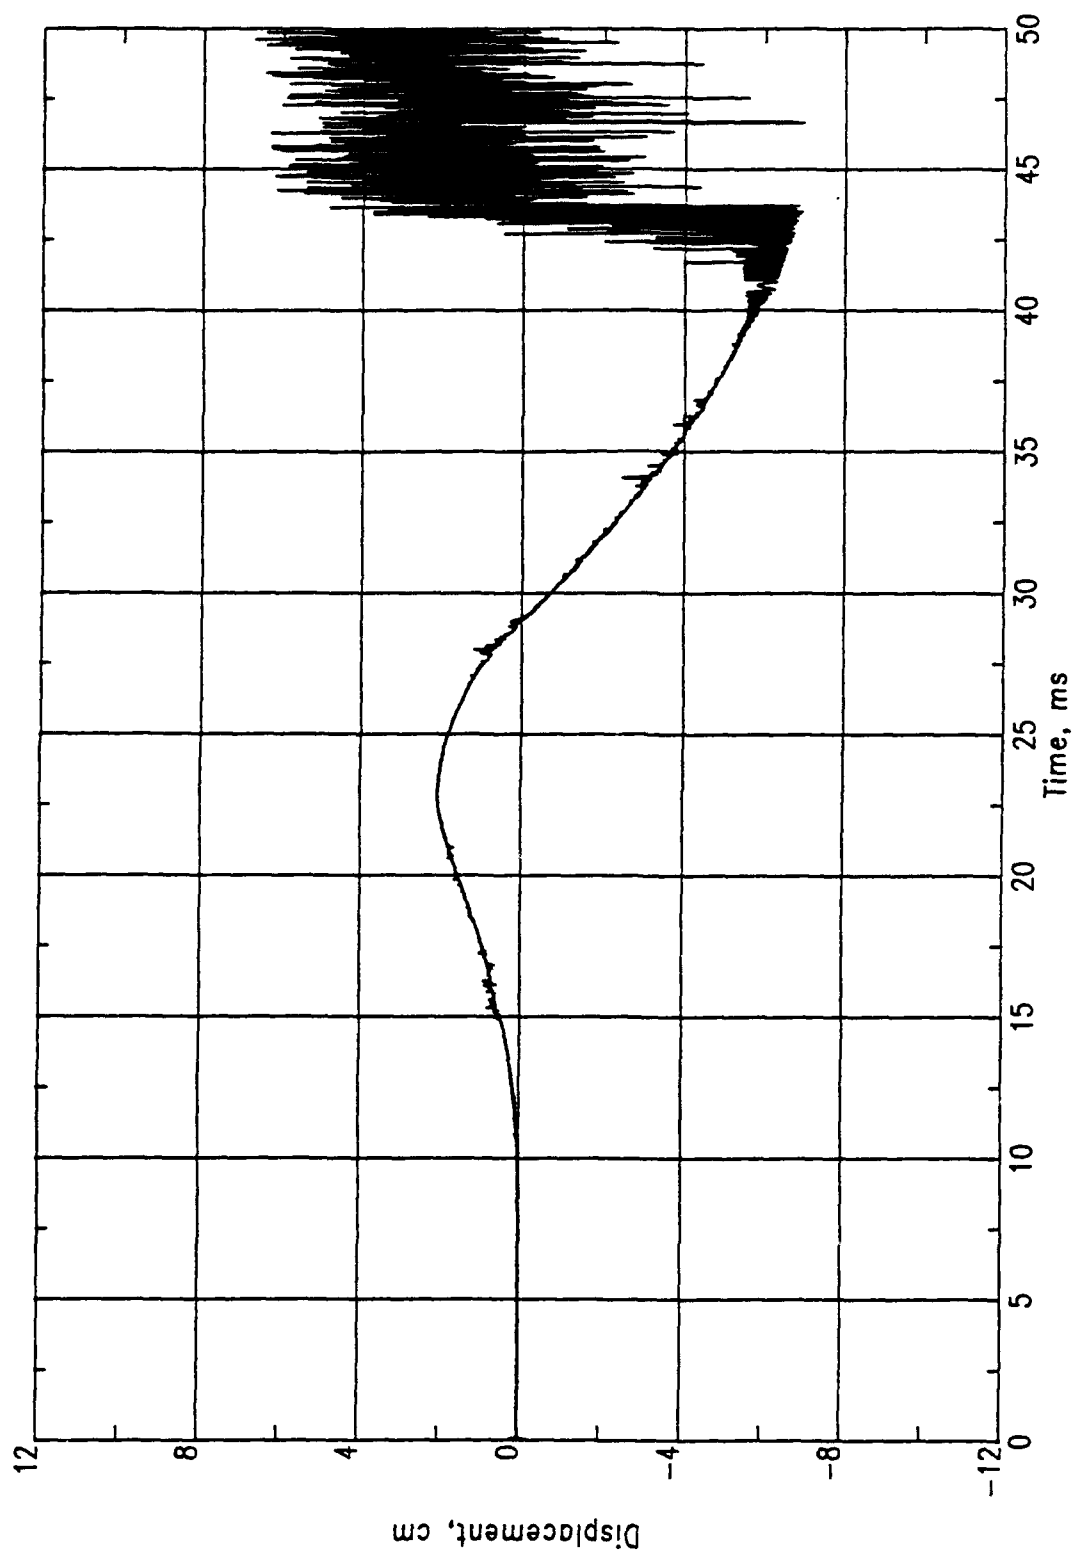
Figure 54. PAS-1, MN 7401.

Three displacement gages were attached to the front door in a vertical line at its centerline. Measurement Number 7401 (Fig. 54) was attached near the top of the door and showed a peak outward displacement of 2.03 cm at 22.5 ms. Measurement Number 7402 (Fig. 55) attached at mid-height of the door showed a peak outward displacement of 2.79 cm at 26.5 ms, and MN 7403 (Fig. 56) at the bottom of the door showed a peak displacement of 0.98 cm at 22.0 ms. The door appears to have fallen from its supports and into the shelter at 30 to 40 ms, and inward displacements recorded after this time are questionable.

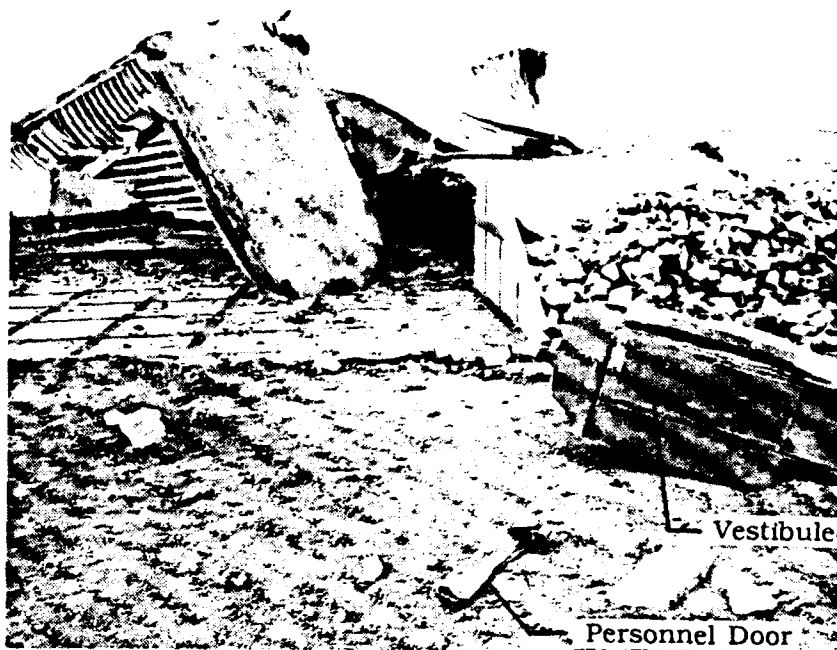
The personnel entrance vestibule was found intact, approximately 2.6 m in front of the left wingwall (Fig. 75). The personnel door, which had been located in a frame installed in the opening in the left front wall, was found near the vestibule. The door was bent in half about its vertical centerline (Fig. 75). All the welds simulating the door hinges and latches were broken. The door frame remained welded to the steel liner (Fig. 76).

Figure 75. Vestibule and personnel door (foreground), PAS-3.

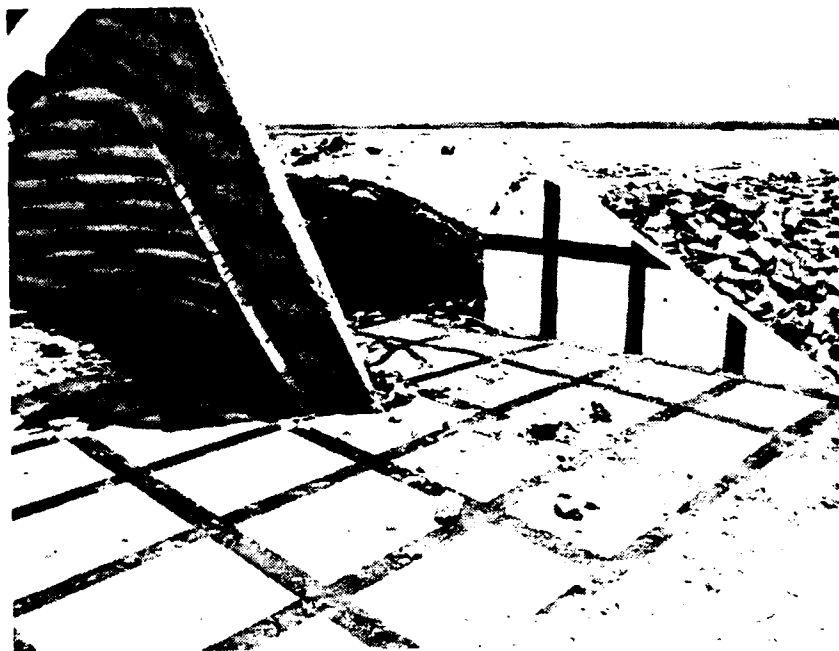
Figure 78. Left wingwall, PAS-3.

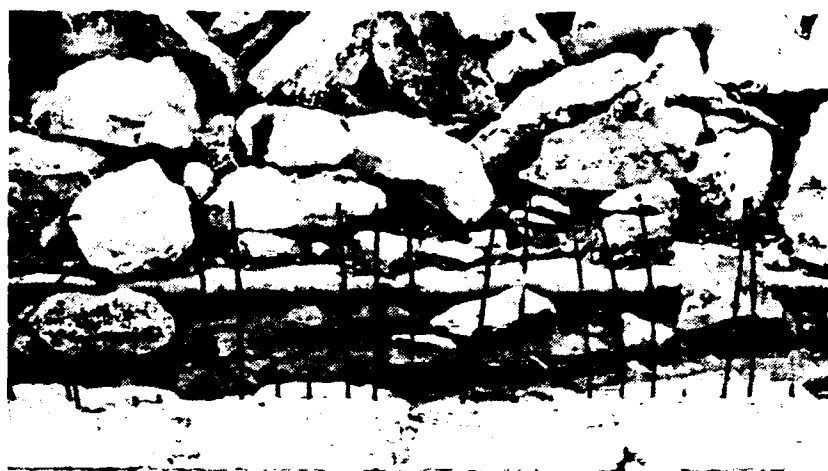
The floor slab was found in place against the arch foundation, with little indication of vertical displacement between the two components (Fig. 103). The floor was heavily damaged due to the impact of the large arch sections falling back down. A portion of a crater caused by the explosive charge was seen in the surface of the floor slab. The

Figure 103. Broken dowel bars in top of the arch foundation, PAS-3.

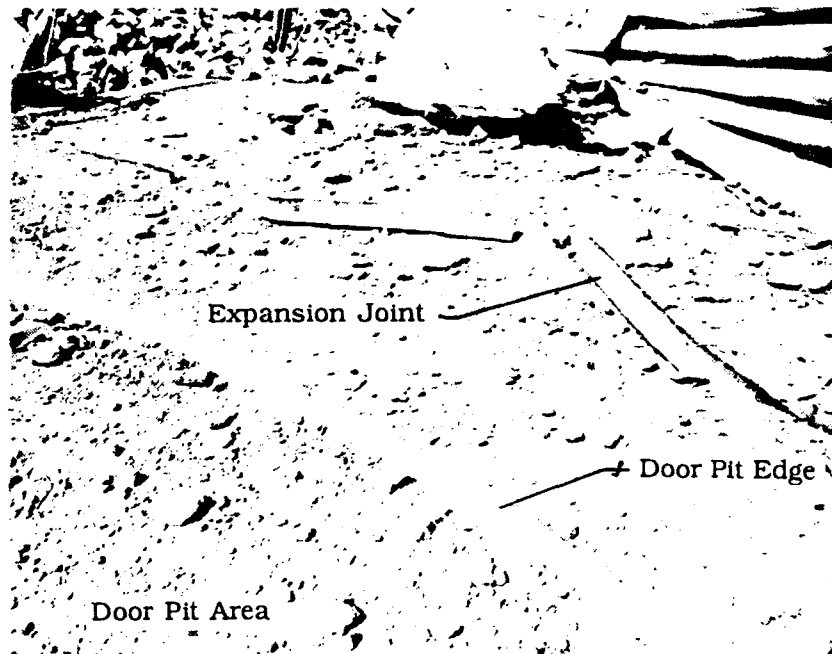
The joint between the floor slab and the heavily reinforced portion of the floor slab containing the door pit showed a relative separation of 25 mm of the two components. The fiber board expansion joint material was blown out of the joint for most of its length (Fig. 104).

Figure 104. Floor slab expansion joint, PAS-3.

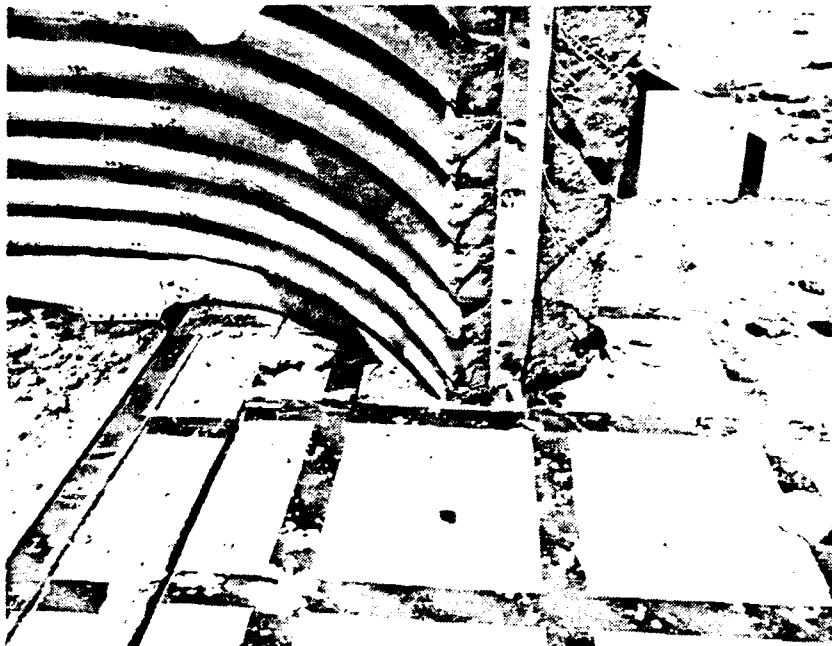
The major damage to the apron slab occurred when it was struck by the corner of the front wall and headworks section as it fell back (Fig. 105). A 30-mm wide gap was noted between the front foundation and the apron slab (Fig. 106). The gap ran the full length of the apron slab.

Figure 105. Damage to apron slab, PAS-3.

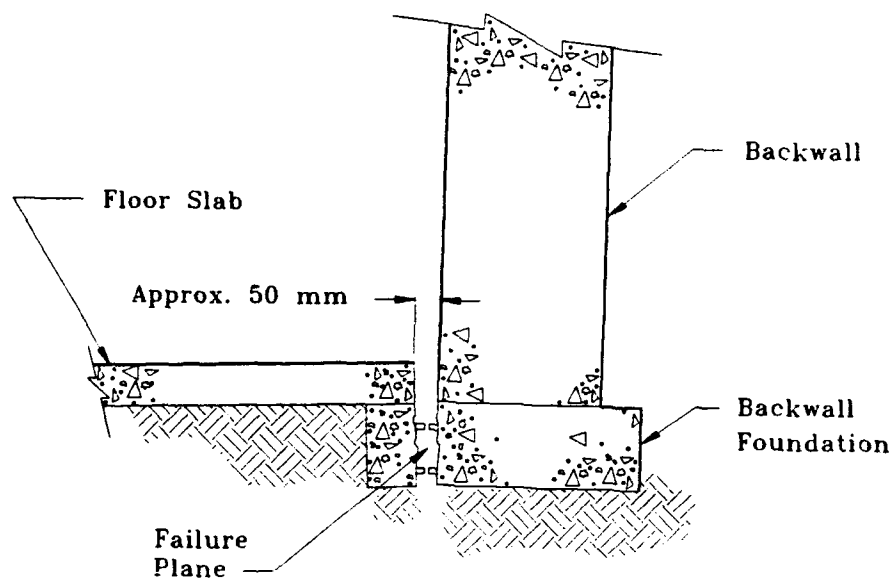
backwall (Fig. 108). The top bars in the transverse stirrups crossing the plane were observed to have failed in tension at the face of the fractured concrete. There was no indication of upward movement of the backwall foundation.

Figure 108. Section: Failure plane in backwall foundation, PAS-3.

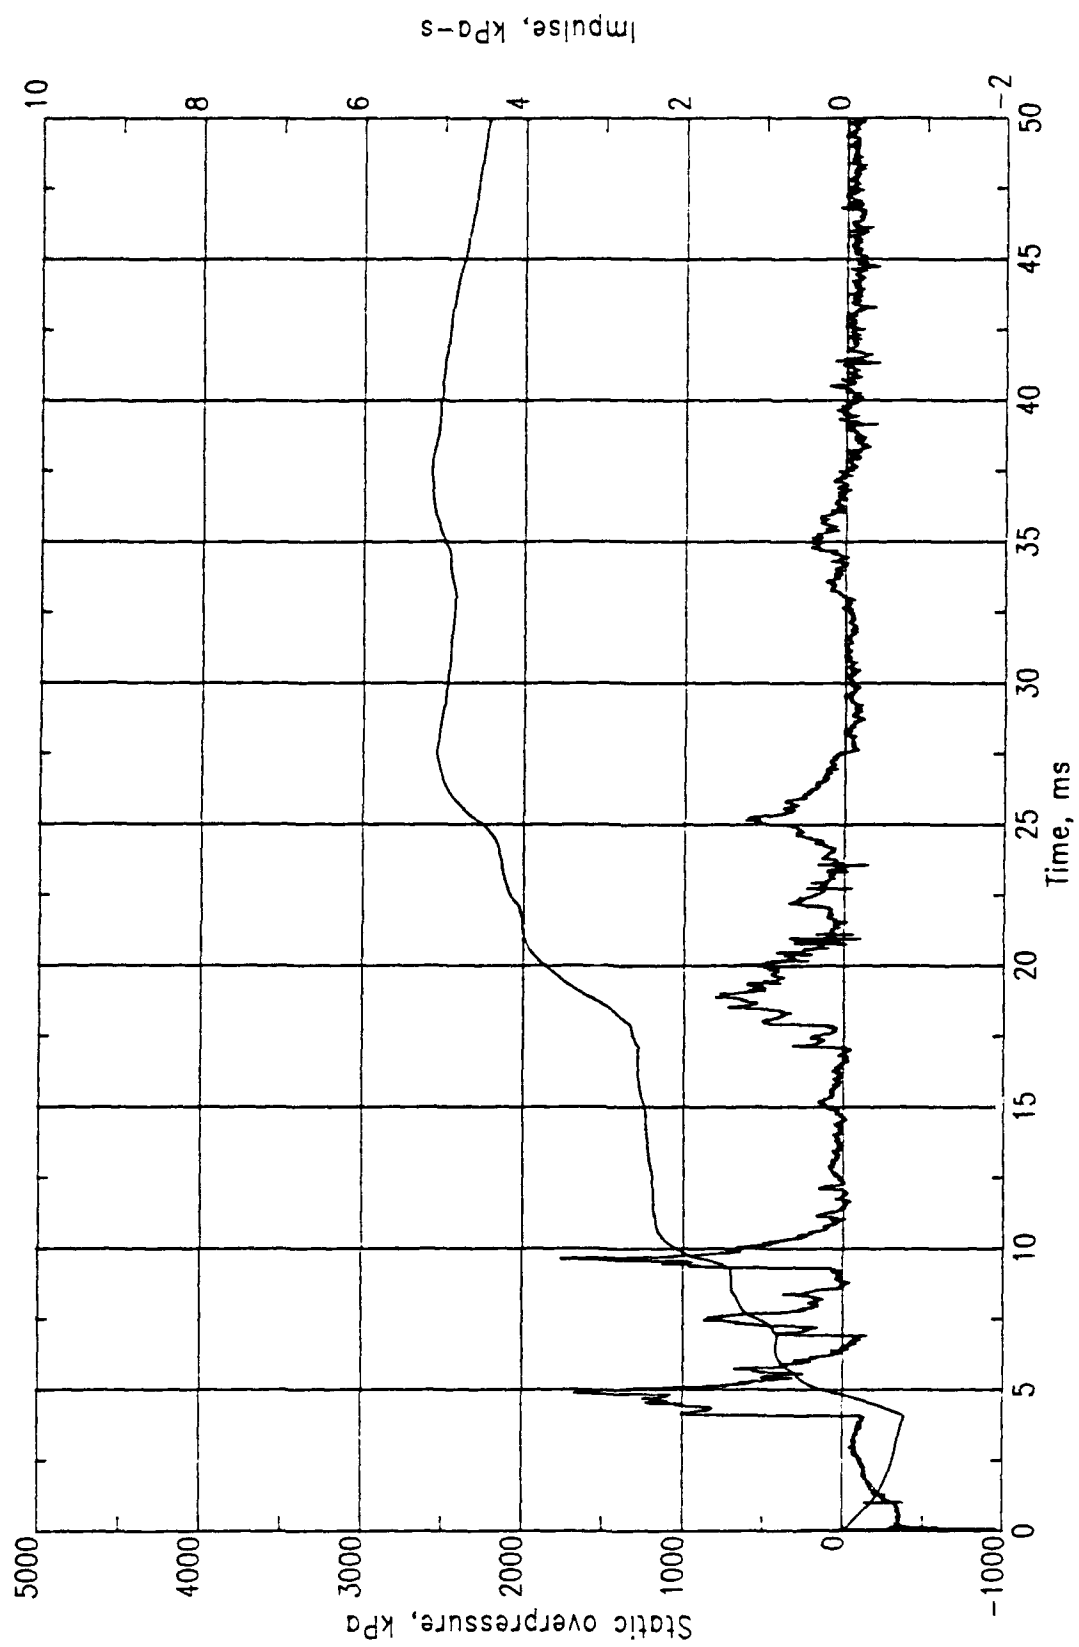
Figure 113. PAS-3, MN 0402.

The only pressure measurement made on the inside surface of the front door in the PAS-3 test was MN 402 (Fig. 113). This gage showed a peak pressure of 1.7 MPa, but a negative baseline shift at  $t = 0$  makes this peak somewhat uncertain. The INBLAST code predicted 2.08 MPa at this location. Measurement Number 202 (Fig. 114) located in the backwall at about the same range and height from GZ, but off of the structure centerline, shows a peak of 1.8 MPa. The INBLAST prediction for this location was also 1.8 MPa. The spike that occurs in MN 202 at about 6 ms appears to be noise and not real data.

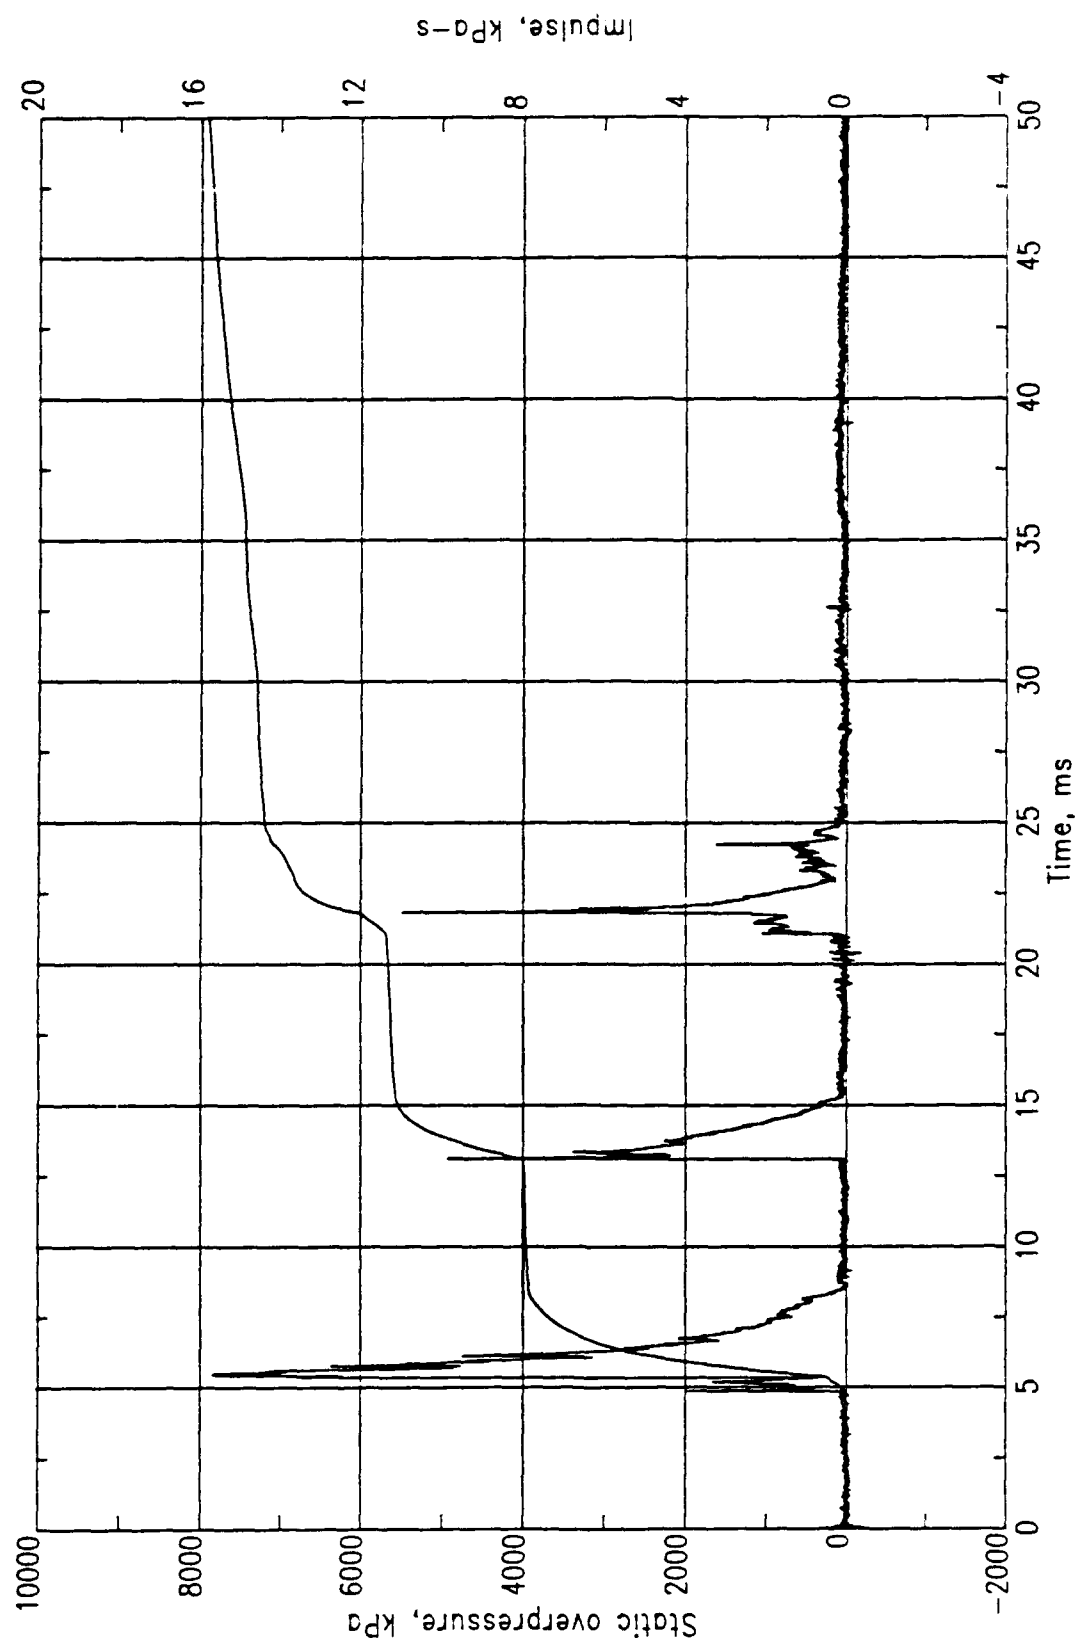
Figure 116. PAS-3, MN 0102.

Measurement Number 501 (Fig. 115) located in the floor at the front corner of the shelter showed a peak pressure of 4.8 MPa. Measurement Number 102 (Fig. 116) located in the floor at the rear corner of the shelter showed a much higher peak of 7.9 MPa at the same time. Although the three peaks in both records occurred at about the same time, those of MN 102 were consistently higher than those of MN 501. The INBLAST prediction for these two locations was only 1.66 MPa.

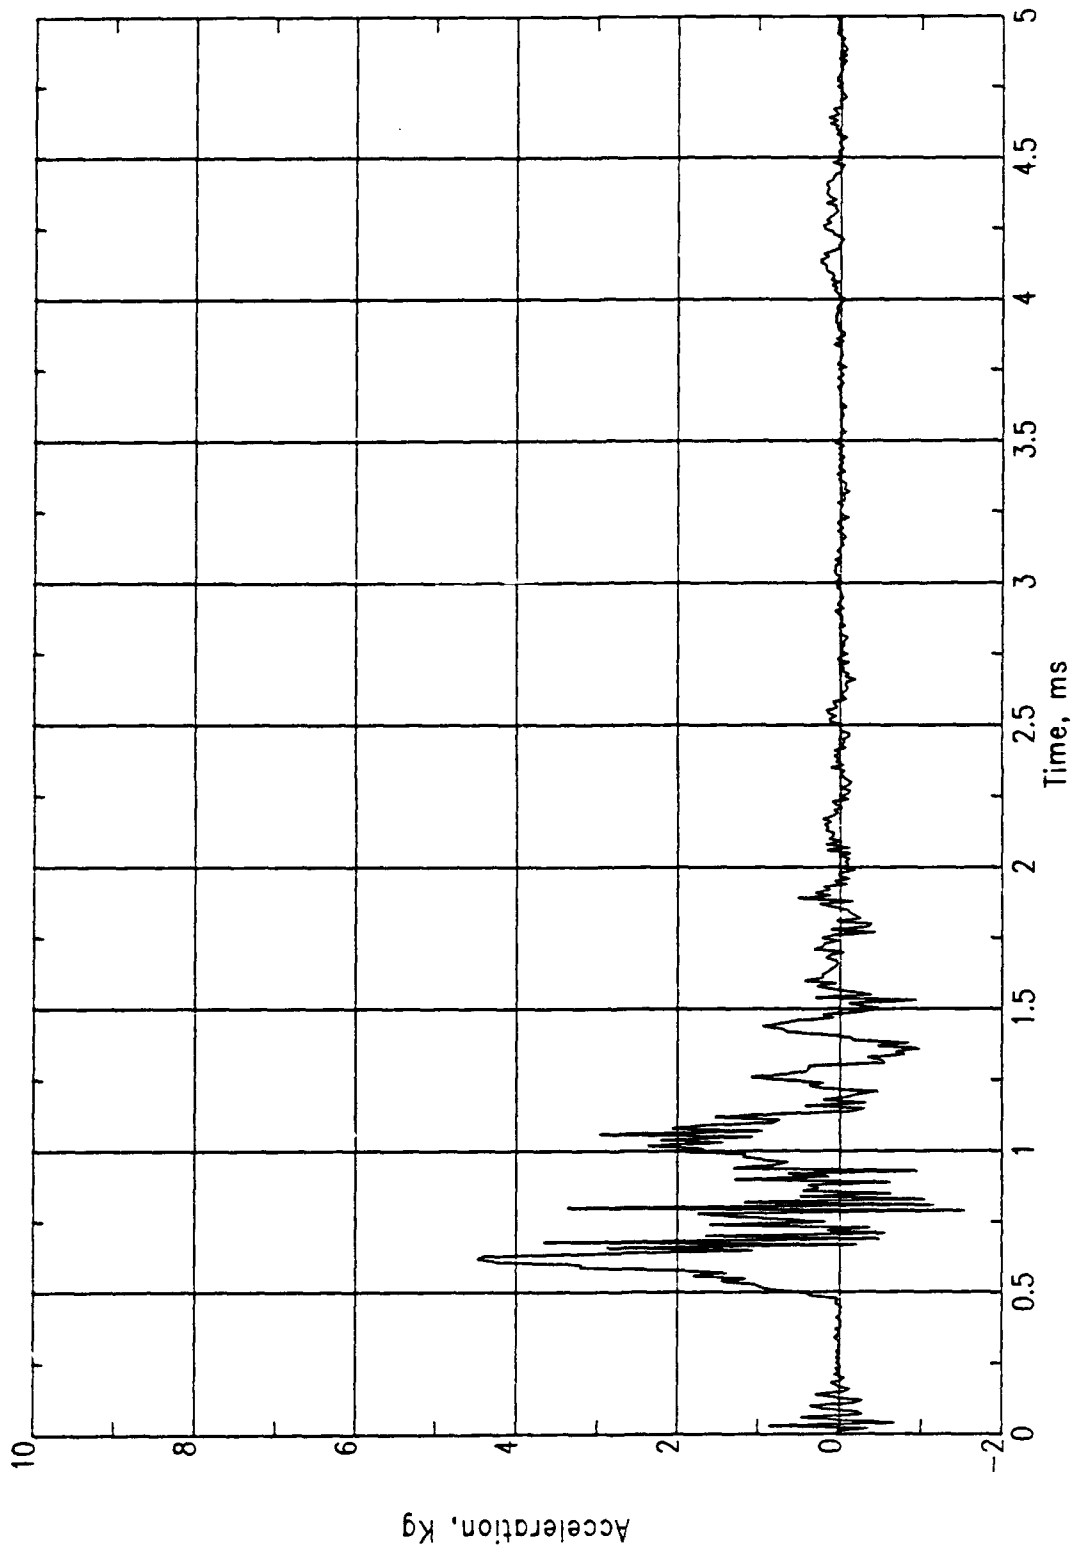
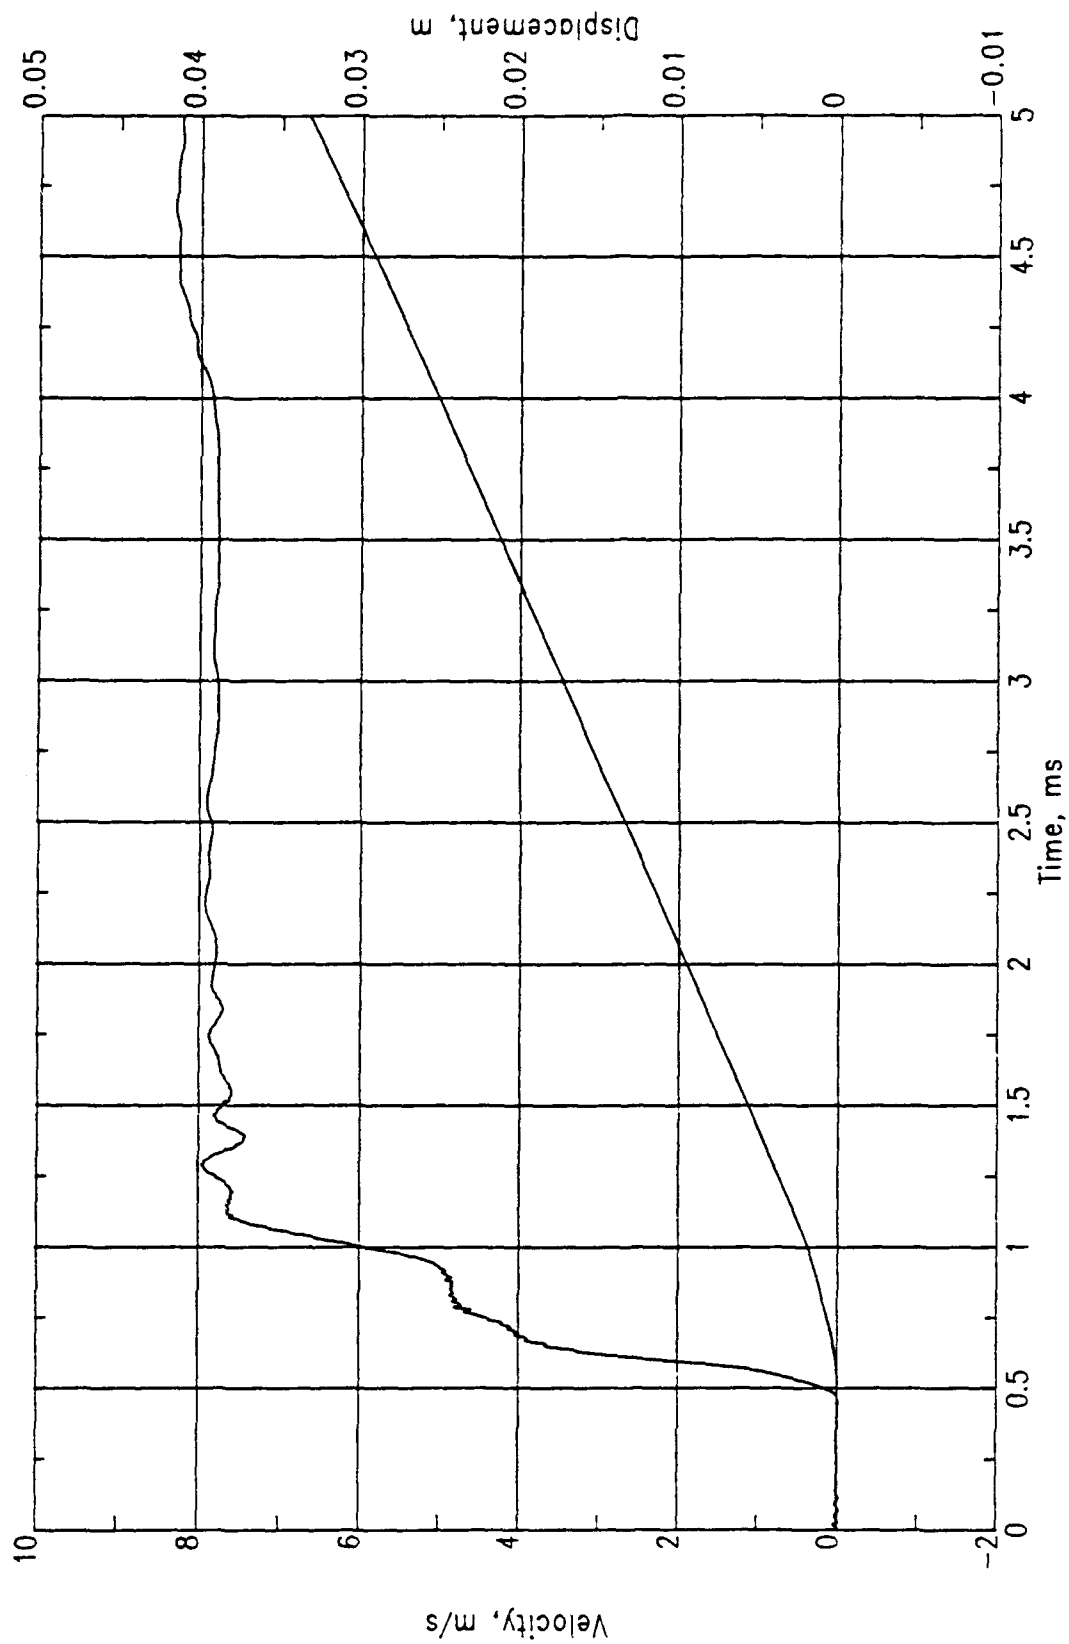
Figure 121. PAS-3, MN 1601.

Only one accelerometer was mounted on the structure in the PAS-3 event. Measurement number 1601 (Fig. 121) was mounted at the crown of the arch directly over the explosive charge. It showed a peak radial acceleration of 4500 g. Integrated over the first 5 ms, this record shows a velocity of 8.0 m/s. This measurement failed at 27.5 ms. A WES self-recording accelerometer installed at the same location recorded a peak radial acceleration of 5500 g. The peak velocity obtained from integration of the WES gage record was 12.5 m/s. Data obtained from high-speed photography appear to support the higher velocity. Table 10 summarizes selected peak accelerations from MN 1601. The record from 1601 is also presented in Volume III.

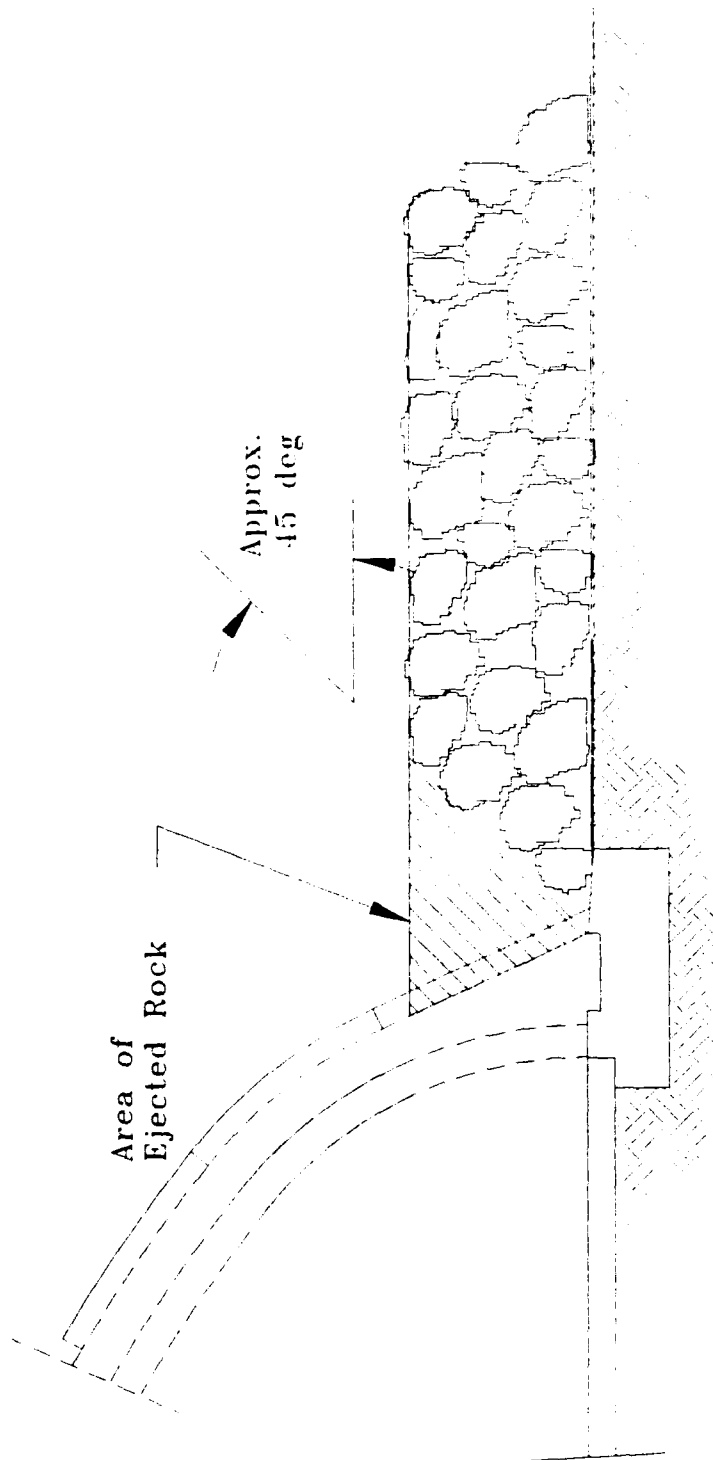
Figure 122. Section: Rock rubble berm, PAS-3.

A portion of the rock rubble berm adjacent to the arch was blown upward and out during the test (Fig. 122). The rocks remaining in the berm were relatively undisturbed by the test. High-speed photography shows that the rocks at the sides of the structure were thrown out at trajectories of 75 deg or less. Individual pieces of rock were a little difficult to follow, but in a few instances their early upward velocities were on the order of 14 to 15 m/s. Ground-impact velocities of pieces of rock rubble varied from 7.5 to 11.5 m/s.

The rock berm along the left front side of the structure in the vicinity of the personnel entrance appeared to have been blown or pushed away to the front and side, probably resulting from the failure of the vestibule and the personnel door at this location. A more complete discussion of the distribution of the rock from the berm is presented next.

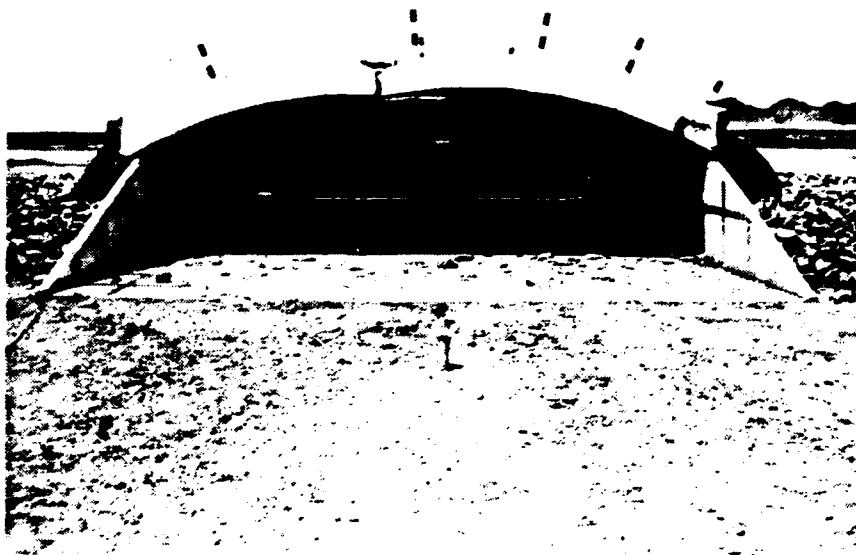
Figure 156. Crack pattern in front face of parapet, PAS-2.

The front walls remained attached to the foundation, but the top of the headworks and the parapet broke away from the front wall with the front arch section (Fig. 155). The separation in the headworks steel liner assembly occurred at or near the welded joint in the liner. In some instances the weld was broken, in others the failure occurred in the base metal of the liner. The door stop at the top of the door frame was broken off of the frame. A series of radial cracks were observed in the front face of the parapet (Fig. 156). The crack pattern was virtually identical to that observed in the PAS-1 test. The large crack at the center of the parapet is consistent with a flexure failure, and probably a result of the front section of the arch falling back onto the wingwalls. There did not appear to be any significant damage to the front wall foundation.

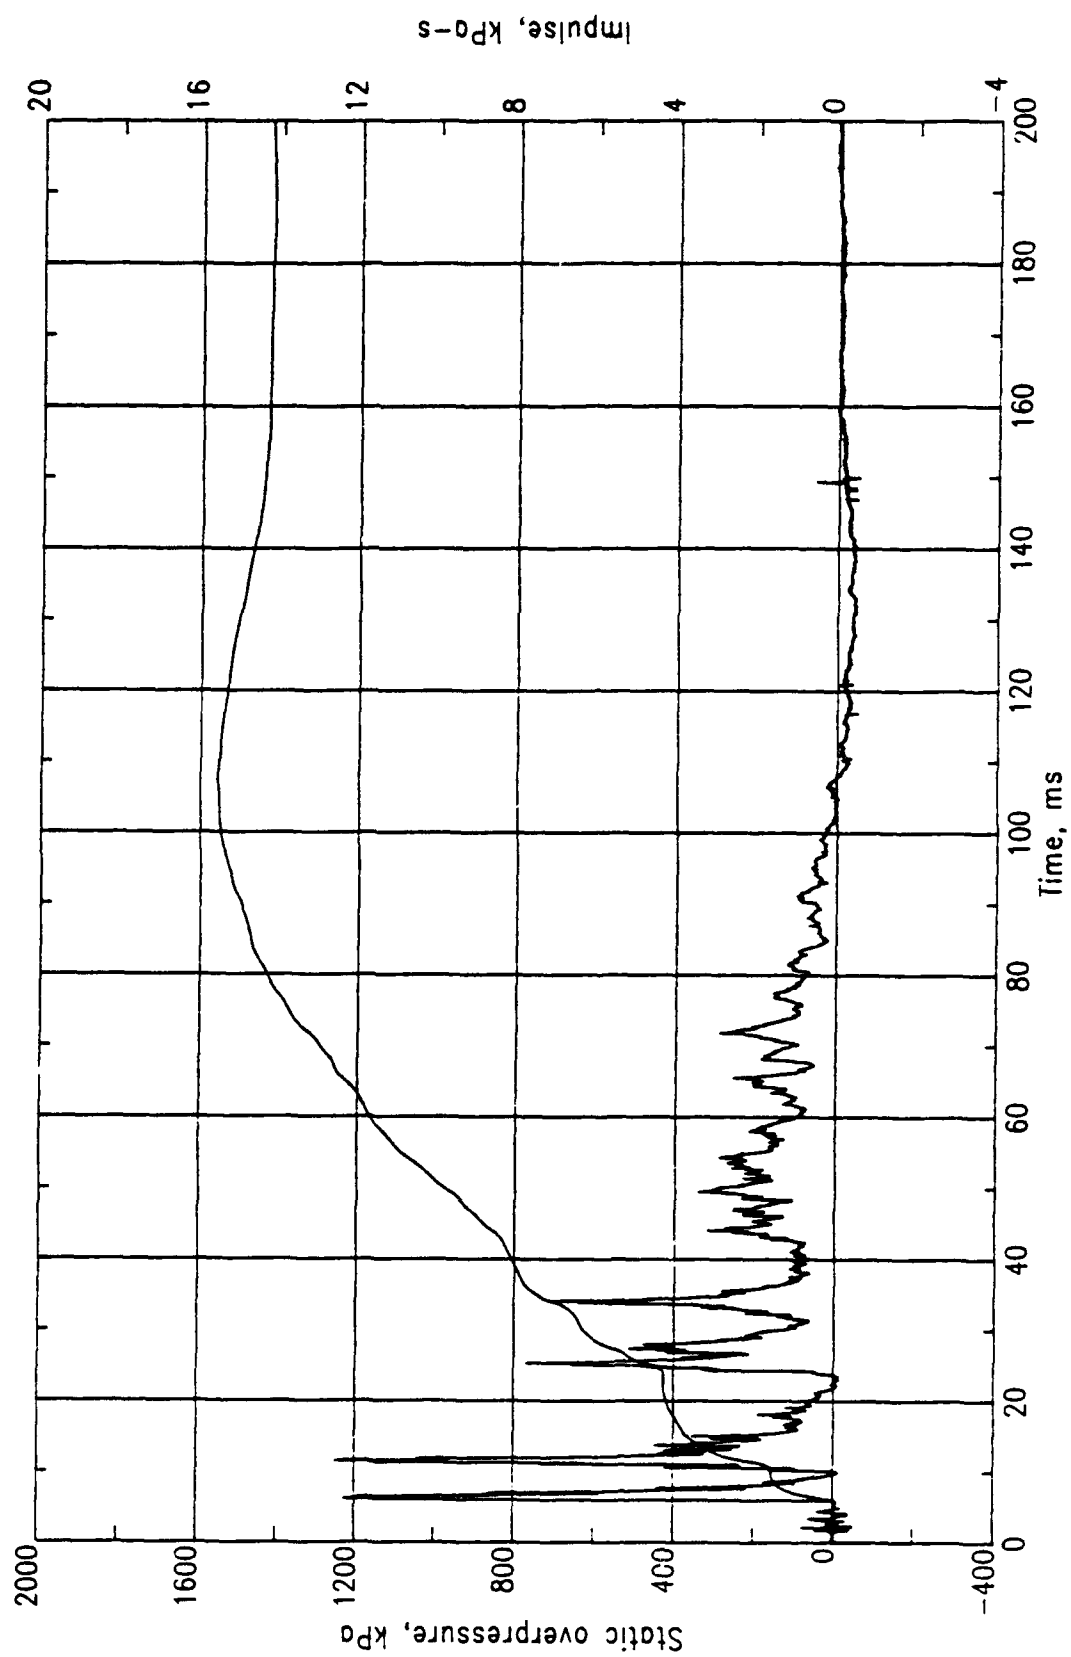
Figure 178. PAS-2, MN 0201.

peak of 0.76 MPa at 7.5 ms at this location. The recorded peak at this time was 0.63 MPa. Measurement Number 201, located in the backwall at about the same range and distance off the structure centerline but at a slightly greater height, shows a peak of 1.27 MPa (Fig. 178). Amplitude differences are also noted between MN 405 in the front wall and MN 203 at a similar location in the backwall. The peak pressure recorded at MN 405 was 2.26 MPa (Fig. 179); at MN 203 it was 6.2 MPa (Fig. 180). These two records had similar characteristics, except for the amplitude of their peaks.

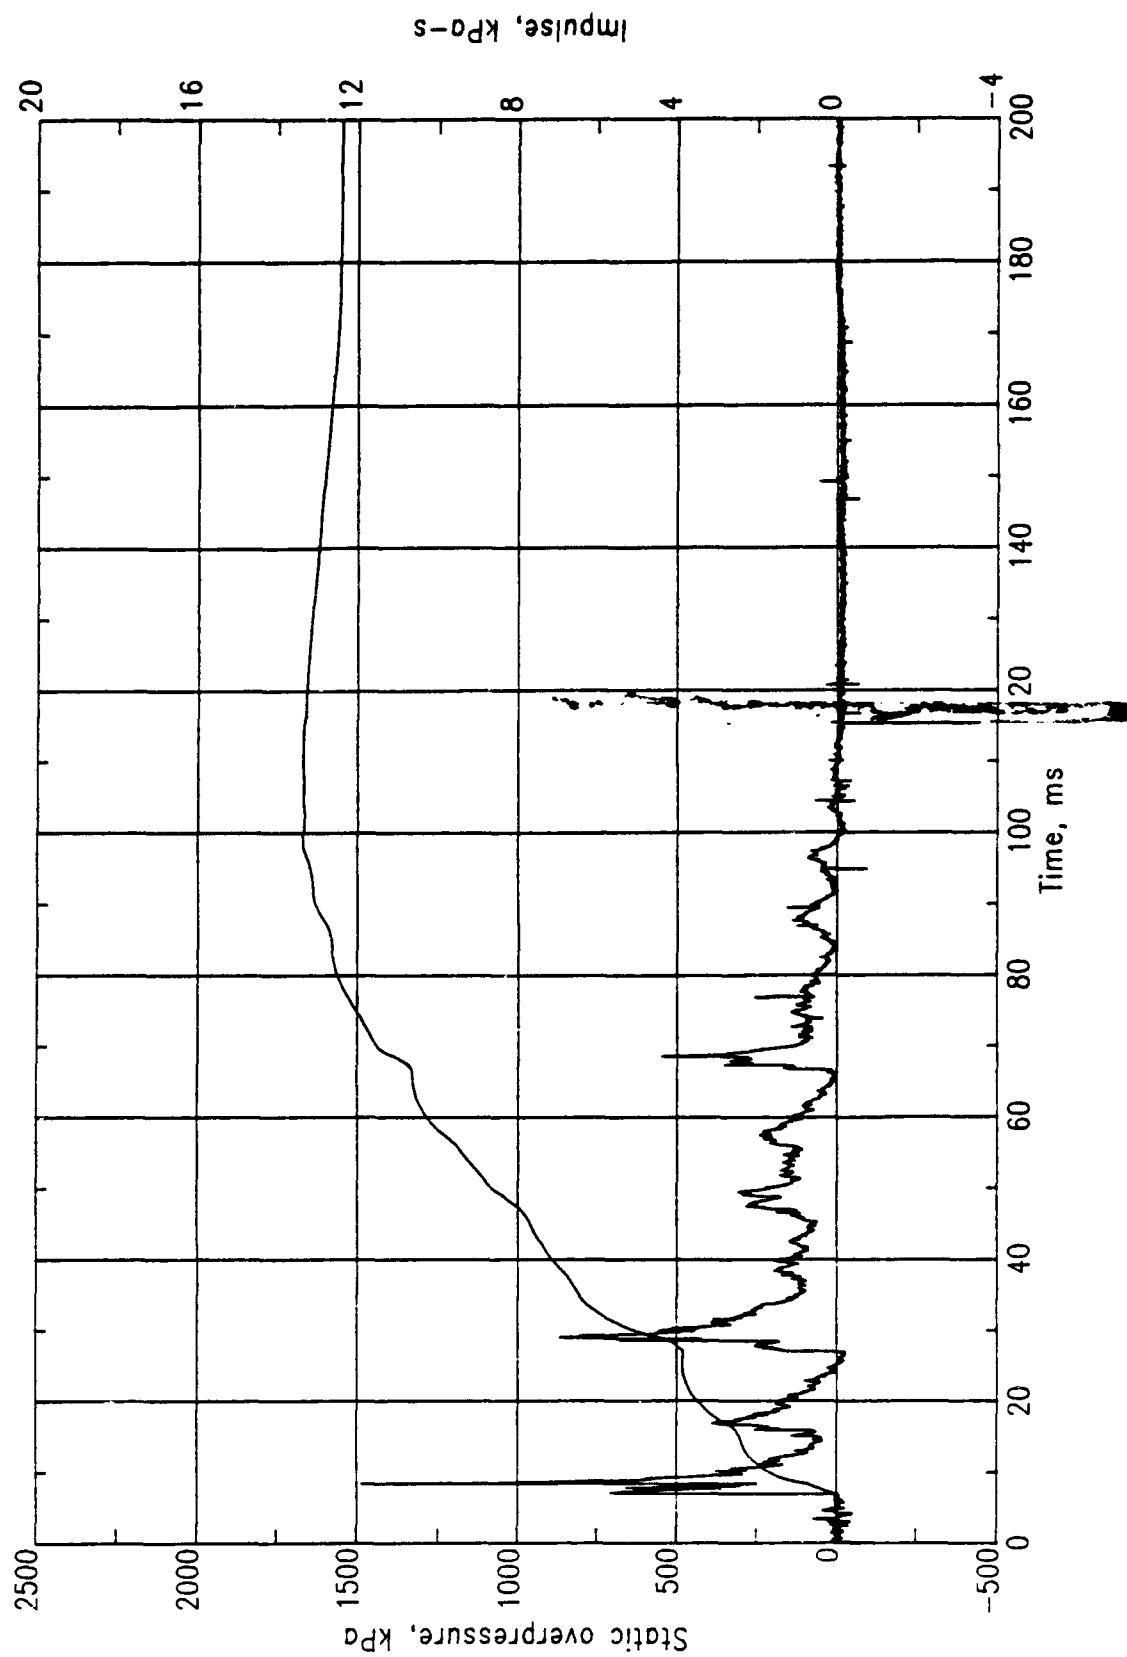
Figure 181. PAS-2, MN 0501.

Measurement Number 501 located in the floor at the front corner of the shelter showed a peak pressure of 1.5 MPa (Fig. 181). Measurement Number 102 located in the floor at the rear corner of the shelter shows a higher peak of 1.95 MPa at the same time (Fig. 182).

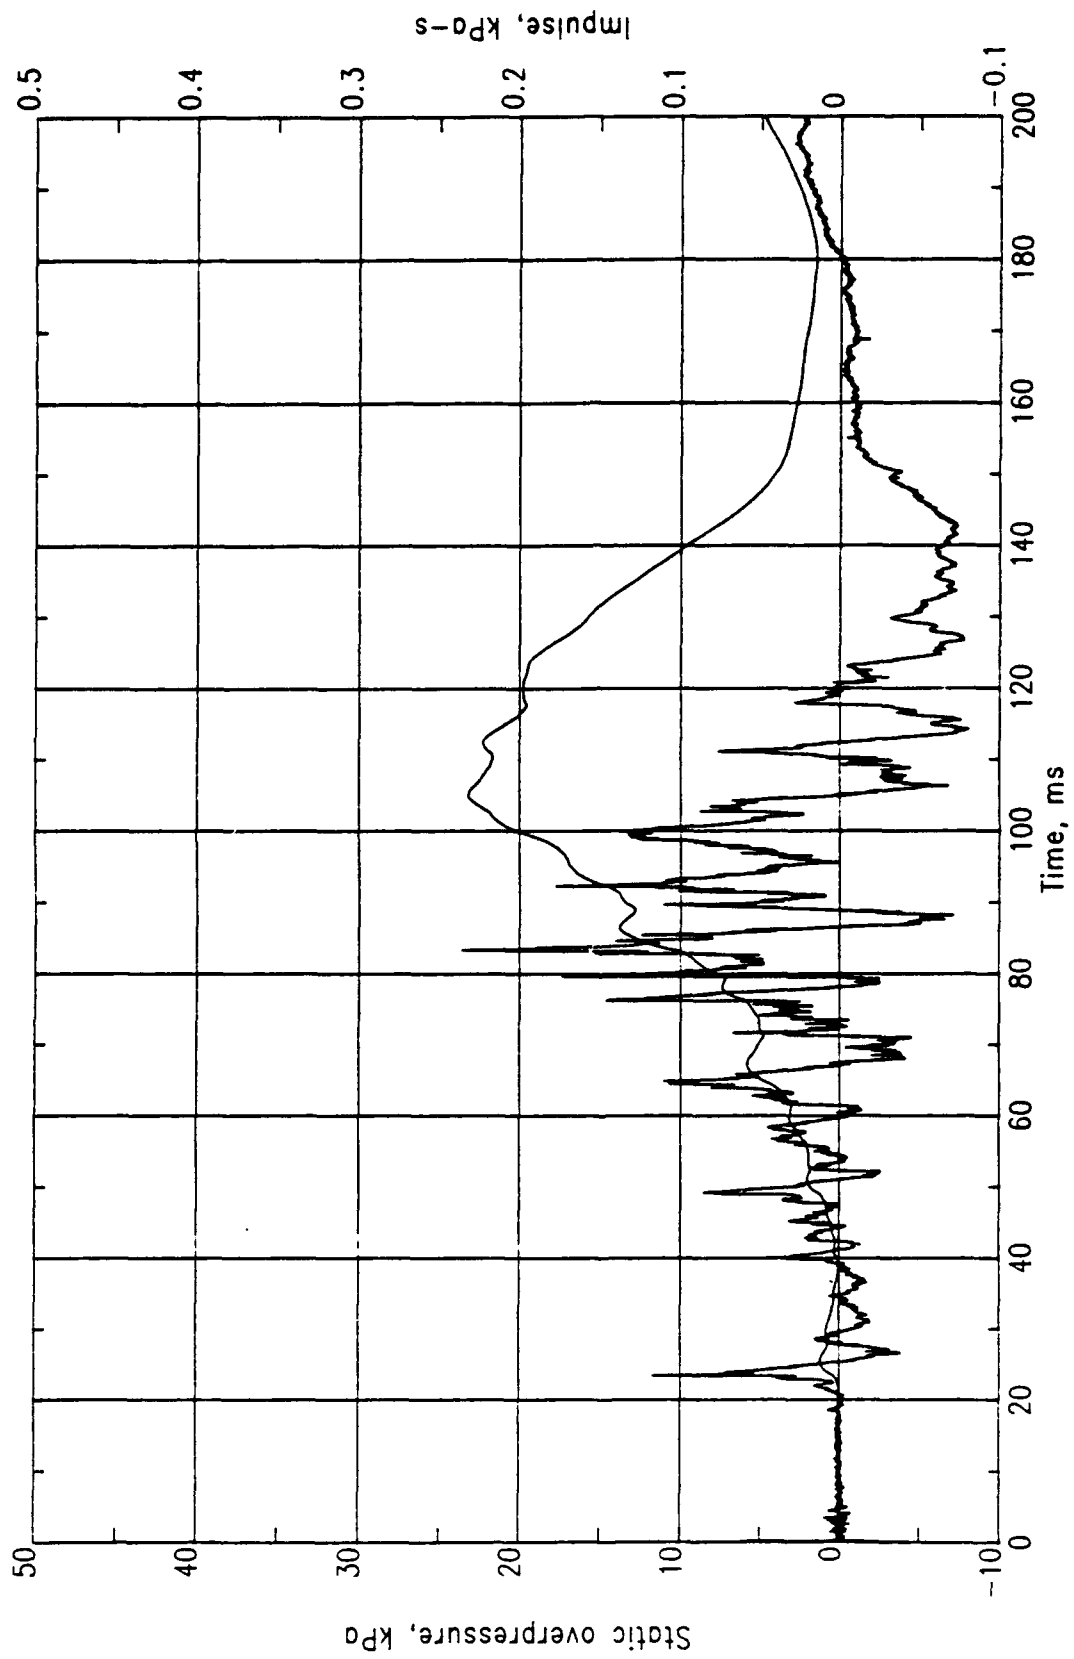
Figure 185. PAS-2, MN 0701.

The initial peak of only one free-field measurement exceeded 6.9 kPa. Measurement Number 701 located 11.8 m from the GZ recorded a peak of 11.5 kPa (Fig. 185). Measurement Number 702 located at 15.8 m from GZ recorded 6.5 kPa (Fig. 186). However, MN 701 showed a peak of 25 kPa at 83 ms and MN 702 a peak of 16.2 kPa at 93 ms. If the maximum values are considered, the 6.9-kPa contour would occur at about 30 m from GZ at the front of the structure. Measurement Number 704 at a range of 30.8 m recorded a peak of 6.5 kPa.

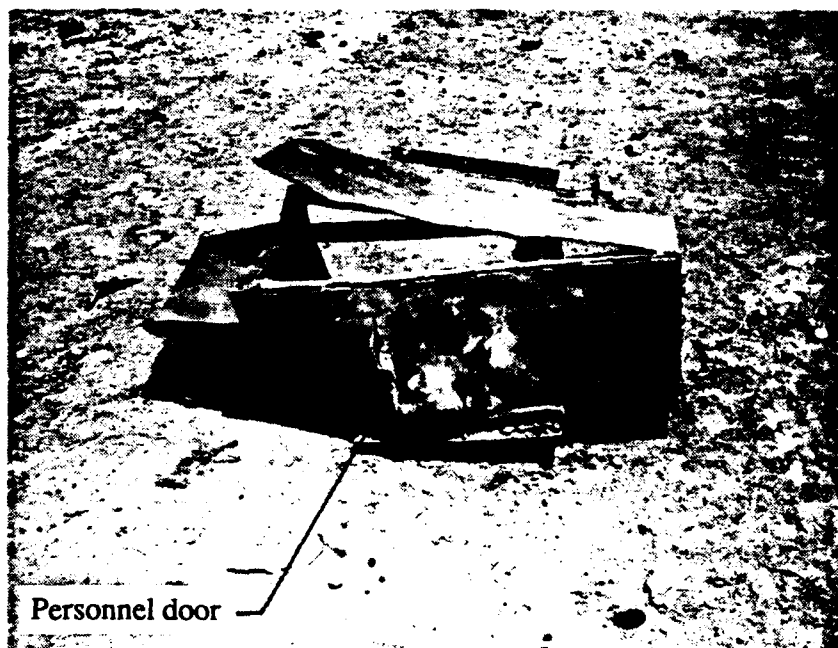
The personnel entrance vestibule was found intact, but severely damaged, approximately 28 m in front of the left wingwall (Fig. 217). The personnel door was found inside the vestibule. It had impacted the inner wall of the vestibule, fracturing the 6-mm-thick steel plate in several places (Fig. 218). The personnel door was deformed to the point of being almost unrecognizable. Although the welds simulating the hinges and latches had all been broken, the door frame remained welded to the steel liner of the headworks.

Figure 218. Vestibule and personnel door (foreground), PAS-4.
