**NORWAY/UNITED STATES DESIGN PROTECTIVE  
AIRCRAFT SHELTER (PAS) QUANTITY-DISTANCE  
PROGRAM 1/3-SCALE TEST SERIES**

**Volume I of V  
PAS 1-4 Summary**

**August 1993**

**Final Report**

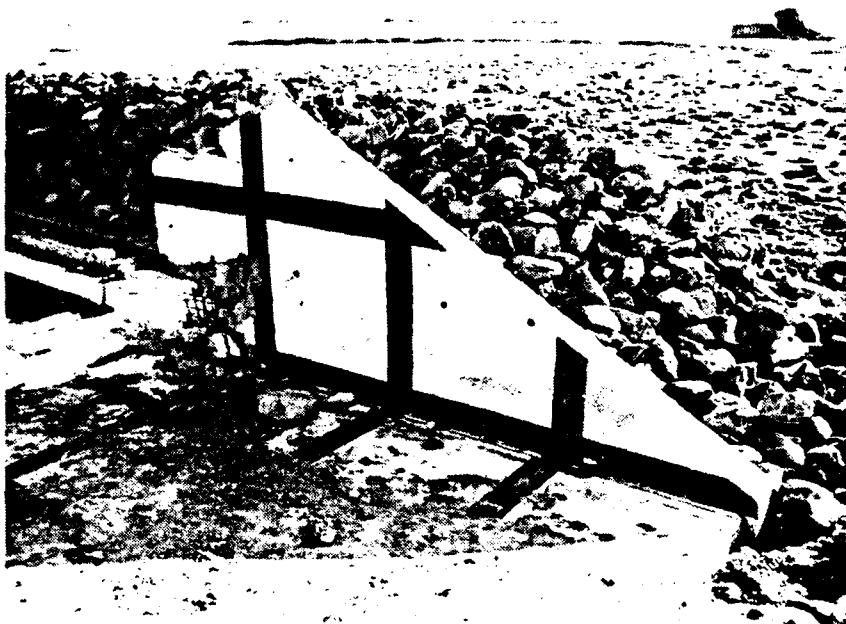
The lower portions of both wingwalls were found in place on their foundations (Figs. 219 and 220). Most of the top portion of the right wingwall was found as a single piece of debris about 29 m from the side of the shelter. A large piece of the top portion of the left wingwall was found 45 m in front of the shelter. All of the reinforcing bars crossing the failure planes had broken in tension. Both wingwalls and their foundations had broken away from the front foundation and moved forward about 65 mm.

Figure 219. Right wingwall, PAS-4.

Figure 220. Left wingwall, PAS-4.

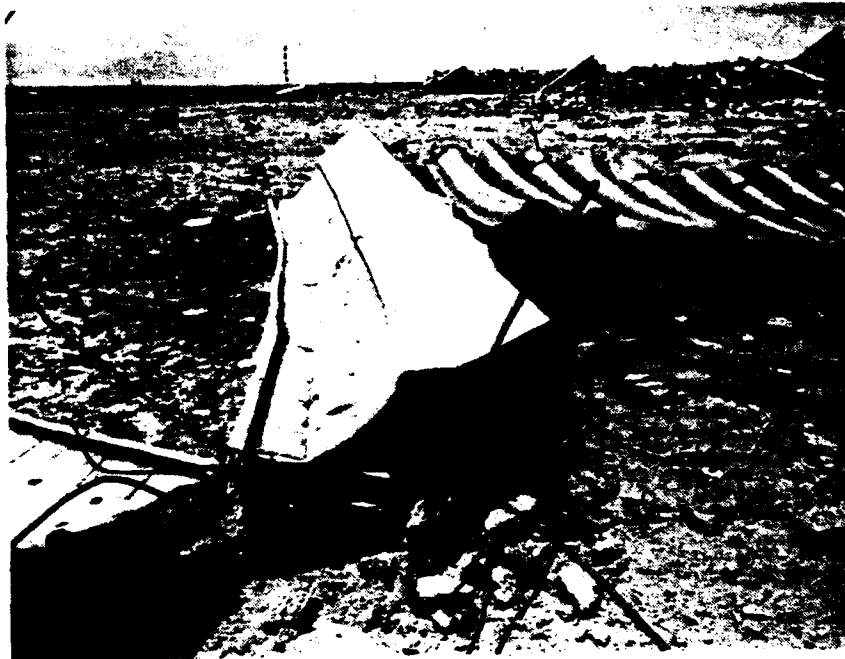
The headworks liner was torn in half along a welded joint near the crown of the arch. The two pieces remained attached to the adjacent large sections of the arch. The top parts of the liner were bent outward (Fig. 223). The concrete in the parapet was rubbleized, exposing the large threaded bars, most of which remained attached to the pair of channels welded to the liner plate (Fig. 224).

Figure 223. Deformed steel plate headworks liner, PAS-4.

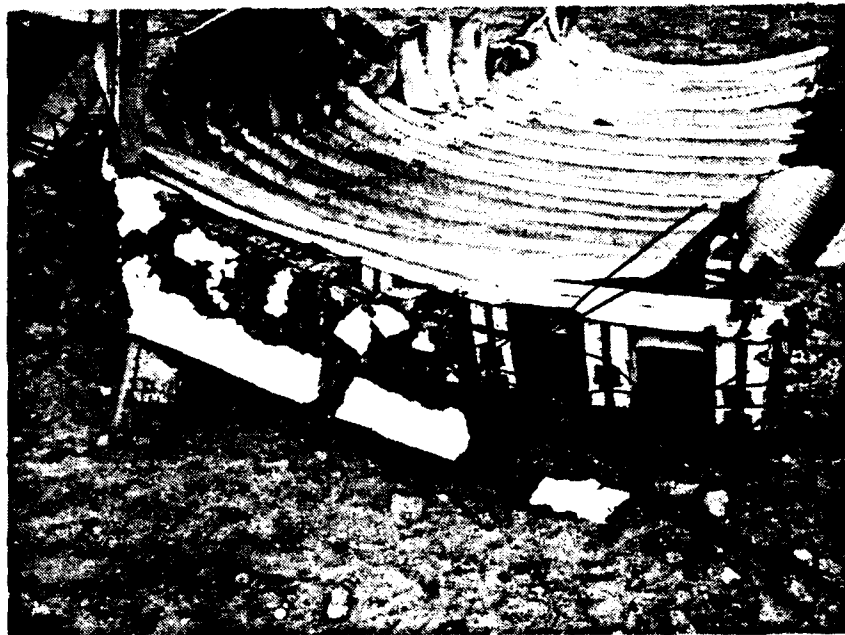
Figure 224. Rubbleized concrete in parapet, PAS-4.

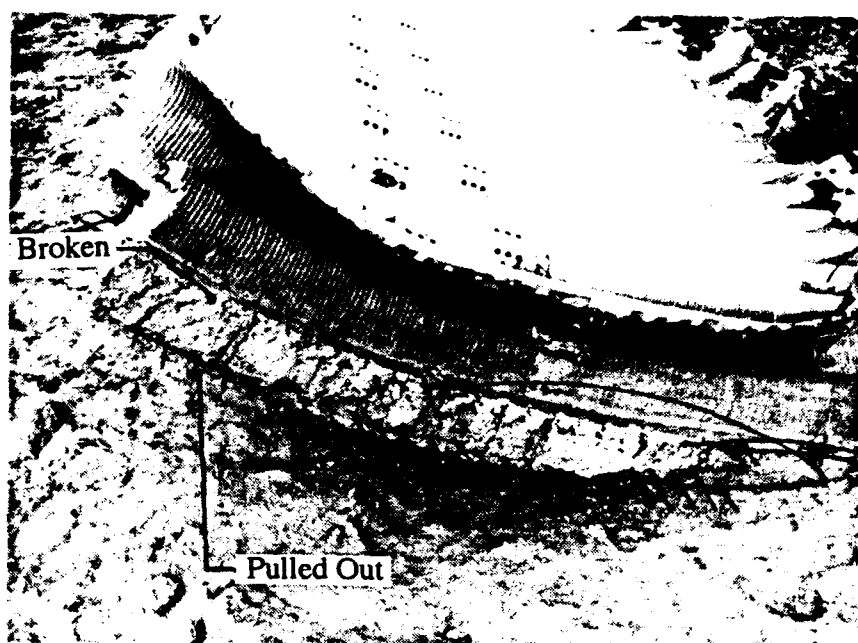
Arch failure in the transverse direction always occurred along a bolted liner joint. At the failure line, the concrete failed in tension, and the corrugated liner material was almost always pulled over the nut and washer of the bolt (Fig. 227). Figure 228 shows the location of the transverse failure planes in relation to the location of the splices in the two layers of longitudinal reinforcing bars. Where the failure plane was at, or near, a line of splices in the reinforcing bars, the bars pulled out of the adjacent piece (Fig. 229). At the other failure planes the reinforcing bars were found to have failed in tension at the fractured face of the concrete (Fig. 230).

Figure 230. Broken reinforcing bars in transverse failure plane, PAS-4.

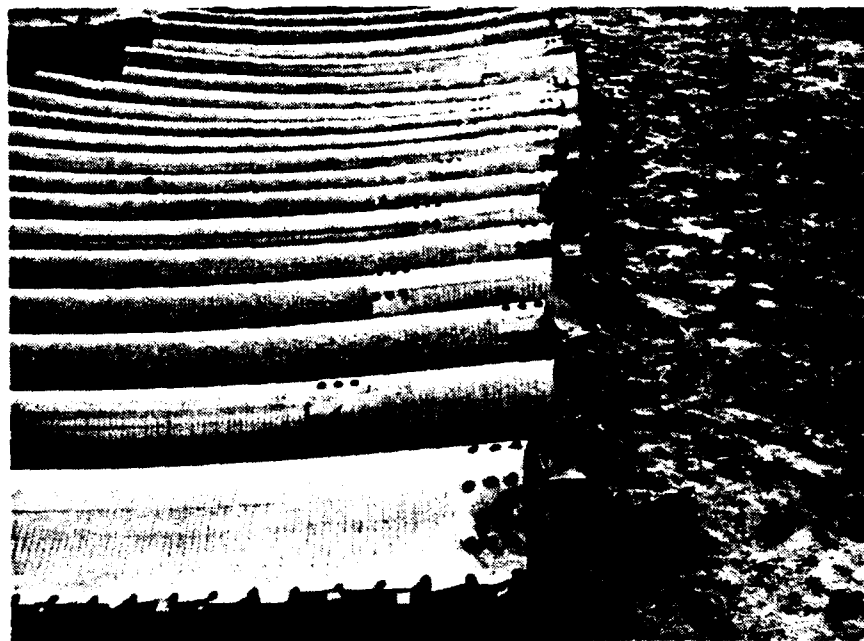
Figure 232. Liner failure at longitudinal failure plane, PAS-4.

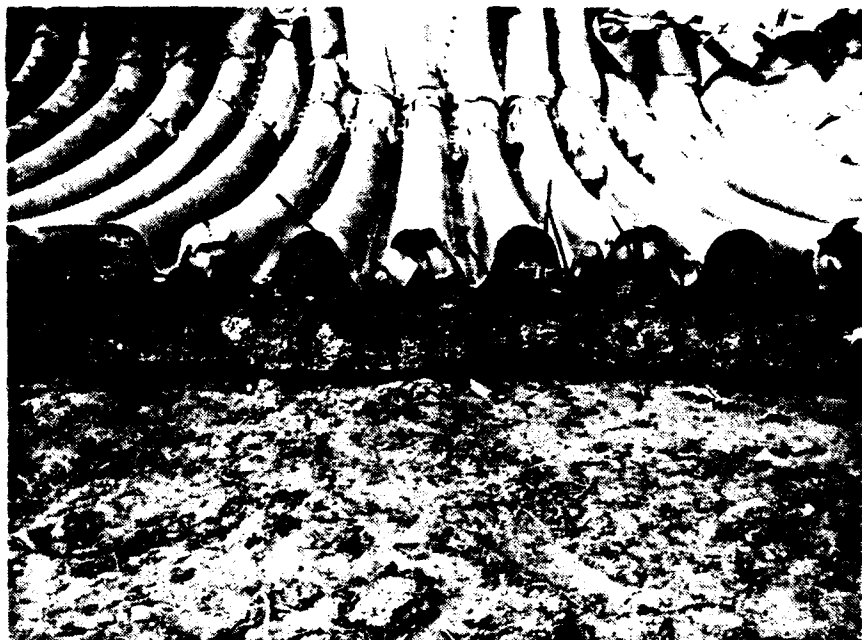
the two failure planes near the foundation, the transverse reinforcing bars failed in tension at, or within a few millimeters either side of, the fractured face of the concrete. At the two failure planes near the splices in the transverse reinforcing bars, most of the bars were found to have pulled out of the lower arch sections (Fig. 233); however, a few longitudinal failure planes at this location had a combination of both failed and pulled-out bars.

Figure 233. Pull-out of reinforcing bars at transverse failure plane, PAS-4.

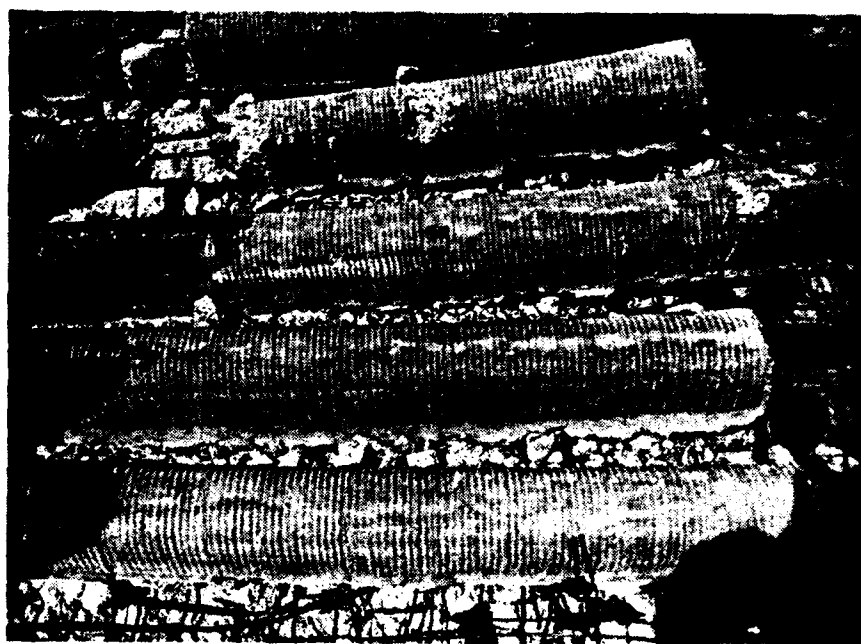
An examination of the fractured face of the longitudinal failure plane revealed tension cracks ranging from hairline to several millimeters in width at almost every transverse liner joint (Fig. 234). There were fewer of them in the thickened arch sections near the foundation. The tension cracks in these sections were also narrower in width and randomly spaced along the edge as compared to those associated with the liner joints. Transverse cracks were also seen on the surface of the arch sections (Fig. 235).

Figure 234. Tension cracks at transverse failure plane, PAS-4.

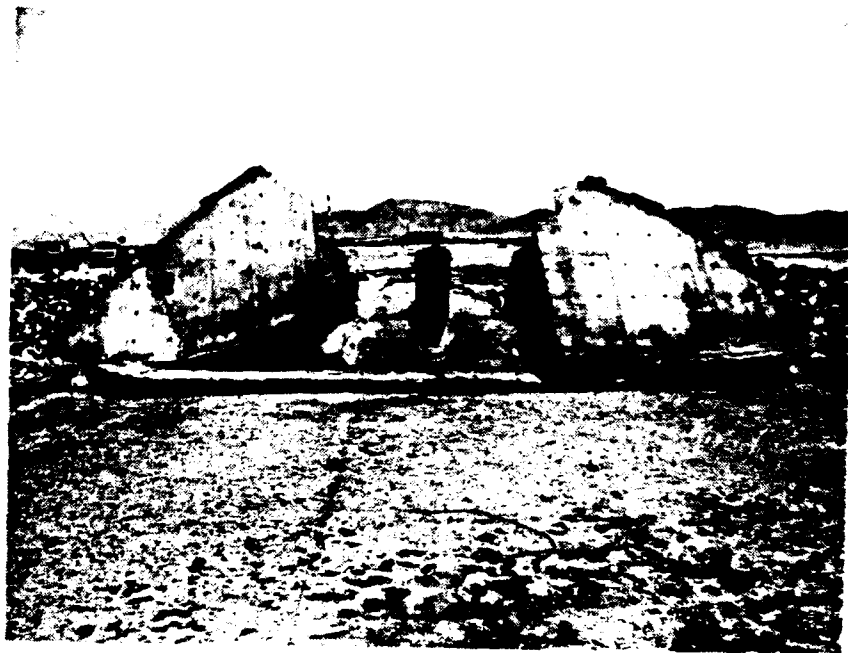
The center section of the backwall over the exhaust port opening had broken away along diagonal lines running from the upper corners of the exhaust port opening (Fig. 245). This section was found in two pieces about 9.1 m behind the shelter. The two remaining sections of the backwall on either side of the opening had broken away from the foundation and were pushed backwards about 200 mm. These walls had tipped backward approximately 30 deg (Fig. 246).

Figure 245. Posttest view of backwall, PAS-4.

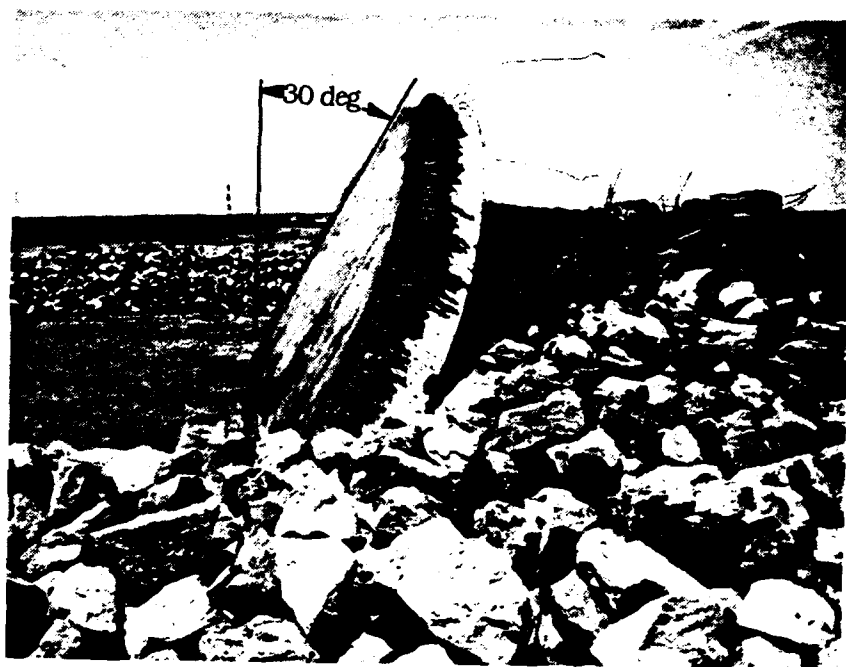
Figure 246. Thirty-degree backward rotation of backwall, PAS-4.

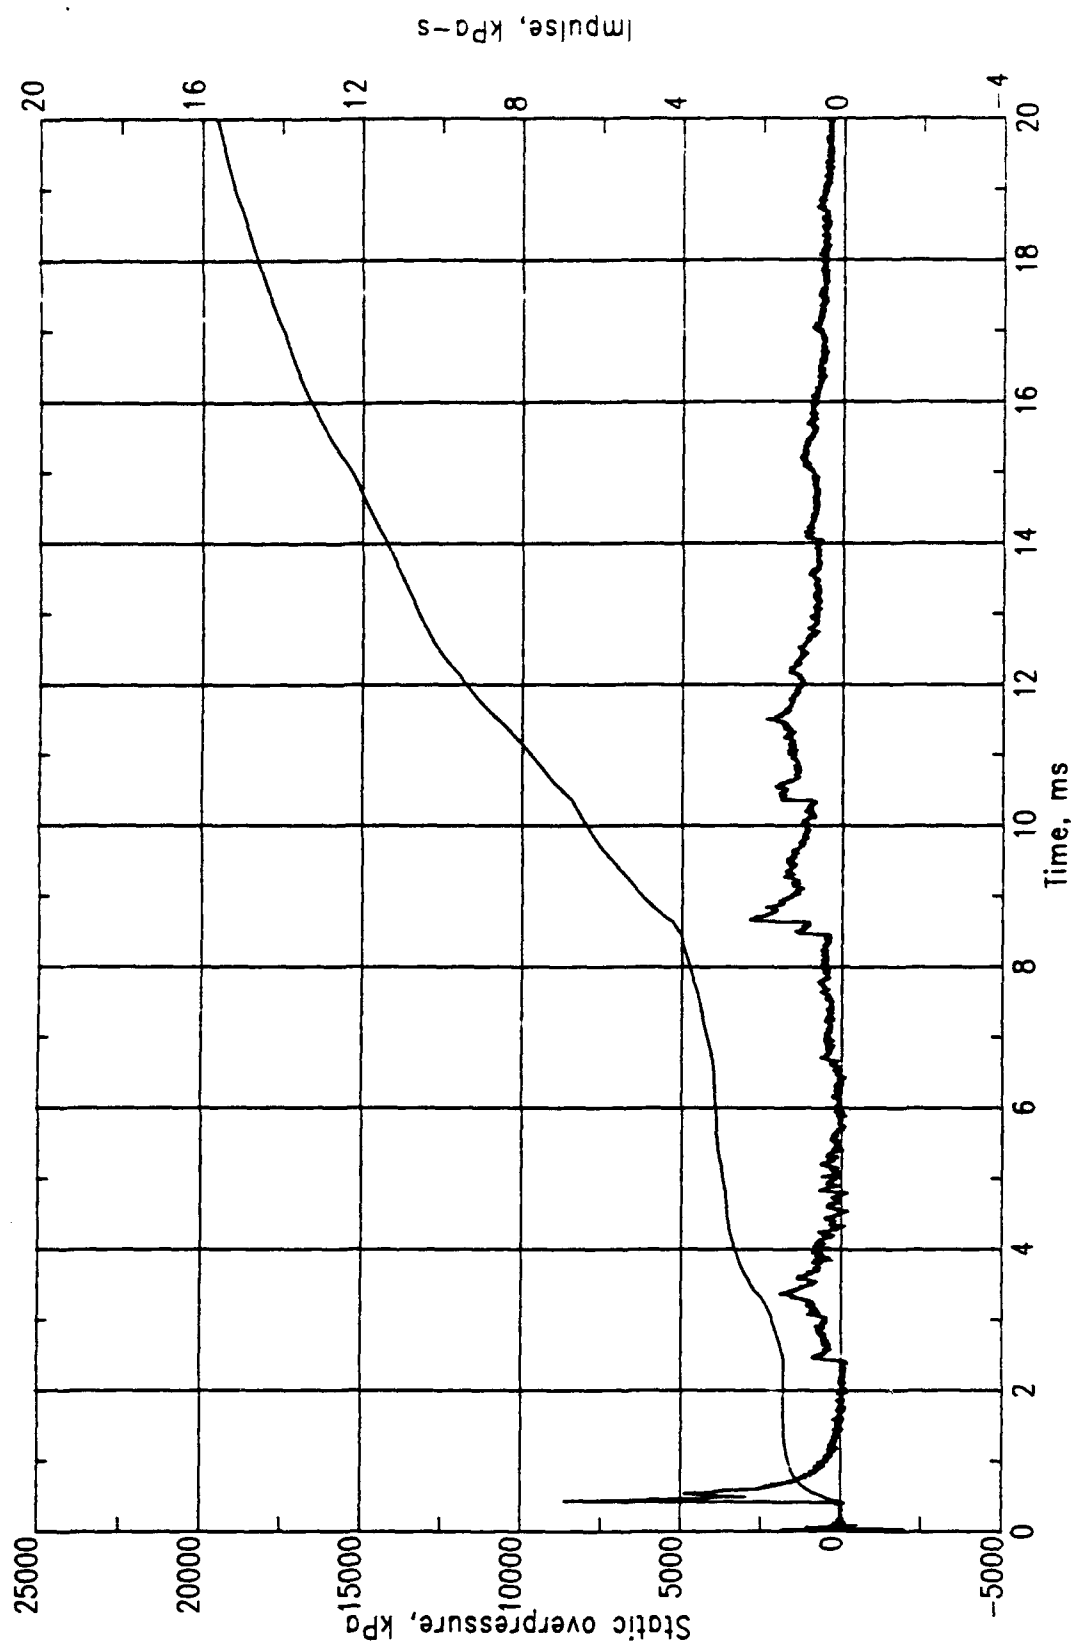
Figure 262. PAS-4, MN 0601.

Measurement Number 601 was made in the floor 1.85 m from GZ towards the side of the shelter. It shows a peak pressure of 8.59 MPa (Fig. 262). The INBLAST code predicted 1.16 MPa at this location. Measurement Number 301, made in the floor 2.84 m from GZ towards the front door, shows a peak of 5.18 MPa (Fig. 263).

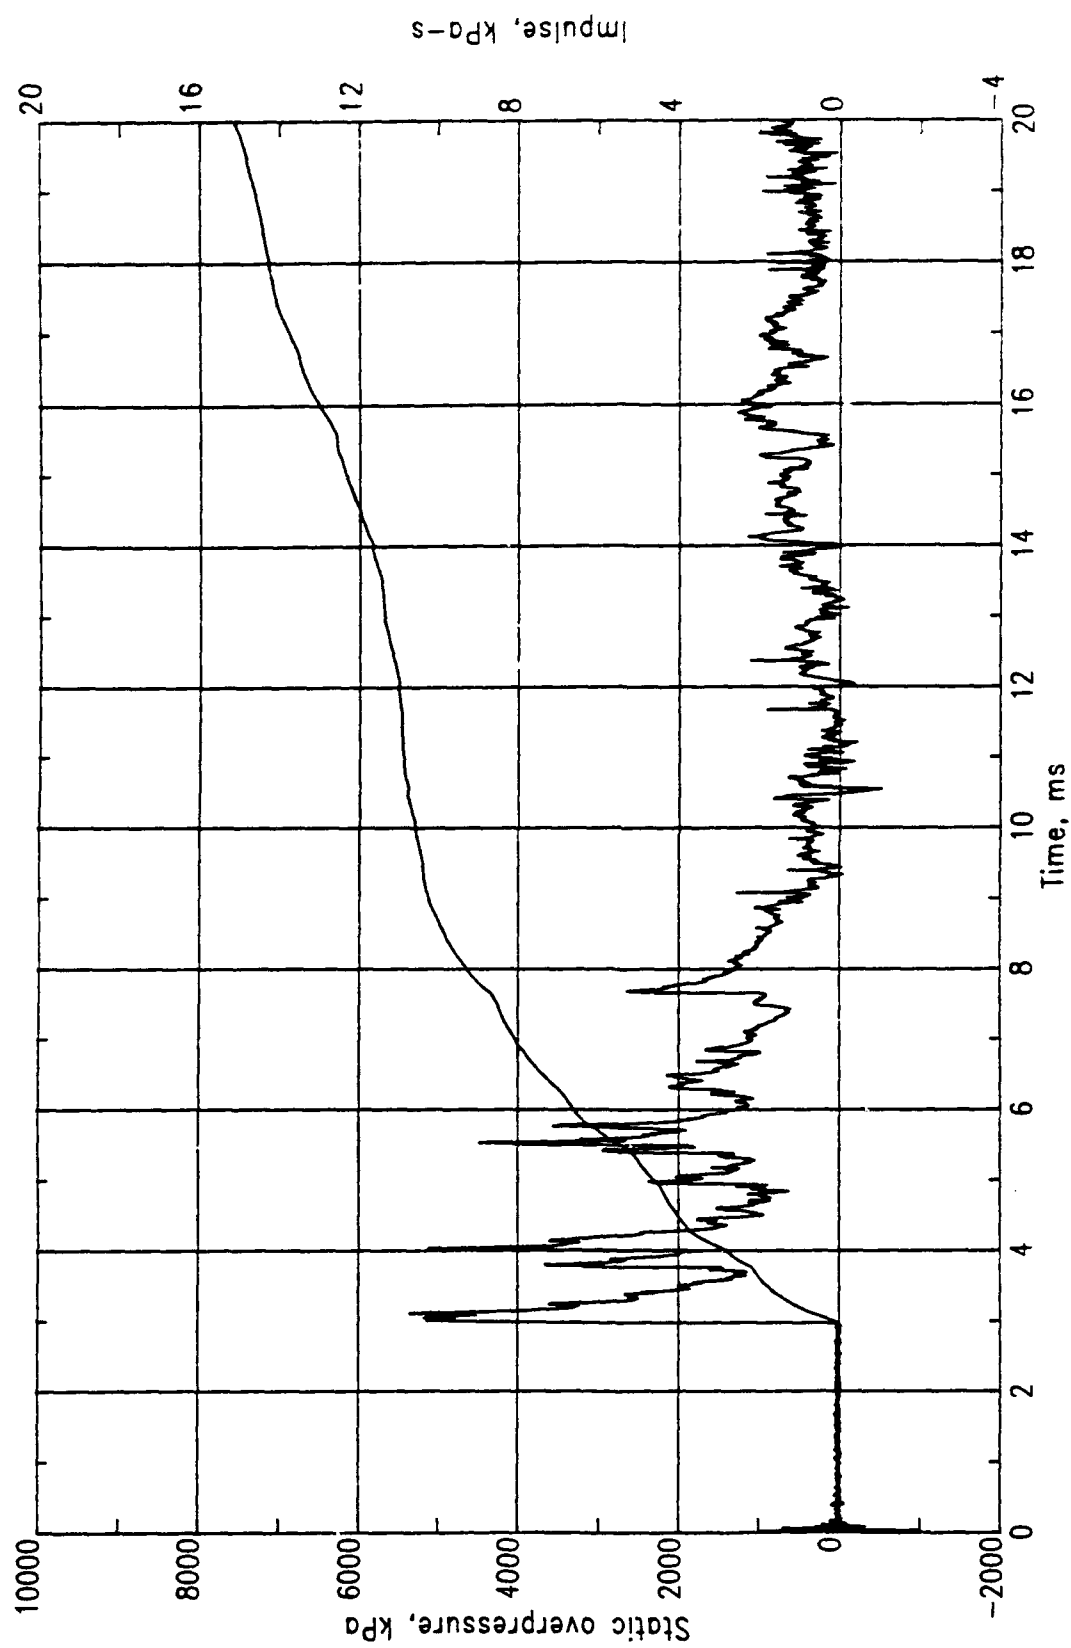
Figure 264. PAS-4, MN 0402.

The only pressure measurement made on the inside surface of the front door in the PAS-4 test was MN 402 (Fig. 264). This gage was located near the center of the door, and it recorded a peak pressure of 5.32 MPa at 3.0 ms. The INBLAST code predicted a peak of 5.06 MPa at 3.3 ms at this location. Measurement Number 202 located in the backwall at a little shorter range (same height off the floor but greater distance off the structure centerline) shows a peak of 6.29 MPa (Fig. 265). The first peak of MN 202 was 6.0 MPa at 3.0 ms. Measurement Number 501 located in the floor of the shelter near the front left corner recorded a peak pressure of 10.2 MPa (Fig. 266).

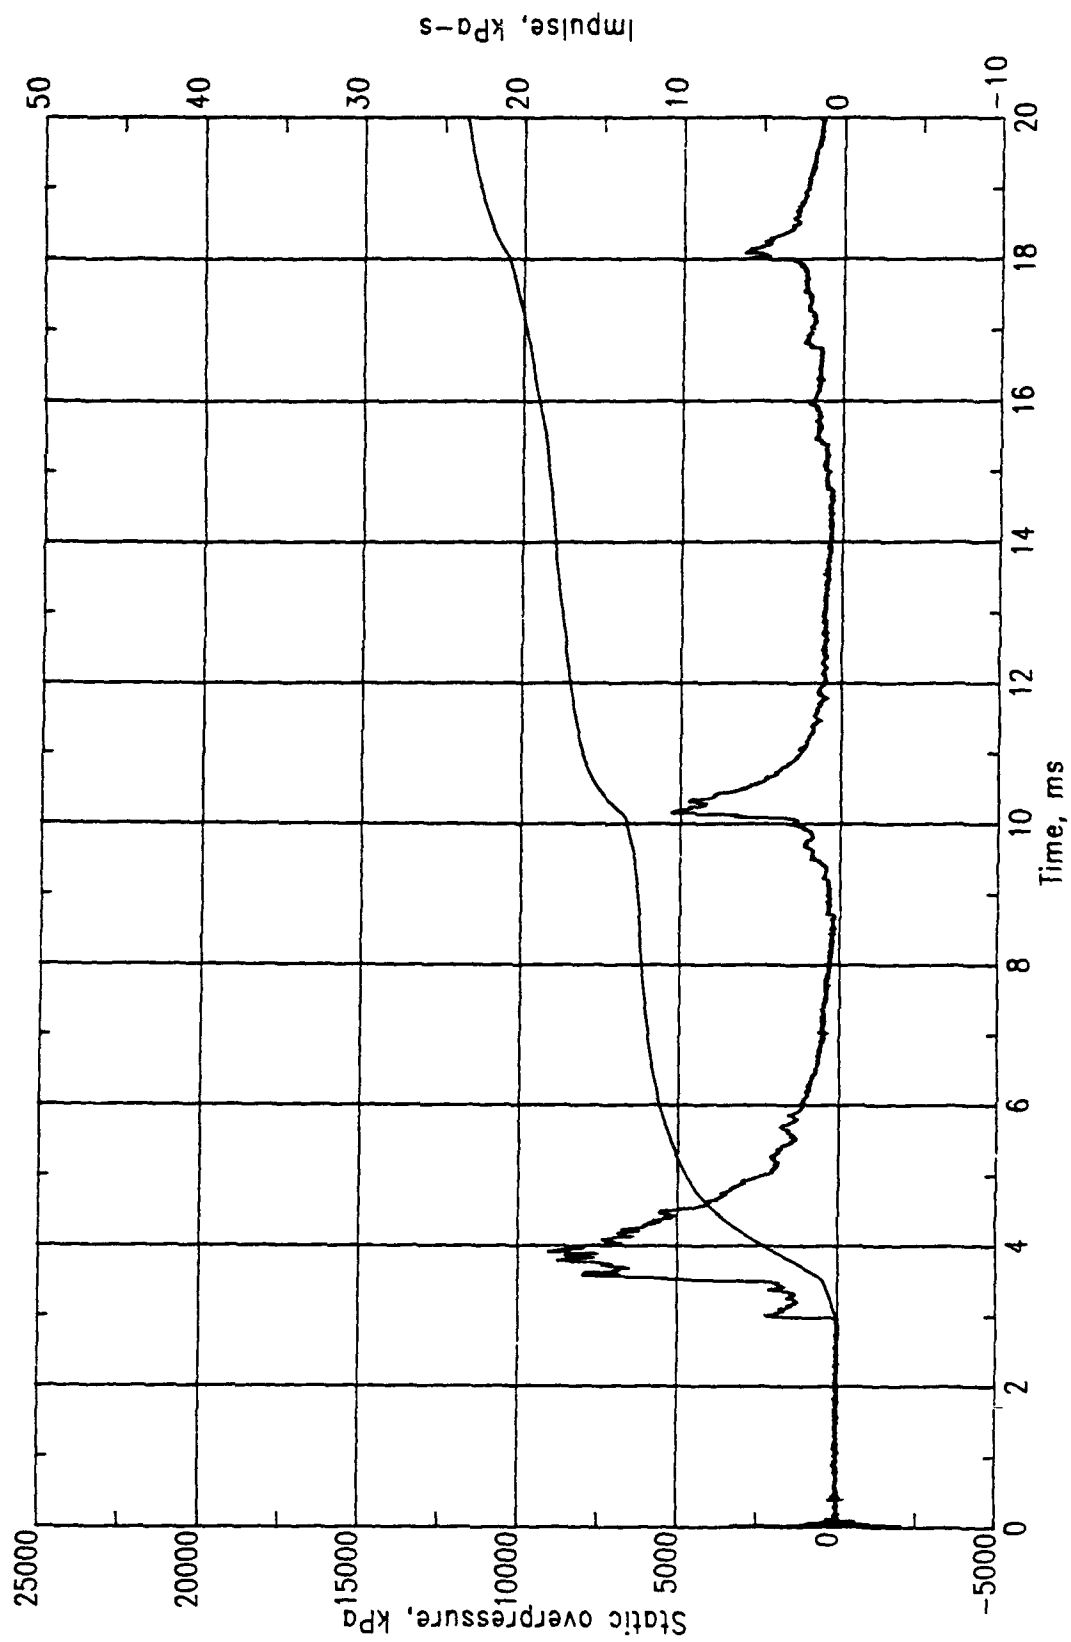
Figure 267. PAS-4, MN 0102.

Measurement Number 102, at about the same location near the left rear corner of the shelter, recorded a peak of 8.95 MPa (Fig. 267).

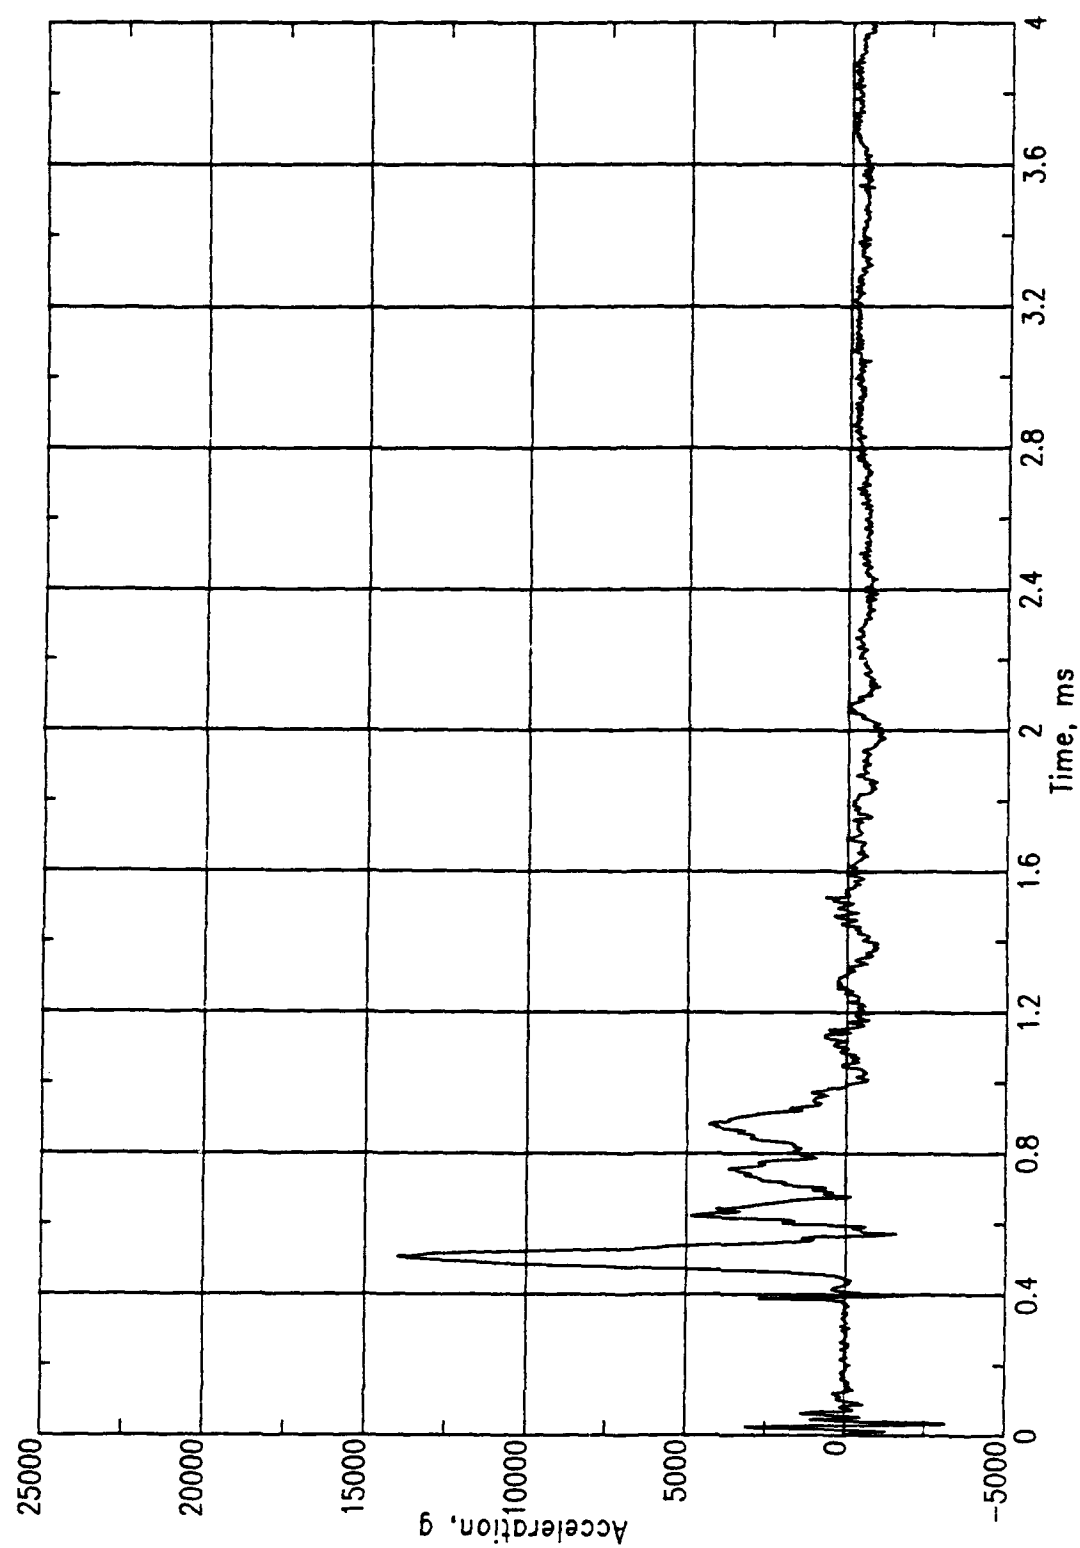
Figure 269. PAS-4, MN 1601.

Three accelerometers were mounted on the exterior surface of the arch in the same cross-sectional plane that included the GZ. The sensing axes of all accelerometers were oriented to measure radial accelerations. Measurement Number 1601 was made at the crown of the arch right over GZ. Figure 269a shows a peak radial acceleration of about 14,000 g for MN 1601. Figure 269b, a plot of the first and second integrals of the accelerometer record for MN 1601, shows a peak radial velocity of 15.8 m/s during the

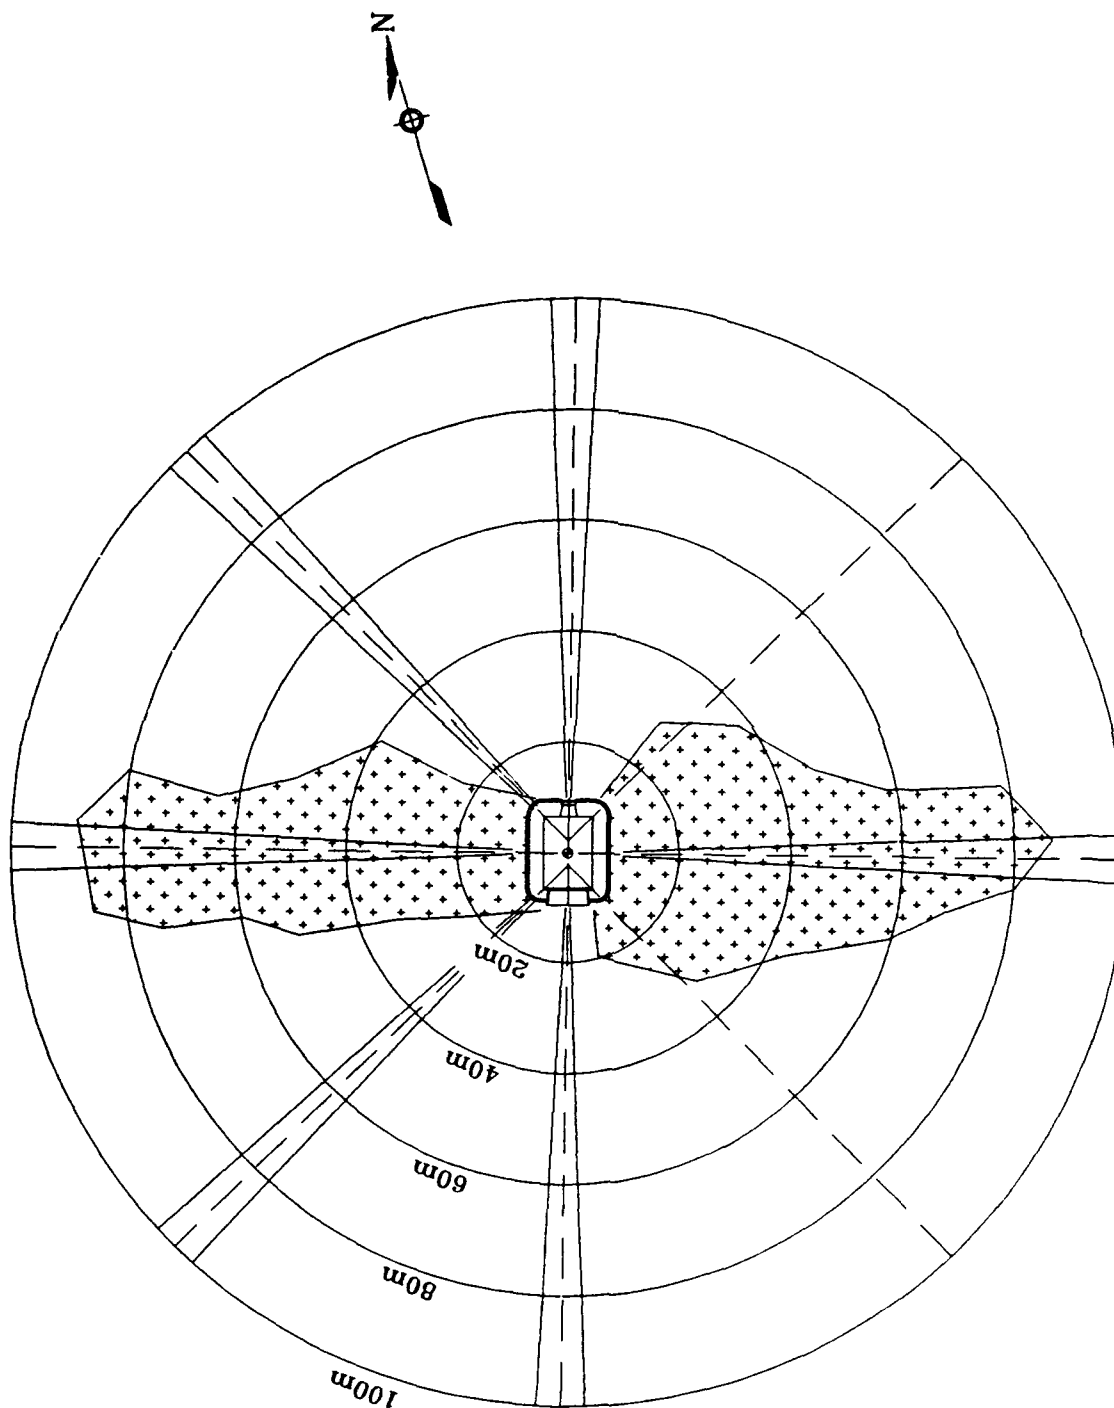
One of the more noticeable results of the test was the relatively large amount of rock from the berm scattered around the structure (Fig. 285). The distribution density of the rock far exceeded the concrete debris, particularly to the sides of the structure. As noted in the discussion of structural response, most of the rock debris came from an area adjacent to the structure. It is estimated that the volume of rock ejected during the test was about 15-20 percent of the total rock berm on either side of the arch. The limits of the rock distribution were surveyed and are illustrated in Figure 286.

Figure 286. Distribution of rocks from berm, PAS-4.

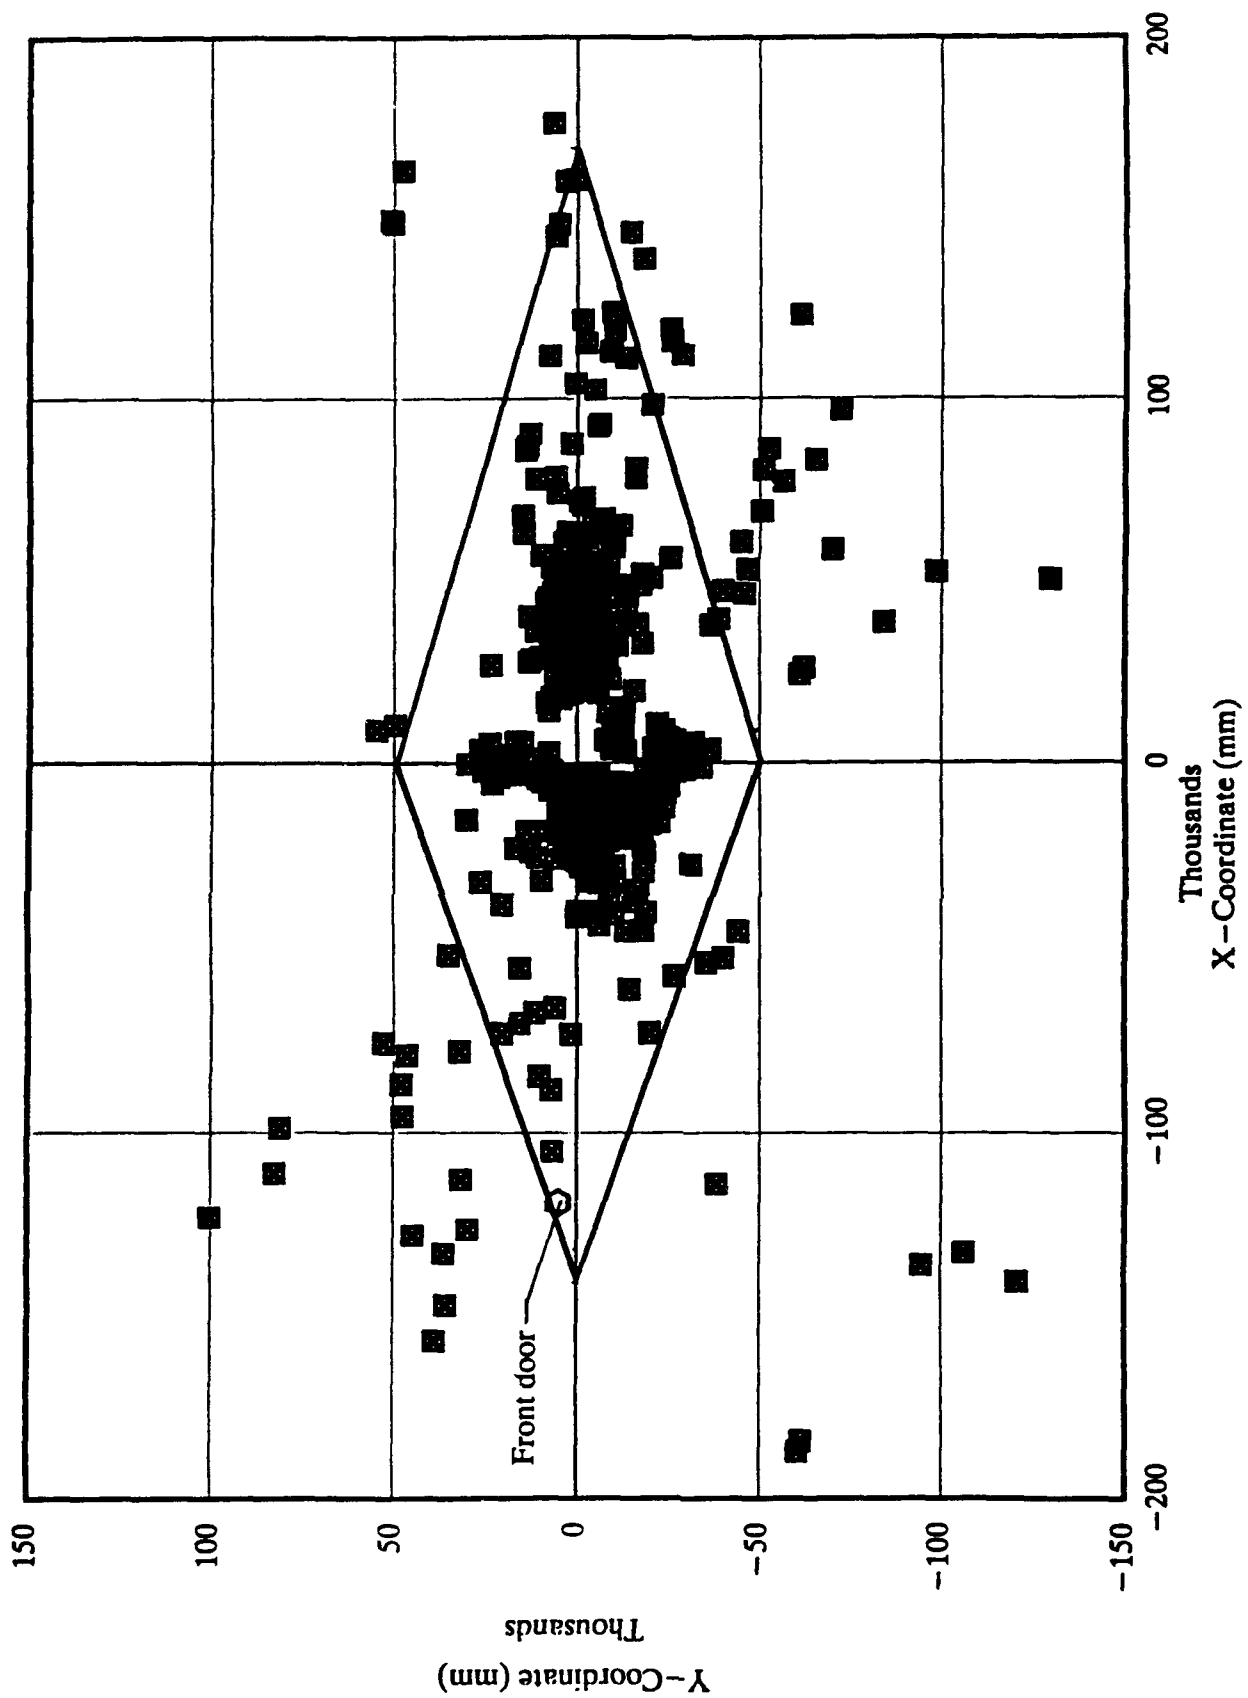
**7.2.1.3 PAS-3**—The majority of the debris recovered was generally distributed along the longitudinal axis of the shelter, rather than to the sides. For example, a diamond drawn with one axis 140 m long from the center of the shelter toward the front, one axis 170 m from the center to the back of the shelter, and the two side axes 50 m long from the center, would encompass 95 percent of all the debris produced (Fig. 287).

Figure 287. Suggested hazard boundary geometry, PAS-3.

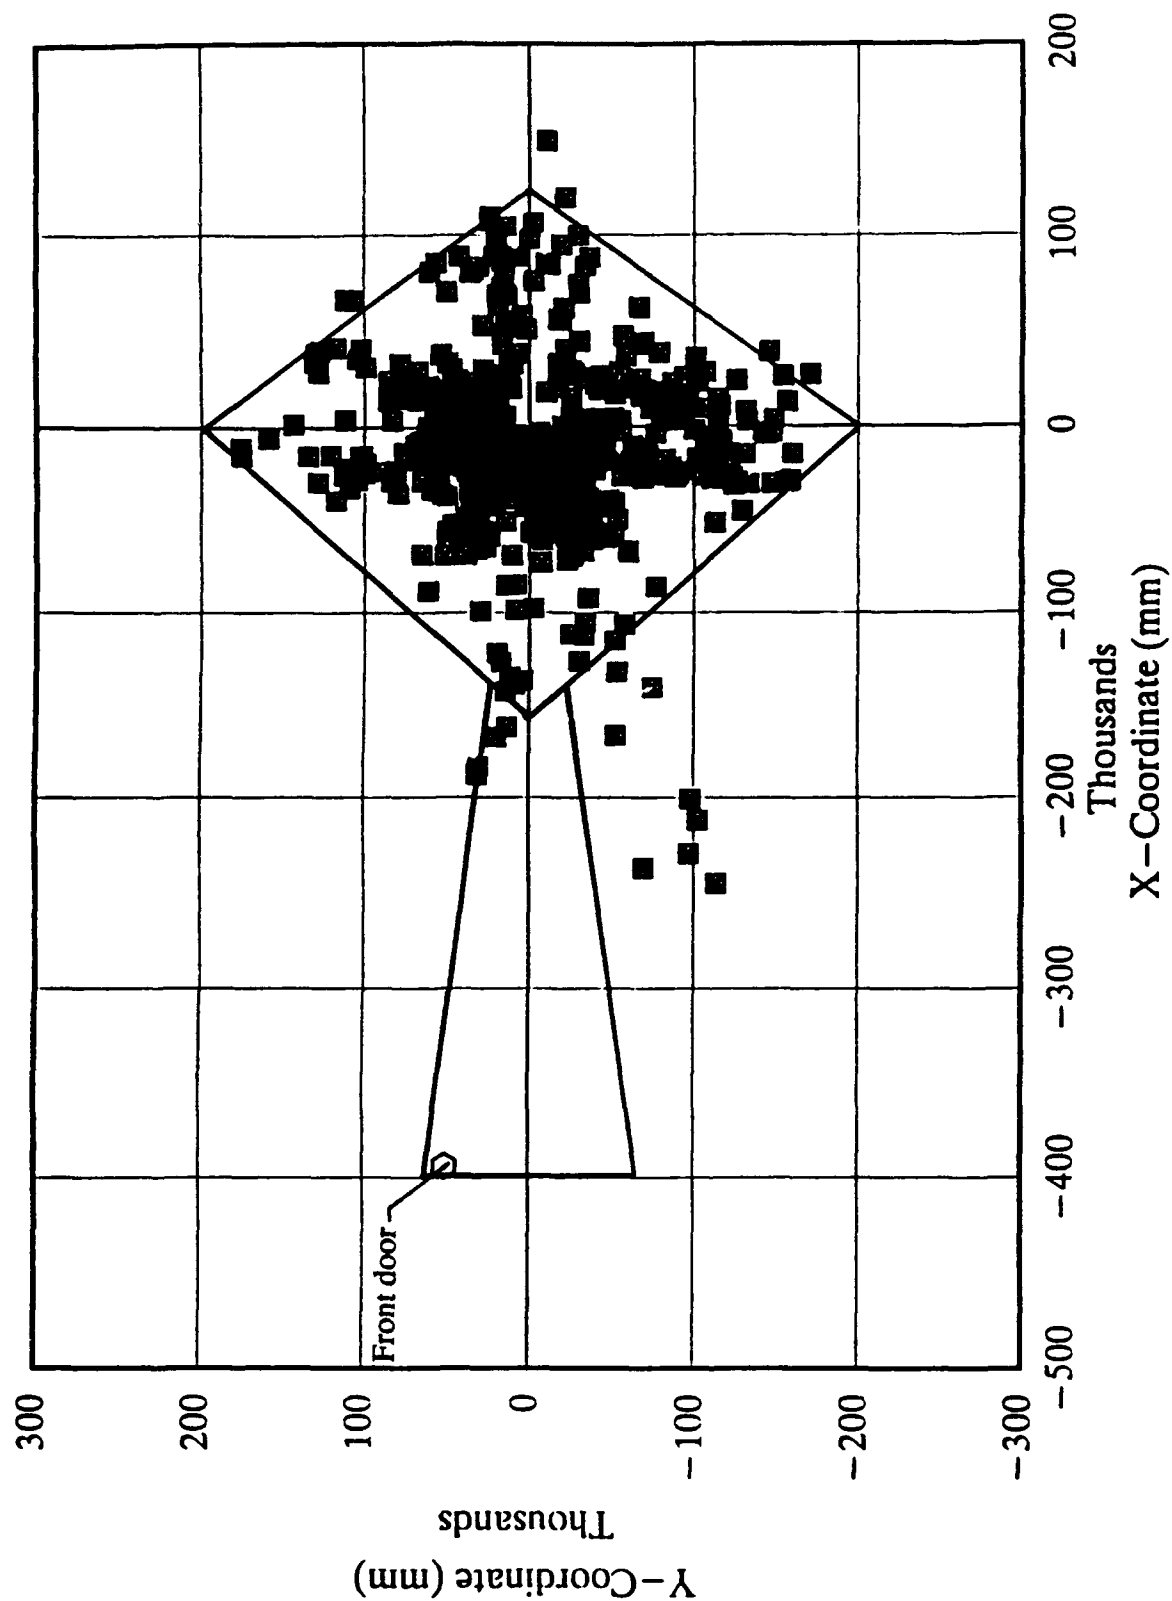
**7.2.1.4 PAS-4**—In comparison to PAS-3, the debris from this test was distributed about the same distances to the front and back of the shelter but almost three times as far to the sides. For example, a diamond drawn with axes of 170 m to the front, 115 m to the back, and 200 m to the sides, would enclose 98 percent of the debris (Fig. 288).

Like PAS-3, the debris recovered at the sides of the PAS-4 shelter appeared to originate from the arch. The debris to the back came from the exhaust port and backwall; the debris found toward the front came from the parapet and wingwalls.

Figure 288. Suggested hazard boundary geometry, PAS-4.
