FINAL REPORT  
MAY 1993

REPORT NO. 93-20

TRANSPORTATION TEST OF  
M876A1 U.S. MARINE CORPS  
(USMC) TELEPHONE  
MAINTENANCE TRUCK (TMT)

VALIDATION ENGINEERING DIVISION  
SAVANNA, ILLINOIS 61074-9639

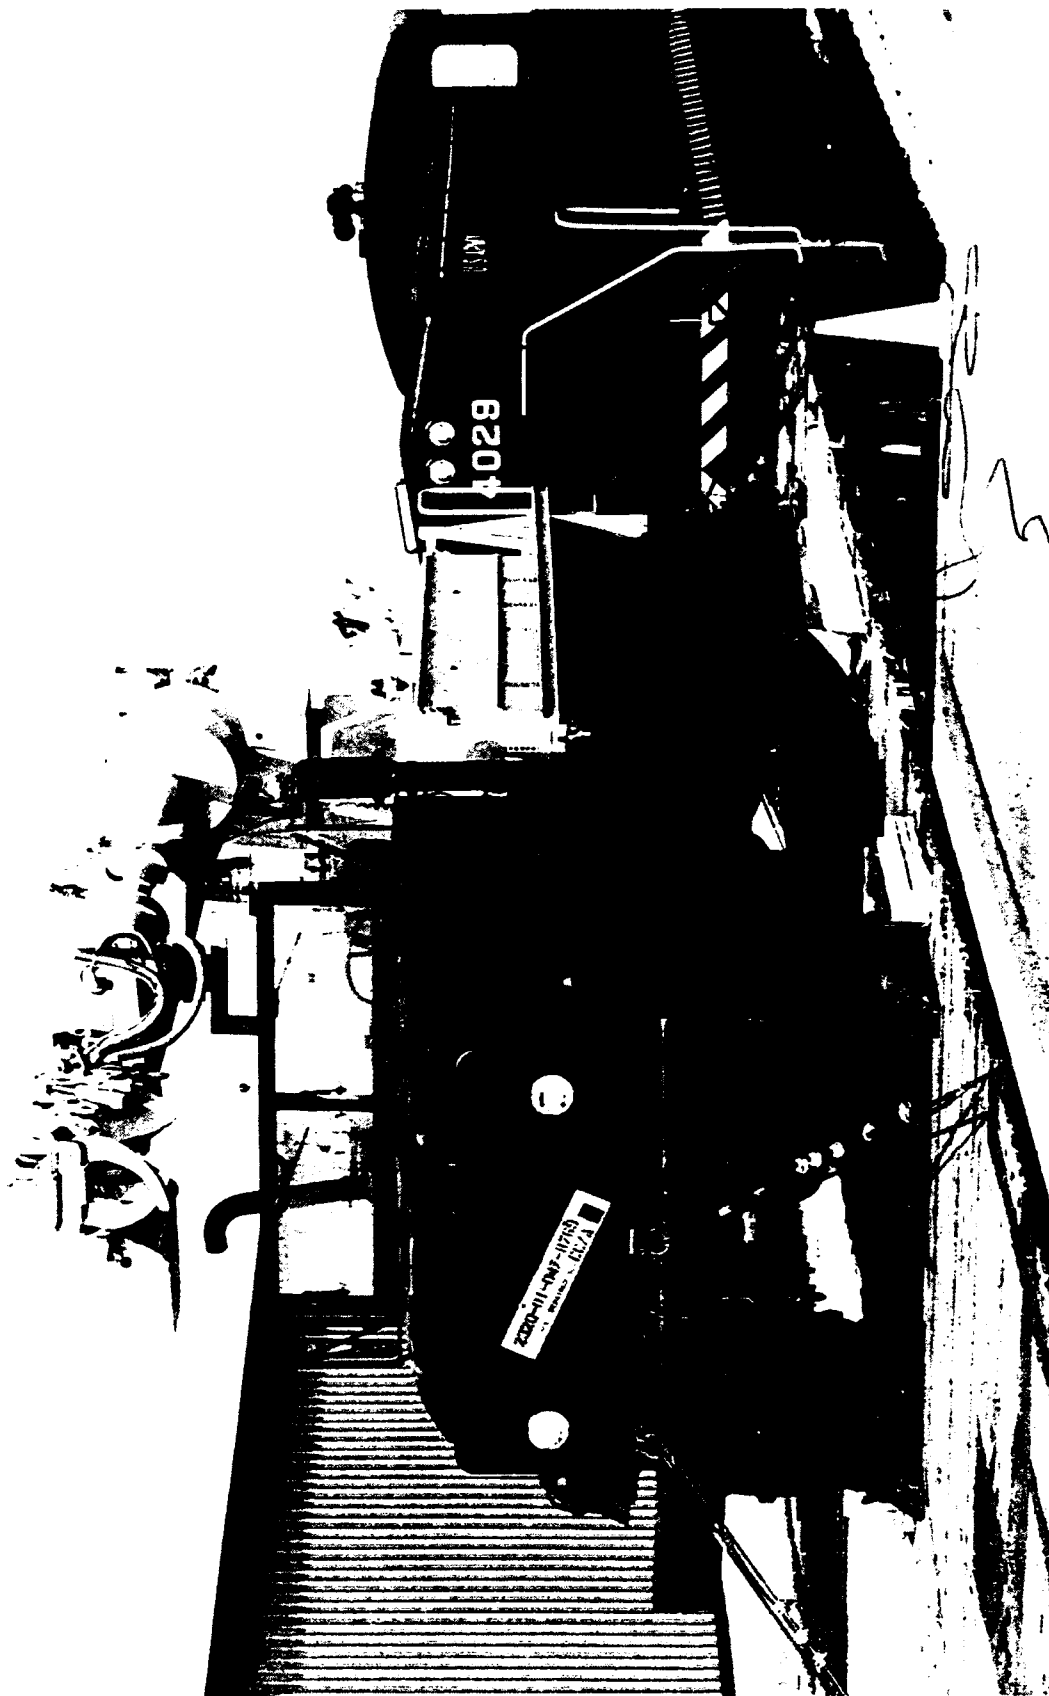
PHOTO NO. A0317 SCN93-152-1868. This photo shows U.S. Marine Corp M876A1 TMT with a commercially-fabricated truck bed. The truck is undergoing rail impact testing to verify its multimode-transportability capability.
