Technical Report RFMR-CS-42  
February 1994

## **Overlays on Horizontal Concrete Surfaces: Case Histories**

by *Roy L. Campbell, Sr.*  
*Structures Laboratory*

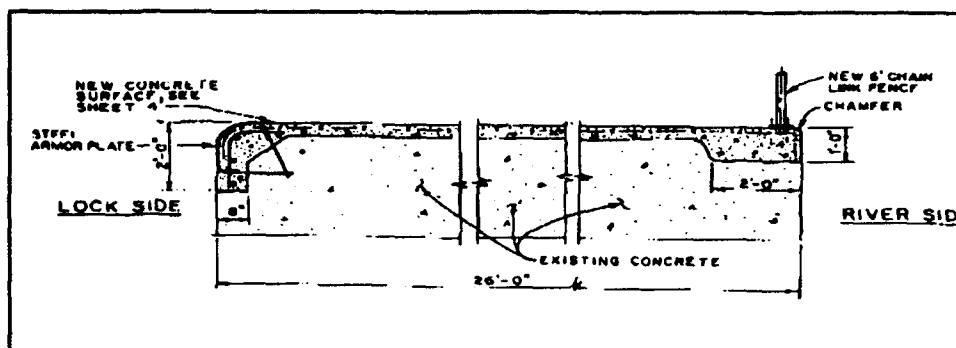
The tops of the east lock wall in 1982 and the west lock wall in 1988 were resurfaced using conventional concrete containing welded-wire fabric (4 in. by 4 in. (102 mm by 102 mm)). New armor plating and reinforcement were provided along chamber face edge of overlay (Figure 1). The concrete specifications required a 37.5-mm (1-1/2-in.) nominal maximum size aggregate, a maximum water-cement ratio by mass of 0.44, an air content of 4.0 to 7.0 percent, a 1-in. to 4-in. (25-mm to 102-mm) slump, and a 28-day compressive strength of 4,000 psi (27.6 MPa).

Figure 1. Typical overlay section, Black Rock Lock, 1988

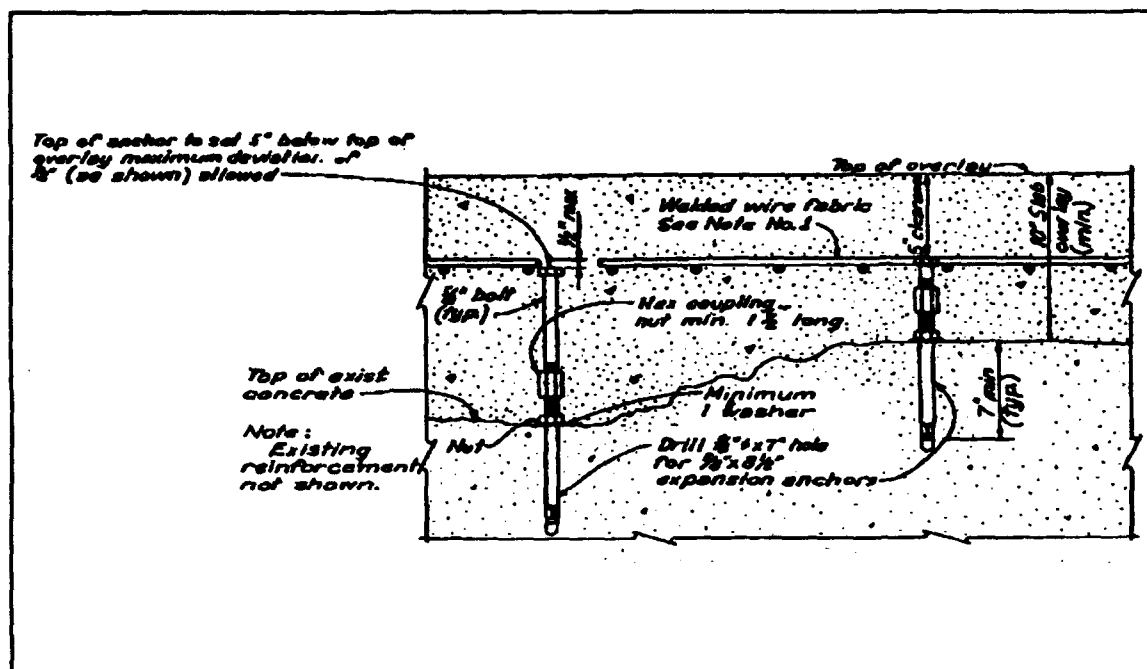
Expansion anchor bolts having a 5/8-in. (16-mm) diameter were installed to a minimum depth of 7 in. (178 mm) in holes drilled in the existing concrete surface (Figure 8). A welded-wire fabric was placed above anchor bolts. The fabric had a steel area of 0.12 in.<sup>2</sup>/ft (254 mm<sup>2</sup>/m) each way and a 4-in. (102-mm) opening.

Figure 8. Overlay and anchor bolt details, Tuttle Creek Dam Stilling Basin, 1975

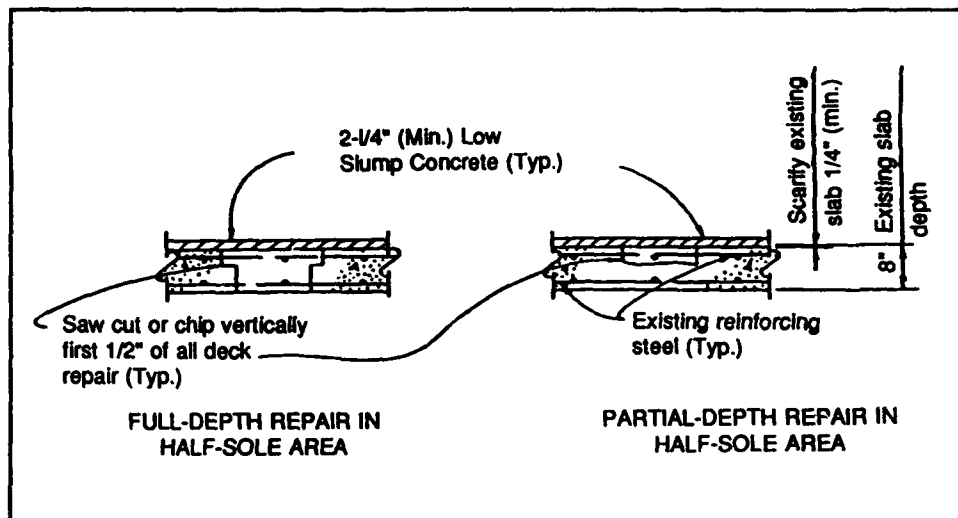
The roadway of bridge decks was scarified to remove a minimum of 1/4-in. (6-mm) of surface. Approximately 20 yd<sup>2</sup> (16.7 m<sup>2</sup>) of roadway had to be patched of which 4 yd<sup>2</sup> (3.34 m<sup>2</sup>) required full depth patches. Details for patching are presented in Figure 19. A 3/4-in. (19-mm) clearance was provided between exposed reinforcing bars and concrete. Reinforcing was cleaned by sandblasting. Cut or broken bars or bars in which 10 percent or more of cross-sectional area had been lost were spliced with a new bar of the

Figure 19. Roadway patching details, Tuttle Creek Dam Spillway Bridge, 1987

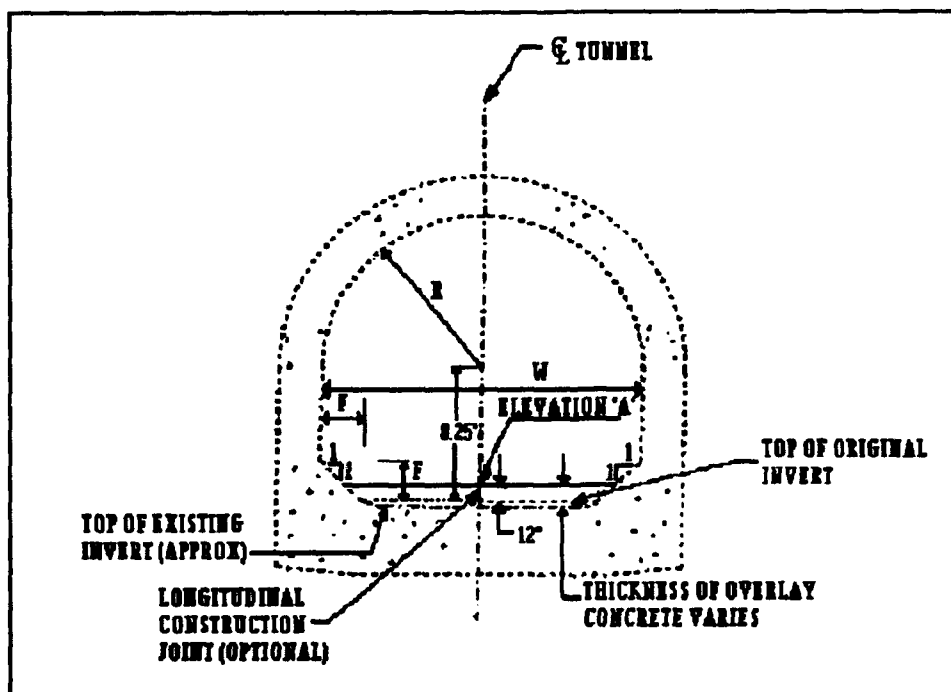
Figure 21. Typical tunnel section for overlay repair, Mojave River Forks Outlet Tunnel, 1990

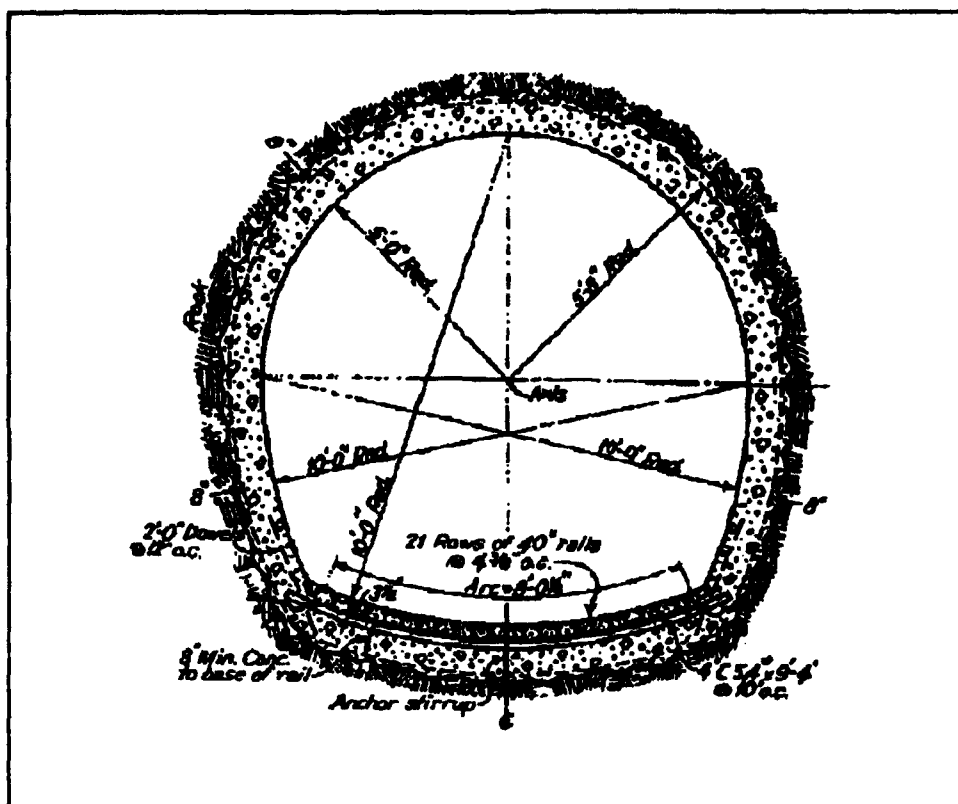
Most of the steel armor rails, except for those along the very edges of the invert, had been lost or removed over time due to erosion of protecting

Figure 22. Sketch of tunnel floor overlay, Lowell Creek Dam Diversion Tunnel, 1991

concrete. In many places, the original, 8-in. (203-mm) thick concrete floor was completely scoured out.

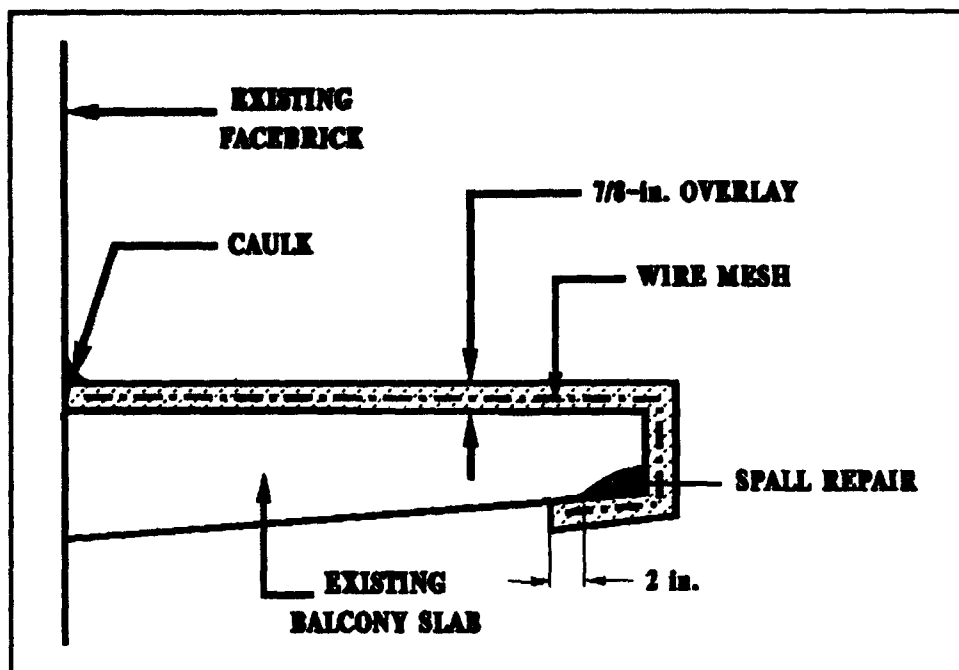
Mortar was placed onto mesh sheets on top of the balcony floors and then vibrated thoroughly. Surface was screeded at a fixed level to provide a minimum cover of 3/16 in. (5 mm) above mesh. The vertical and underside faces of balcony floors were formed and mortar placed and vibrated. All placing and finishing was specified to be completed within about 20 min of batching. The mortar was wet cured for 48 hr and opened for use after 24 hr of dry curing. A sketch of the overlay is shown in Figure 25, and the completed repair is shown in Figure 26.

Figure 25. Sketch of overlay repair to apartment balconies, Guelph, Ontario, Canada, 1992

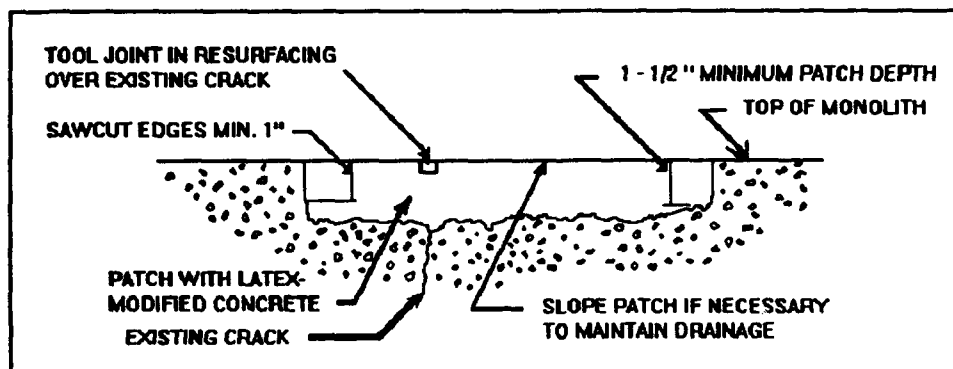
In 1990 and 1991, portions of the top surfaces of the lock walls and guide walls were resurfaced or patched with latex-modified concrete. The bid specifications called for a styrene-butadiene latex; however, in the submittal phase, an acrylic latex (SikaLatex, manufactured by Sika Corporation) was approved as a substitute. The perimeter of damage was specified to be saw cut a minimum of 1-in (25-mm) deep, and the concrete within was removed to a depth of 1-1/2 in. (38 mm). Control joints were specified to be tooled in overlay above remaining cracks in surface of concrete after removal (Figure 27).

Figure 27. Typical surface repair, Mississippi River Lock 3, 1991

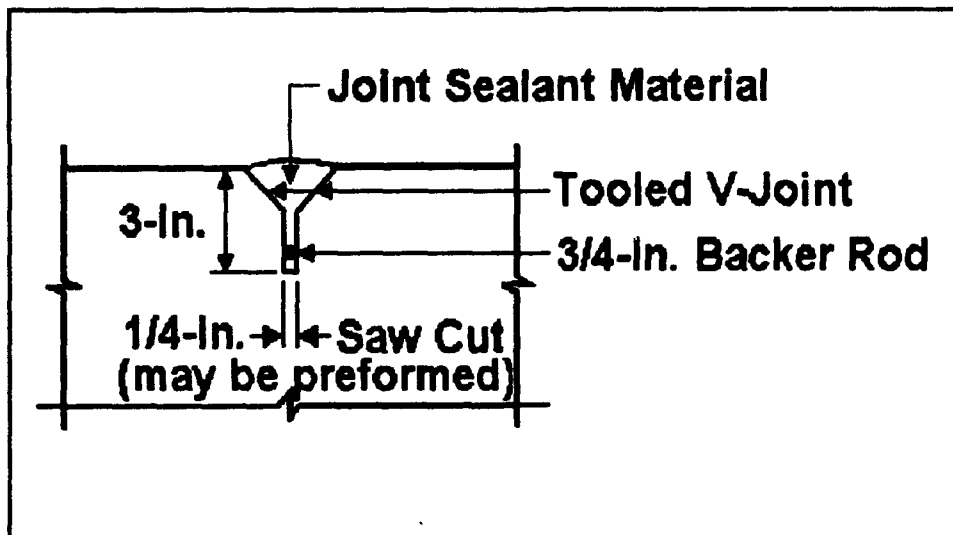
Figure 42. Details of dummy joint, Dashields Locks, 1989

The metal inserts were favored by field personnel over saw cutting. Details of dummy joints are illustrated in Figure 42. Note that the tooled V-joint is over exaggerated in this detail.
