**US Army Corps  
of Engineers**  
Waterways Experiment  
Station

August 1994

*Repair, Evaluation, Maintenance, and Rehabilitation Research Program*

## **Proceedings of REMR Workshop on Levee Rehabilitation**

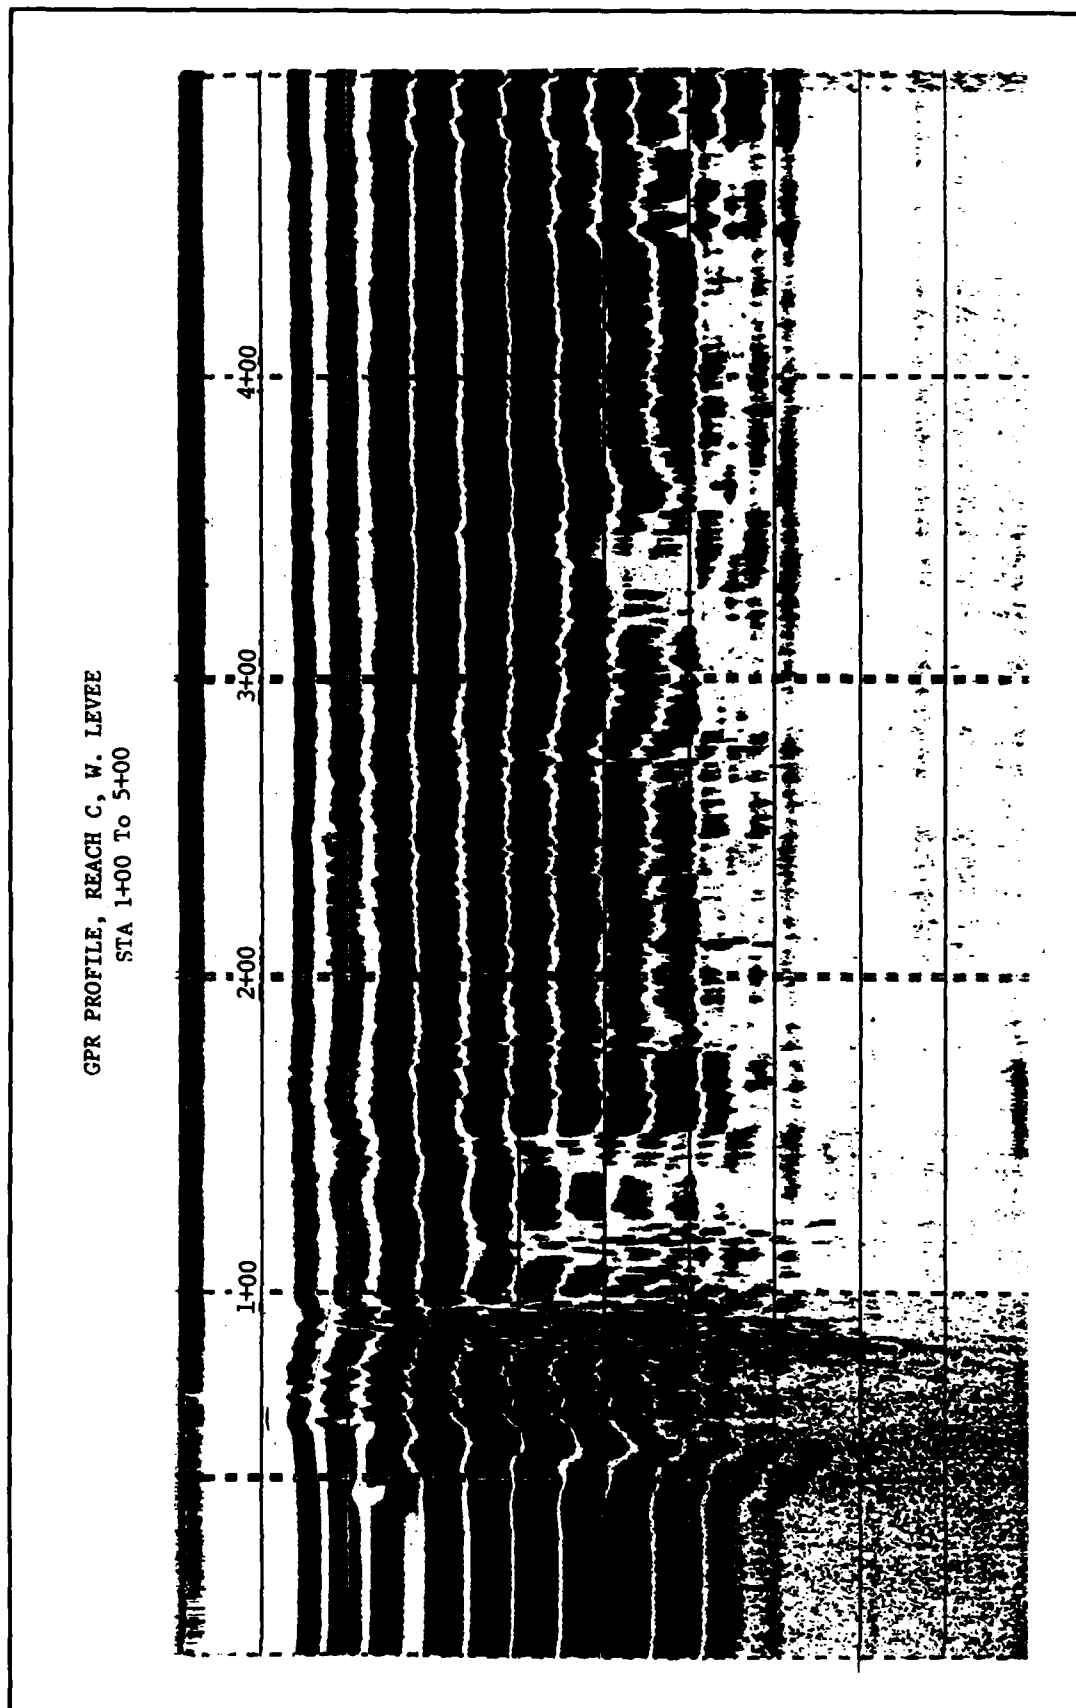
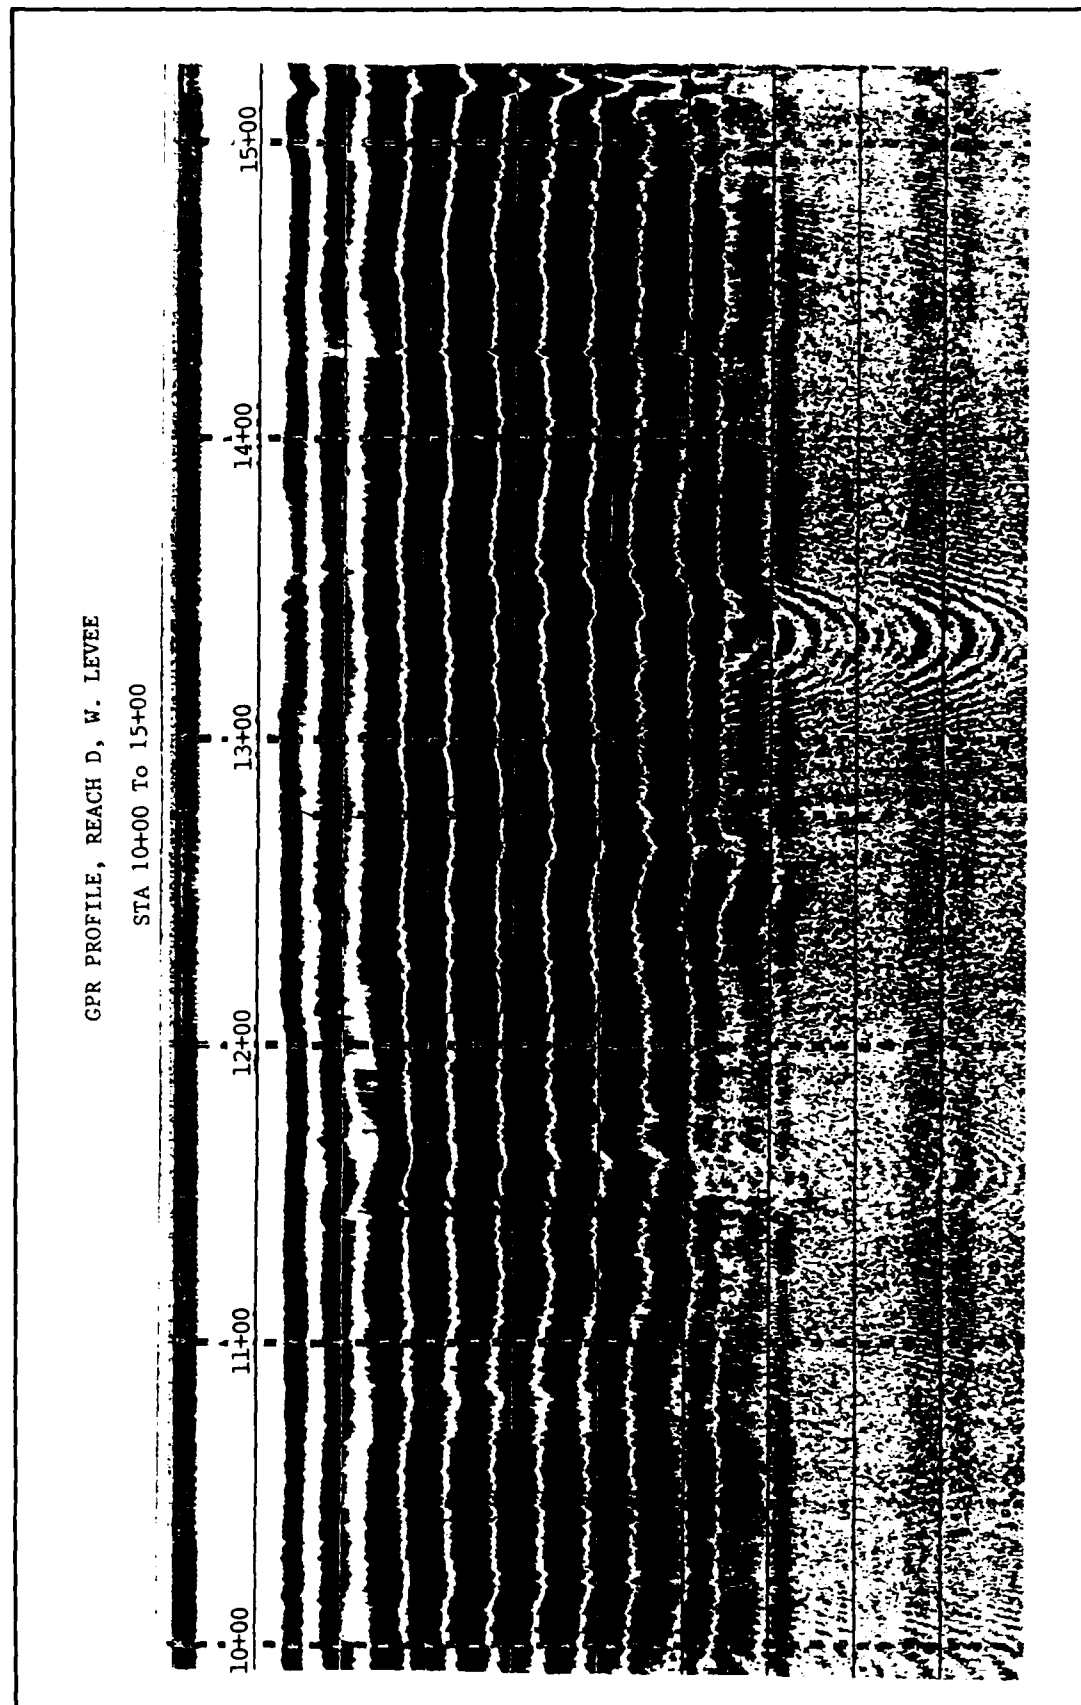
Figure 12. San Lorenzo River, sample GPR record, repaired levee, 300 Mhz, 60 nsec record

Figure 13. San Lorenzo River, sample GPR record, repaired levee, 300 Mhz

The results of the GPR records obtained along the San Lorenzo River levees are similar to those obtained along the Pajaro River levees. Approximately 18,000 lin ft of record were obtained along the entire levee system in Santa Cruz, California.

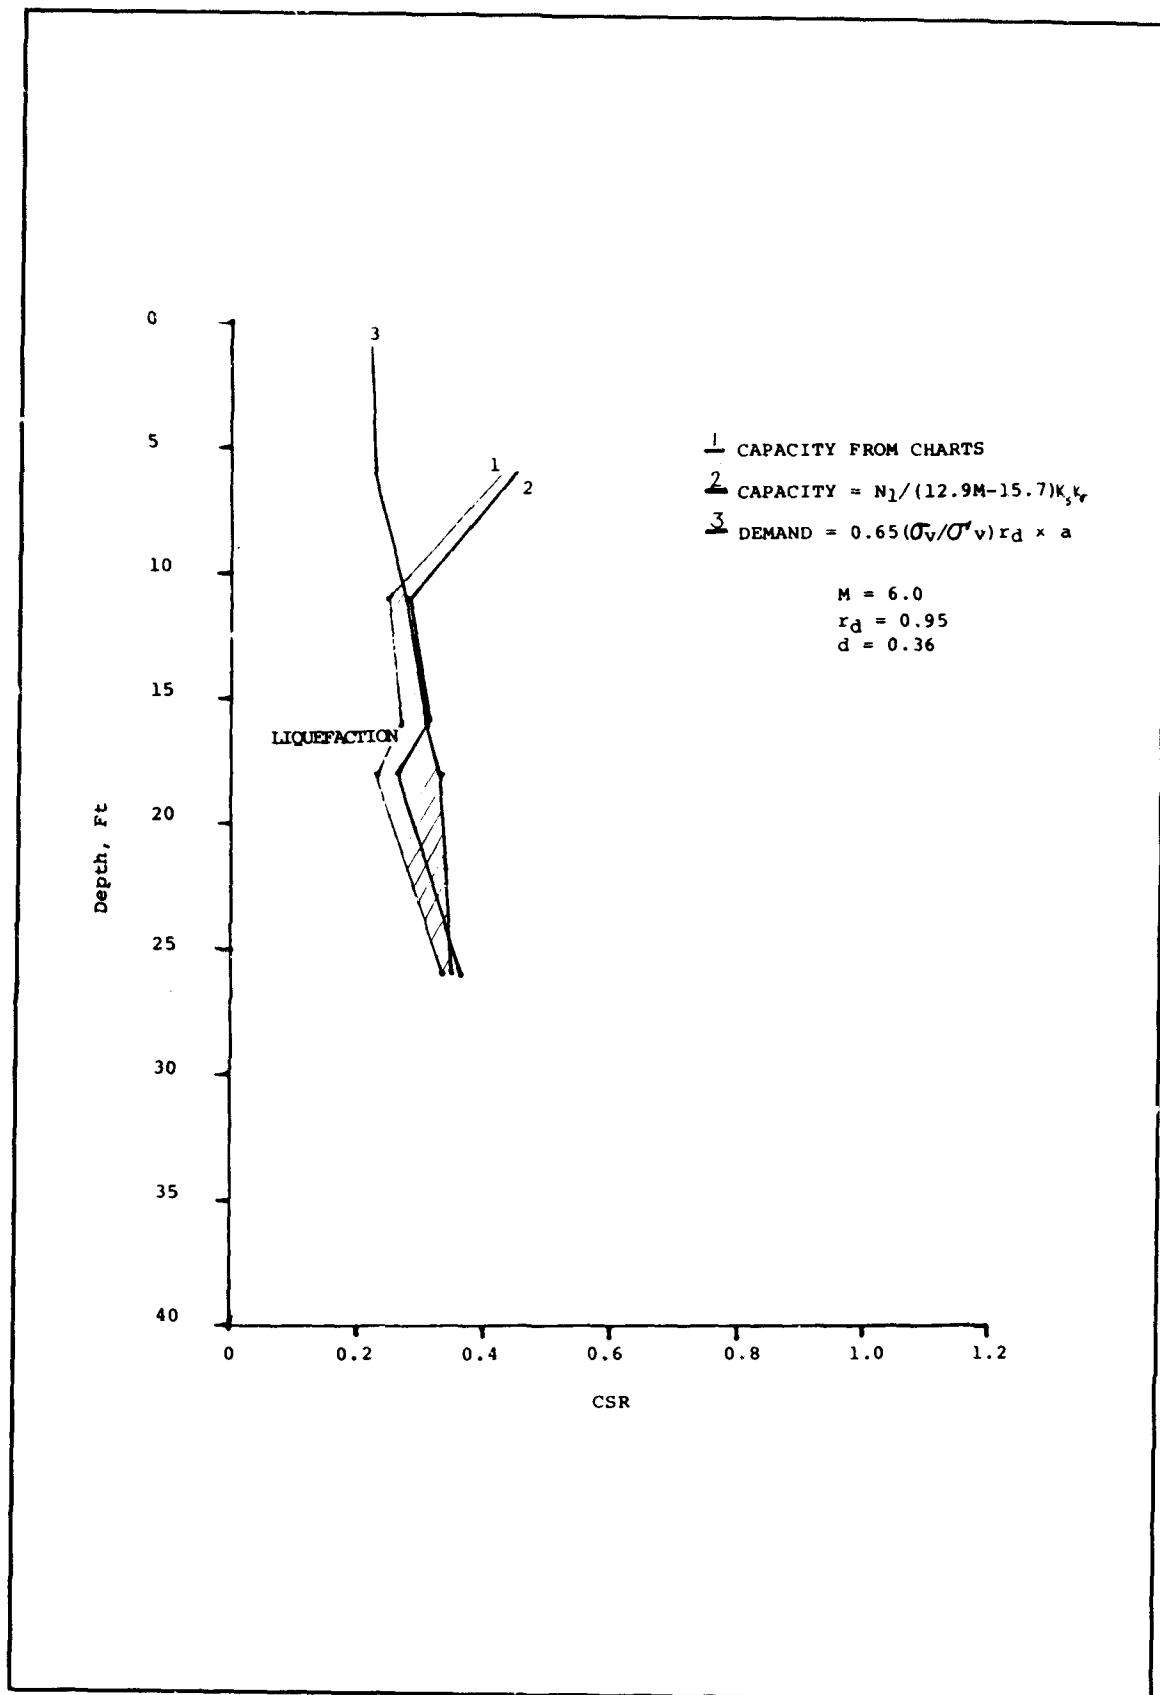
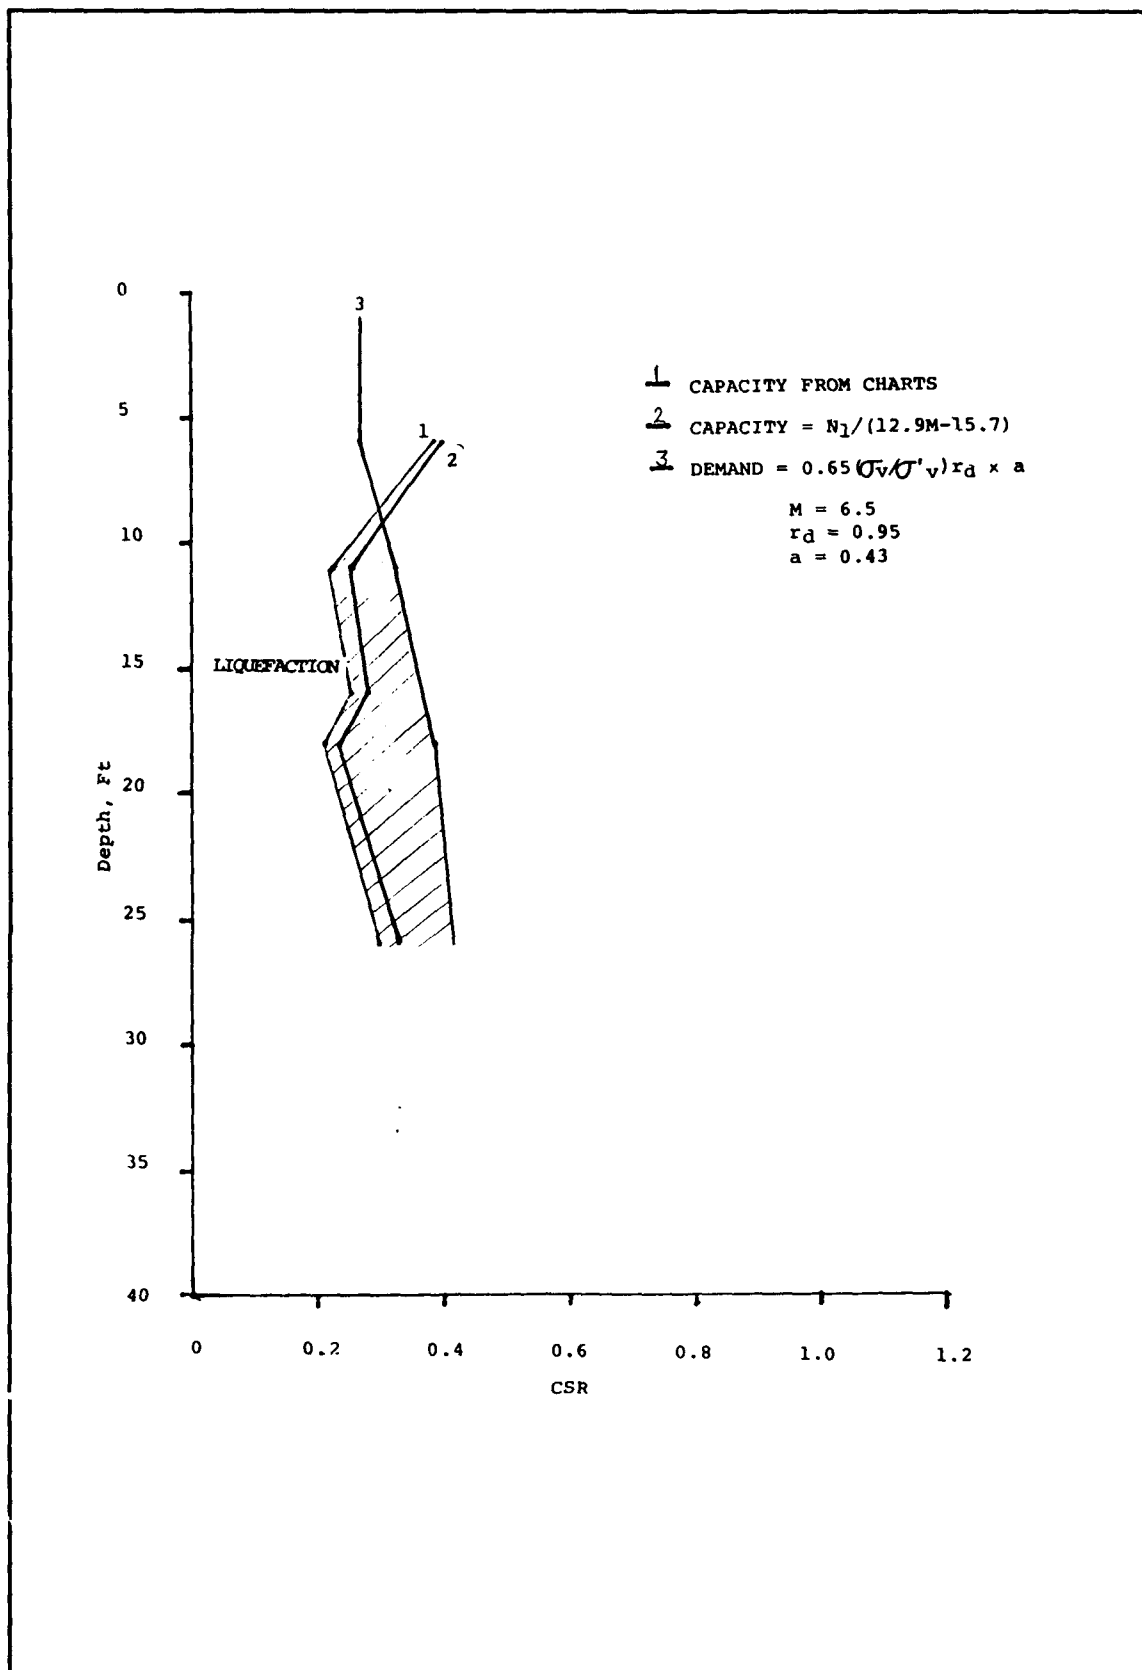
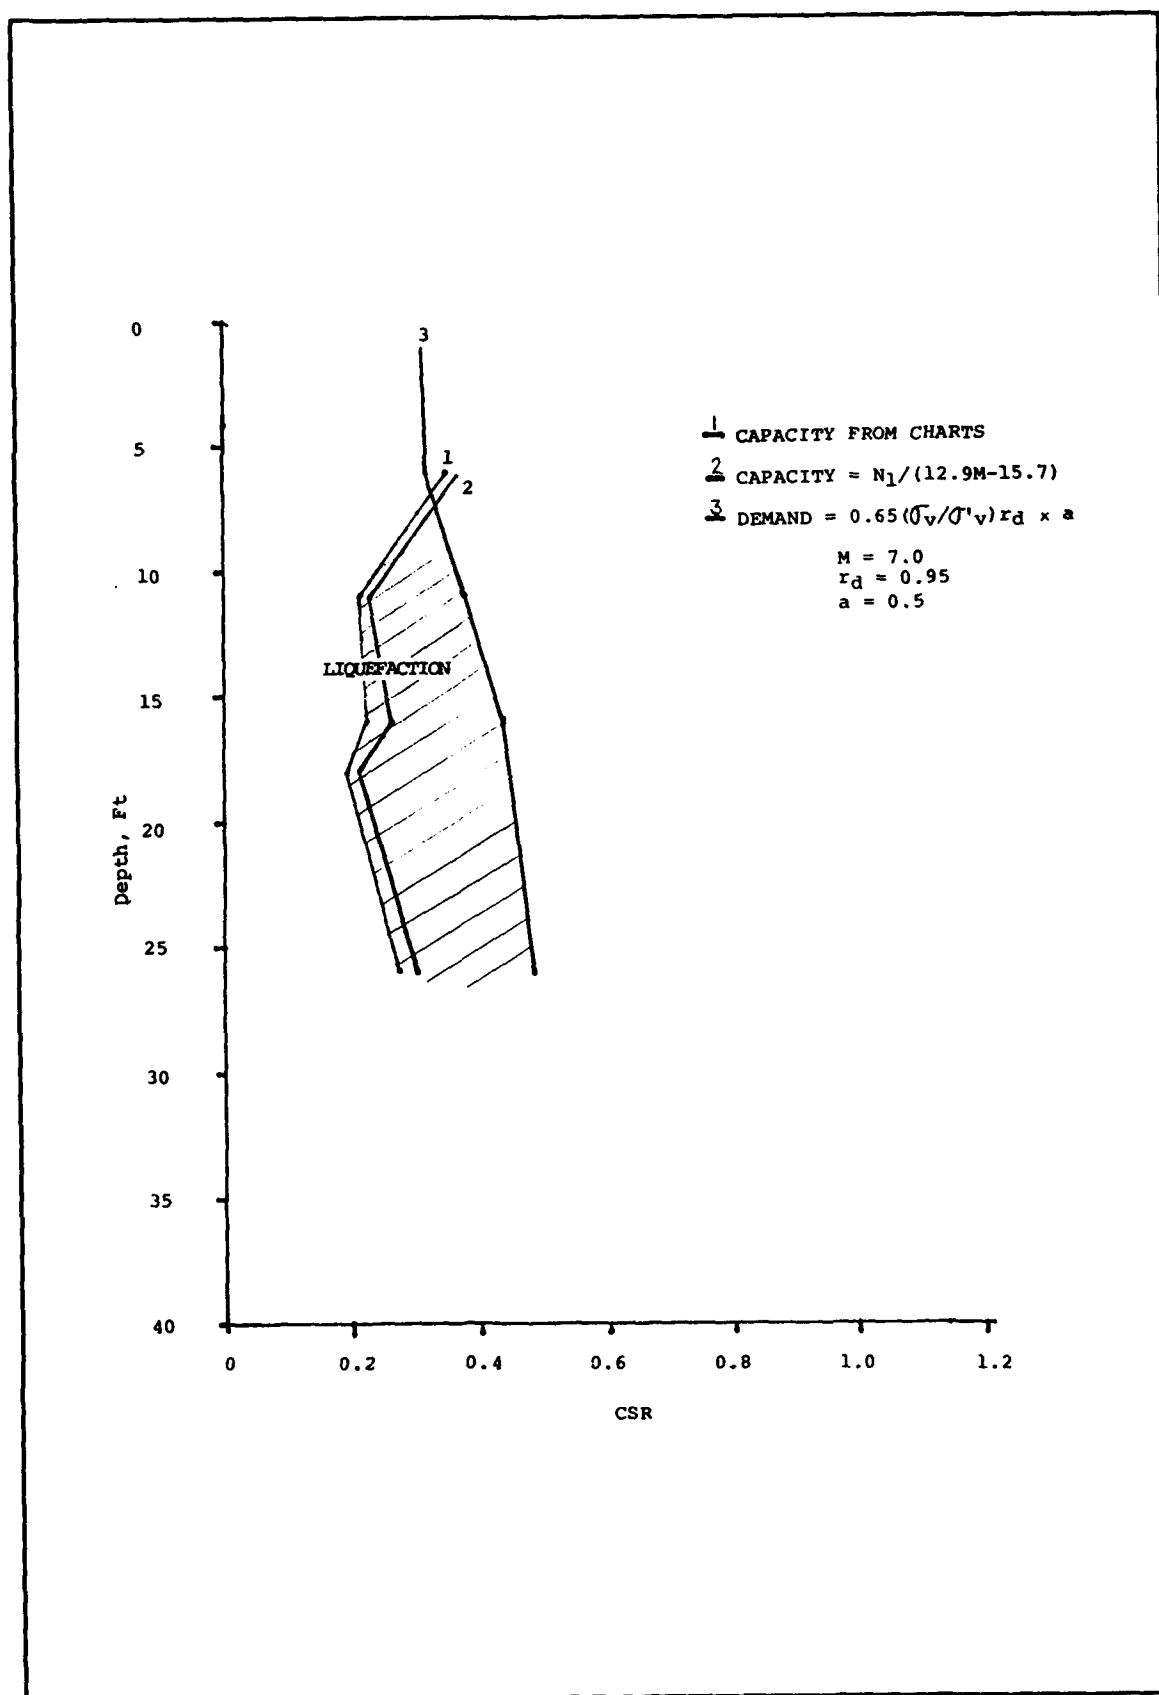
maximum ground accelerations of 0.36, 0.43, 0.5 g's at the site were used in the analyses. The reaches are shown in Figure 2. The typical cross section used for Reach A is shown in Figure 19. Plots showing the results of the analyses are shown in Figures 20 through 22 for Reach A. The plots show the results of the analyses for column B through the top of the levee. Data were obtained only through the top of the levee; therefore, the plotted results are based on measured field data. The accelerations used are based on a seismic assessment of the area.

Figure 20. Liquefaction assessment, east levee, reach a, boring SL-7-90, column B

Figure 21. Liquefaction assessment, east levee, reach a, boring SL-7-90, column B

Figure 22. Liquefaction assessment, east levee, reach a, boring SL-7-90, column B

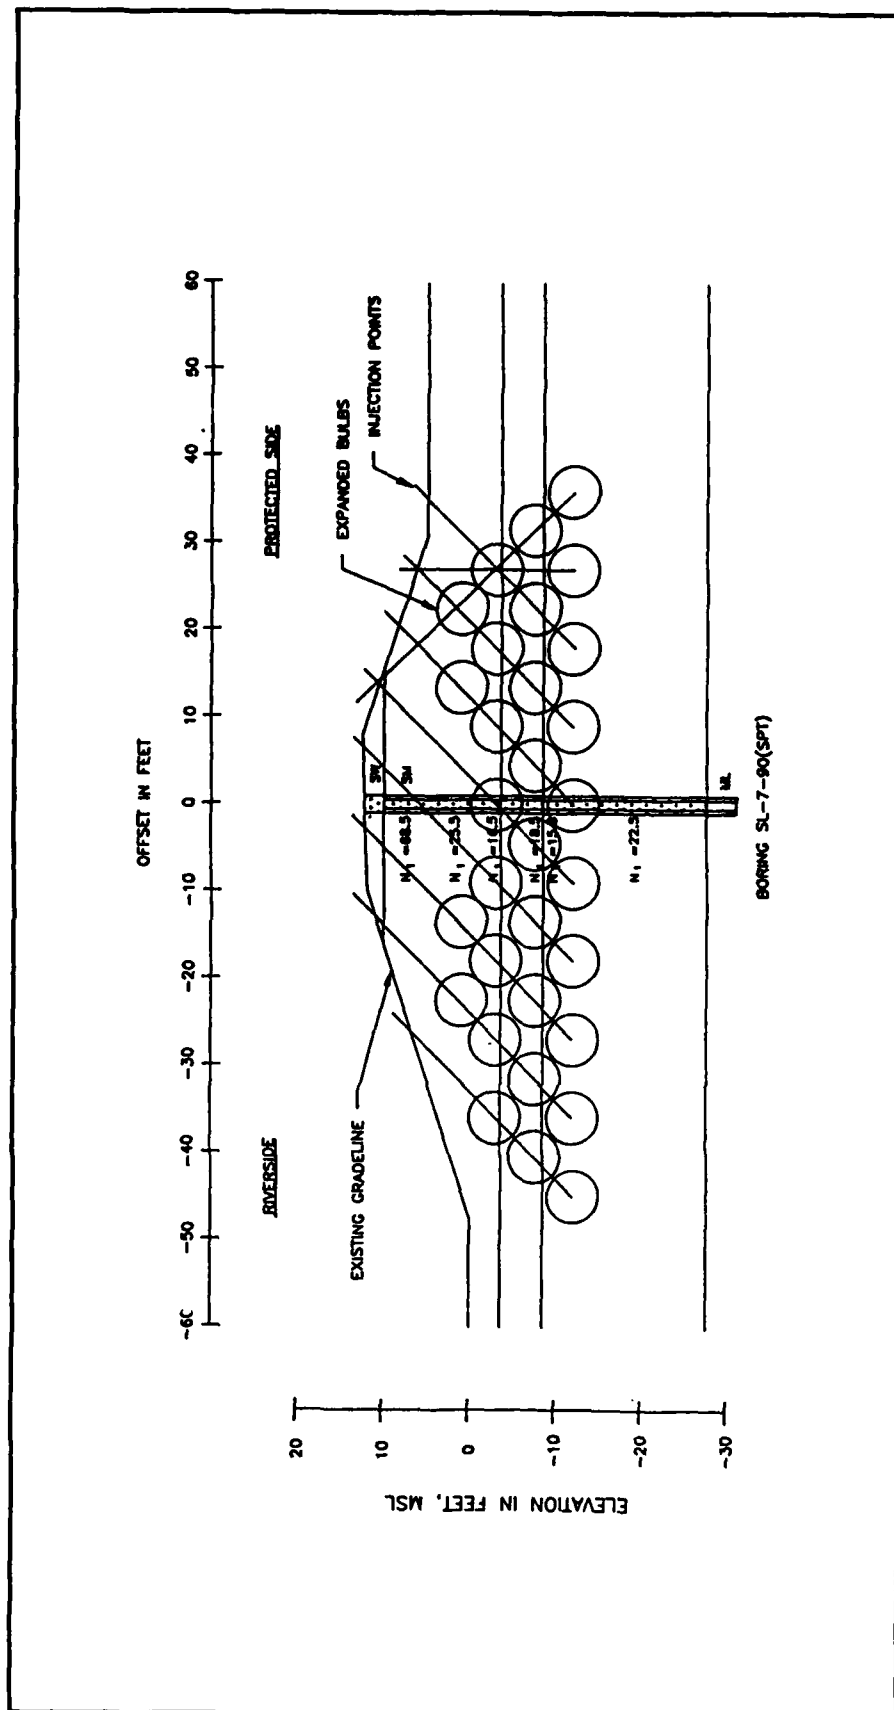
Figure 24. Compaction grouting conceptual design

A highly viscous soil, cement, and water, pressurized grout is used to radially compress or compact the surrounding soil. Grout pipes are installed and compaction grouting done a predetermined pattern and depth. Figure 24 shows a conceptual design of this scheme.

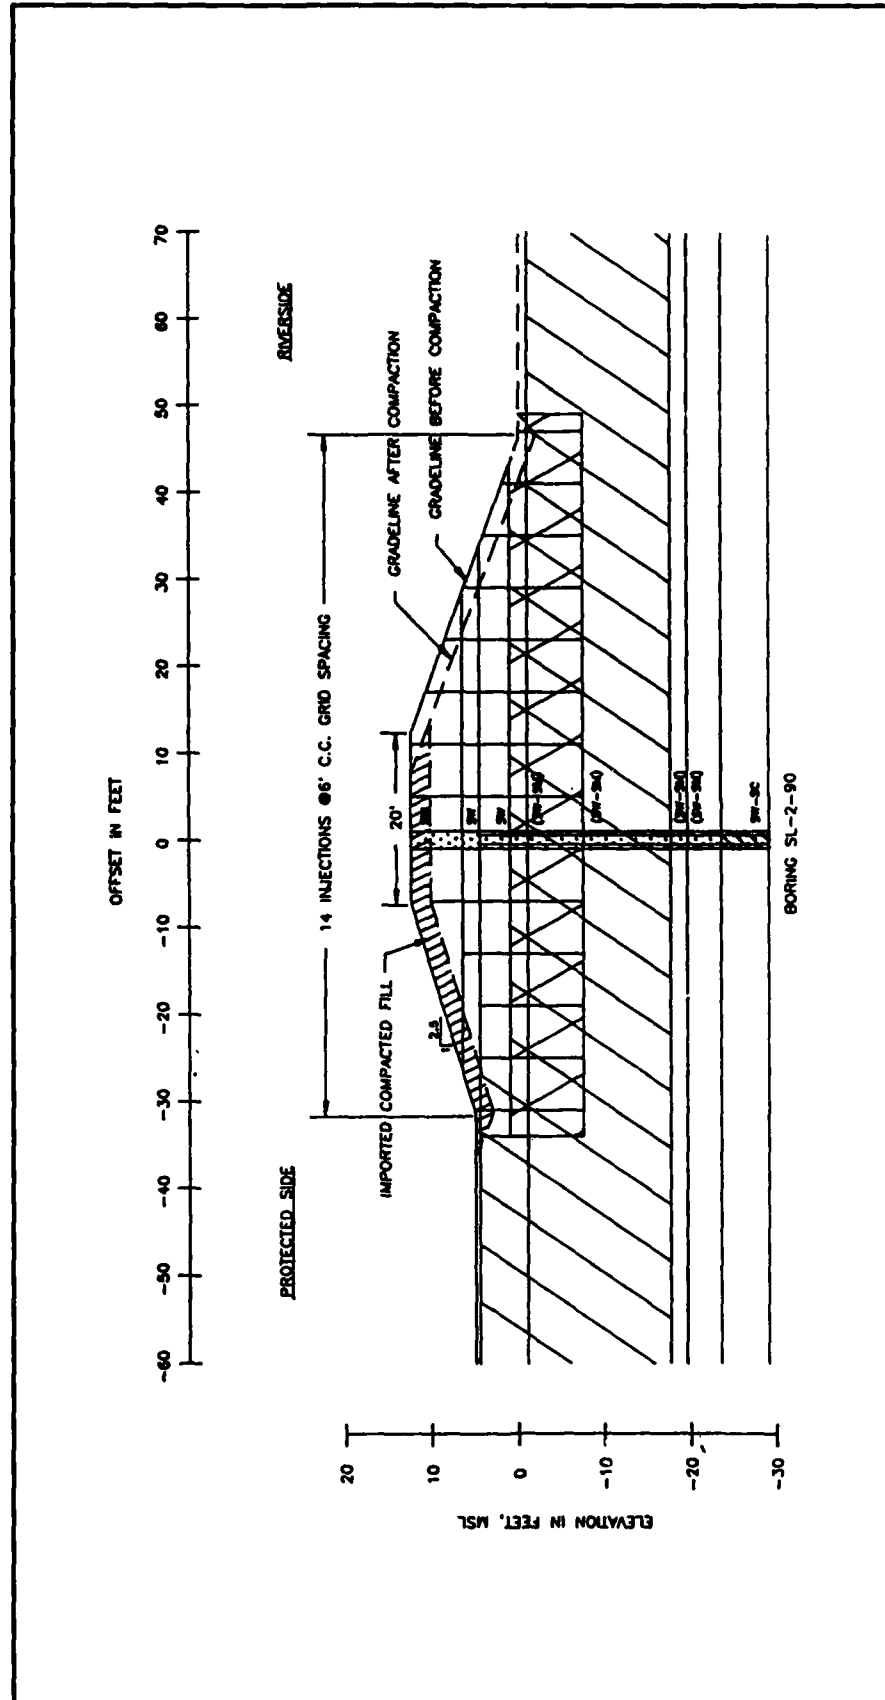
Figure 25. Vibrocompaction conceptual design

This method involves the rearrangement of soil particles into a denser configuration by use of powerful vibrators. The probes are inserted into the ground to the bottom of the soil layer which is to be densified. The probes are inserted and vibration performed in a predetermined pattern. A strong vibration is applied as the probes are slowly withdrawn. Preliminary analysis indicate that the probes should be inserted and vibration performed on a 6-ft center to center grid spacing. A conceptual design is shown in Figure 25.

Liquefiable foundation materials were found throughout the project site. There is a reasonable chance of an earthquake occurring on the San Francisco Peninsula segment of the San Andreas fault and causing liquefaction at the site. There are also other faults that have a high potential of causing liquefaction at the site. These faults include the Zayante-Vergeles Fault, the San Gregorio-Seal Cove Fault and the Monterey Bay fault zone. The Monterey Bay fault zone and the Zayante-Vergeles fault are capable of earthquakes with a return period of approximately 18 years. Magnitude 6 earthquakes on these faults can cause liquefaction at the project site and possible damage to the levees. The Zayante-Vergeles fault and the San Gregorio-Seal Cove fault are capable of magnitude 6.5 earthquakes with a return period of approximately 43 to 53 years. These earthquakes can liquefy the site and possibly damage the levees. The liquefiable foundation materials need to be strengthened in order to prevent future damage to the levee and structures from liquefaction.

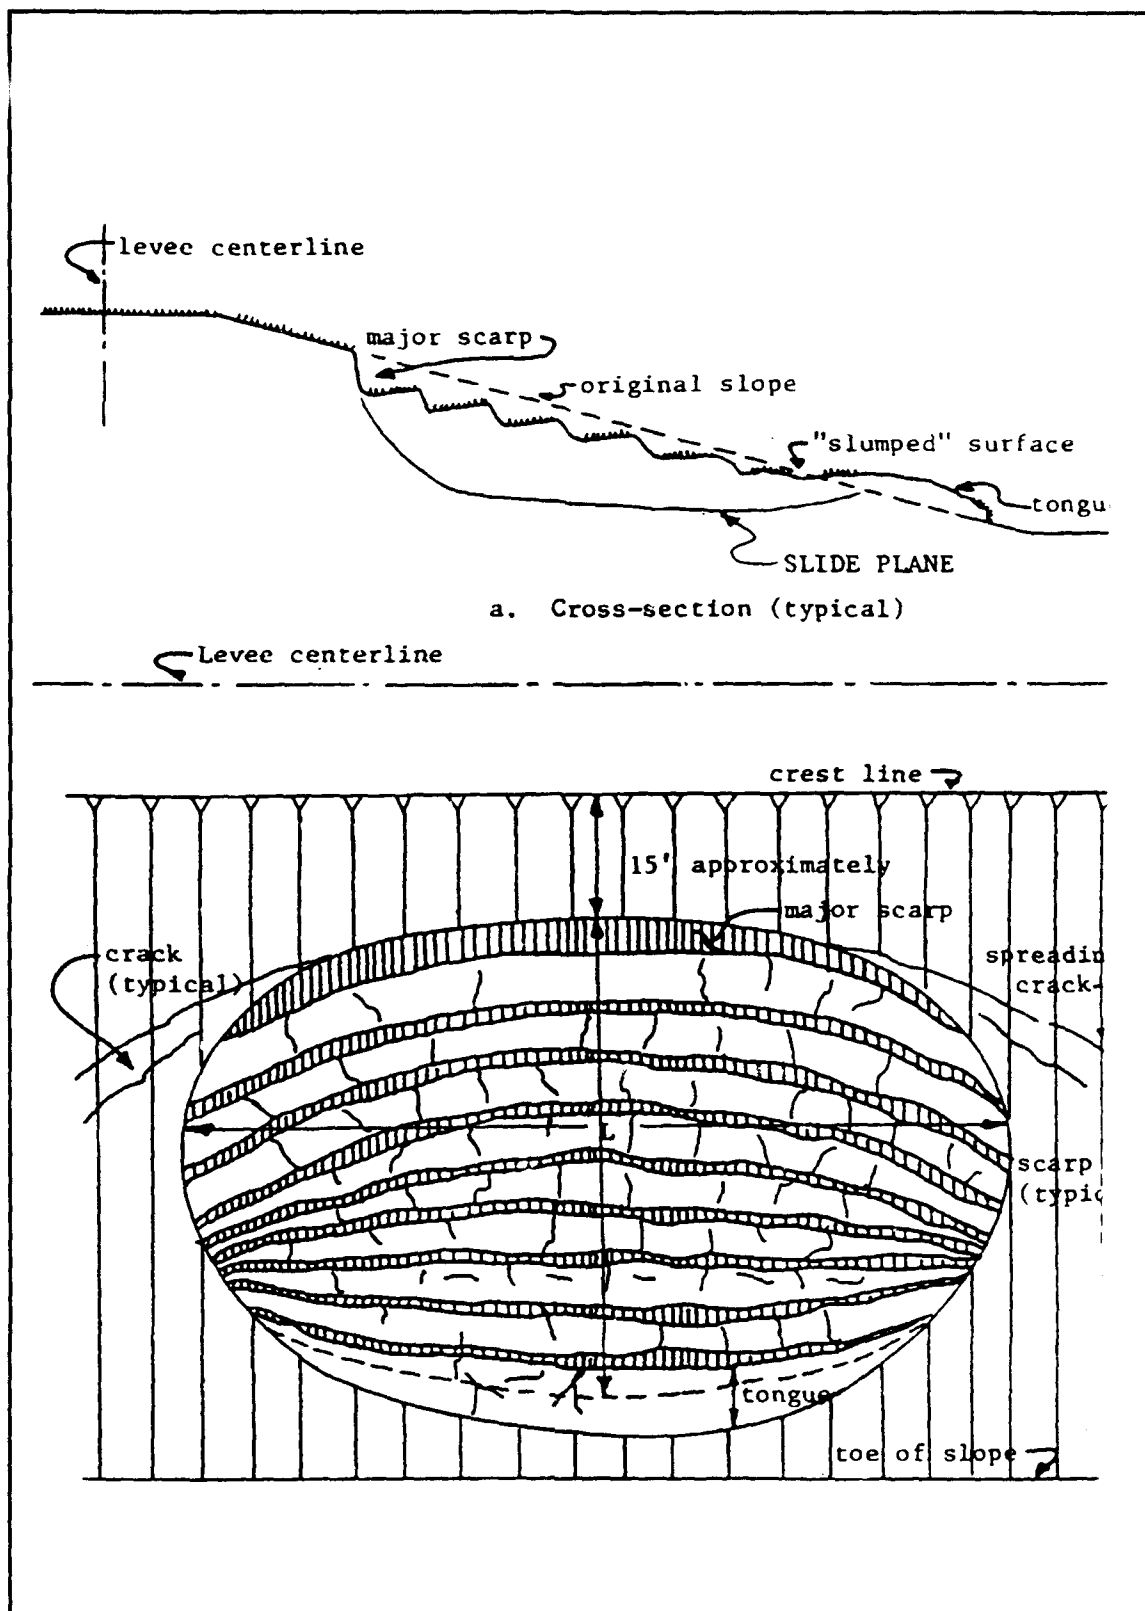
The typical slough slide usually develops in the riverside slope which is normally steeper than the landside slope. Most riverside slopes are a 1V on 4H slope. The typical slide can be defined as a shallow slide whose maximum depth to the slip plane varies between 4 and 8 ft and whose failure is triggered by heavy rainfall after an extended period of weathering. Weathering results from desiccation and causes strains to be induced during the seasonal shrinking and swelling process. The zone of weathering that develops usually extends to a depth of 5 to 7 ft. The process and its effect on slide development is described in detail later in this paper. The slides occur primarily between the riverside crown and a point midway down the slope and range in length from 100 to 300 ft along the levee. A typical slide is shown in section and plan in Figure 1.

Figure 1. Typical slough slide: (a) cross section; (b) plan view

Prior to the early 1980's, the method of repairing these slides normally consisted of excavating the failed material and rebuilding the slopes on a flatter angle with new material from a borrow source. In some cases a berm was used to repair the slides. Although not required by the 1947 Mississippi River Commission Levee Code, it had become the policy of the Vicksburg District to construct a standard 40-ft-wide riverside buttress berm on all levees 25 ft or greater in height. This policy was unofficially adopted in 1962 in an effort to prevent slough slides. In the late 1960's and 1970's, the slides seemed to become more numerous. Also, obtaining rights-of-way and additional sources of borrow was becoming more and more costly and time consuming. It was clear that a more cost-effective method of repairing the slides was needed.

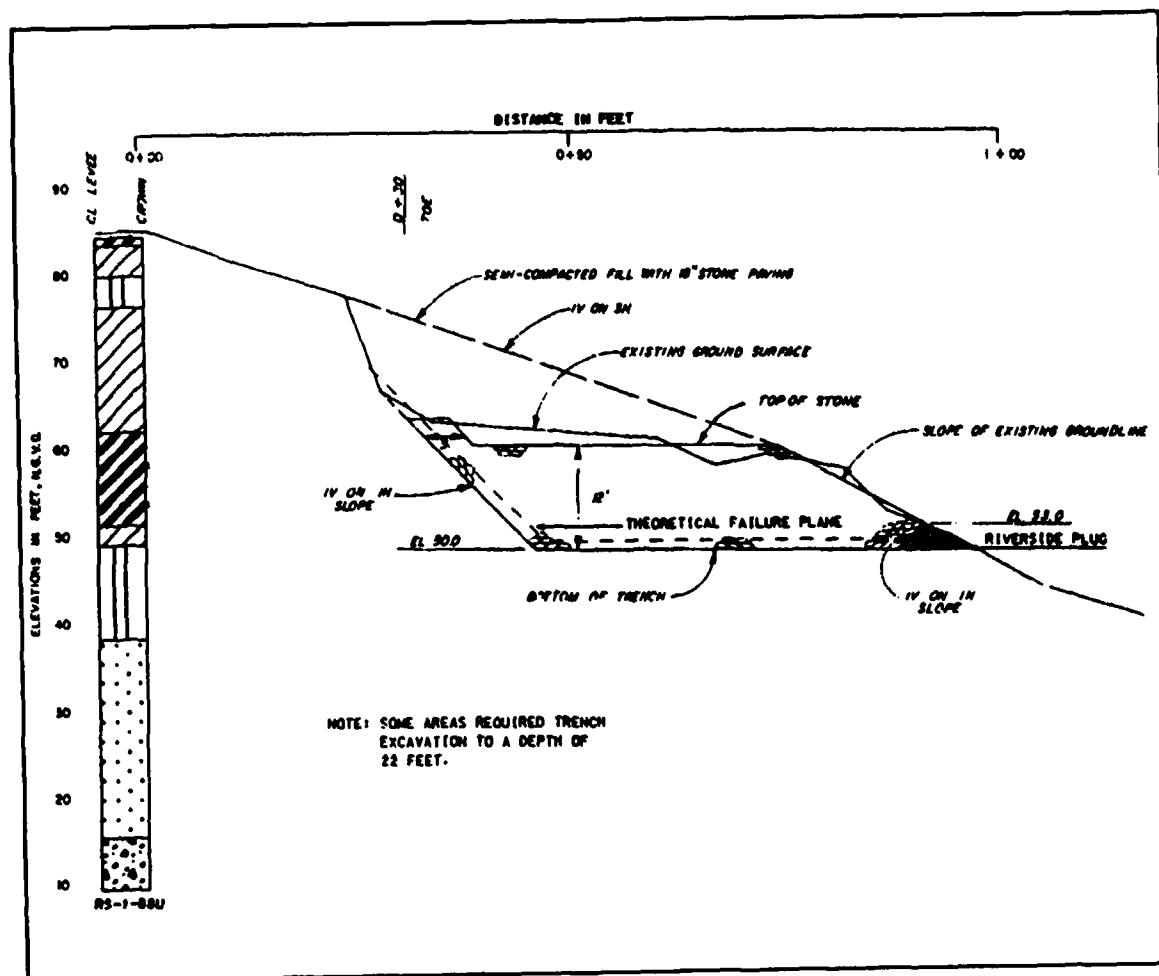
*Exploration program.* The investigation of the soil conditions at the site consisted of three undisturbed borings taken in September 1983 and two undisturbed borings taken in June 1988. The borings indicated a silt layer of the natural levee deposit and a backswamp clay deposit consisting of a layer of very stiff clay (CL) overlying a medium to very stiff clay (CH). The generalized soil and slide profile is presented in Figure 2. The borings which were made through the existing levee are shown in plan on Figure 3.

*Conditions contributing to slide.* The site investigations in 1983 and 1988, cross sections of the area taken on regular intervals and familiarity with the construction problems associated with the 1984-85 repair led to the conclusions that the initial triggering mechanism for the slide was the steepening of the river bank due to erosion of the silty sand substratum. This in turn caused sliding to occur in the backswamp clays. The initial attempt to stabilize the slide using the stone dike and sand berm was to consist of building a stone dike to elevation 62 and rebuilding the slope to a 1V on 3H with sand fill. The sand fill would be protected from scour with engineering fabric and riprap. In November 1984, high water conditions existed at the construction site. The contractor chose to place the sand fill prior to completion of the stone dike. The weight of the additional sand fill caused the slide to experience further movement in the backswamp clay. The contract was modified to ensure the stone dike was completed before any more sand fill was placed. The modification also allowed placement of the riprap in other than dry conditions which was precluded in the original contract. The work was completed in January 1985 and the section continued to experience some movement. This movement was assumed to be occurring along a remolded slip plane that existed in the backswamp clay. The movement was more than strain cracking, but did not seem to be endangering the levee. In the summer of 1988, the movement had reached the point that it was considered to be an endangerment to the levee. It was also clear at this time that the slip plane was located in the backswamp clay and that further attempts to stabilize the slide must plan for this condition.

Figure 2. Typical section of slide area

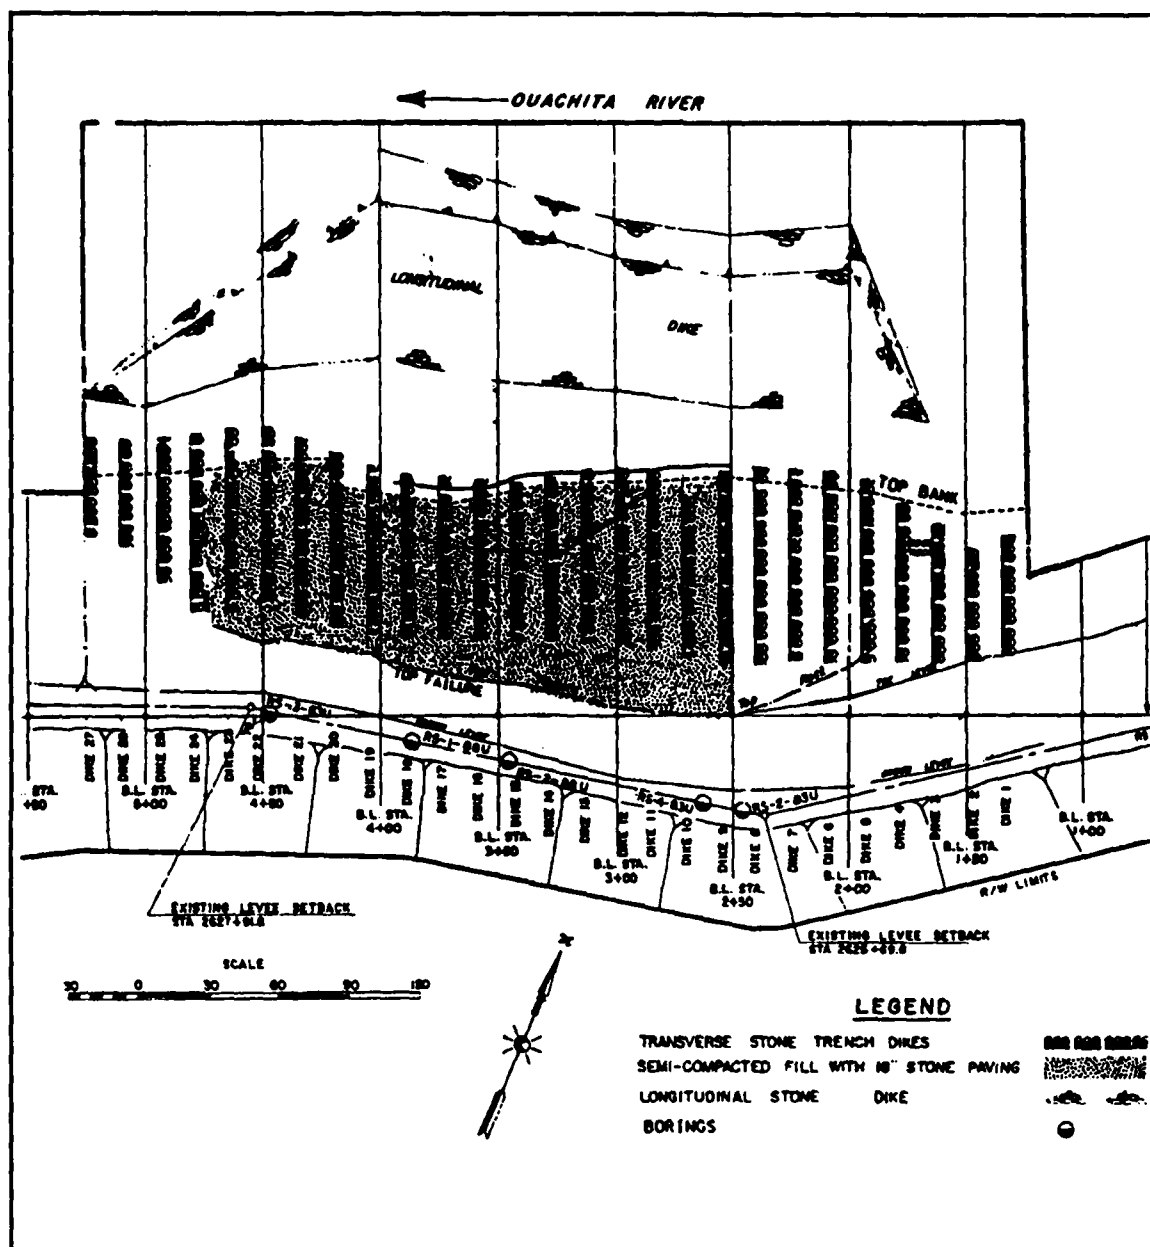
Figure 3. Site plan

Construction of the stone-fill trench stabilization for the U.S. Army Engineer District, Vicksburg, in December 1988 was accomplished by contract. The contract required that 27 transverse stone-fill trenches (Figure 3) be constructed beginning downstream and proceeding upstream. The work area was within the Columbia Lock and Dam Pool which maintained a minimum river of 52 ft NGVD. Since the trenches were required to be excavated to elevation 50, a soil plug was left in place on the riverside of the trench, Figure 2. The trenches were constructed beginning at the riverside plug and proceeding landward toward the levee toe.

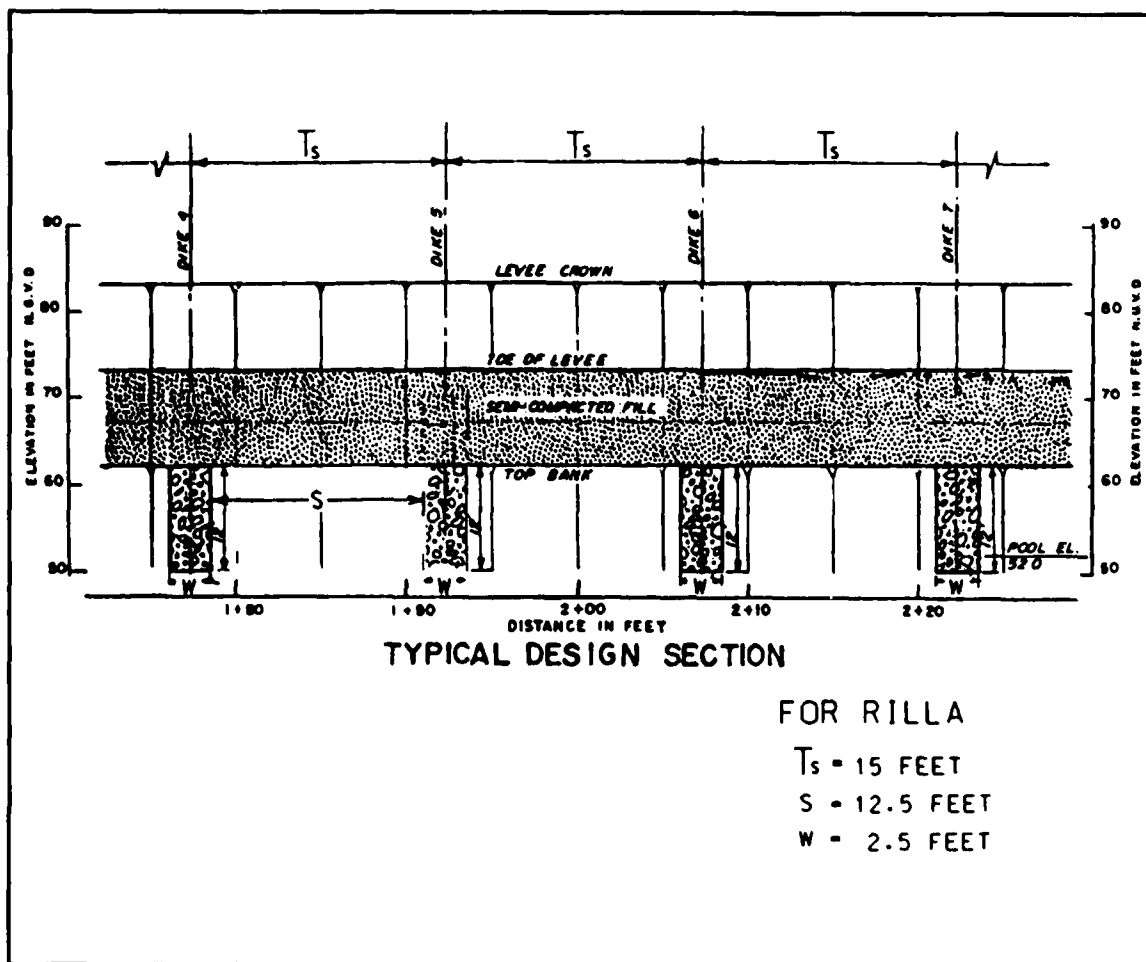
Figure 4. Typical design section

Solving equation 3 it was determined that a center to center trench spacing of 15 ft would provide the required average strength parameters of  $\phi' = 20^\circ$  and  $c' = 0$  psf. It should be noted that since arching of the soil should occur between the stone-fill trenches the actual factor of safety should be greater than 1.25. A typical design section is shown in Figure 4.
