TECHNICAL REPORT ARCCB-TR-94030

**FAILURE ANALYSIS OF 120-MM  
MORTAR BUSHINGS AND FIRING PINS**

KATHRYN E. NOLL

AUGUST 1994

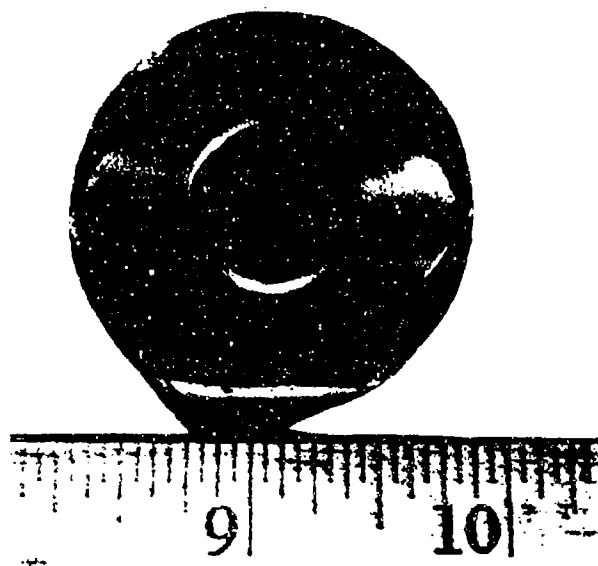
A visual examination was performed on the as-received firing pins and bushings in order to identify any significant features. Pins 1 and 2 displayed extensive damage toward the tip of the pin. Bushing 1 shown in the center of the bushing assembly in Figure 3 was also visibly damaged. The discoloration observed on the face of the bushing assembly is not considered unusual for components that have been subjected to firing tests. Pin 3 sustained minor damage (arrows, Figure 4), with the bushing assembly (Figure 5) displaying no visible damage to Bushing 2. The unfired pins (Pins 4, 5, and 6) were supplied for comparison with the fired pins. From the visual examination, there were no observable differences between the unfired U.S.-made and unfired Israeli-made firing pins.

Figure 5. Photograph of bushing assembly, as-received, with Bushing 2 located at the center.

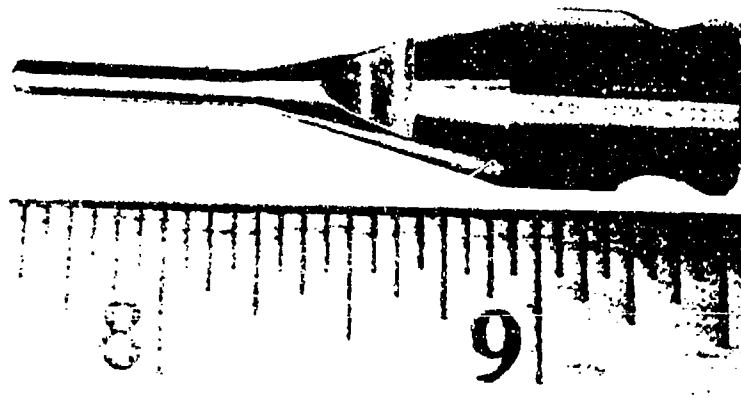
Figure 6. Photograph of Pin 4, as-received.

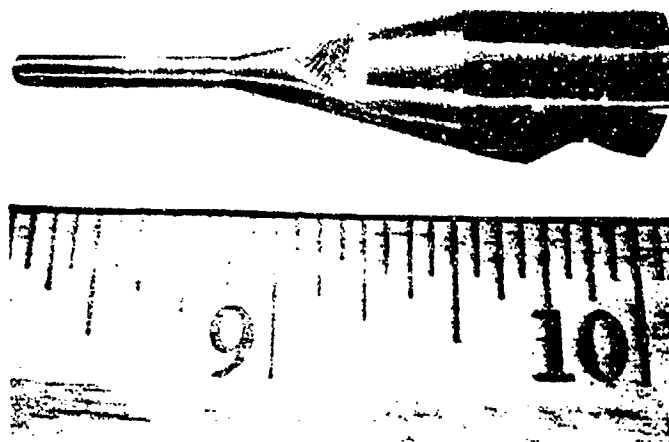
Figure 7. Photograph of Pin 5, as-received.

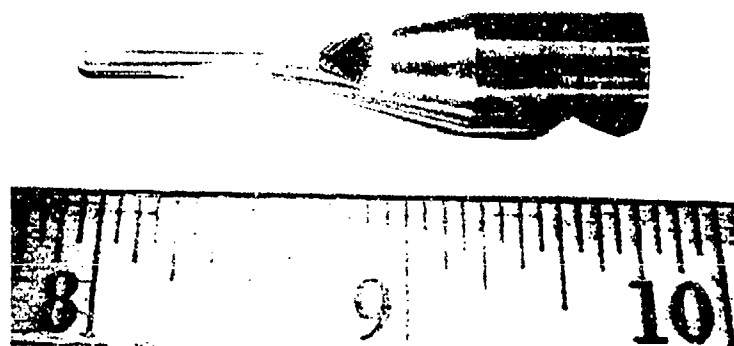
Figure 8. Photograph of Pin 6, as-received.

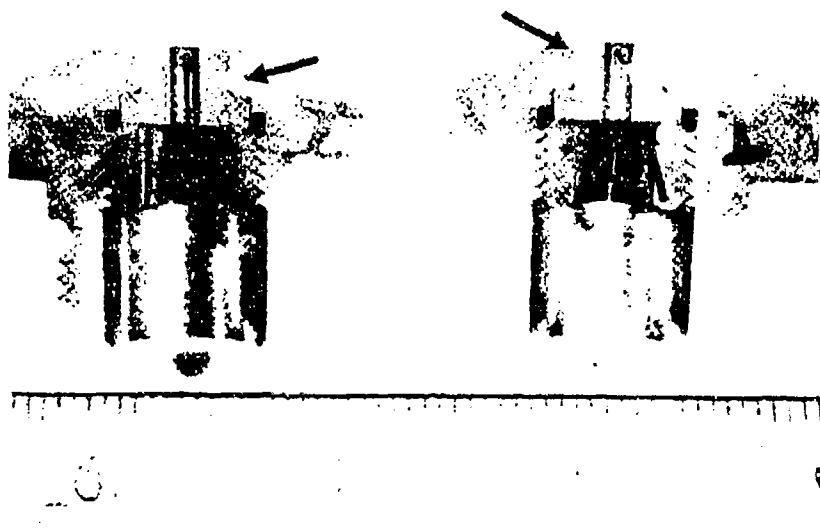
The bushing assemblies were then sectioned (Figure 10) and the bushings (arrows, Figure 10) were removed in order to further characterize the component. Overall photographs of the four bushings are shown in Figures 11 through 14. Bushing 1 sustained the more severe damage seen in Figure 11, with the inner diameter being affected down the entire length of the bushing. Bushing 2 experienced slight damage to the inner diameter of the bushing (Figure 12). Bushings 3 and 4 were supplied for comparison with the damaged bushings. From the visual examination, there were no observable differences between the proof-fired, U.S.-made and proof-fired, Israeli-made bushings (Figures 13 and 14, respectively).

Figure 10. Photograph of a sectioned bushing assembly, with arrows pointing to the tungsten carbide bushing.

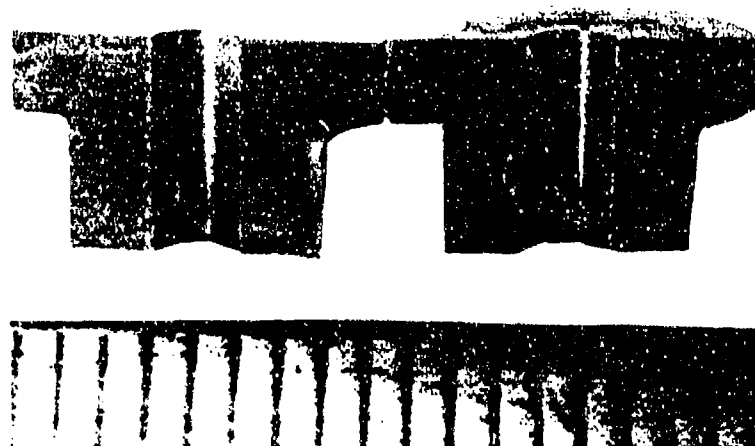
Figure 14. Longitudinal view of sectioned Bushing 4.

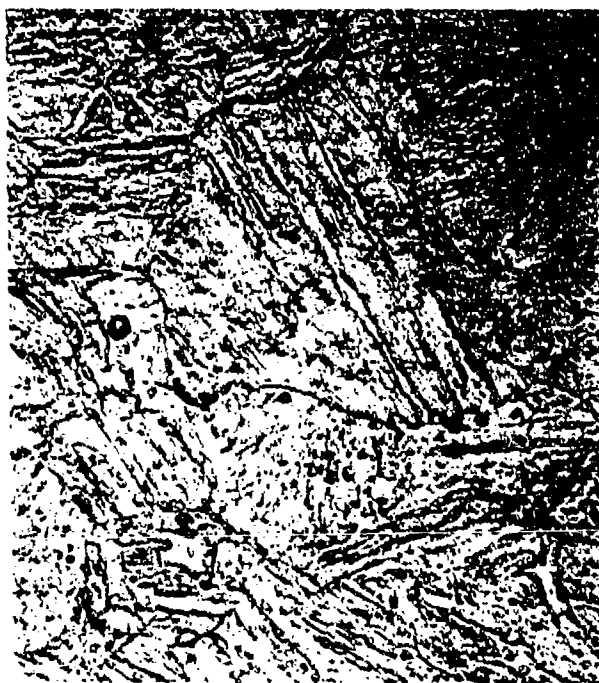
All six firing pins displayed similar microstructures in the bulk of the material. Figures 15 and 16 show representative photomicrographs of the firing pins in the as-polished and etched conditions, respectively. The microstructure shown in Figure 16 is representative of a properly solution heat treated and aged 17-4 PH stainless steel alloy.

Figure 10. Representative photomicrographs of 17-4 PH microstructure found in the bulk of firing pin material. Etched in equal amounts of HCl, HNO<sub>3</sub>, and H<sub>2</sub>O.

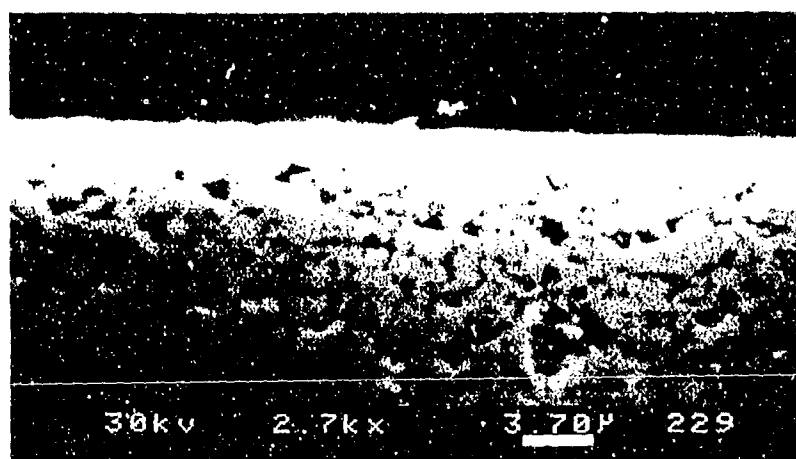
Figure 40. SEM micrograph showing a cross-sectional area of the inner diameter of Bushing 4, at 2700X.
