Technical Report REMR-CS-46  
March 1995

## **Repair and Maintenance of Masonry Structures: Case Histories**

*by Edward F. O'Neil*

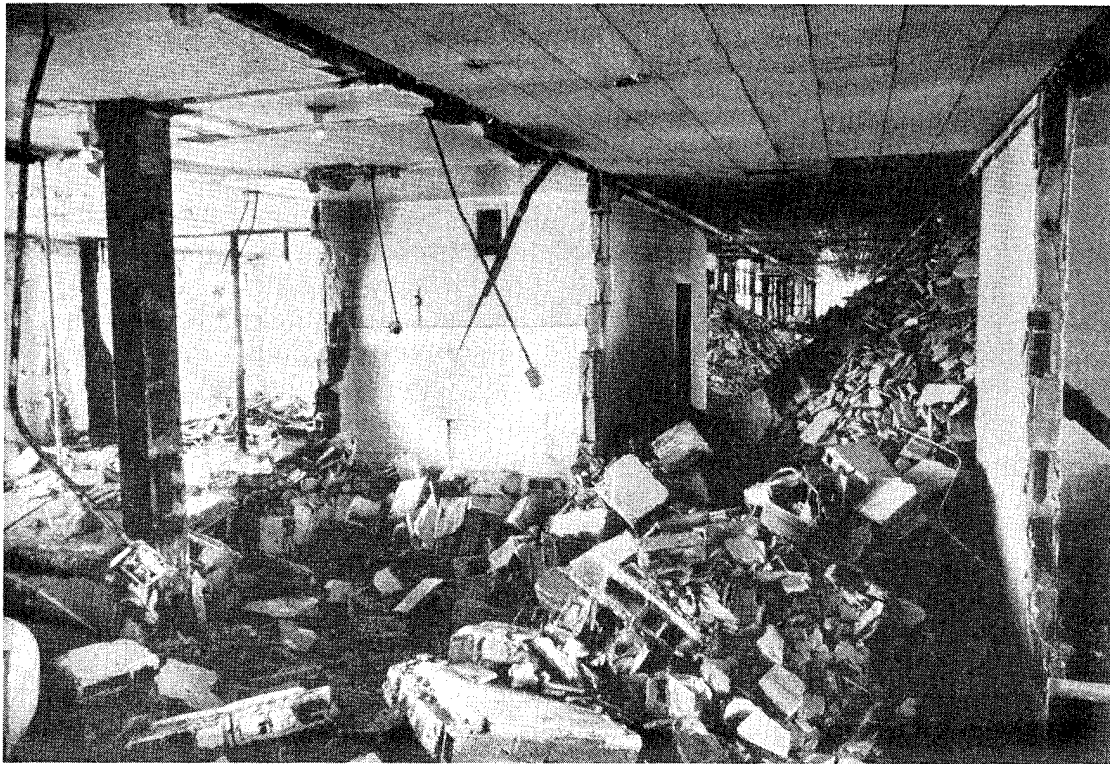
In the initial efforts to renovate the building, many schemes were tried to remodel the existing rooms and corridors for apartment use. It soon became apparent that the existing scheme of rooms would not provide the number of units necessary to financially carry the project. This, coupled with the fact that the interior walls were constructed of hollow clay tile, led to an early decision to demolish all interior walls from the underside of the roof to the basement. Exceptions to this decision were the concrete floors, the exterior walls and the historical rooms. Removal of the hollow clay tile partitions eliminated substantial earthquake hazard, since they will shatter in an

earthquake. Figure 47 shows these tiles during the 1979 renovations. This also reduced the total mass of the building thus lowering the effective earthquake inertia forces.

Figure 47. Clay tile partition rubble from 1979 renovations

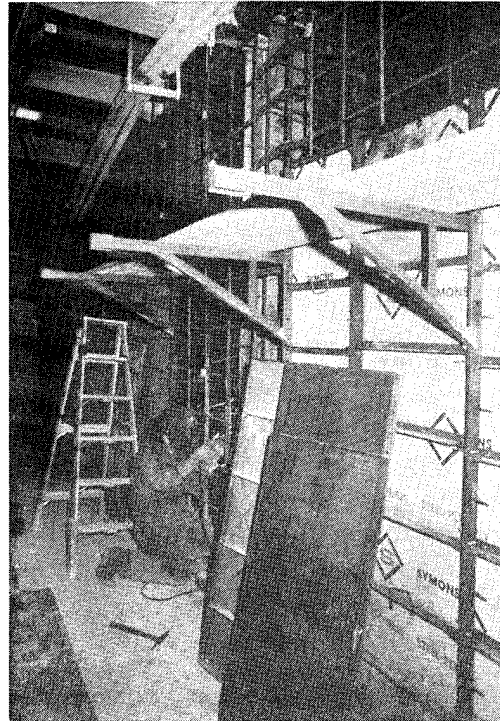
Figure 50. Forming for interior shear walls

Reinforcement of the exterior brick walls was important to the performance of the building in an earthquake, but it was only part of the story. To provide additional strength and ductility to resist major earthquakes, a new system of reinforced concrete shear walls was designed to be added around the stair and elevator shafts (Figure 50). This system, well distributed around the building in the upper stories, was supplemented by additional shear walls from the second floor down to the foundations.

Several functions are served by this system: the needed seismic shear resistance was provided by the new walls, the shafts (stairwell, elevator, etc.) would remain accessible and operable (free of debris that would result from use of a more brittle material), and a 4-hr fire-resistive environment in the shafts was provided.

The new shear wall systems also worked well within the confines of the existing structural framing system. The walls were tied into steel floor beams which served as collectors to deliver diaphragm forces, and into the steel columns, which acted as chord members to resist the tension and compression due to the cantilever action of the wall. Nelson studs were required to be added to the existing structural steel members to develop the forces. The new walls were reinforced for the shear stresses as well as to resist net tension forces at the steel columns to supplement the capacity of the column splices. The most critical aspect of the design of the new shear walls was the overturning effect. Although the interior stresses within a shear wall were readily accommodated, it was necessary to mobilize enough gravity load in the walls to enable them to resist overturning. To accomplish this, the

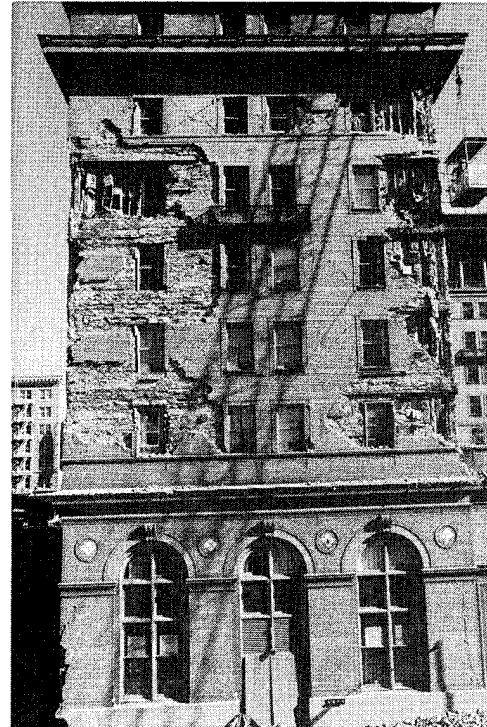
Although the 1989 Loma Prieta earthquake did no damage to the integrity of the structure, there was considerable architectural damage to the exterior brick masonry walls and to a number of apartments. Substantial amounts of brick had fallen to the street from the southwest corner of the building, exposing some of the apartments and the steel framing (Figure 51). With the engineers working to determine the extent of the damage, it was soon learned that the damage was not structural and that except for 30 apartments, the remaining 185 units could continue to be occupied while the repairs to the remaining units were conducted.

The most evident and significant damage sustained by the hotel was the cracking of the exterior brick walls. Although they are not load-bearing walls, the brick walls are the stiffest elements in the building and resisted the main thrust of the earthquake force. The walls are infill brick supported on the structural steel frame, and therefore the damage did not affect the vertical load-carrying capacity of the building. The damage to the brick was manifested as diagonal (X) cracks in the wall piers with virtually no cracking in the horizontal spandrels. Reference to Figure 51 shows this X cracking between bays of windows.

The most severe brick damage took place on the Thirteenth Street end of the Harrison Street wing of the building. There were cracks over 1/2 in. wide, with complex fracturing through the entire thickness of this wall. There were also areas where the face brick had fallen and other areas where it was loose.

Figure 51. Damage to southwest facade after removal of loose brick
