# Review of Long-Term Maintenance Plans for the South Jetty, Grays Harbor, Washington

June 1995

Final report

Prepared for U.S. Army Engineer District, Seattle  
Seattle, WA 98124-2255

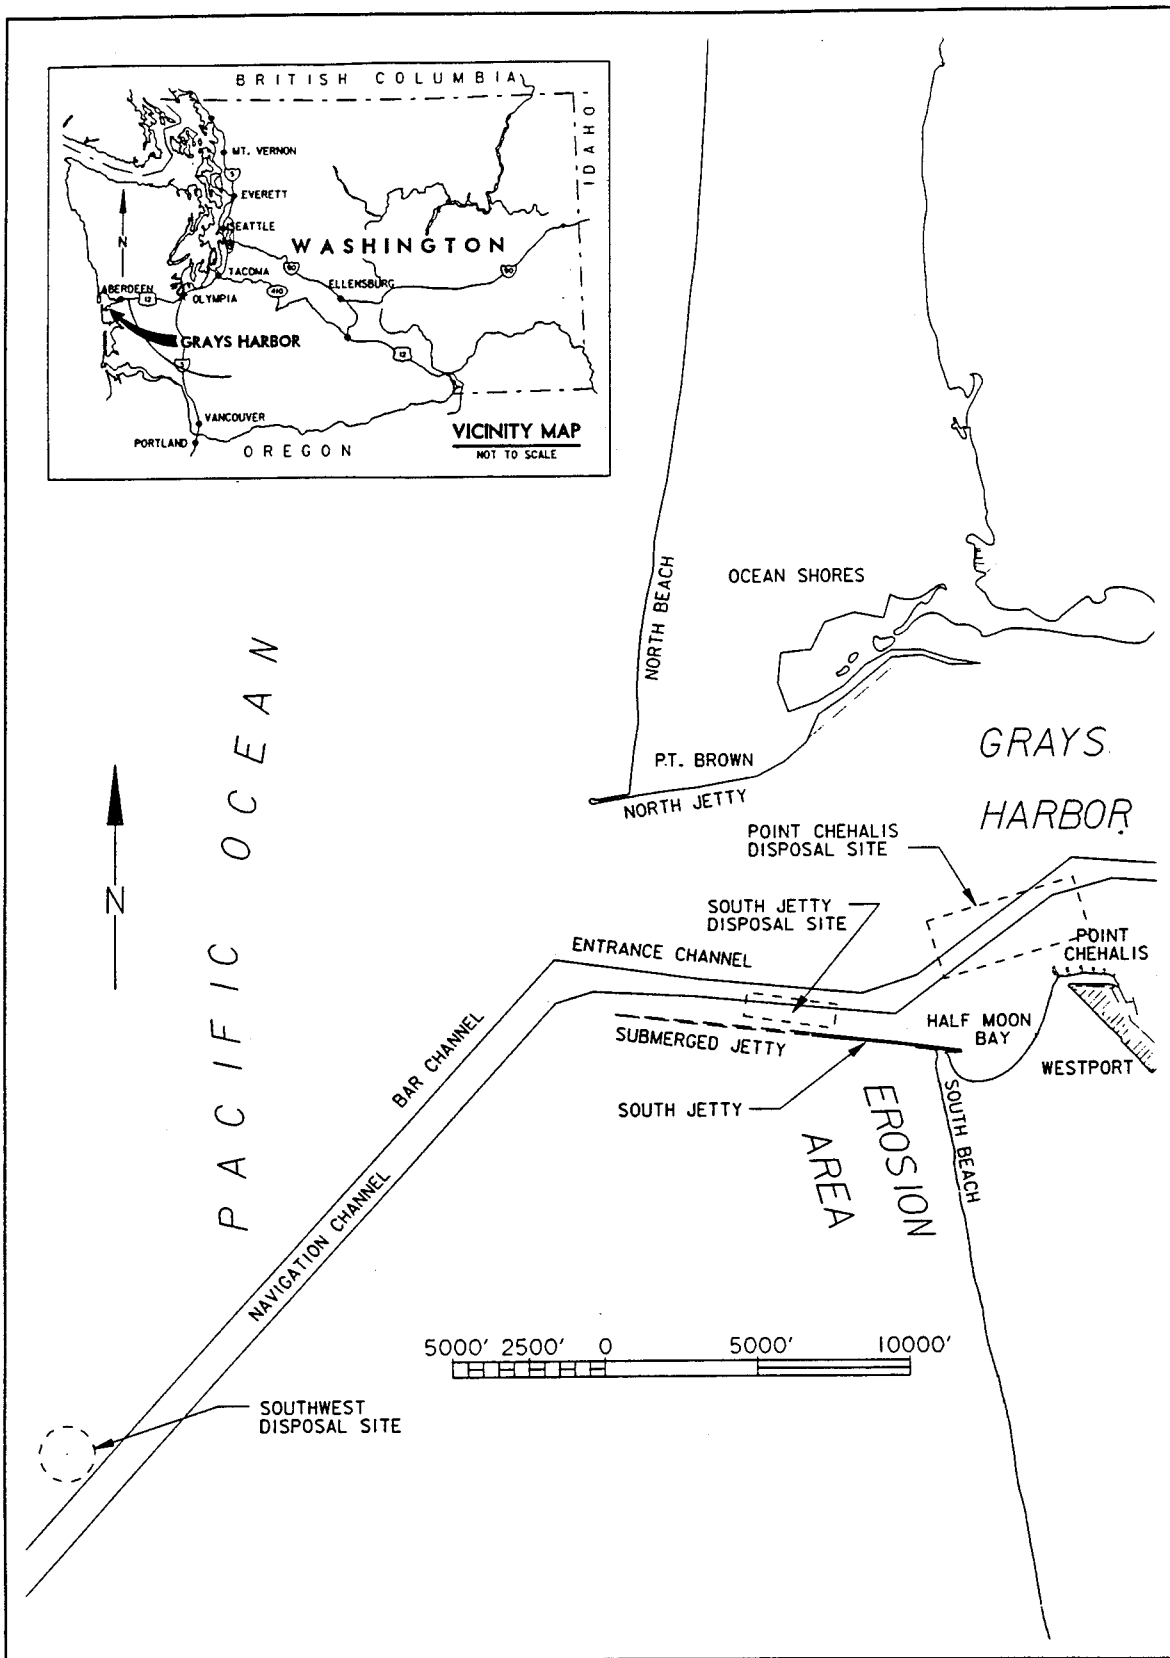
Figure 1. Grays Harbor entrance and vicinity

8. Grays Harbor entrance is located on the Washington coast about 45 miles north of the mouth of the Columbia River and 110 miles south of the entrance to the Strait of Juan de Fuca. A vicinity map and the navigation facilities in the entrance are shown in Figure 1. The Harbor broadens gradually from the river channel at Aberdeen to a large pear-shaped shallow estuary encompassing North and South Bays. An entrance is formed by sand spits extending from north and south. The Harbor is about 11 miles wide near the entrance and extends about 15 miles from Aberdeen to the entrance. The water surface of the shallow Harbor is 91 square miles at mean higher high water and 38 square miles at mean lower low water.

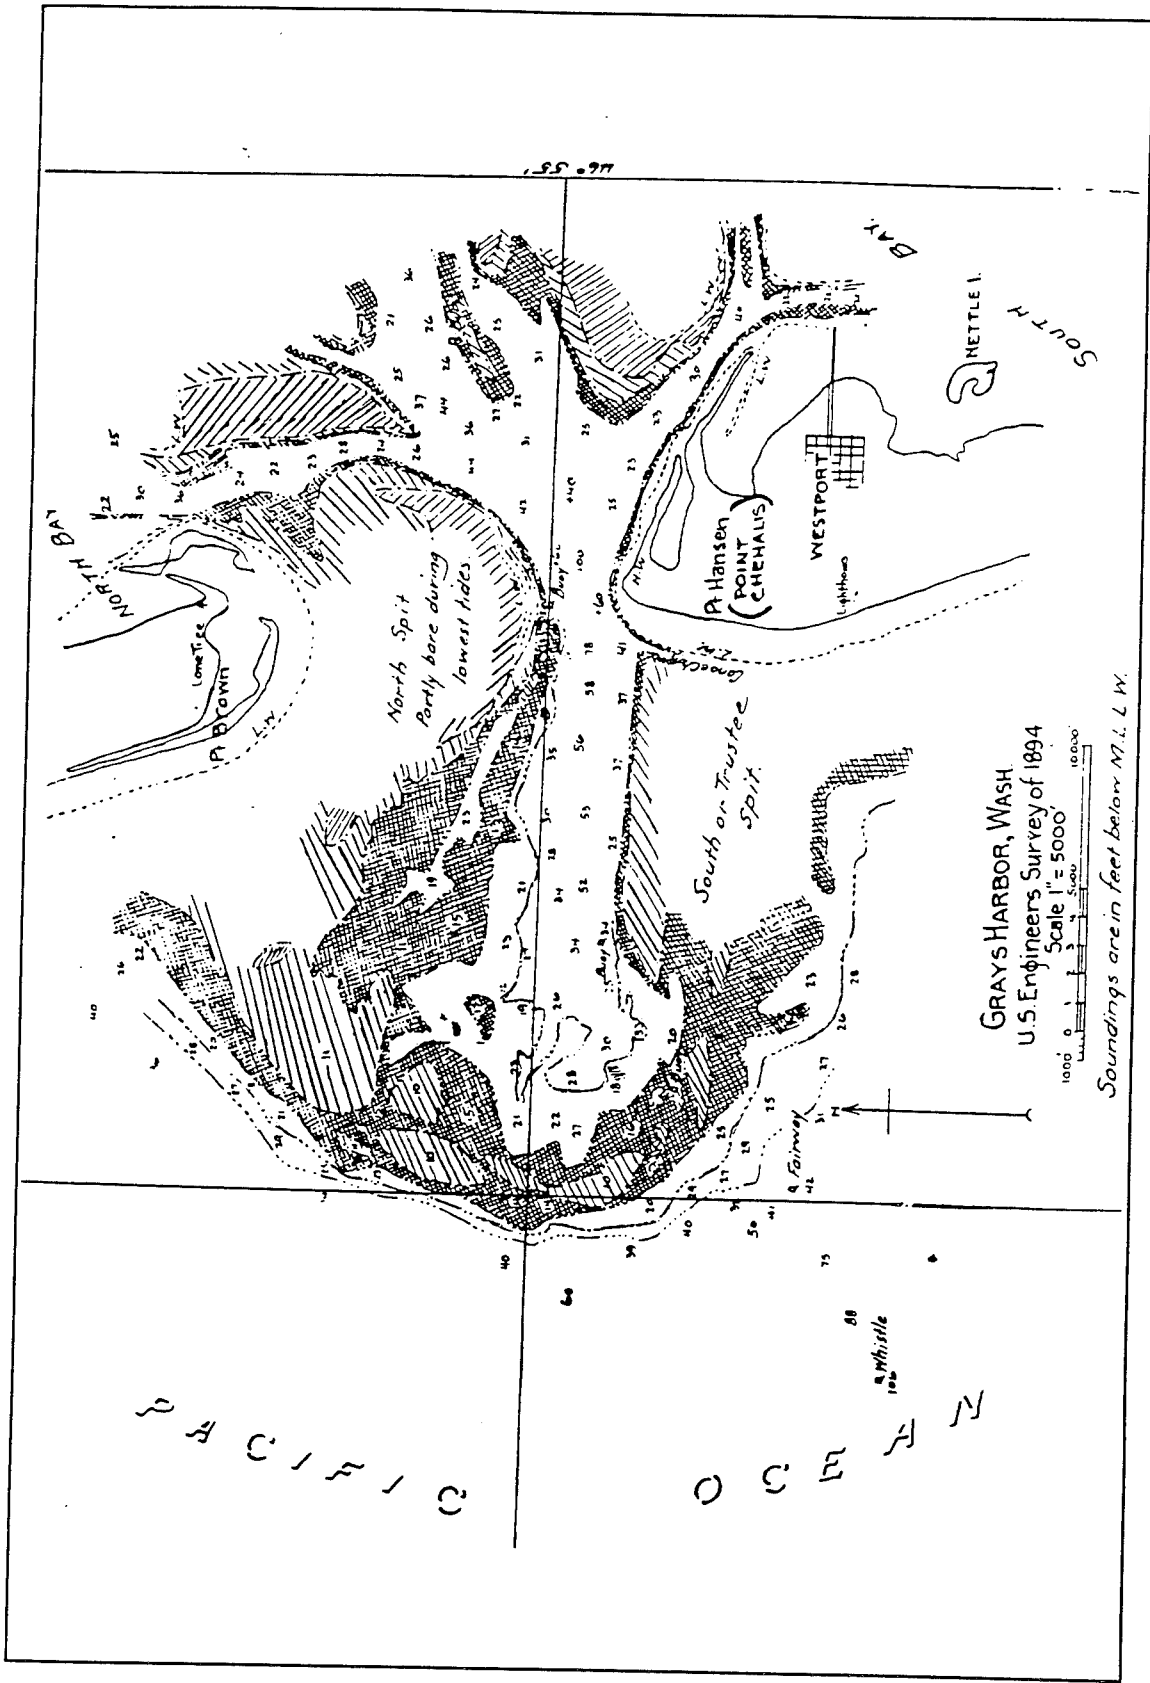
Figure 2. Entrance configuration before jetty construction

9. The configuration of the entrance in 1894, prior to construction of jetties, is presented in Figure 2. A deep entrance channel is shown in the figure. This channel was maintained by strong ebb currents resulting from constriction of tidal flows by sand encroaching from both north and south. An outer bar and deposits inside the entrance formed where ebbing and flooding tidal current velocities slowed. This figure is a "snap-shot" of a very dynamic natural entrance that changed its configuration with changing wind, wave, and sediment supplies. Shifting sands and shallow water at the outer bar created severe hazards to navigation, including grounding of ships and steepened wave conditions. Construction of jetties to stabilize the position of the entrance channel, to provide a protected entrance, and to create eroding currents at the outer bar began in 1898 and were completed in 1916. Alignments of the jetties are shown in Figure 3.

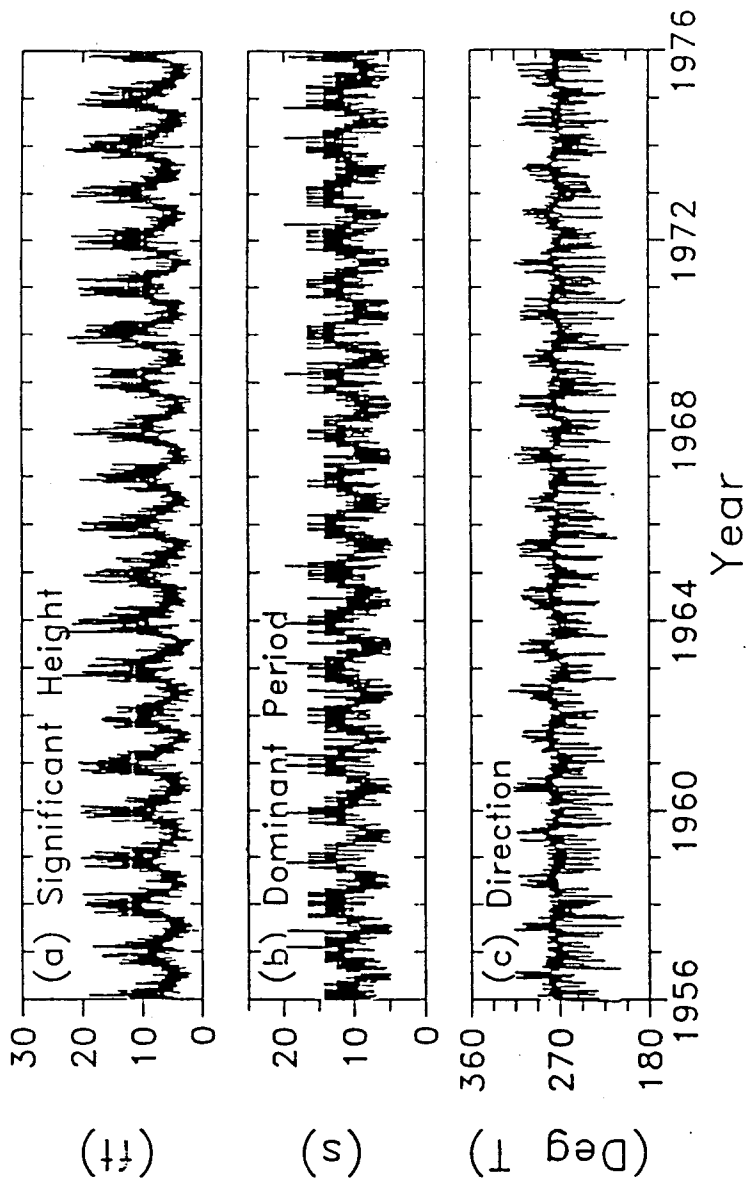
Figure 11. Hindcast wave data for WIS station 16 (from Battelle/Marine Sciences Laboratory 1992)

25. Time series of wave height, period, and direction obtained from the Wave Information Studies (WIS) by the USACE Coastal Engineering Research Center (Jensen, Hubertz, and Payne 1986) are plotted in the Battelle report (Battelle/Marine Sciences Laboratory 1992, p 42) and are shown in Figure 11. This figure shows that winter waves having significant heights on the order of 20 ft and significant periods of 16 seconds approach the entrance from the southwest to west directions. Summer waves have significant heights on the order of 4 to 5 ft, periods of 5 seconds, and approach from west to northwest.

Time Series of Wave Information Studies Wave Model Hindcasts for Station 16 at 3-h Intervals from 1956 to 1976. (a) Significant wave height, (b) dominant wave period, (c) average wave direction.

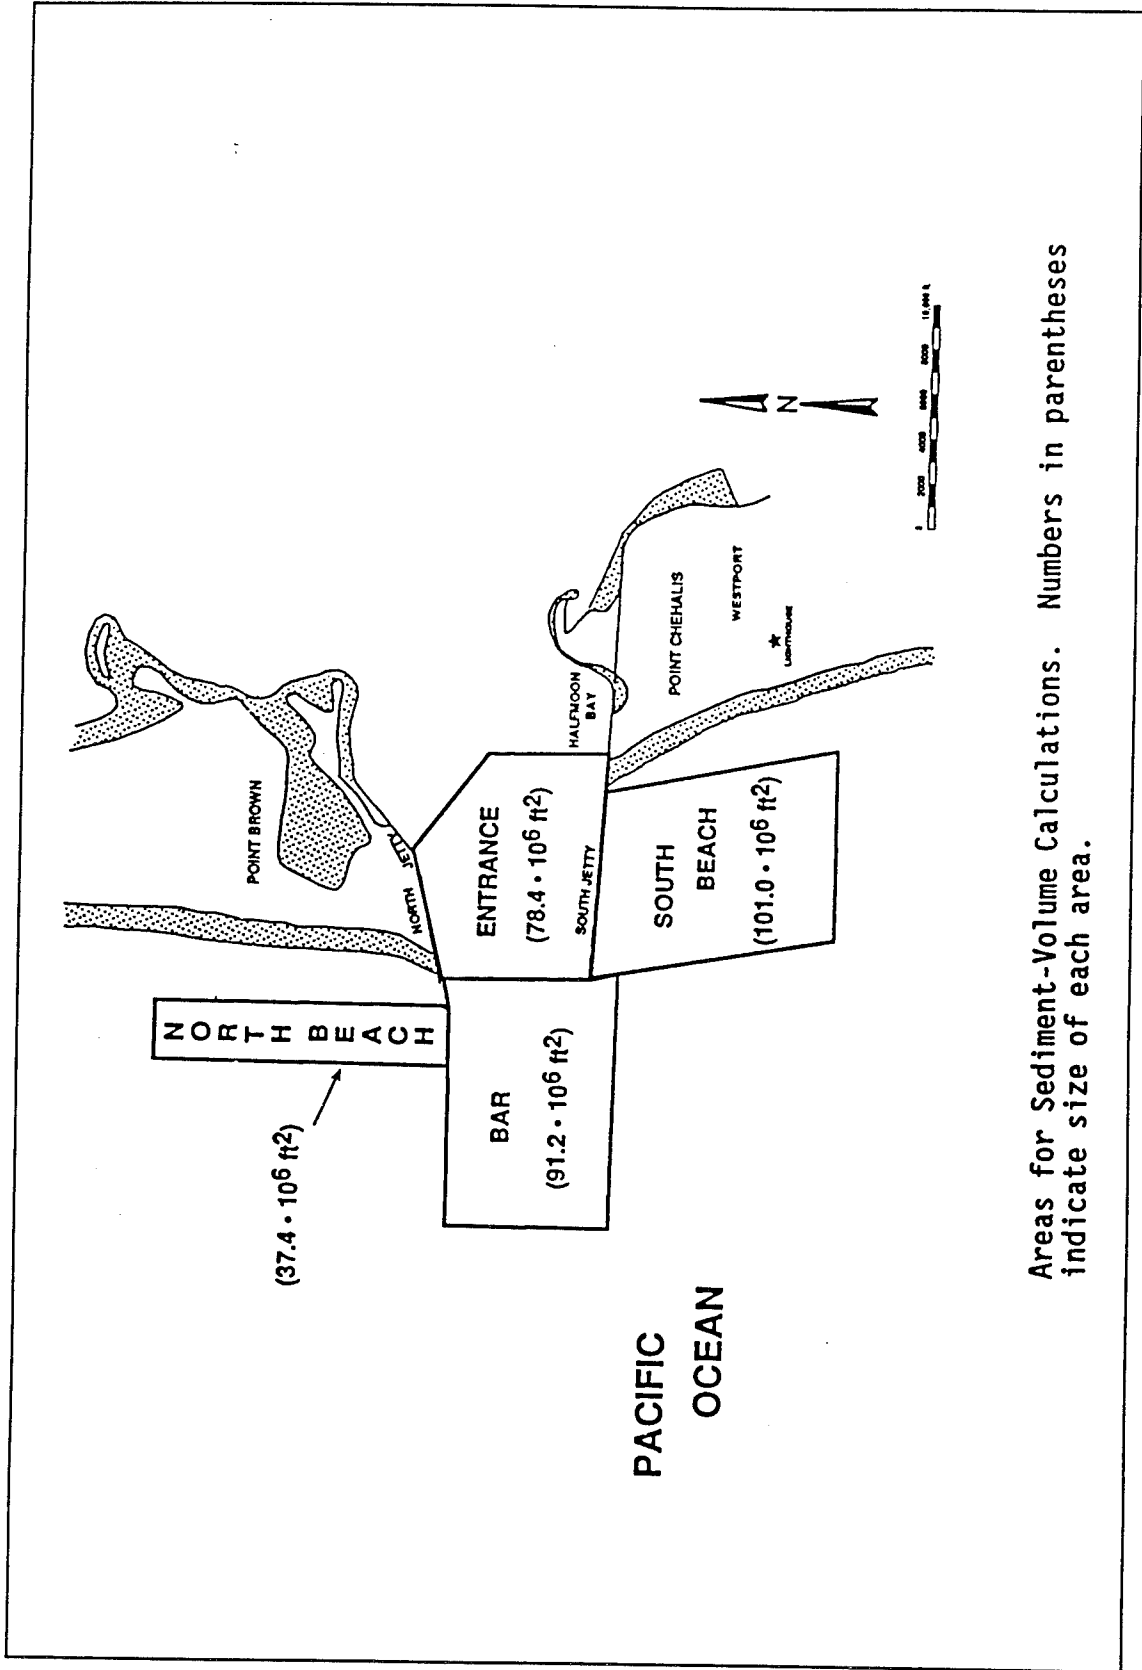
Figure 12. Areas selected for evaluation of volume changes (from Battelle/Marine Sciences Laboratory 1992)

Areas for Sediment-Volume Calculations. Numbers in parentheses indicate size of each area.

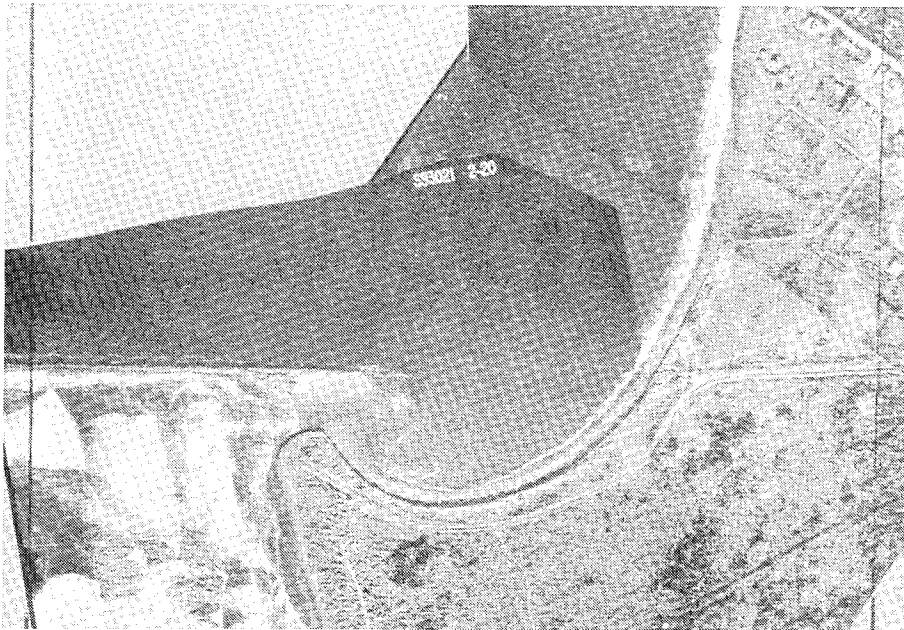
Photo 4. 17 December 1993, tide elevation +6.5 ft mllw, approximate scale  
1 in. = 1,400 ft

22. The breach occurred during a storm on December 10, 1993. The storm started on the evening of December 8 and lasted until December 15 (Hartman Associates 1994, p 7). The maximum significant offshore wave height was recorded by the Grays Harbor buoy at 0230 December 10. The wave height was 25 ft and the period was 13 seconds. The direction of offshore waves varied from 33 to 91 degrees relative to the shore. Hartman & Associates calculated the largest wave height at the 33-ft depth to be 16.7 ft with a length of 450 ft. They calculated a wave recurrence interval of two years. Evidently, setup from south winds combined with high waves caused overtopping of the narrow portion of the spit between South Beach and Half Moon Bay. Much of the material that was washed out of the breach has deposited in Half Moon Bay. Figure 10 shows details of the breach in May, 1994.
