1. AGENCY USE ONLY (LEAVE BLANK)	2. REPORT DATE 5 September 1995	3. REPORT TYPE AND DATES COVERED Professional Paper	
4. TITLE AND SUBTITLE  Developing Flight Test Techniques to Ensure Proper Rigging of Highly Augmented Aircraft		5. FUNDING NUMBERS  <b>19951107 055</b>

6. AUTHOR(S)  CAPT Ricardo Traven, CAF Susan E. Whitley		8. PERFORMING ORGANIZATION REPORT NUMBER	
7. PERFORMING ORGANIZATION NAME(S) AND ADDRESS(ES)  Visual and Technical Information Branch 7.2.4.3.A, Mail Stop 2, Bldg. 405 Naval Air Warfare Center Aircraft Division Patuxent River, Maryland 20670-5304

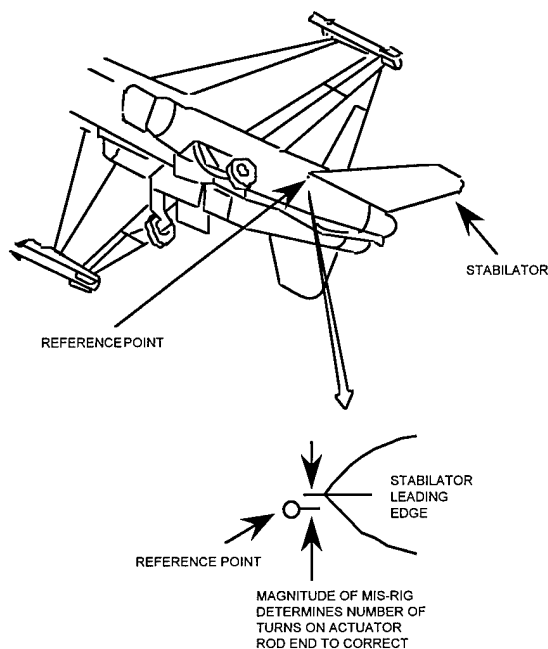
Figure 1  
RIGGING REFERENCE POINT FOR THE  
F/A-18 STABILATOR

The flight control surfaces are physically disconnected from the actuators during the rigging process. The surfaces are rigged either to a reference point on the fuselage or to another surface (the Production Zero Reference point) and then reconnected to the actuators. An example of the stabilator rigging reference point is presented in figure 1.

A flight control surface is considered to be mis-rigged if the distance between the Production Zero Reference point and the reference on the surface is beyond the allowable rigging tolerance. Rigging is performed on all flight control surfaces except the LEF's by converting the amount of the mis-rig in inches to a prescribed number of turns on the actuator rod end.

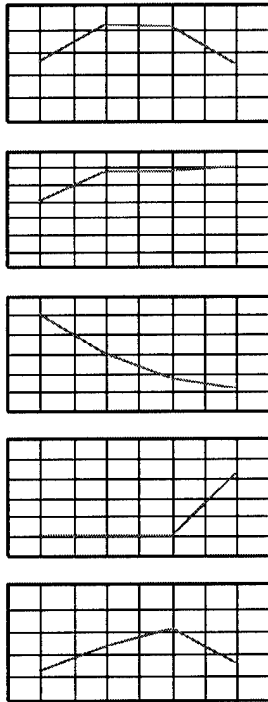
Figure 2  
SIMULATOR MIS-RIG DATA

moment. The simulator data for the CR configuration is presented in figure 2.

then compared to the simulator data to identify the suspect surface. Since the roll rate traces are unique for each flight control surface, identification of the suspect surface is simple.
