DOT/FAA/AR-95/51

Nondestructive Inspection of Piper PA-25 Forward Spar Fuselage Attachment Fitting

Final Report

| 7. Author(s) David G. Moore | | | | 8. Performing Organization Report No. | |

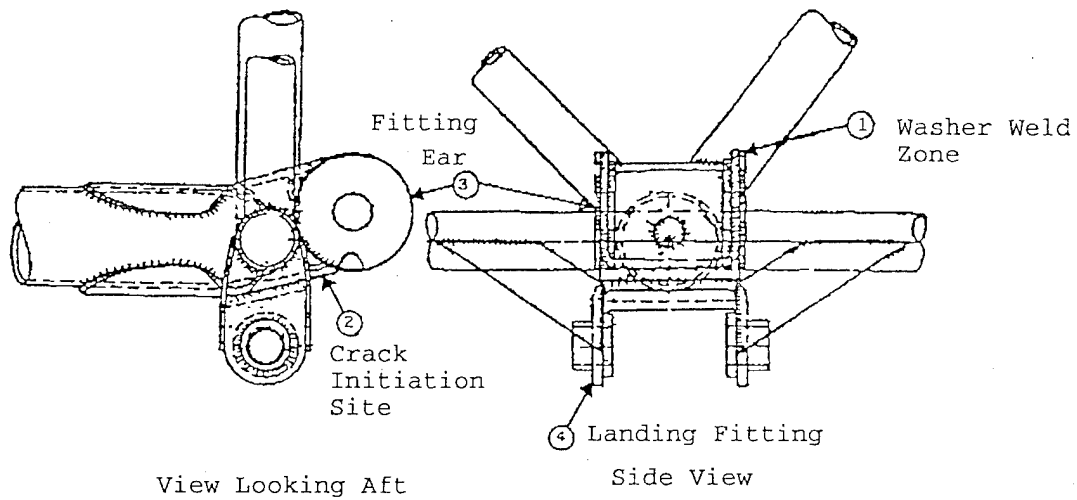
FIGURE 1. VIEW LOOKING AFT AND A SIDE VIEW OF THE SPAR ATTACHMENT FITTING FOR THE PIPER MODEL PA-25-150. FIGURE WAS TAKEN FROM AD 93-21-12.

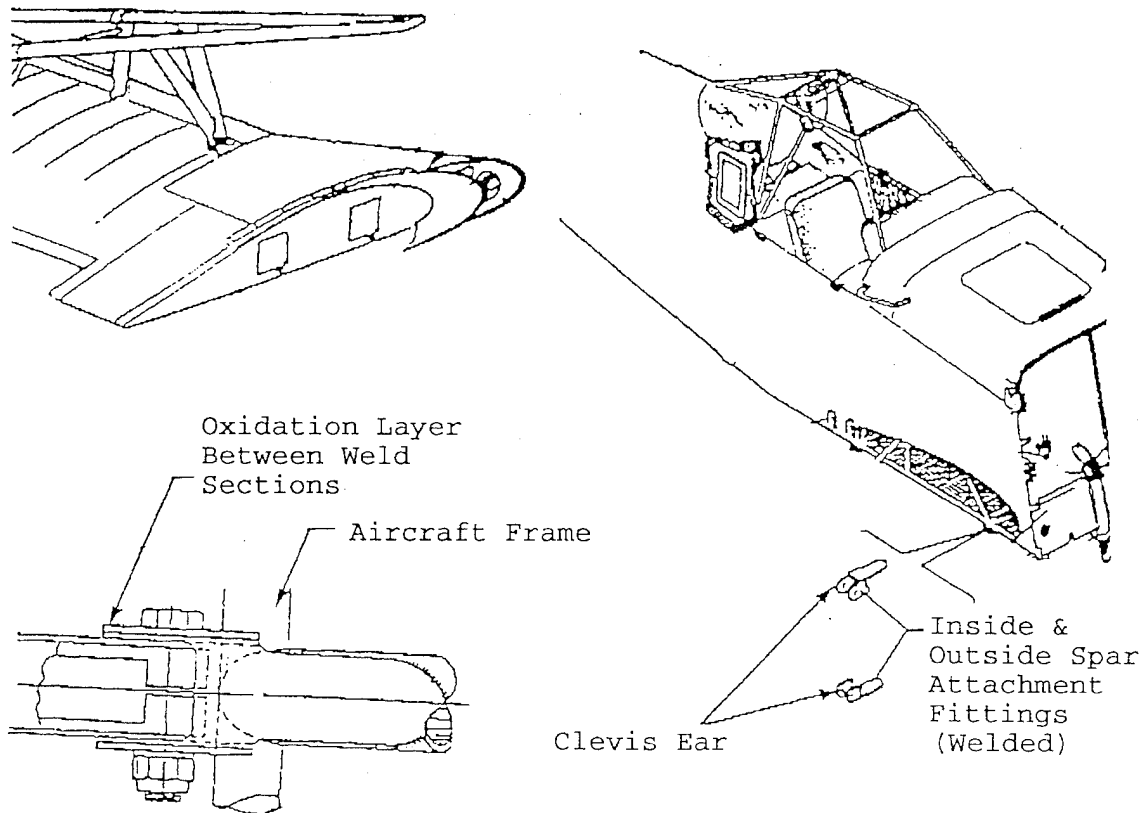
FIGURE 2. LOWER ATTACHMENT FITTING EAR AS ASSEMBLED IN THE PRESENT CONFIGURATION. FIGURE WAS TAKEN FROM AD-93-21-12.

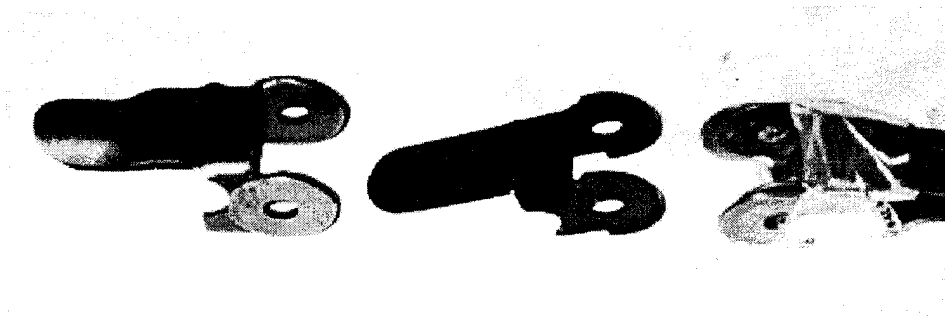
On March 4, 1994, two forward attachment spar clusters and a new Piper manufactured fitting were received from the Atlanta ACO. Sample 1 was a new, fully assembled ear fitting. To help understand the current welding process, two subassembly piece parts were also sent (figure 5). Sample 2 was a forward spar fuselage attachment cluster which had extensive pitting and surface

FIGURE 5. SAMPLE 1 - A NEW, FULLY ASSEMBLED EAR FITTING (FAR LEFT) AND TWO SUBASSEMBLY PARTS.
