# NASA Contractor Report 3715

## DC-10 Composite Vertical Stabilizer Ground Test Program

J. M. Palmer, Jr., C. O. Stephens,  
and J. O. Sutton

CONTRACT NAS1-14869  
AUGUST 1983

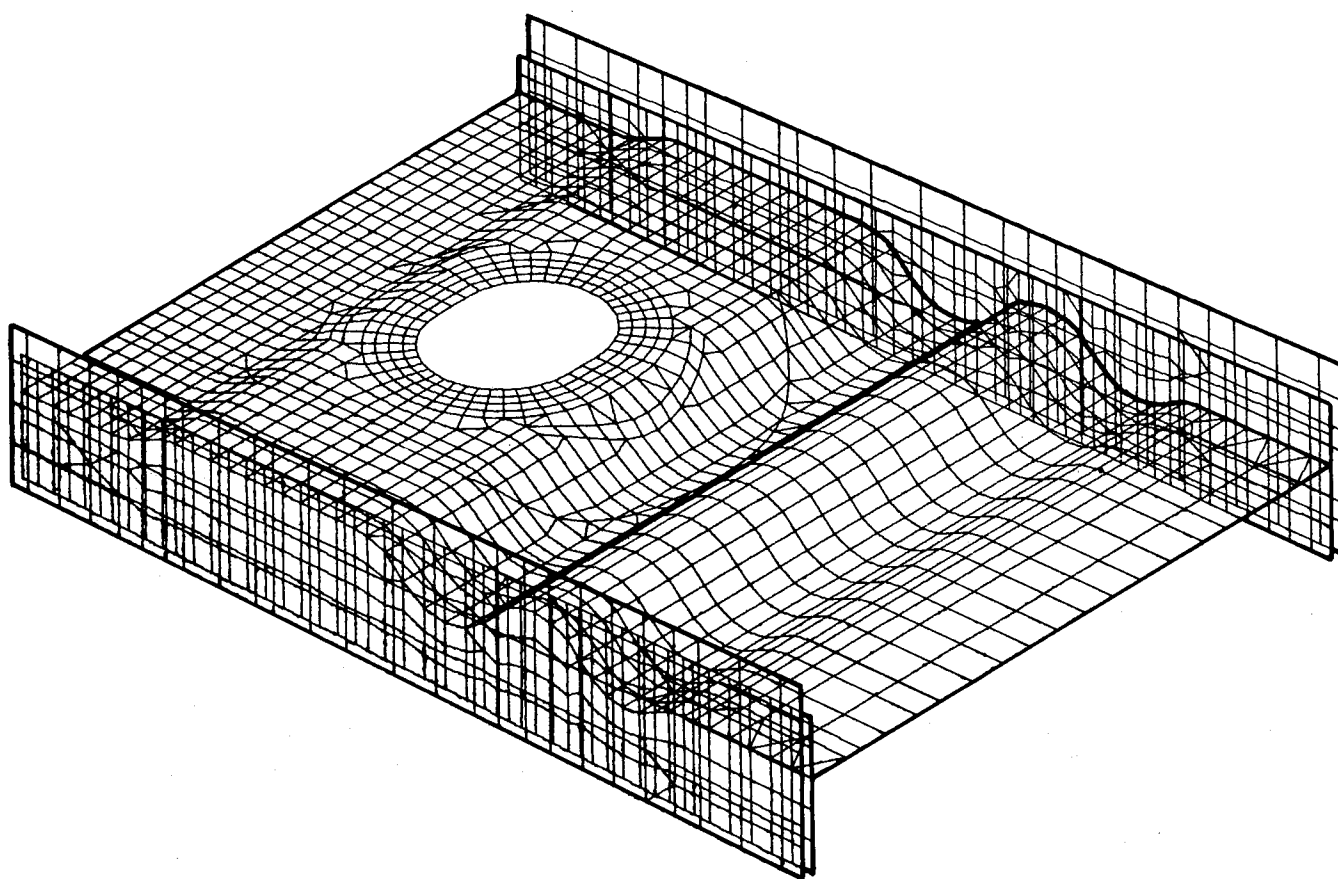
**FIGURE 24. NASTRAN MODEL OF REAR SPAR WEB**

The second area of investigation was the covered cutouts in the rear spar web and the center bay of the ZFR Station 314 rib. A simple planar analysis indicated that the strains at the perimeter of the cutouts were not critical even with the door missing. However, it was recognized that the sine wave web produces significant out of plane forces at the hole which would modify those results. Accordingly, a detailed three dimensional NASTRAN model of the critical rear spar web was developed (Figure 24). Web shear, spar cap and bolted joint interface loads were applied to the model while the attachment of the door module to the web module was analytically varied from full shear effectivity to zero shear effectivity. A reference case with no door installed was also run. The results are shown in Figure 25, where the laminate mid-plane strains at the perimeter of the access opening are plotted for each quality of fastener fit. Clearly, if sufficient slippage between the door and web is available, the presence of the fasteners provides almost no relief from the maximum strains, while fully effective fasteners (i.e., a fully effective door) provides considerable support at the edge of the cutouts.

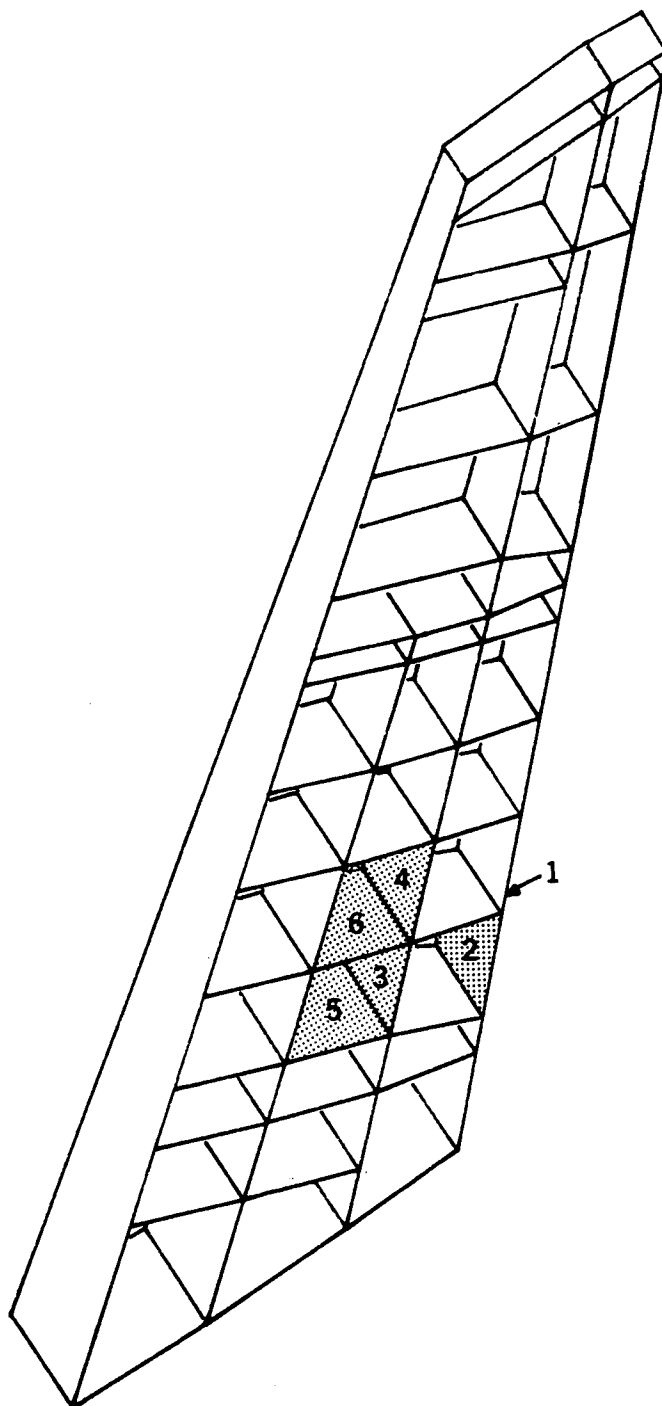
**FIGURE 26. FAILURE INITIATION INVESTIGATION POINTS**

The NASTRAN internal loads model for the complete stabilizer was next modified to reflect assumed failures in areas which were failed in both the stub box and GTU in order to establish the probable failure initiation point. The locations are shown in Figure 26. Loads equal to the test loads at failure were applied to the model. Only the assumed failure in the rear spar web between ZFR Stations 326 and 350 resulted in negative margins of safety for the remaining structure.

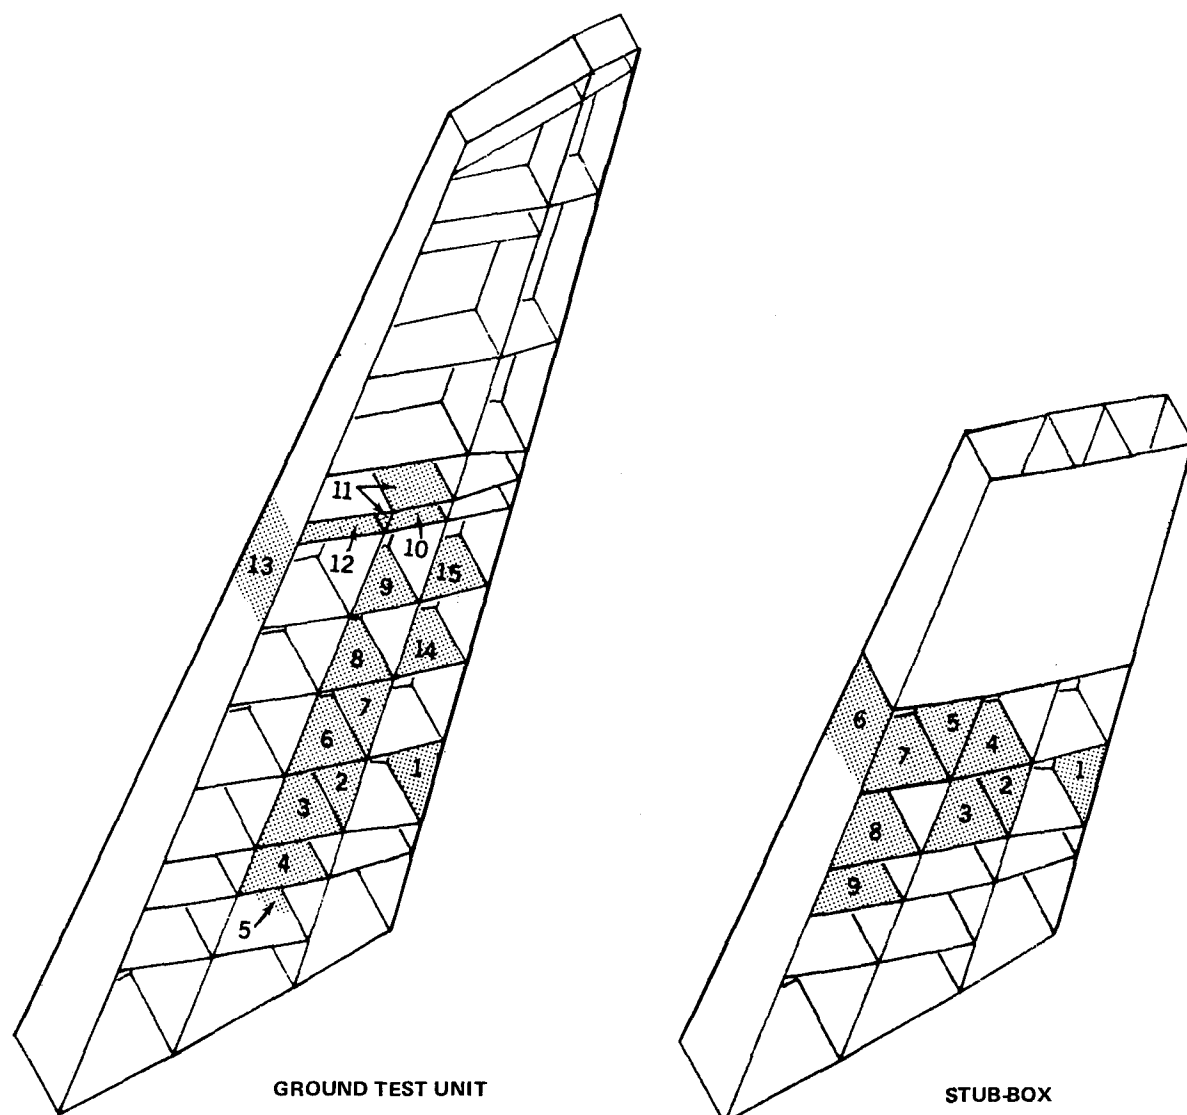
FIGURE 27. ANALYTICAL FAILURE SEQUENCE

The NASTRAN model for the stabilizer was modified to reflect an assumed failure in the rear spar web at Z<sub>FR</sub> Station 342 and was subjected to the appropriate load condition (maximum bending case). This analysis indicated a progression of failure to the aft center spar web between Z<sub>FR</sub> Stations 329 and 350. This failure progression was pursued analytically with the finite element model to determine the probable sequence of failure. Each structural element that subsequently indicated a negative margin was deleted from the model and the loads reapplied. A search was then made for negative margins in the remaining structure. In this fashion, a probable failure sequence was established for both test articles as shown in Figure 27. Each distinctive structural failure observed in the substructure of both test articles was predicted by this analysis.

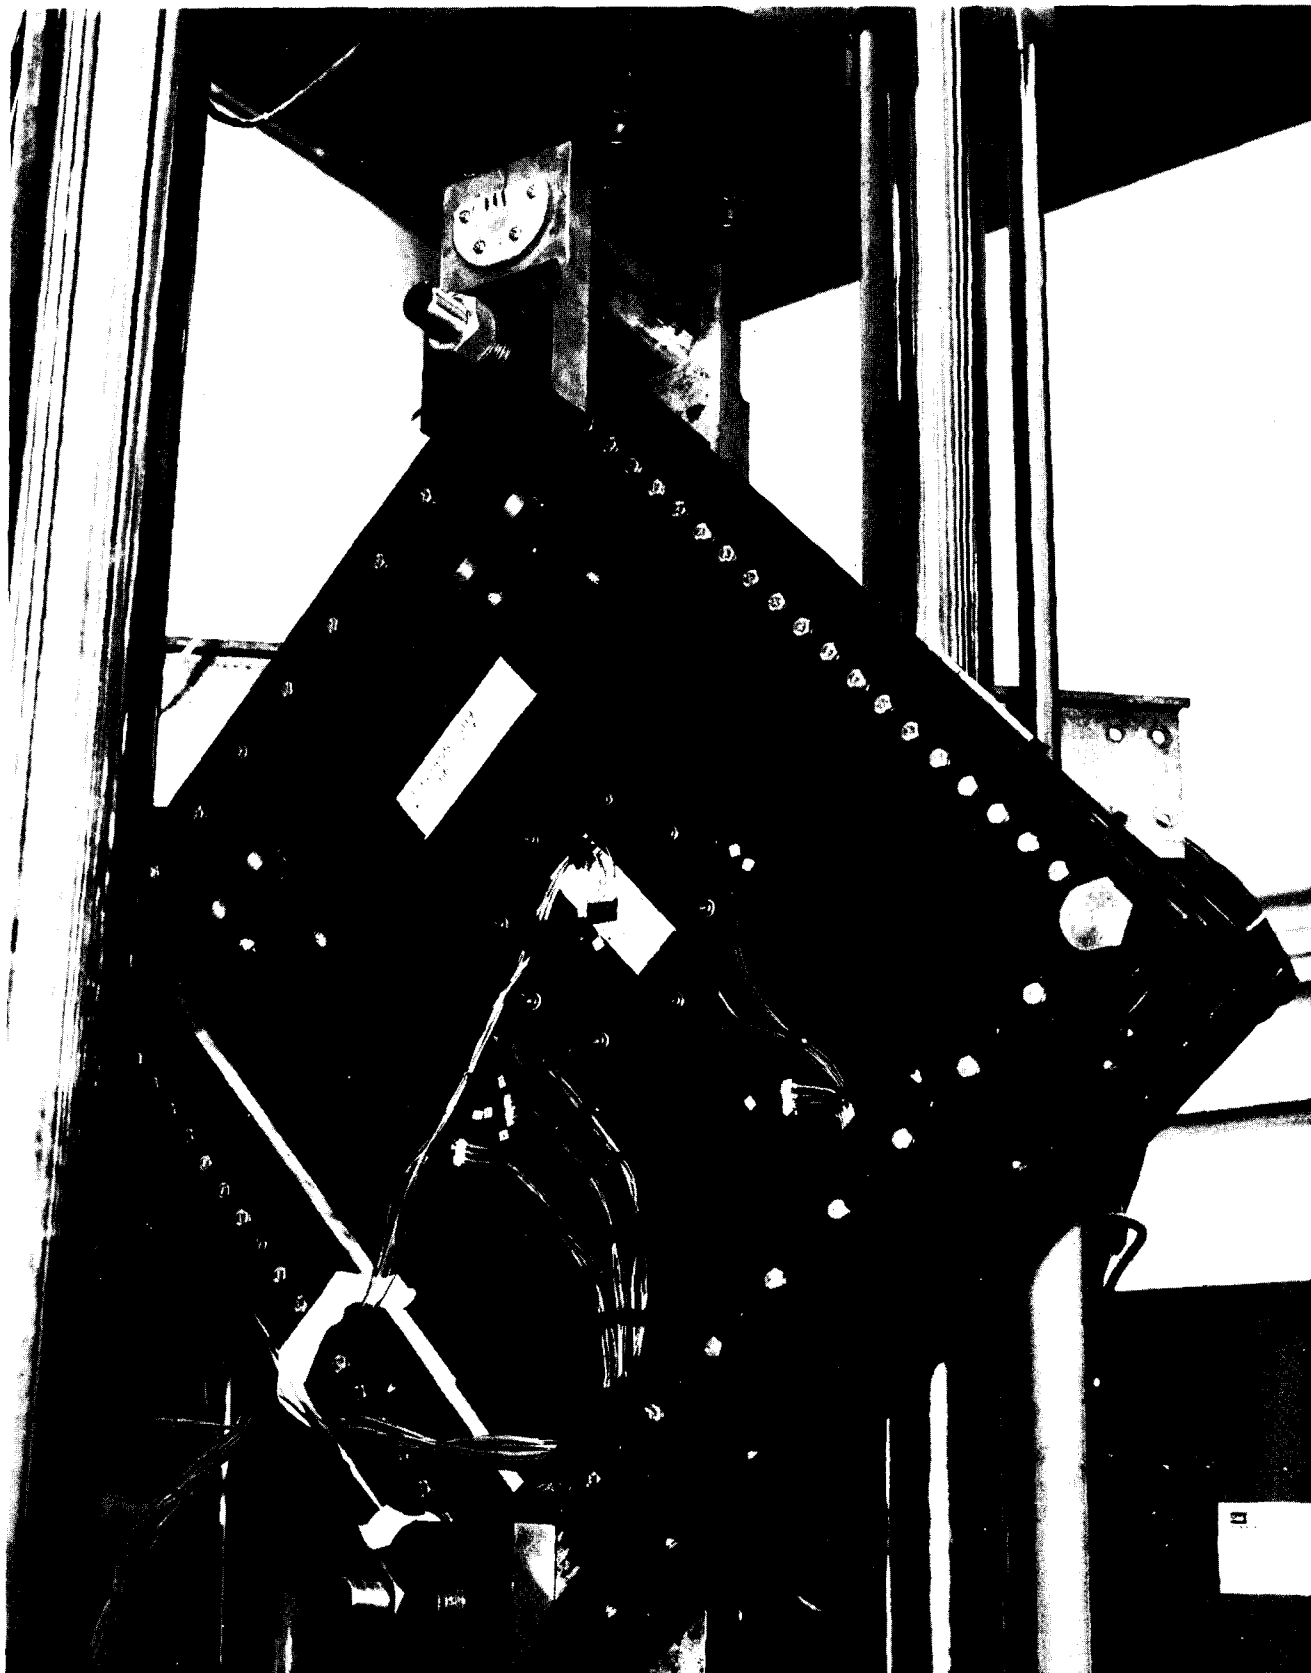
A picture frame type of test fixture was built, and the rib component was tested in shear (Figure 28). The rib was first loaded with the door removed. The door was then installed with good fastener fits in all holes and the specimen reloaded. Next the fastener holes in the door were drilled out to correspond to the stub box configuration and the specimen was reloaded. The fastener holes in the web were then drilled out to correspond to the GTU configuration and the specimen was reloaded.

FIGURE 28. AMC7855-5 RIB COMPONENT IN SHEAR TEST FIXTURE WITH DOOR INSTALLED

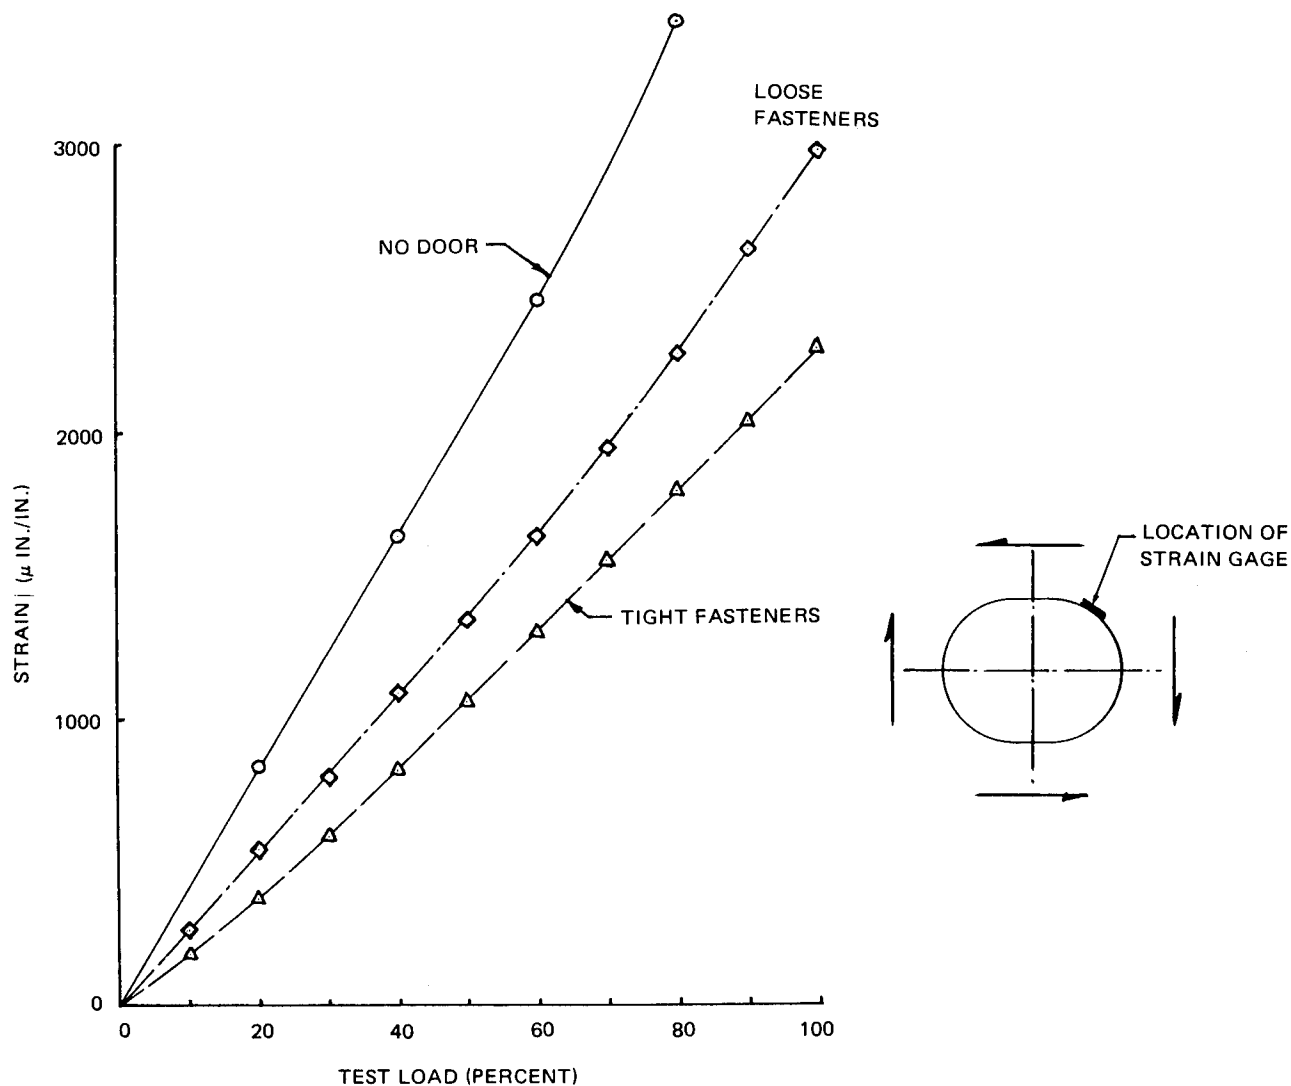
FIGURE 29. STRAIN AT PERIMETER OF CUTOUT IN AMC7855-5 RIB COMPONENT

The results of these tests are shown in Figure 29, where the maximum strains measured at the perimeter of the access opening are plotted versus load. Without a door attached, the hole perimeter strains were extremely high. With the tight fit holes, the perimeter strains were considerably reduced. When the door holes were drilled out, the strains increased, as was expected. When the web holes were drilled out (not shown) no additional effect was observed. This is consistent with the failure theory, in that once the fasteners lose contact with the holes, additional clearance can do no additional harm. Only after sufficient distortion had occurred to bring the intermediate fit configuration fasteners into contact with their holes would any difference become apparent. This load level was not reached during the test due to the risk of prematurely damaging the specimen.

The analyses using the NASTRAN models of the stabilizer and the critical rear spar web together with the results of the tests on the rib component all confirmed the validity of the failure theory. The failures in both test articles was the result of high stress concentrations at the edge of the lower rear spar access opening. These high stress concentrations were the result of the clearance between the holes and fasteners attaching the load-carrying access covers to the spar webs. The discrepancy in load level at failure between the two test articles was the result of differences in fit of the fasteners.

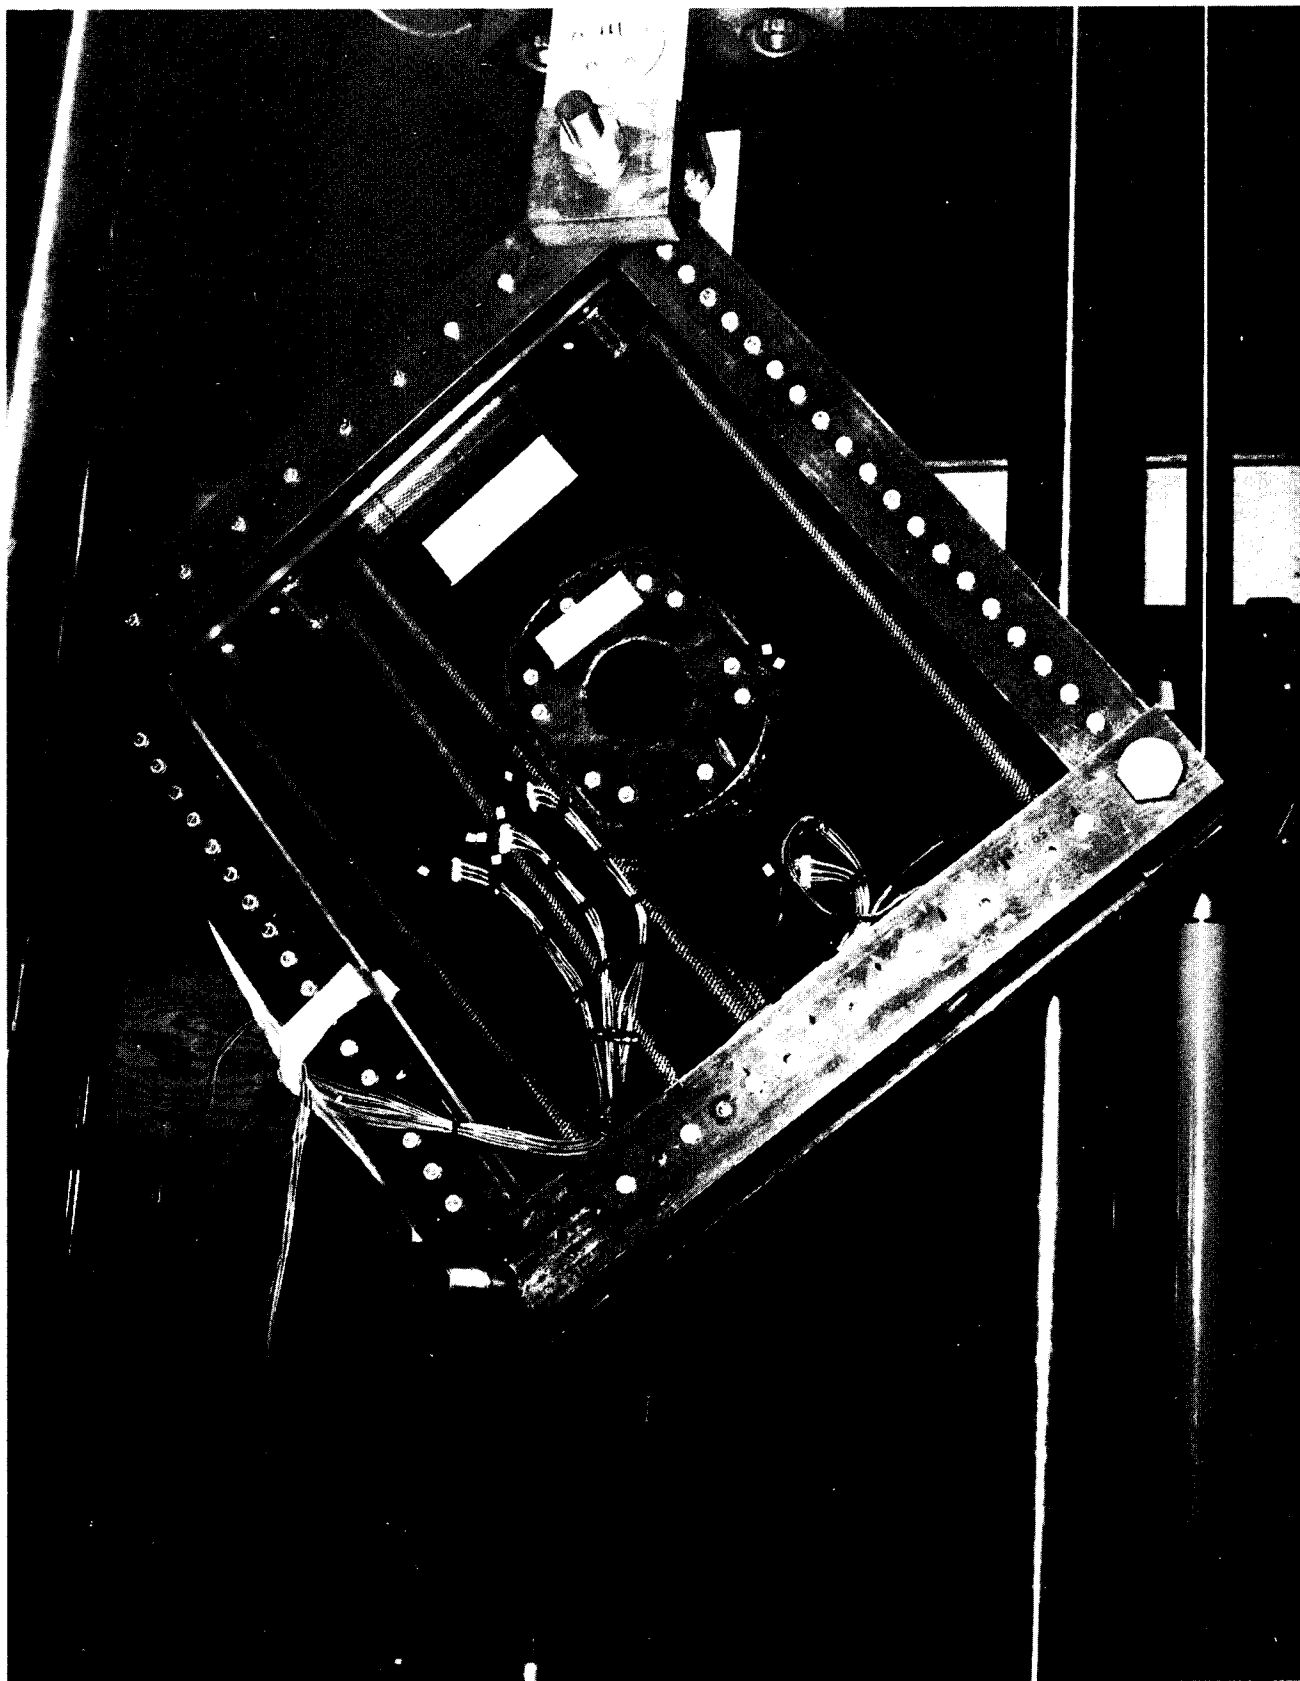
**FIGURE 31. AMC7855-5 RIB COMPONENT IN SHEAR TEST FIXTURE WITH FLANGED PLATE BONDED/BOLTED IN PLACE**

To test the validity of the concept, a flanged plate was made and installed on the AMC7855-5 rib test specimen (Figure 31). The panel was tested to failure, with failure occurring in the basic sine-wave web, well away from the opening (Figure 32). The strains measured at the perimeter of the hole with the bonded cover in place are shown in Figure 33.
