**Beaver Dam - White River, Arkansas**

# **Beaver Dam Secant Pile Wall Completion Report**

**OCTOBER 1995**

**Volume 1**

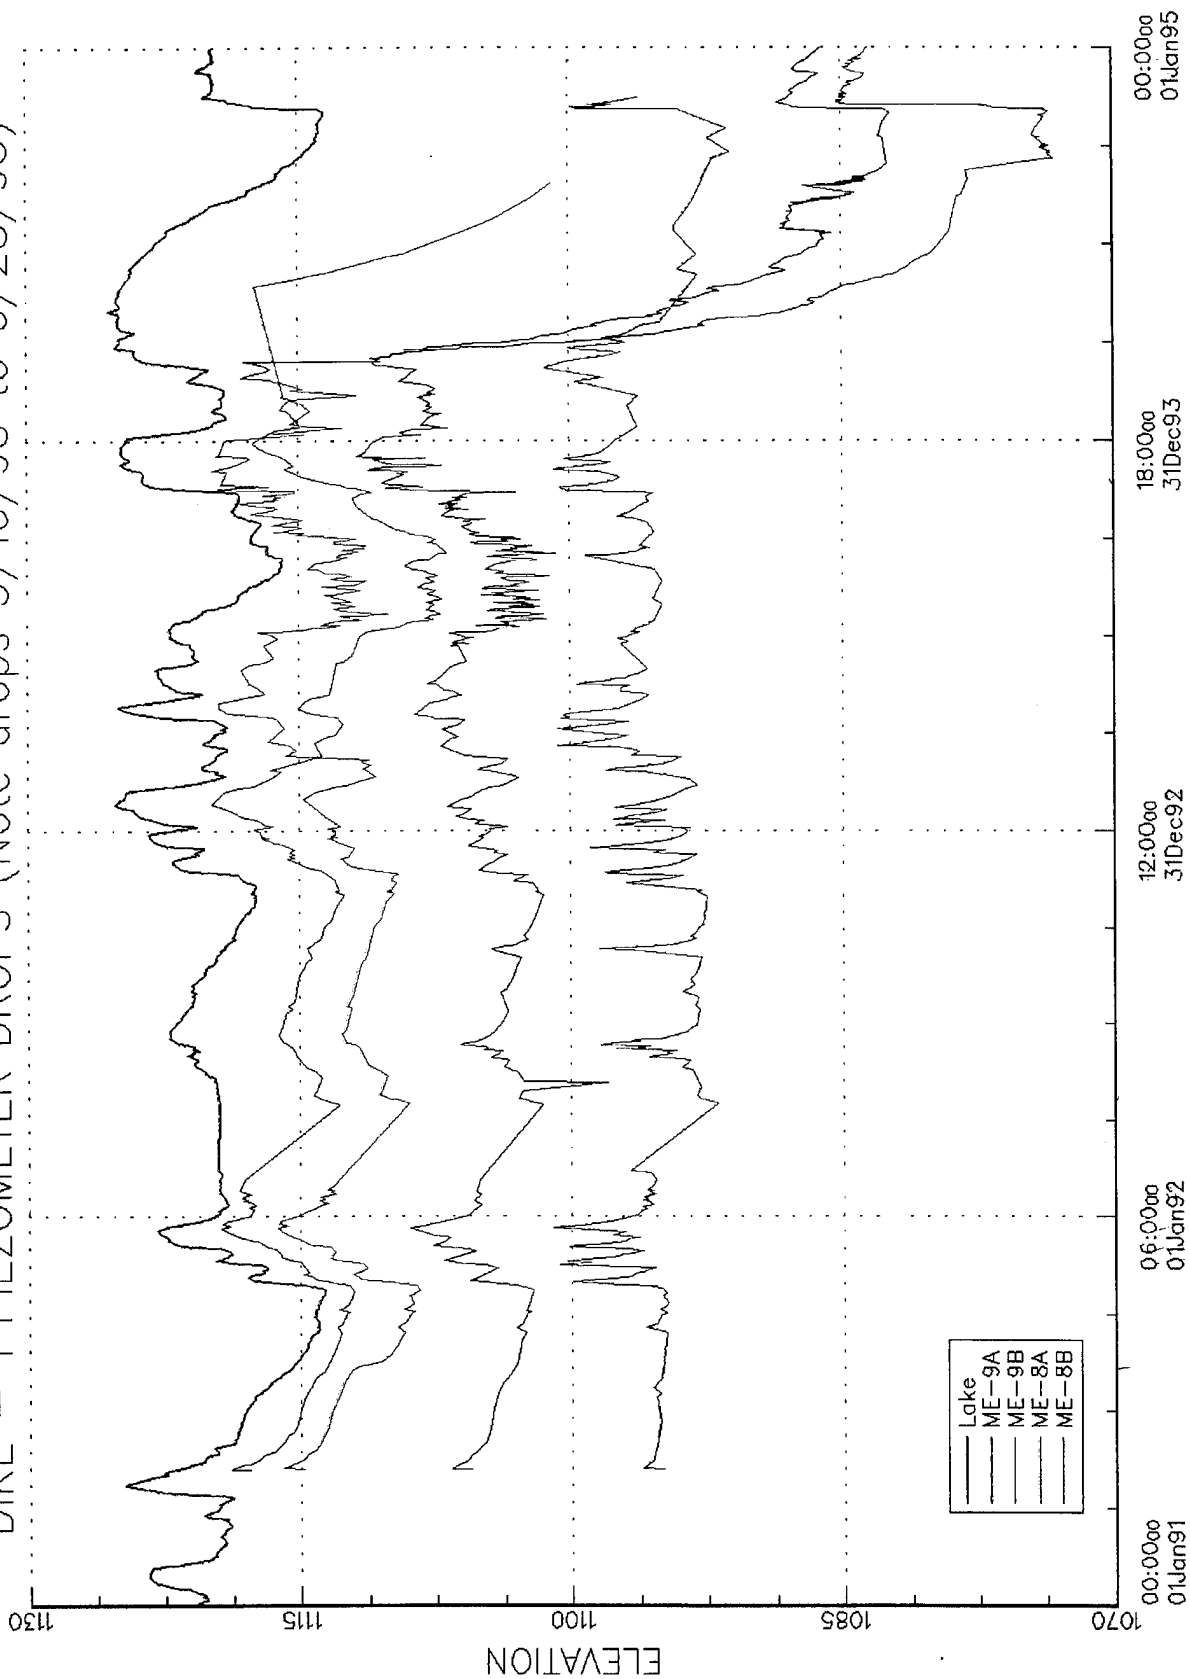
PLATE C-14

# DIKE - 1 PIEZOMETER DROPS (Note drops 5/16/93 to 6/28/93)

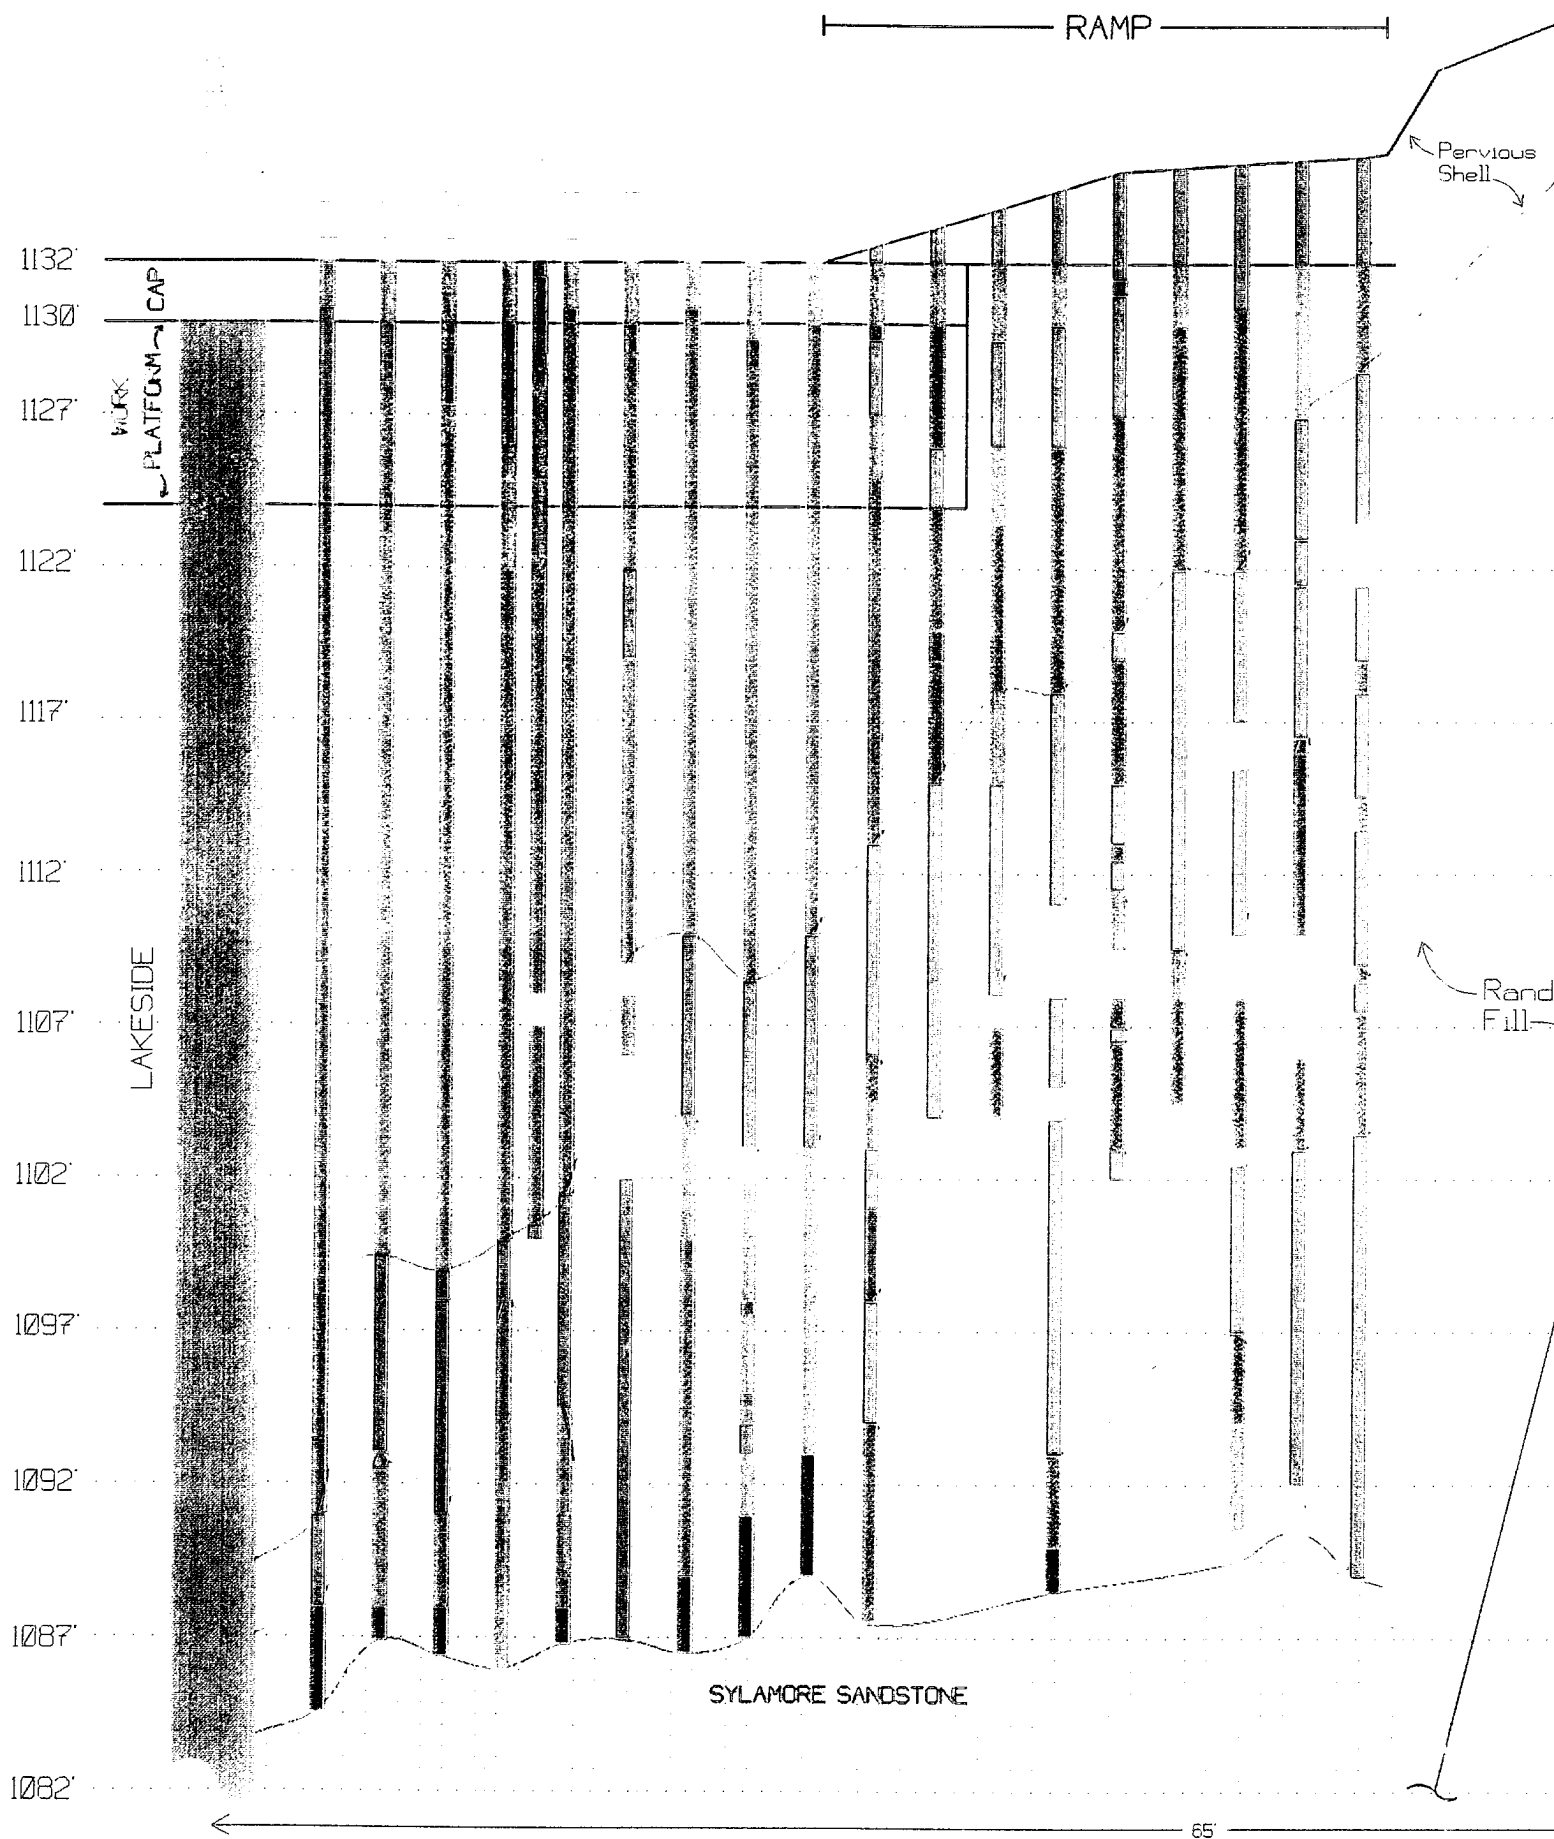
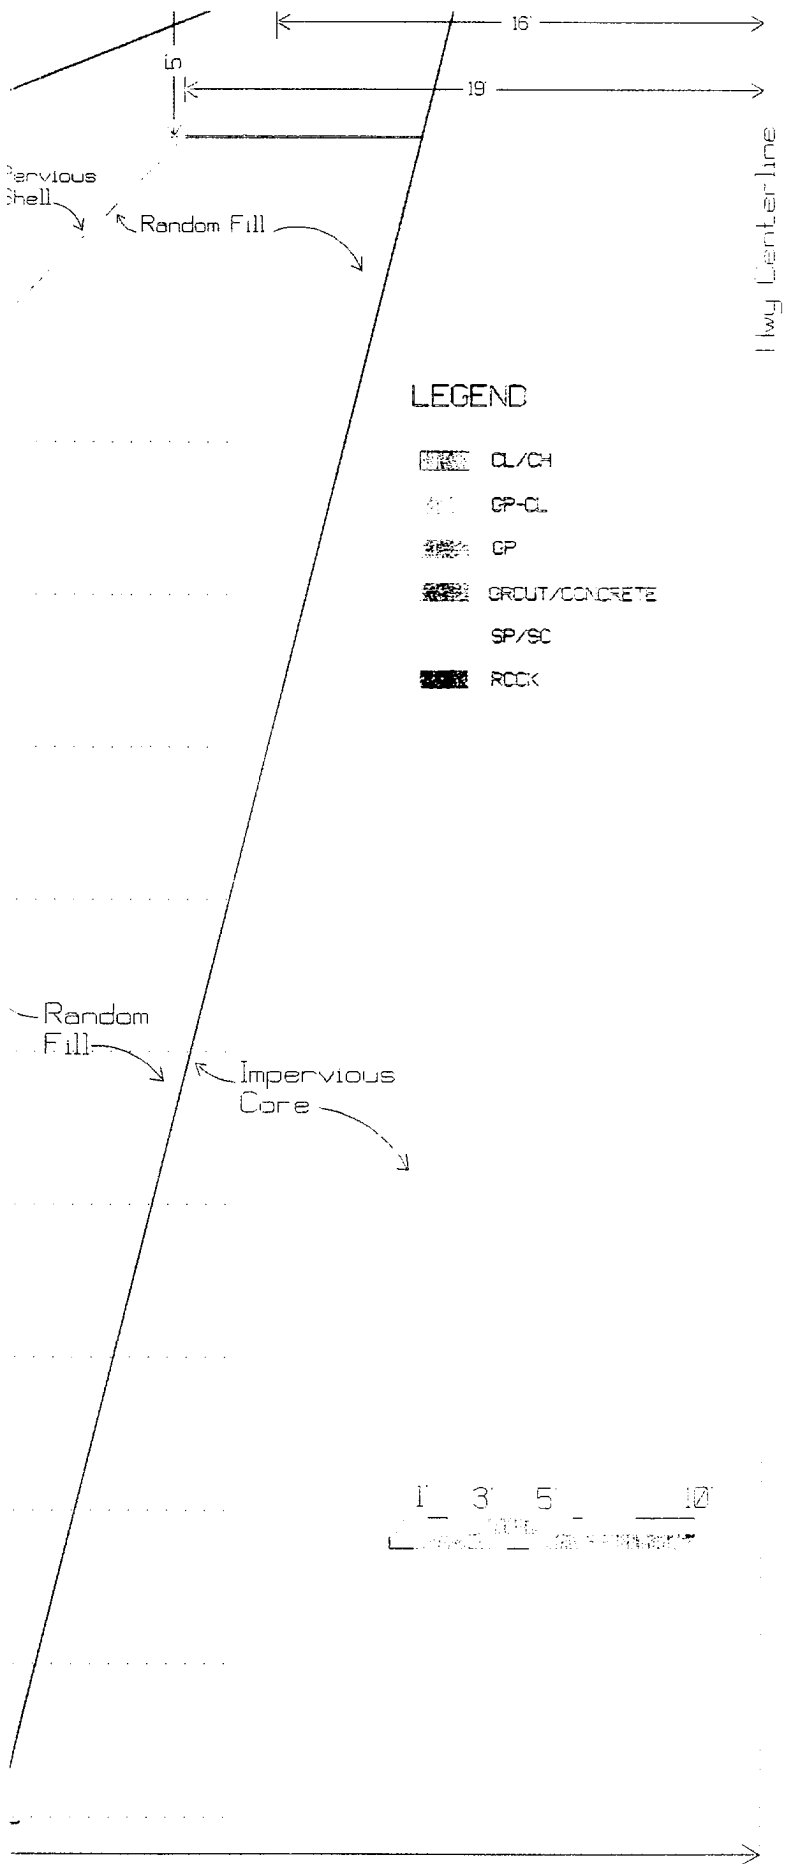
FIGURE 1  
CROSS-SECTION  
OF AS-BUILT  
GROUT CURTAIN

The random fill zone was initially believed to consist totally of clays making it impermeable. This was found not true for the location selected for the grout curtain (Fig-1). Half of the random fill consisted of very large gravel, 2-4 inches in diameter. All of the (GP) material and most of the sand initially produced large amounts of lake water. This change of material from what was anticipated resulted in the deepening of several grout holes that were originally intended to be completed at the top of the random fill zone (Fig-2). This can be seen

when the originally predicted depths of holes in Figure-2 are compared to the As-Constructed depths in Figure-1. If the holes had not been deepened, water would have flowed under the grout curtain. It is hoped that the material below the Sylamore Sandstone is relatively impermeable or this could still occur.

Drilling and grouting results for each hole are summarized in Table-1 and a cross section of the grout curtain area is provided in Figure-1. Further information, including drill logs and a fact sheet made on each boring drilled can be obtain from the Soils, Geology and Materials Section at Little Rock District Office.

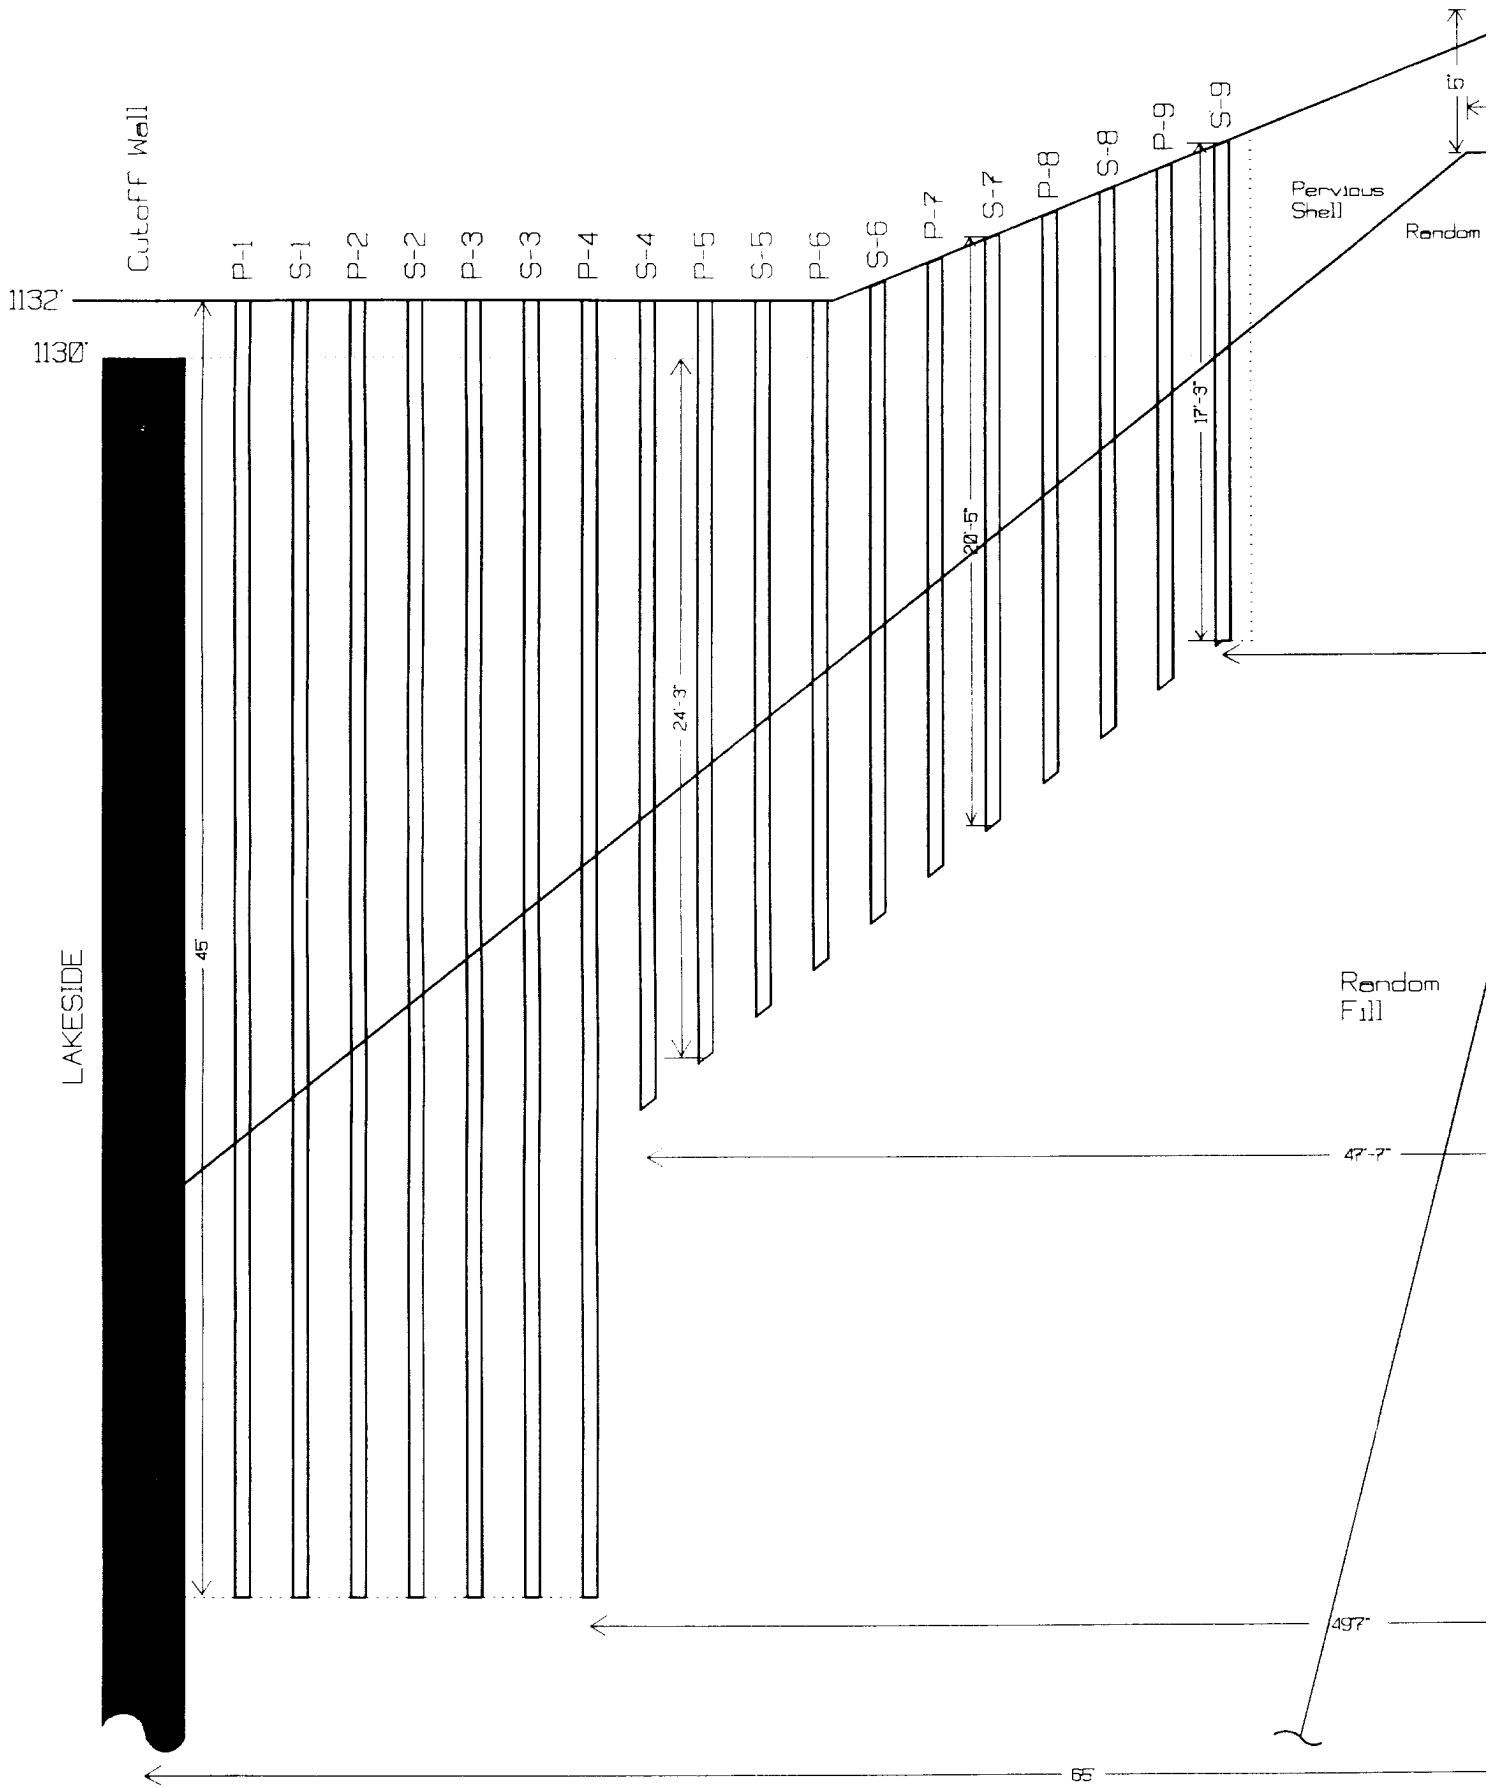
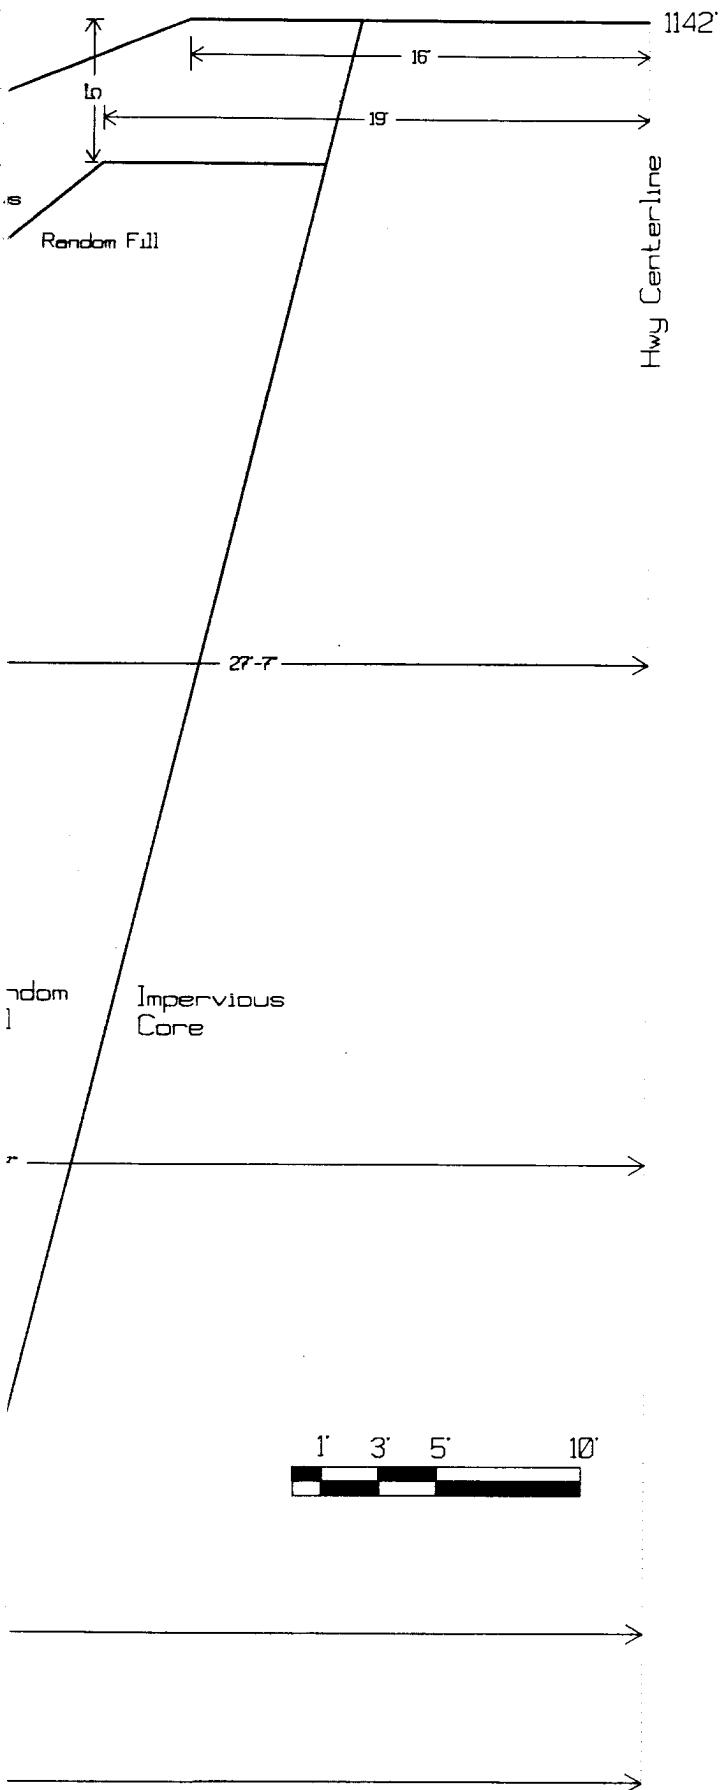
FIGURE 2  
ORIGINAL PLAN  
OF GROUT CURTAIN

1.4 Planning Beaver Wall Extension Grout Curtain. A single line grout curtain extending downstream from the RNJV wall and tying into the impervious portion of the dam was the chosen method of blocking seepage around the south end of the wall (Fig-2). The grout curtain was proposed to be constructed by close spaced drilling (grout holes 2 ft. apart), consisting of primary and secondary holes, with further split spacing if necessary and utilizing gravity as the method of grout placement. The pervious shell was believed to be porous enough that gravity grouting could be used to form the grout curtain. Using gravity alone; however, proved to be inadequate, because of the large amount of fines present in some portions of the pervious shell.

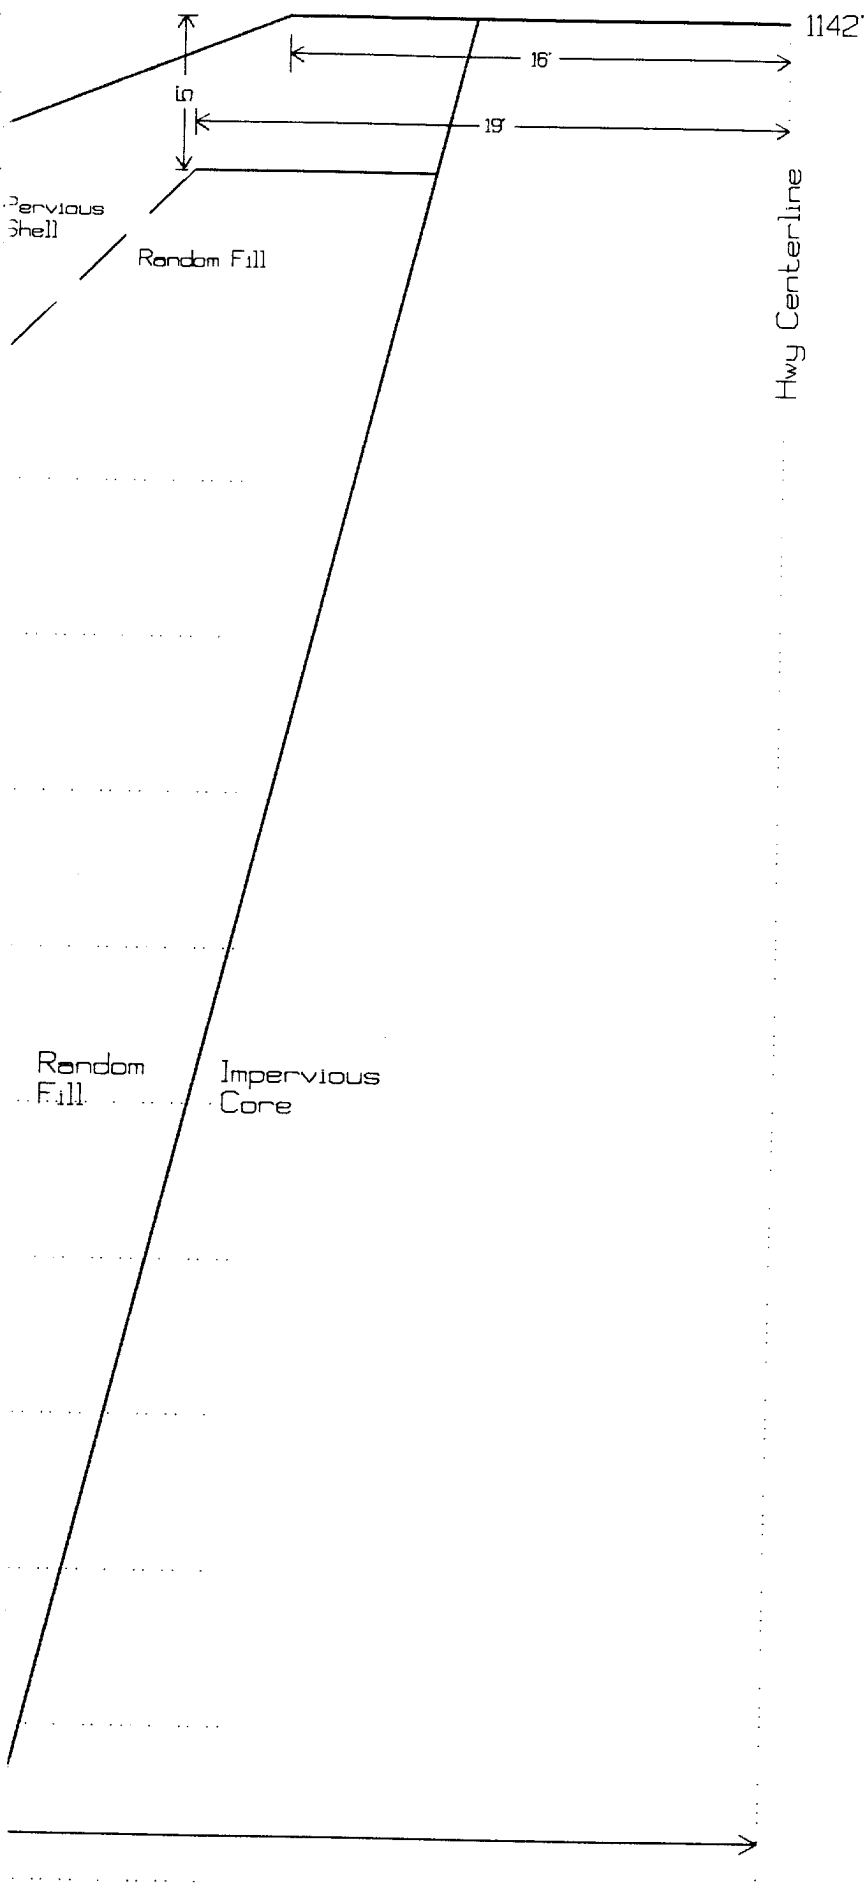
FIGURE 4  
GROUT QUANTITY AND  
PLACEMENT PSI IN  
RANDOM FILL AND  
PERVIOUS SHELL

The last 7 secondary holes also took less grout normally than the primary holes (Table-2, Fig-4) and would have taken significantly less if the grouting pressures had not been increased. The tertiary hole (TS-2) actually took less grout than indicated because it was necessary to wash the hole out

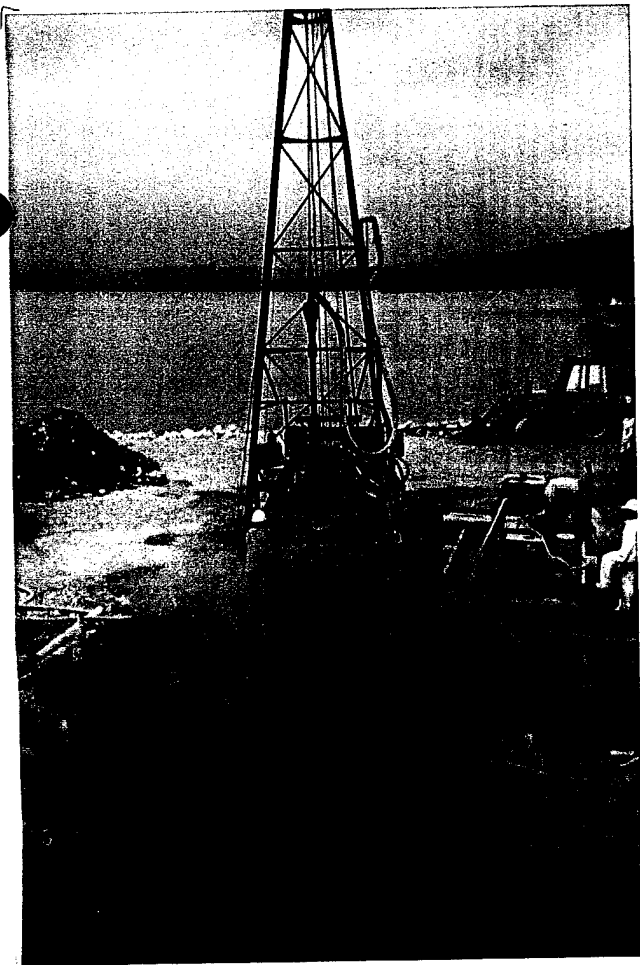
## PHOTO NO. 1

Primary Holes like P-5 shown at left produced a lot of water during air drilling.

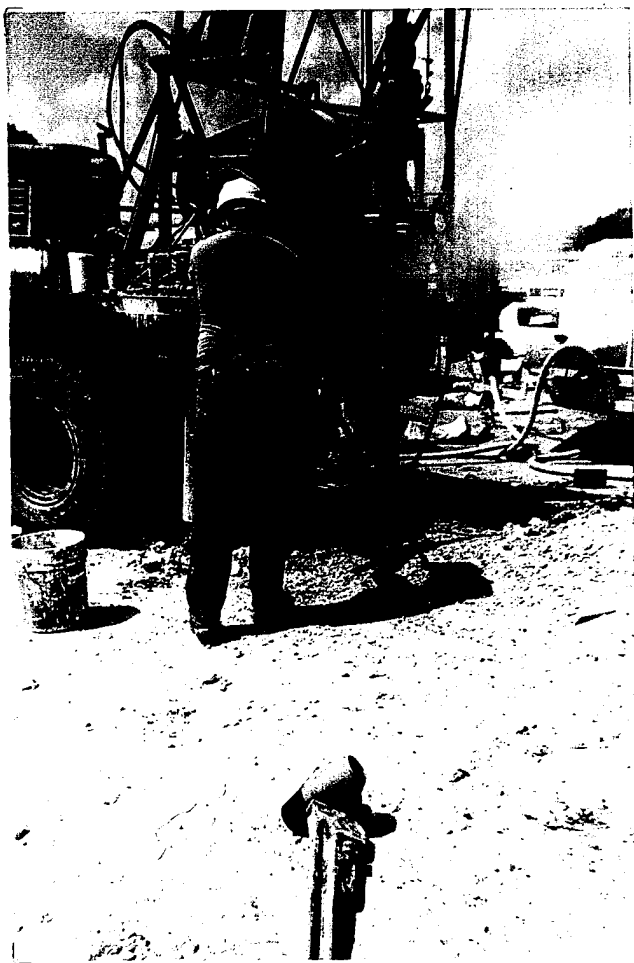
## PHOTO NO. 2

Normally, Secoundary Holes like S-4 shown, produced minimal water. (Dust Rises From Hole)

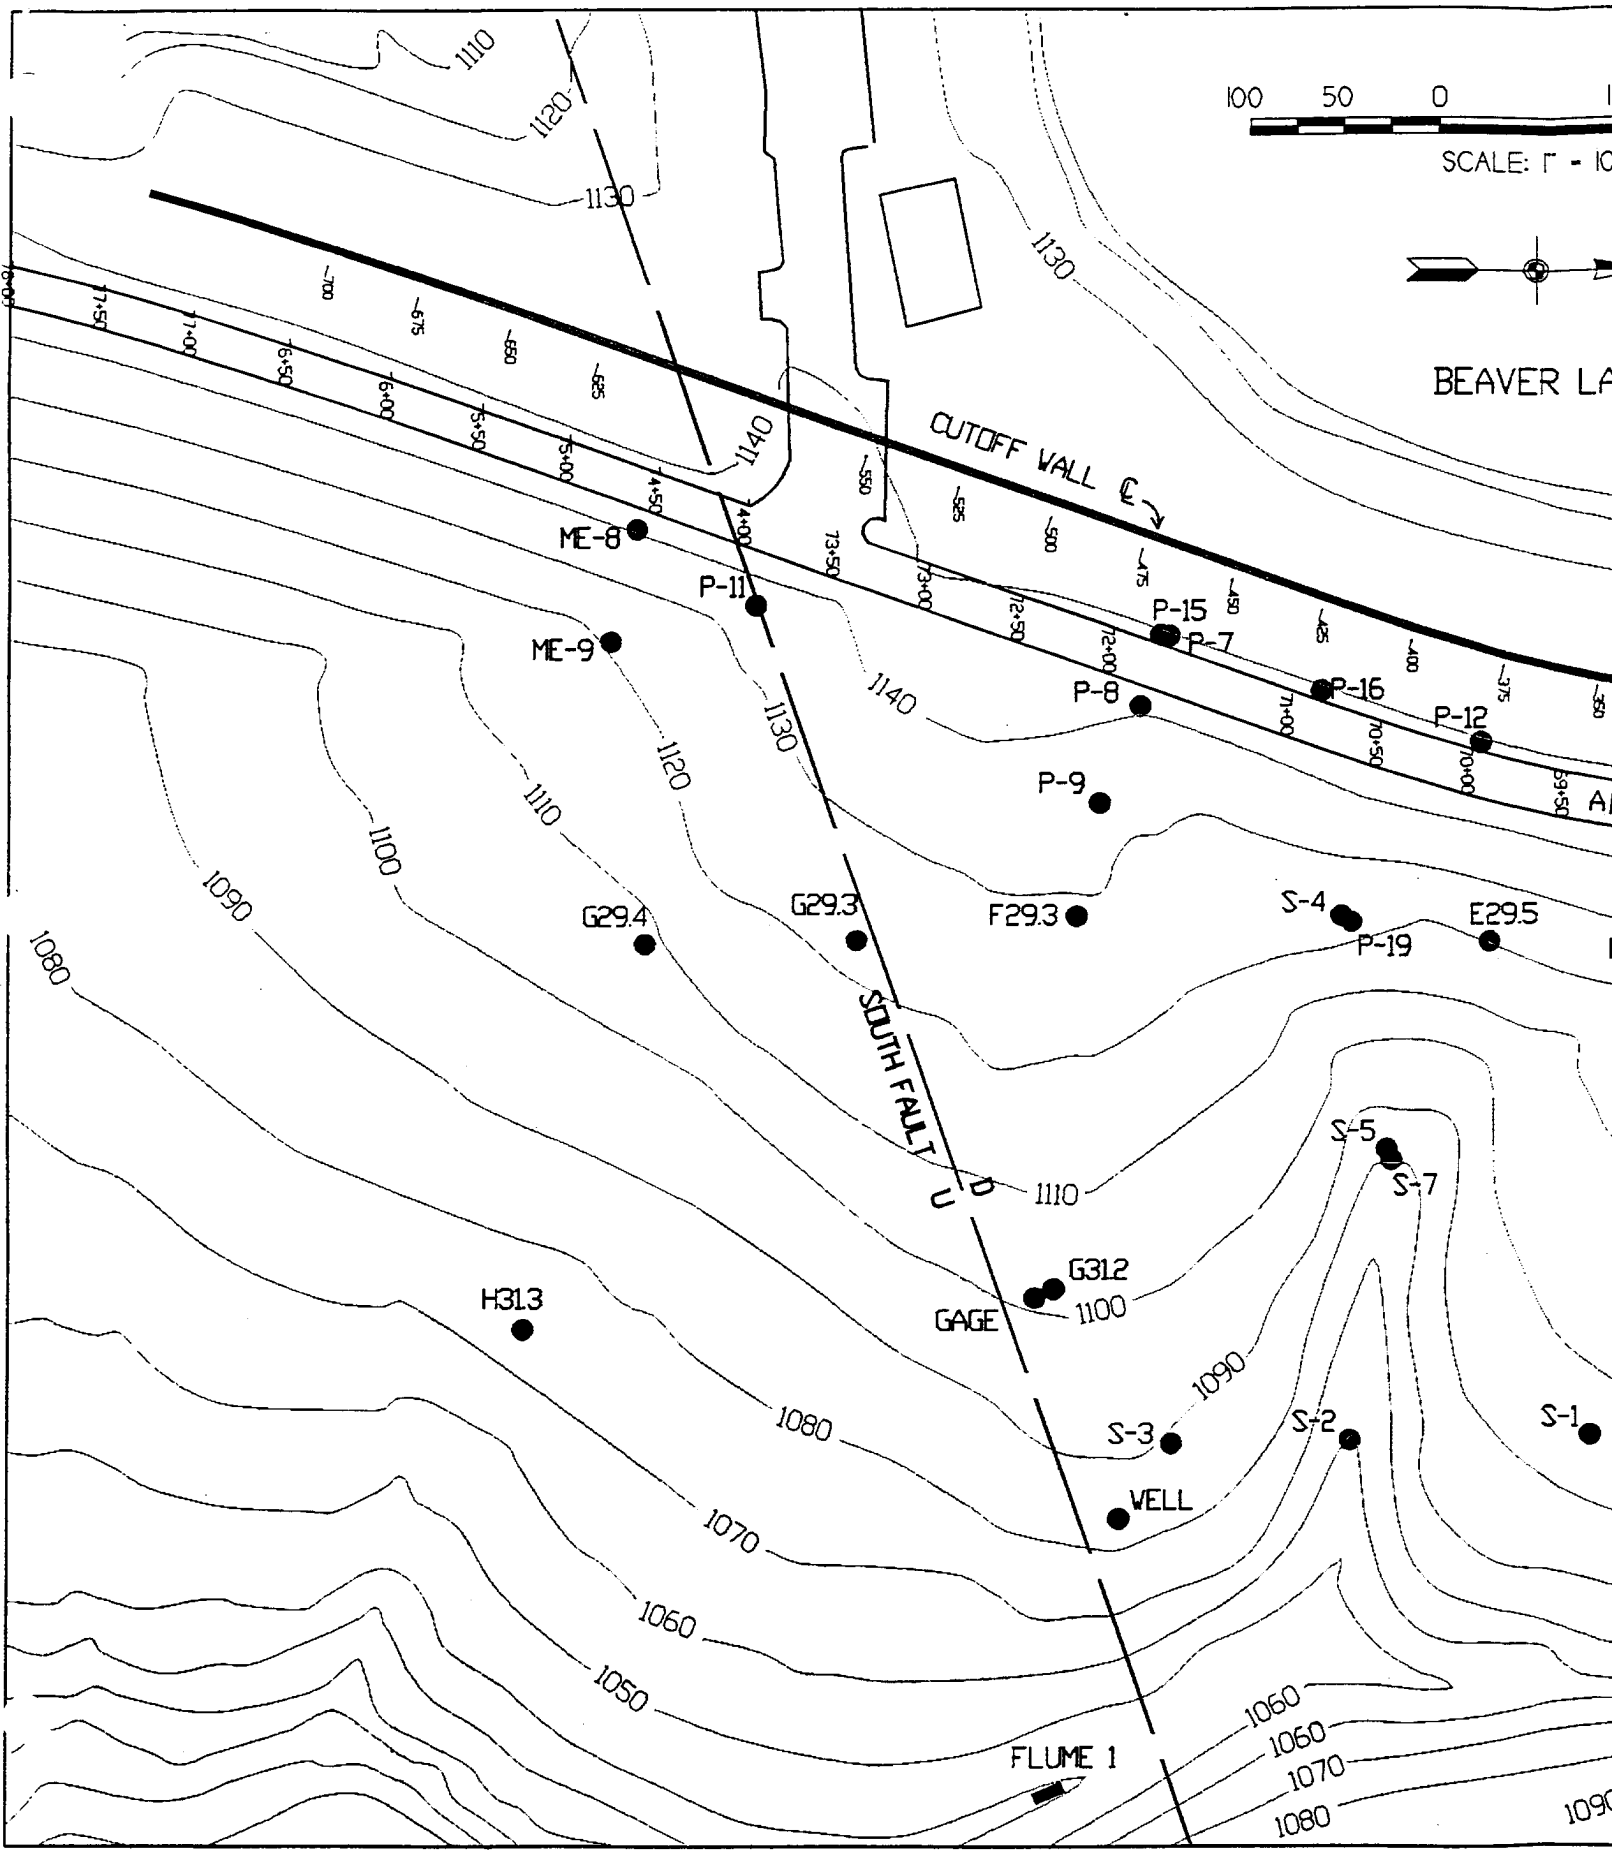
to the pool. One of the automated piezometers (P-11) was evidently damaged by fire this past spring during the intentional burn of the Main Embankment grass.

b. The Main Embankment, Dike 1 and Dike 3 should be mowed before the grass becomes longer than 12 inches to permit observation and monitoring for seepage (reference CESWL-CO-0 memo concerning Mowing of Embankments for Dam Safety, dated 18 November 1994, and ER 1130-2-303 concerning Project Operation Maintenance Guide, dated 15 December 1967). Burning of the grass slopes should be discontinued or be conducted with greater caution to avoid additional damage to automated piezometer equipment.

c. Repairs to seepage instrumentation will be completed by Core Drill personnel at the earliest convenience.

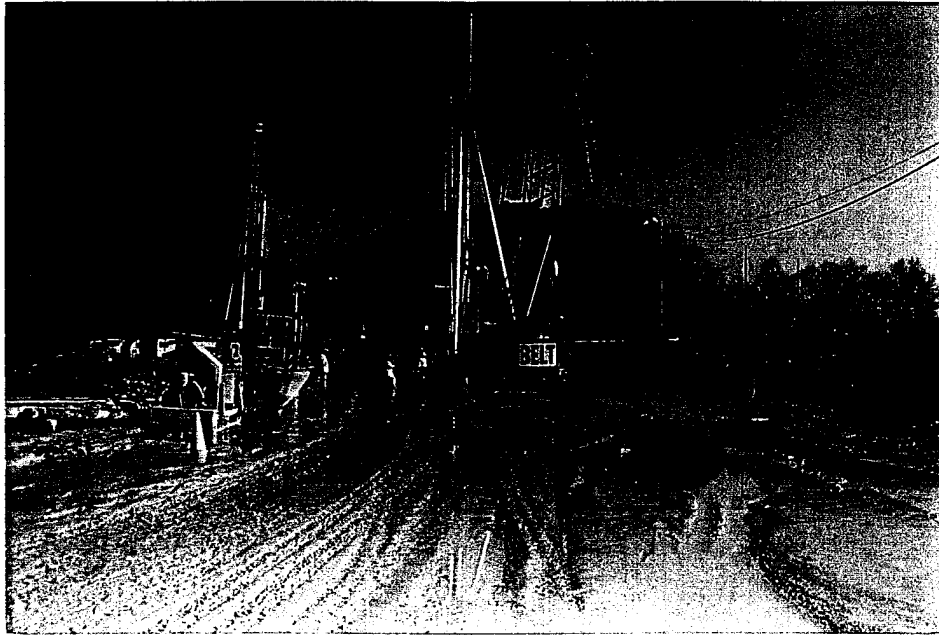
**PHOTO No. 24**

**Platform before drainage system was modified (April, 93)**
