NASA Contractor Report 145326

Flight Service Evaluation of
Kevlar-49 Epoxy Composite
Panels in Wide-Bodied
Commercial Transport
Aircraft - Fourth Annual
Flight Service Report

LOCKHEED-CALIFORNIA COMPANY
BURBANK, CA 91520

April 1978

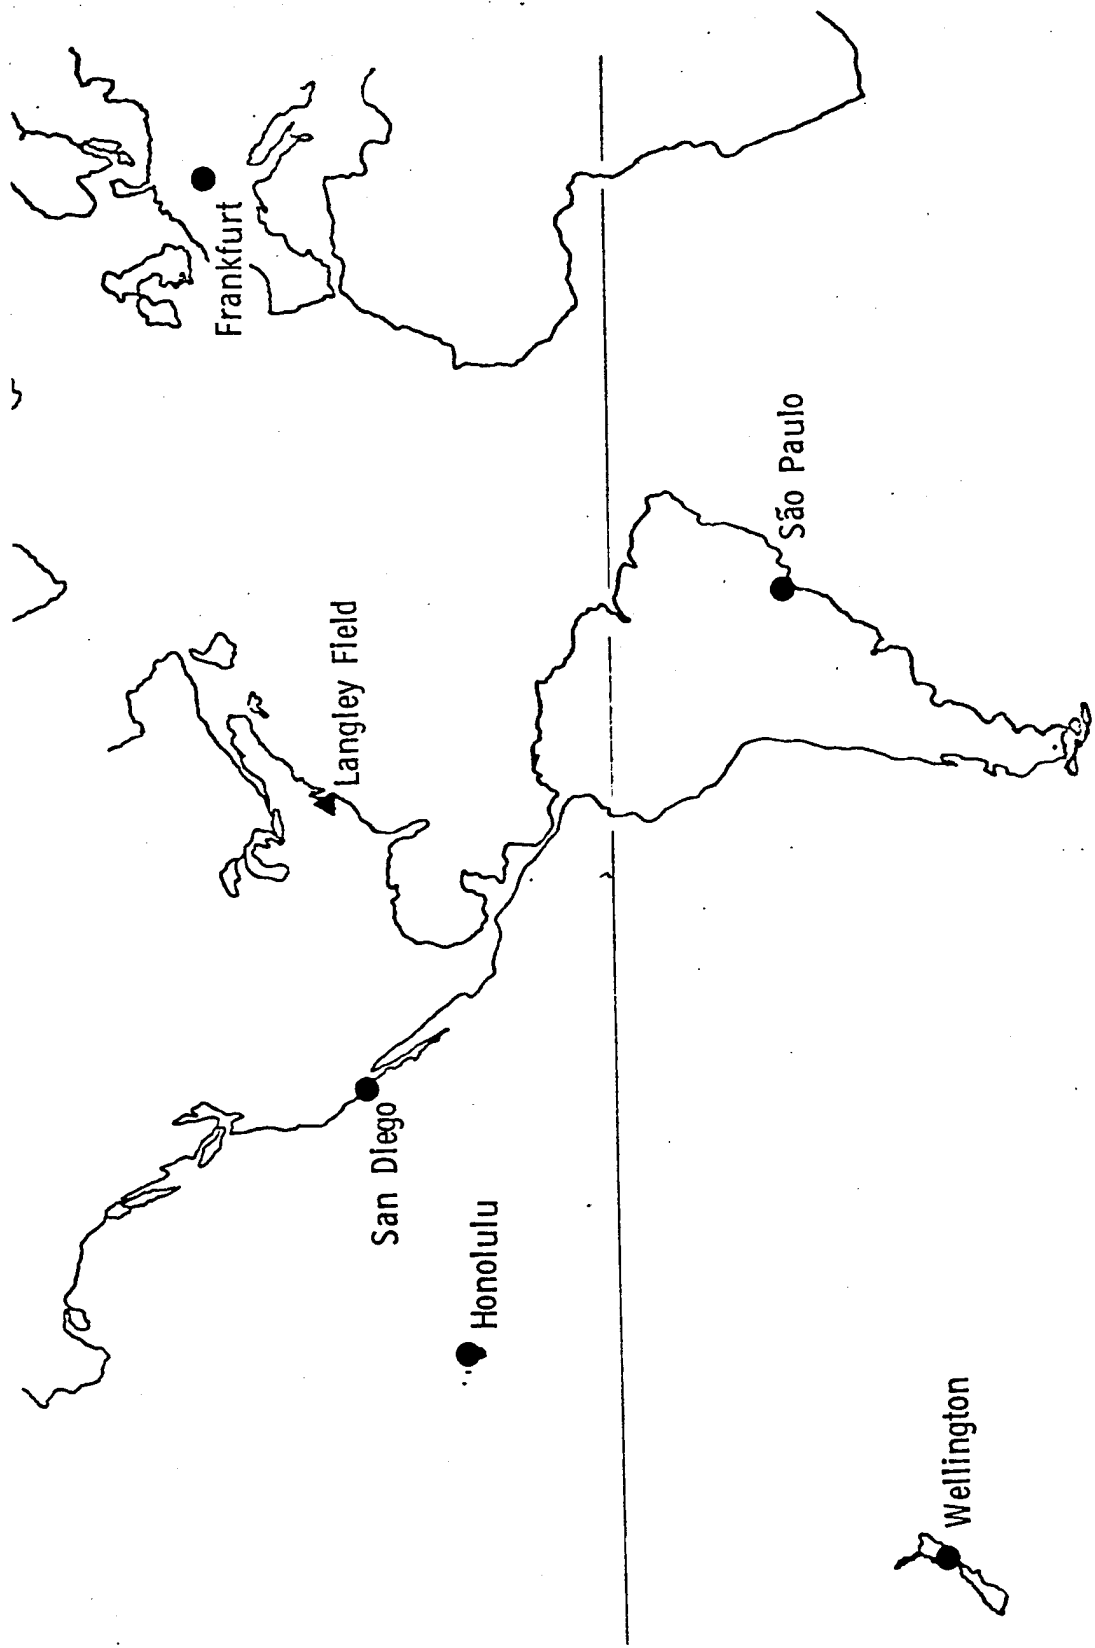
Figure 2. Worldwide Distribution of Environmental Exposure Racks

Figure 2 shows the worldwide distribution of the environmental exposure racks. The average annual temperature and relative humidity for all exposure sites are 290K (62°F) and 75 percent, respectively. Figure 3 shows the moisture pickup data for Kevlar-49/F-155 and Kevlar-49/F-161 flexure specimens after 1 and 3 years exposure. The data shown is for all exposure sites except for the 3 year Brazil data which is not currently available. The average moisture pickup after three years exposure is 2.1 percent for the 450K (350°F) cure Kevlar-49/F-161 system and 1.9 percent for the 394K (250°F) cure Kevlar-49/F-155 system. Figure 4 shows the weight loss data resulting from 3 years outdoor ultraviolet exposure for all exposure sites except Brazil. The exposed surface dimensions for the flexure specimens was 2.54 cm x 6.48 cm (1.00 in. x 2.55 in.). The weight loss data are presented as a function of exposure site latitude. The ultraviolet weight loss varies from 1.5 mg/cm² for the Kevlar-49/F-161 material at the Germany rack location to 7.9 mg/cm² for the Kevlar-49/F-155 material at the Hawaii rack location. The limited data obtained to date indicates that weight loss due to ultraviolet exposure is approximately inversely proportional to the distance of the exposure site from the equator. The weight loss of 7.9 mg/cm² represents about 25 percent of the weight of one ply for the 3.17 mm (.125 in.) thick flexure specimens. Table 1 lists the moisture pickup and ultraviolet weight loss data presented in Figures 3 and 4. It should be pointed out that all the specimens had bare surfaces. Preliminary data from other tests indicate that standard commercial aircraft paint practically eliminates ultraviolet weight loss of composite laminates. However, the paint does not prevent moisture absorption.

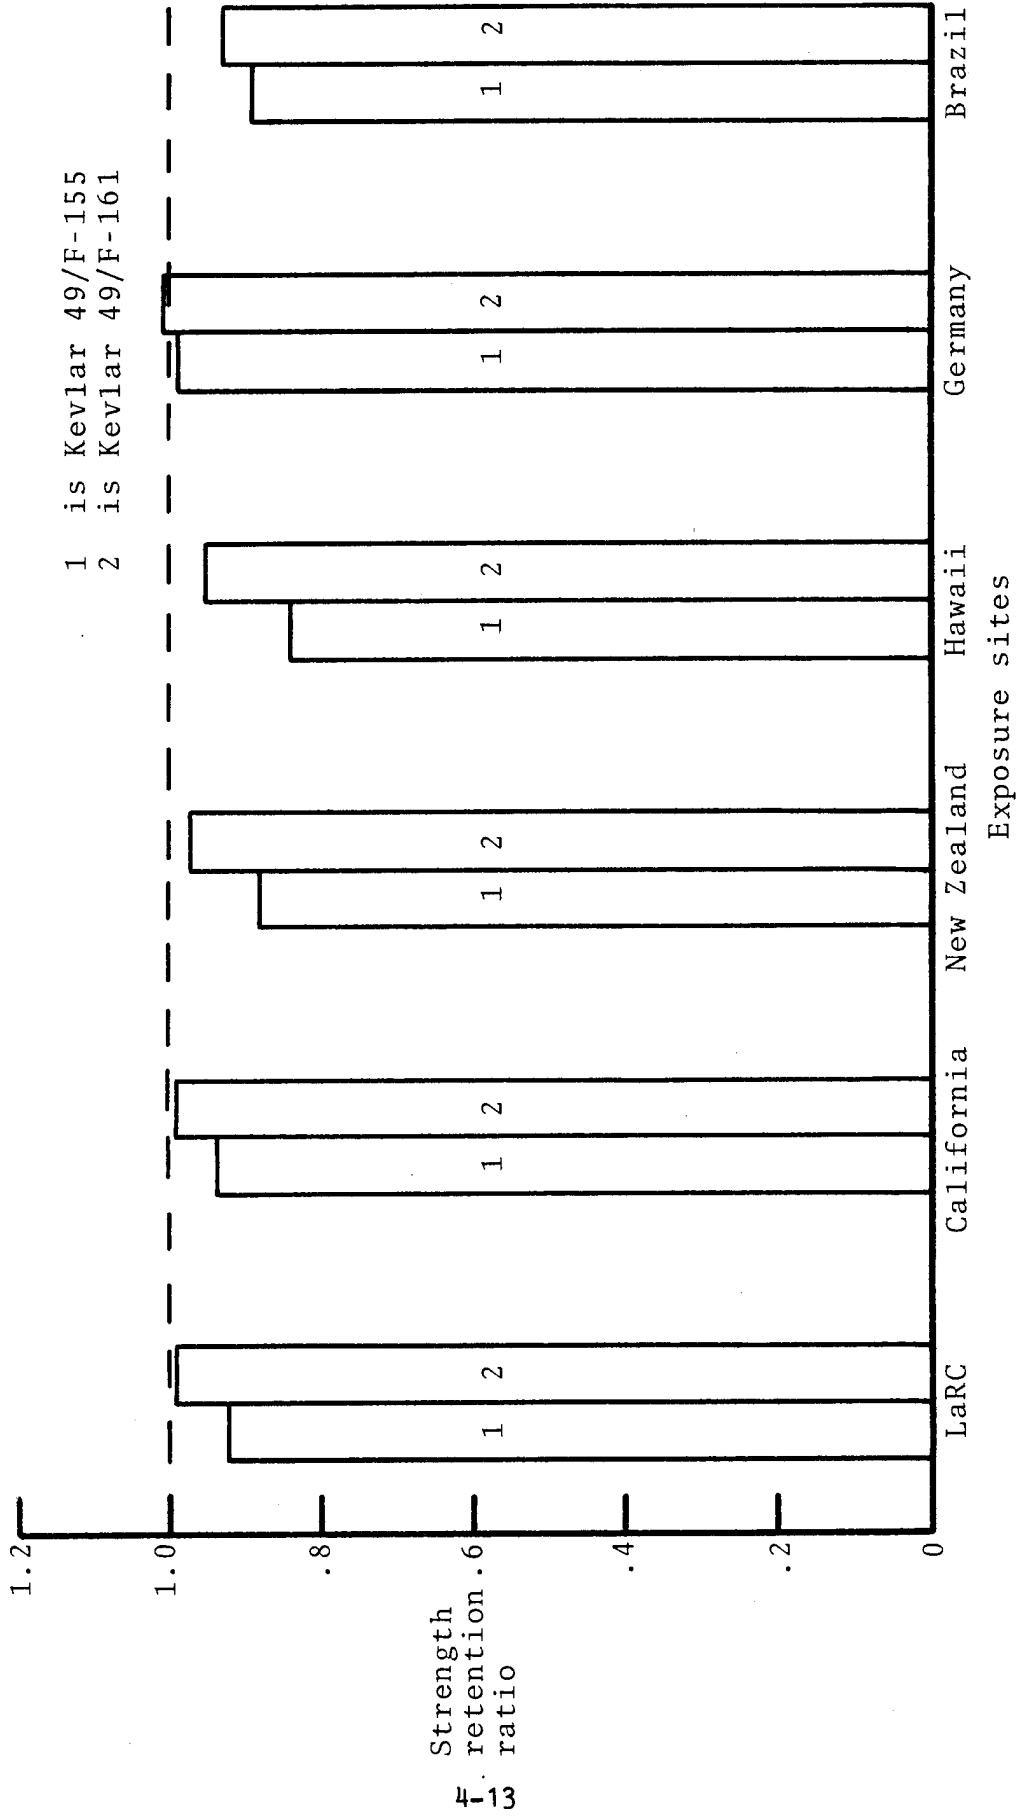
Figure 6. RT Flexure Strength Retention of Kevlar/Epoxy After 3 Years Outdoor Ground-Based Exposure

strength retention for the Kevlar-49/F-155 Hawaii specimens is shown in Figure 6. Very little strength changes have occurred for the Kevlar-49/F-161 flexure specimens after 3 years exposure at all six locations as shown in Figure 6.

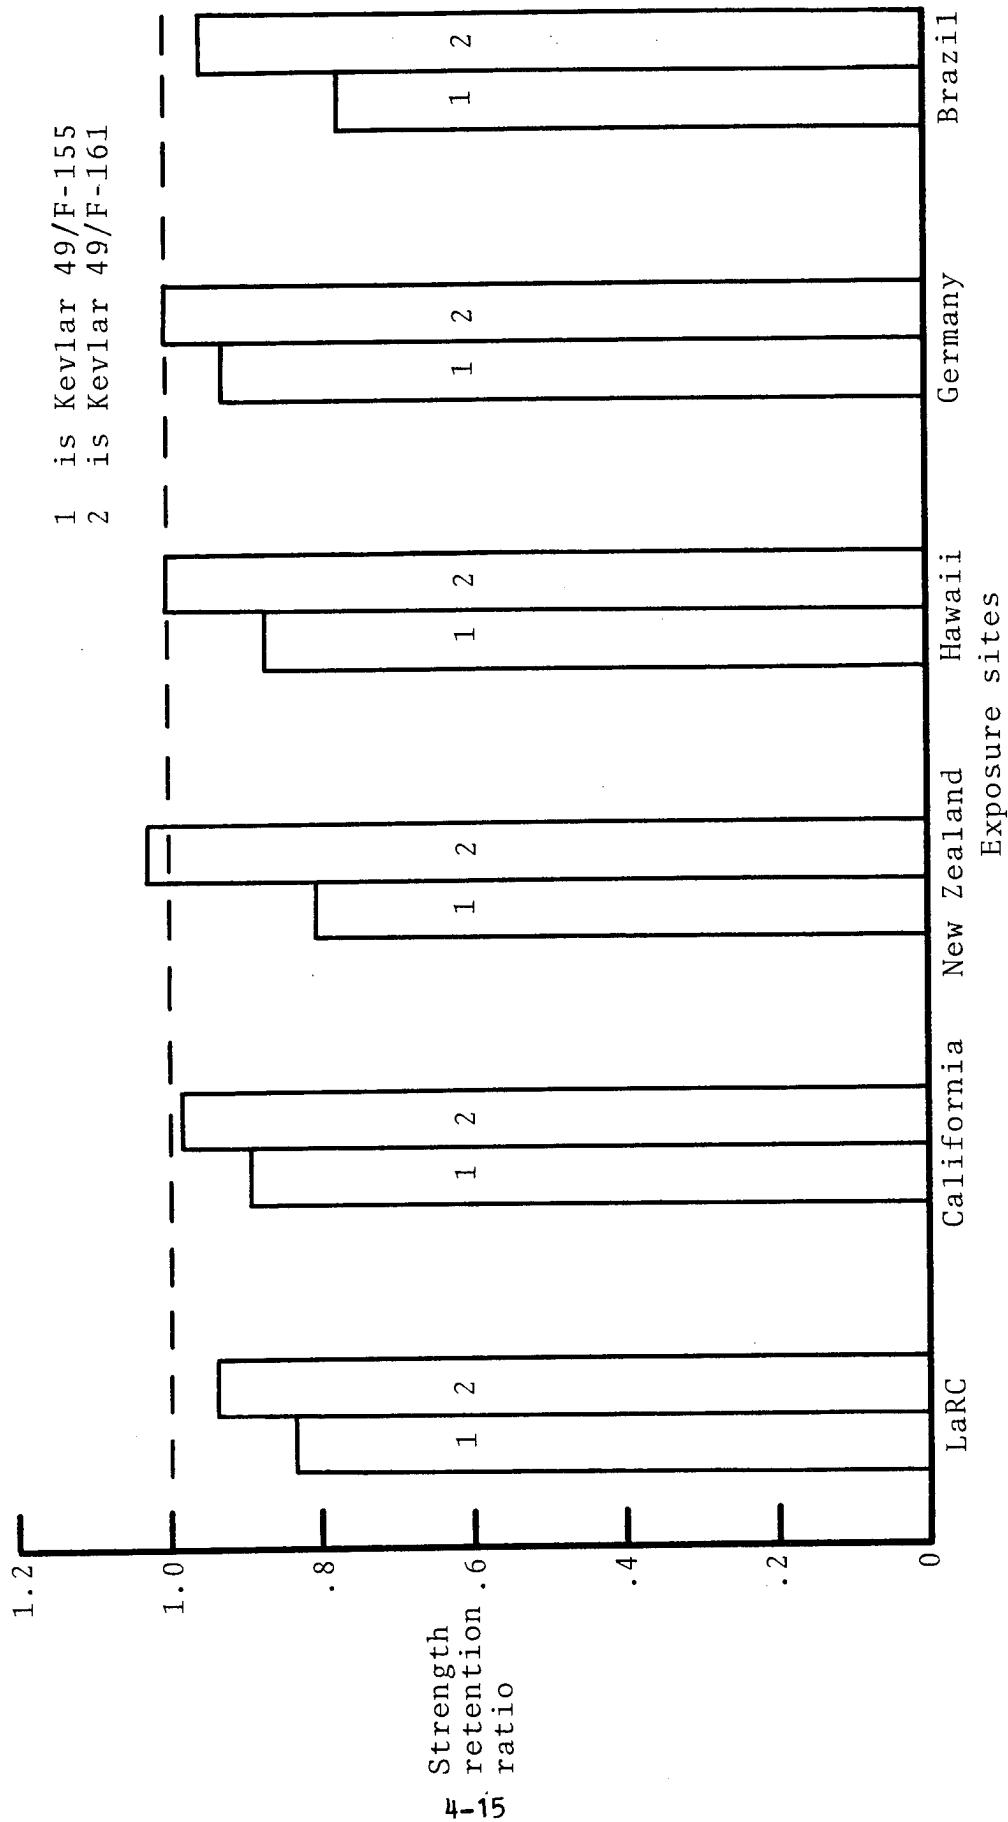
Figure 8. RT Shear Strength Retention of Kevlar/Epoxy After 3 Years Outdoor Ground-Based Exposure

The largest short beam interlaminar shear strength reduction occurred after 3 years exposure in Brazil. A 76 percent strength retention for the Kevlar-49/F-155 Brazil specimens is shown in Figure 8. The largest strength reduction for the Kevlar-49/F-161 shear specimens occurred after 3 years exposure at the Langley Research Center. This strength reduction was only about 6 percent.

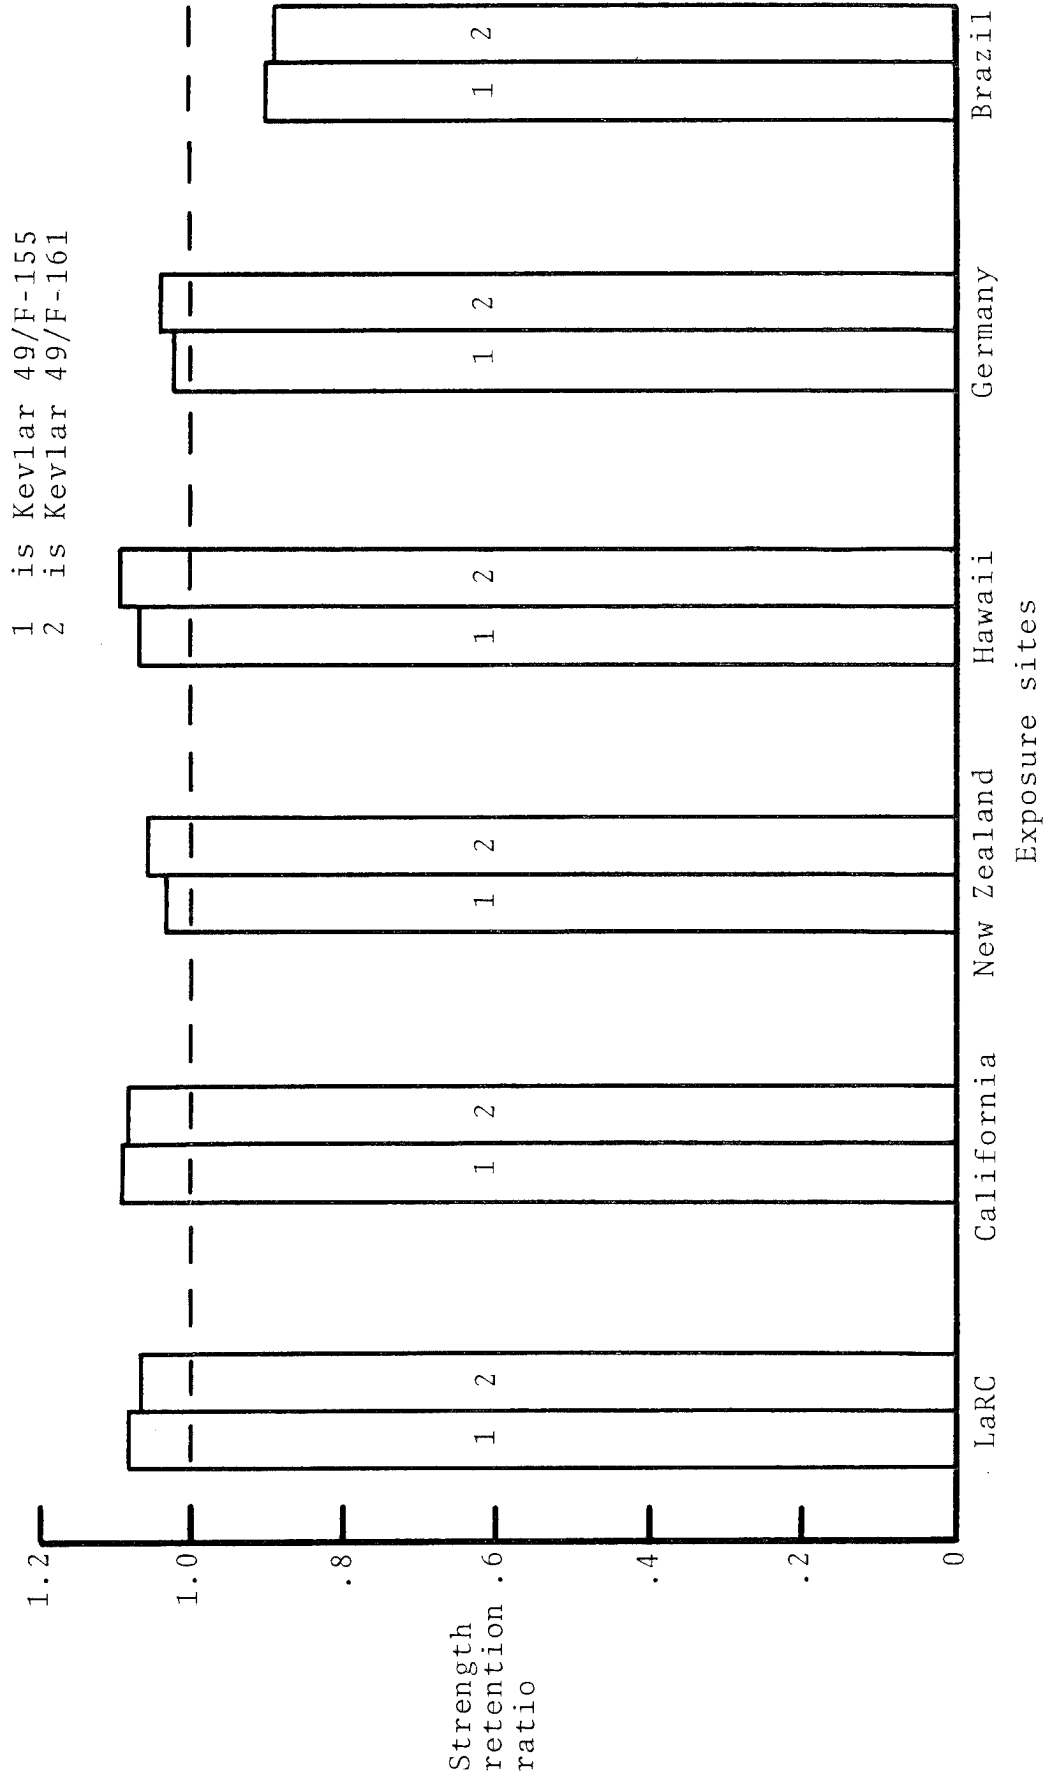
Figure 9. RT Compressive Strength Retention of Kevlar/Epoxy After 1 Year Outdoor Ground-Based Exposure

The 1 year compression strength increased compared to the baseline except for the specimens exposed in Brazil which showed a 10 percent strength reduction as shown in Figure 9. The 3 year compression strength decreased except for the specimens exposed in Brazil which showed a 2 to 4 percent strength increase compared to the baseline specimens as shown in Figure 10. Scatter in the data and a limited number of tests are probably the cause of variations in data trends.

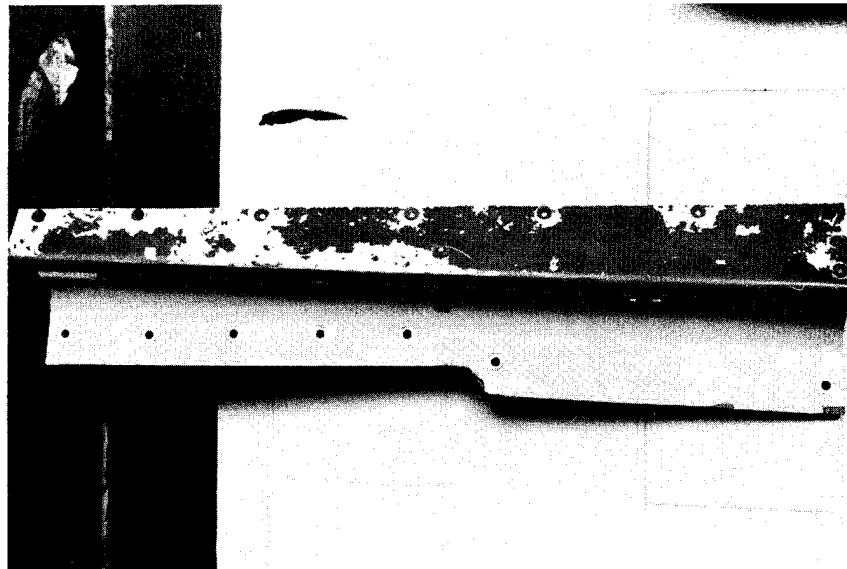
- 2) No surface damage or defects were noted on either surface but considerable paint loss was observed in the upper exterior surface with the Kevlar-49 surface exposed. (Figure 24).
- 3) Slight fraying was observed on all fastener holes. Hole deformation was noted on four holes in the lower area, and seven holes in the upper area. (Figure 25). Four of these were only slight deformation, but the others had maximum dimensions of 0.6 cm (1/4 in.), and 1.1 cm (7/16 in.) in some cases from the original 0.5 cm (3/16 in.) diameter. This represented some increase in the incidence of hole deformation over that observed in 1976, specifically three of the holes in the lower area which were noted to have a slight deformation in 1977, and three of the holes in the upper area observed to have deformation up to 1.1 cm (7/16 in.) in 1977.

Figure 24. Air Canada LH Underwing Fillet - Exterior Surface

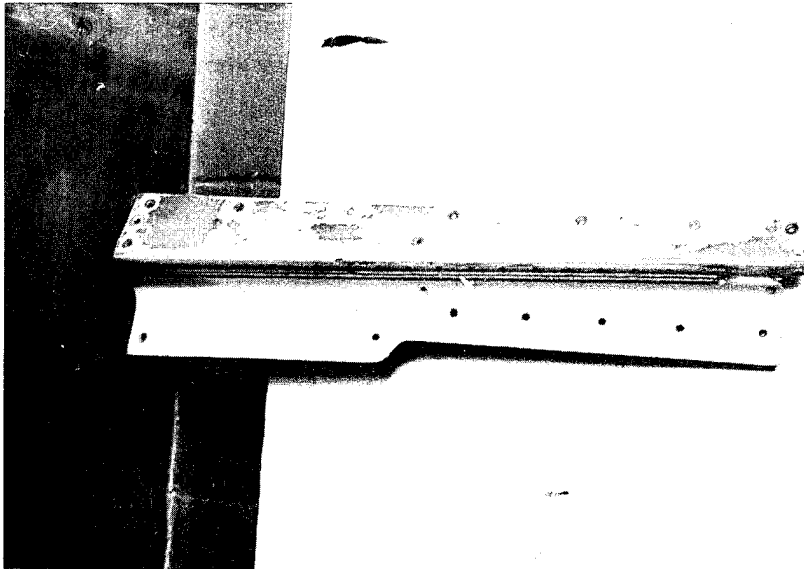
- 1) The panel weight was 0.85 kg (1 7/8 lbs.).
- 2) No damage or defects were noted on either surface, but considerable paint loss was observed on the upper area with the Kevlar-49 surface exposed. (Figure 26).
- 3) Slight fraying was observed around all fastener holes. Hole deformation was noted on eight holes in the upper area, four to a slight degree and the others deformed to a maximum dimension of 1.1 cm (7/16 in.) (Figure 27) from the original 0.5 cm (3/16) diameter. One hole on the lower edge was slightly elongated. This represented an increase in the observed number of elongated holes since their

Figure 26. Air Canada RH Underwing Fillet - Exterior Surface

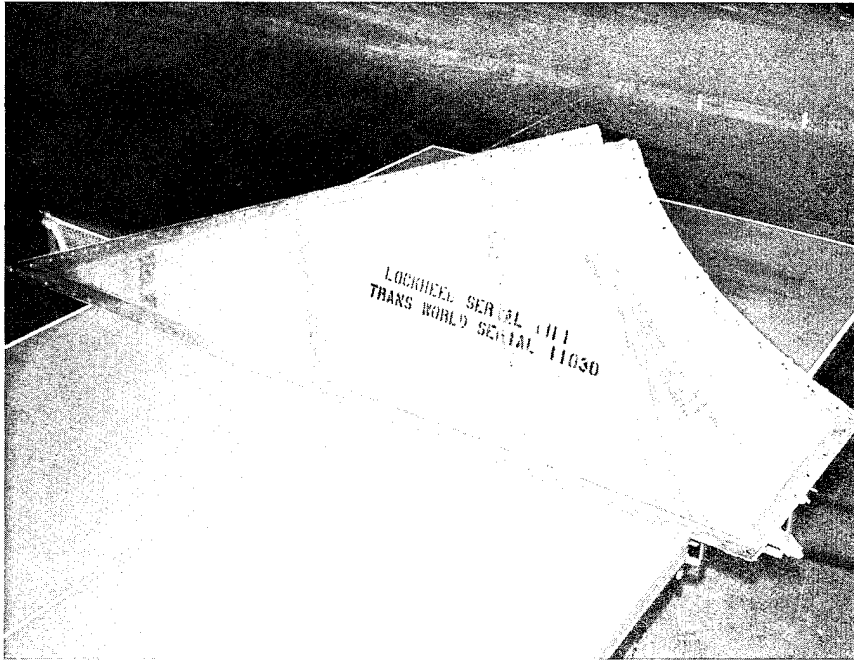
- 1) A paint loss area observed in 1976 had been repainted. (Figure 36). The paint had a rough, porous appearance, and two possible damage areas were observed in the center of the painted area. One was 0.3 cm (1/8 in.) diameter, and the other was 0.5 cm (3/16 in.) diameter. There was no associated delamination.
- 2) The inner surface was free of defects or damage, with the vapor barrier coating applied during reinstallation in lieu of Tedlar Film showing no defective areas or disbonds. (Figure 37).

Figure 37. TWA RH Aft Engine Fairing - Inner Surface with Vapor Barrier Coating

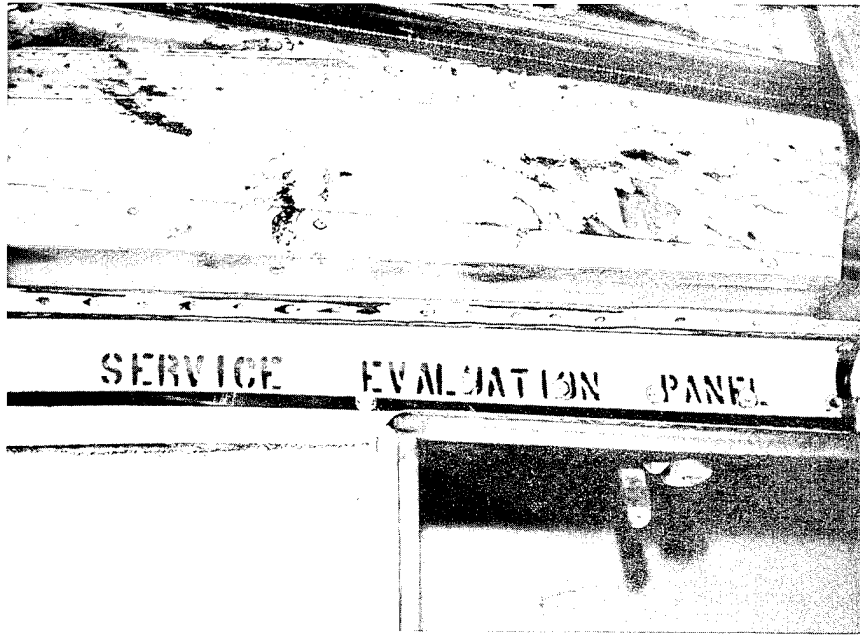
- 1) No damage or defects were visible on the exterior surface. (Figure 41). The lower aft edge had a bulged appearance indicating possible misalignment. No fasteners showed evidence of misalignment, however.

Figure 41. TWA RH Underwing Fillet - Exterior Surface on Aircraft
