SAND 80-0808
UNLIMITED DISTRIBUTION

PROTECTIVE COATINGS AND SEALANTS FOR
SOLAR APPLICATIONS

K. B. WISCHMANN
M. H. GONZALES

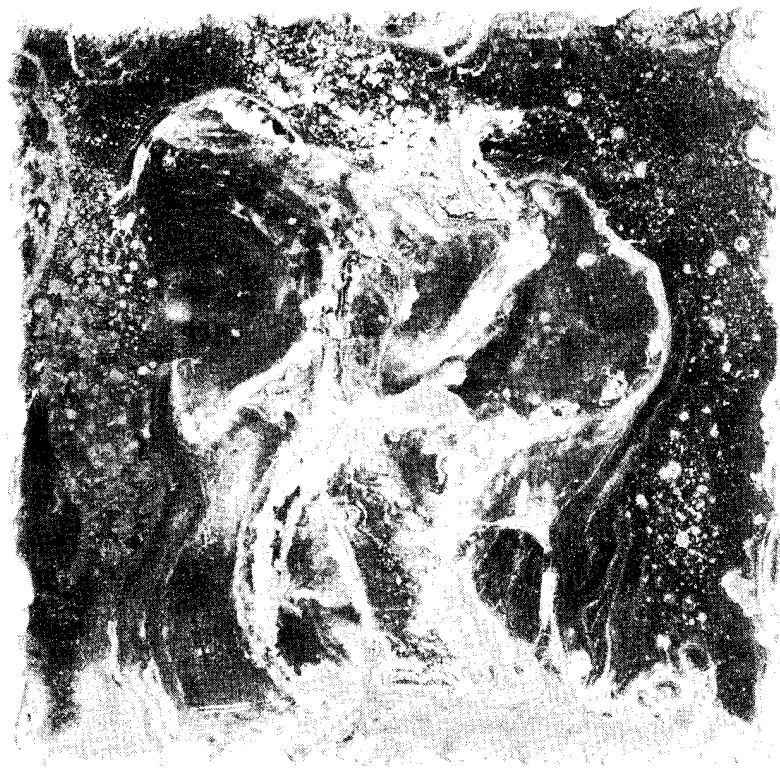
FIGURE 13

The sine wave fiberglass substrates sealed with either epoxy-fiberglass or melamine exhibited mirror deterioration after 6 months with increased degradation at 12 months (see Table 4 and Figures 11-16). Figures 11 and 15 are samples in which accidental impacts led to cracks. No deterioration was noted around the crack shown in Figure 11, whereas the sample in Figure 15 exhibited considerable pitting along the crack edges. In the first instance the bonding integrity of the silver and gray paint must still be substantial to preclude any silver degradation. In the latter sample, the bonding must have been weakened from the impact resulting in degradation. Post-mortem examination of the modules shown in Figures 11 and 12 dramatizes the degradation effects attributed to thermal expansion mismatches in sandwich heliostat structures. The sine wave ribs are perpendicular to the mirror surface and work against the mirror during thermal cycling causing debonding in the immediate contact area. This phenomenon provides a pathway for moisture to enter. Notice how the corrosion pattern replicates the sine wave structure. Mirror longevity is just as much a function of heliostat design as is material selection.

FIBERGLASS FACE
SINE WAVE FIBERGLASS BODY
