NASA Contractor Report 3816

Advanced Composite Vertical Fin for L-1011 Aircraft

*Design, Manufacture, and Test
(Executive Summary)*

A. C. Jackson
*Lockheed-California Company
Burbank, California*

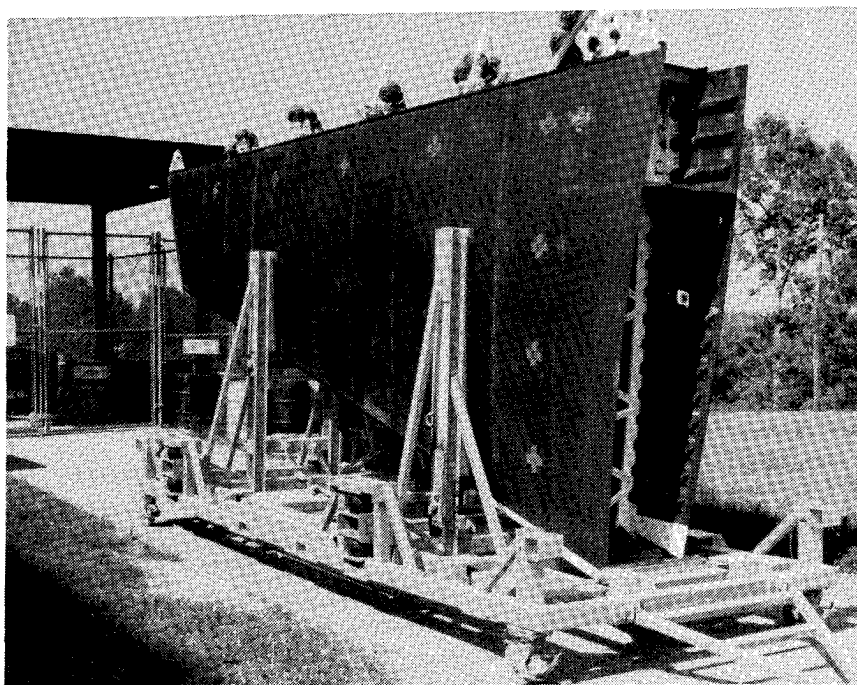
Figure 26. - Shipment of fin box on specially designed, shock-mounted dolly.

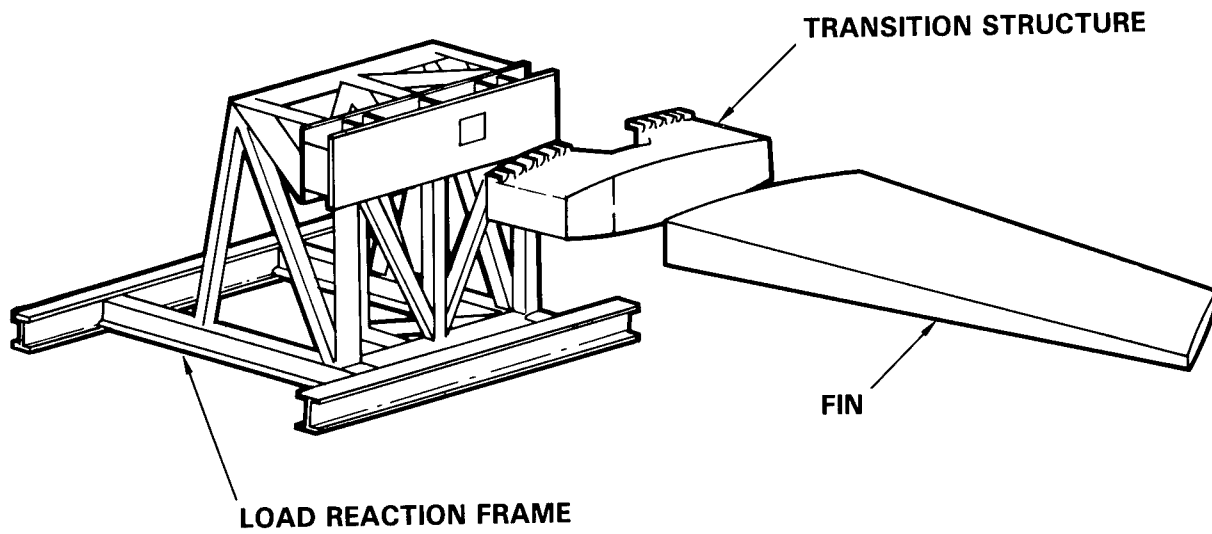
The fin and transition structure were attached to the load reaction frame in a horizontal attitude as shown in figure 27.

Figure 27. - Test installation of fin in load reaction frame.

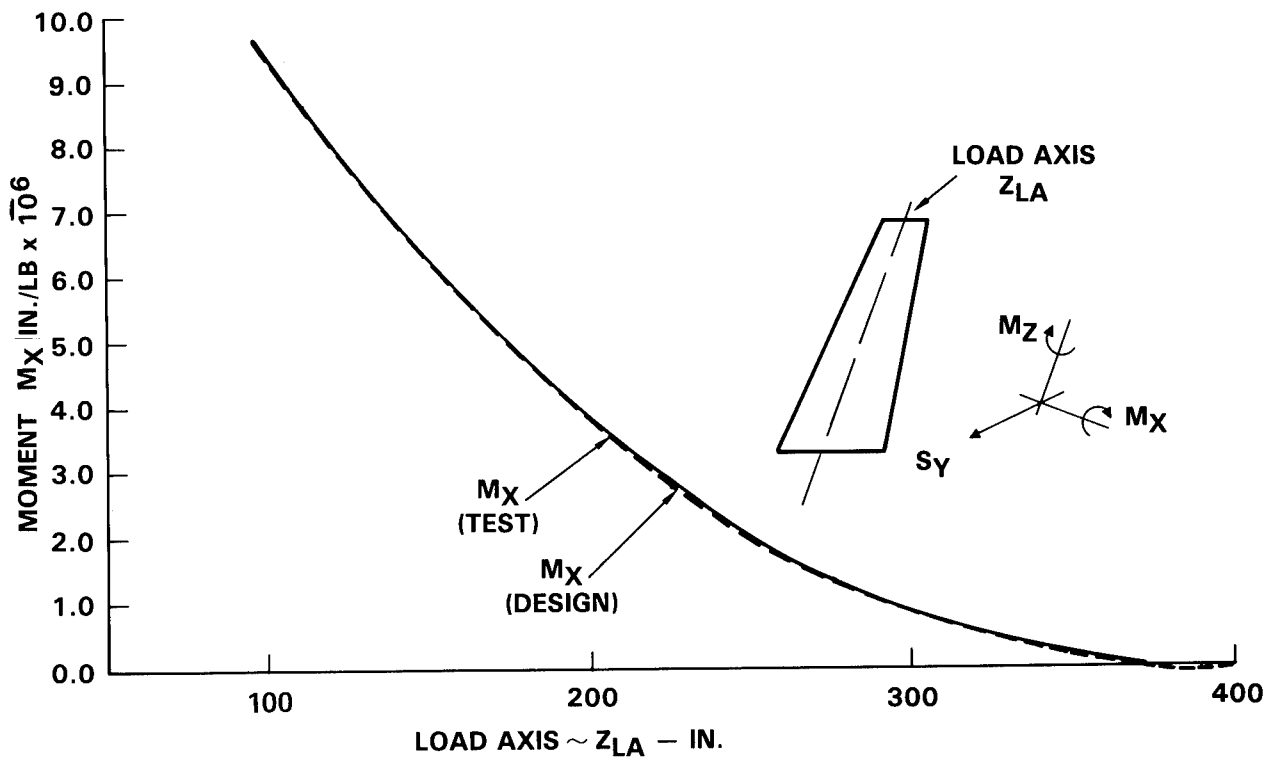
The ground test article (GTA) was tested with static loads simulating a high bending dynamic lateral gust condition. This condition was critical for the front spar and covers and adequately loaded the whole structure. A comparison of the design and test bending moments is shown in figure 28. A factor of 1.06 was applied to the loading to account for environmental effects as the tests were conducted at ambient temperature and moisture levels.

Figure 28. - Test bending moment compared with design bending moment.
