# THE IMPACT RESISTANCE OF CURRENT DESIGN COMPOSITE FAN BLADES TESTED UNDER SHORT-HAUL OPERATING CONDITIONS

INTERIM REPORT

GENERAL ELECTRIC COMPANY  
Advanced Engineering and Technology  
Programs Department

NASA Lewis Research Center  
Contract NAS3-16777

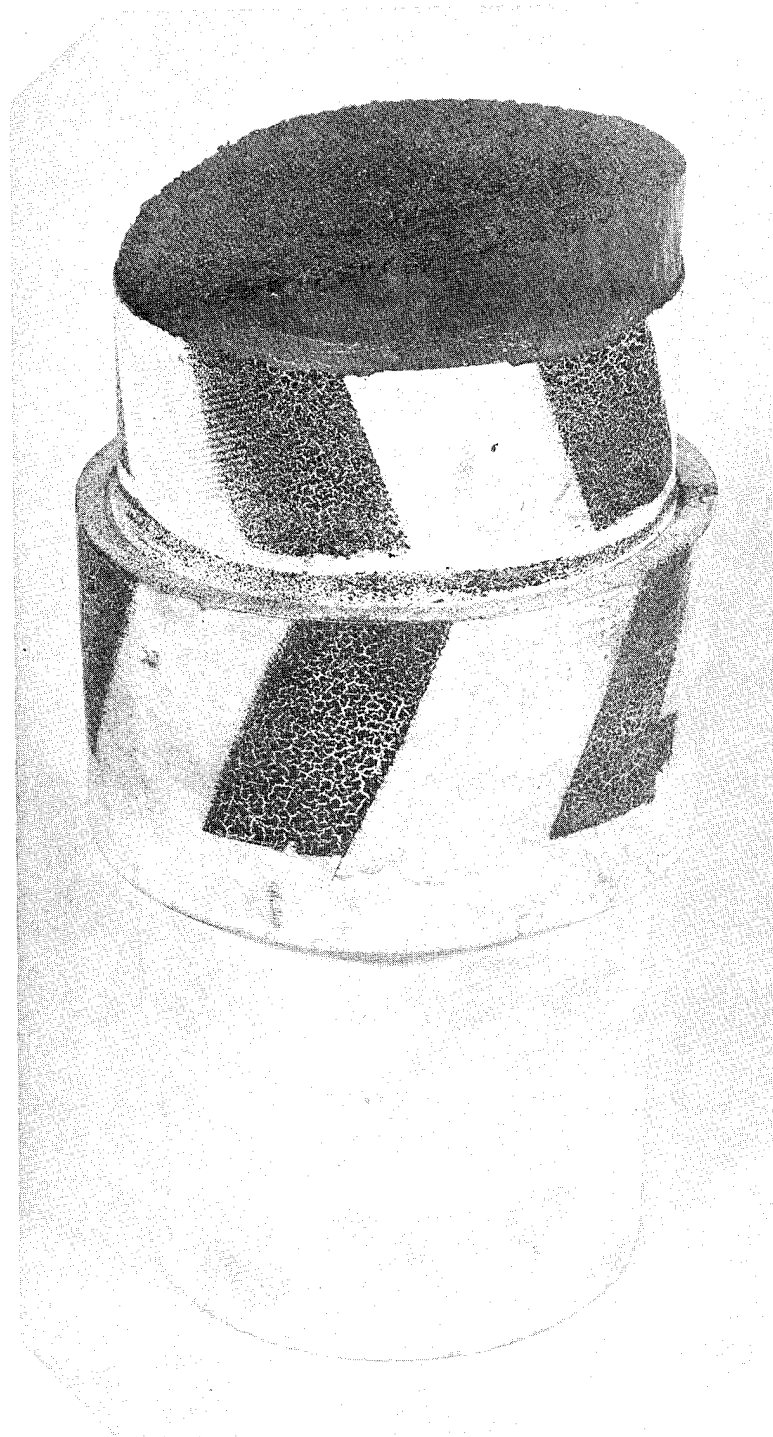
Figure 3. Photograph Showing Containment of Simulated (RTV) Bird After Impact, 12 oz Slice Removed.

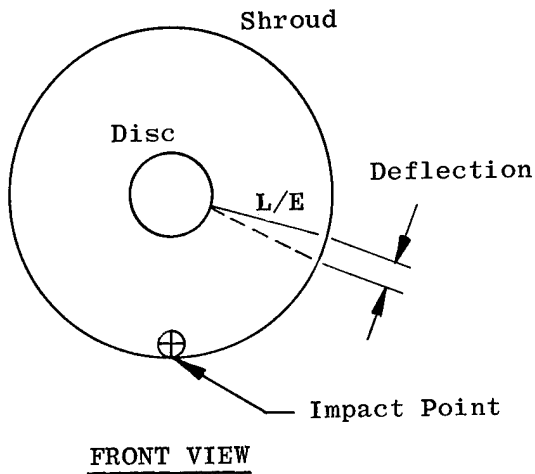
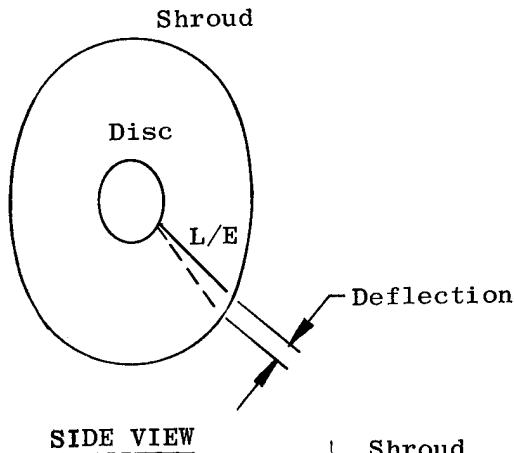
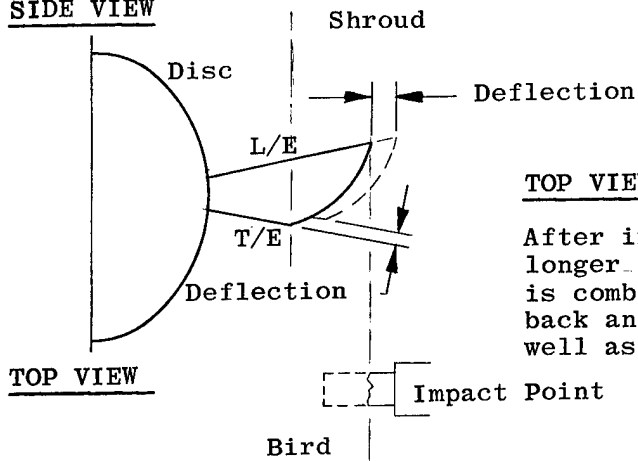
Front and side views show position of blade leading edge before and after impact typical for 5 and 3 o'clock positions.

Deflections are a combination of bending and twisting.

After impact blade appears longer and narrower. Deflection is combination of blade bending back and axially forward as well as untwisting.

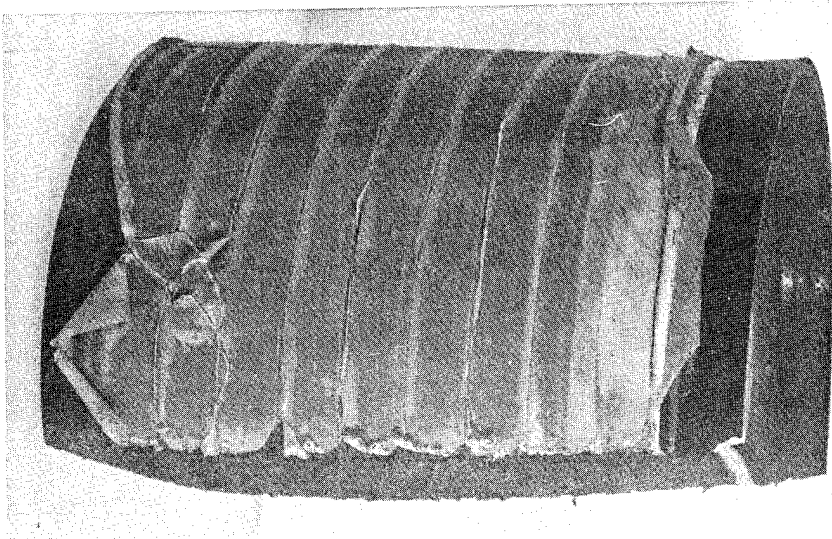
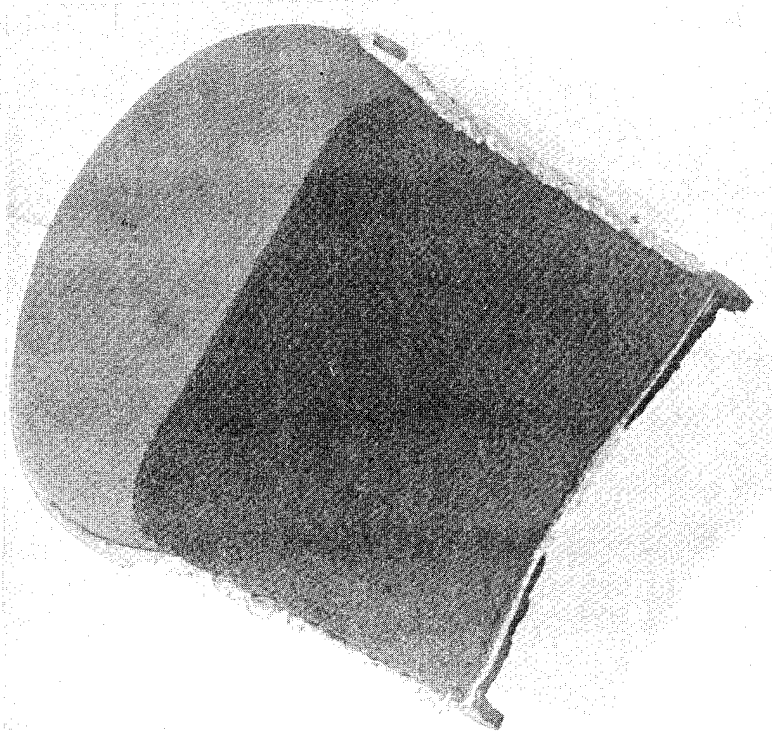
These facts have been greatly clarified during the present program by the recovery of projectiles after impact. A typical projectile recovered after testing is shown in Figure 15. The sliced plane is clearly shown as the dark region extending from the front of the projectiles, and tapering into the projectile toward the rear. The sharp intersection of the slice-plane with the front surface of the projectile shows the initial projectile "bite" that is set up as an initial test condition.

Figure 15. Typical RTV Recovered Projectile after Inertial Head Impacting of Composite Blades.
