The Significance of Defects in CFRP Bonded Honeycomb Structures  
and Non-Destructive Test Methods for Their Destruction

R. L Crocker, et al

Fulmer Research Institute  
Stoke Poges, England

R736/4/May, 1978

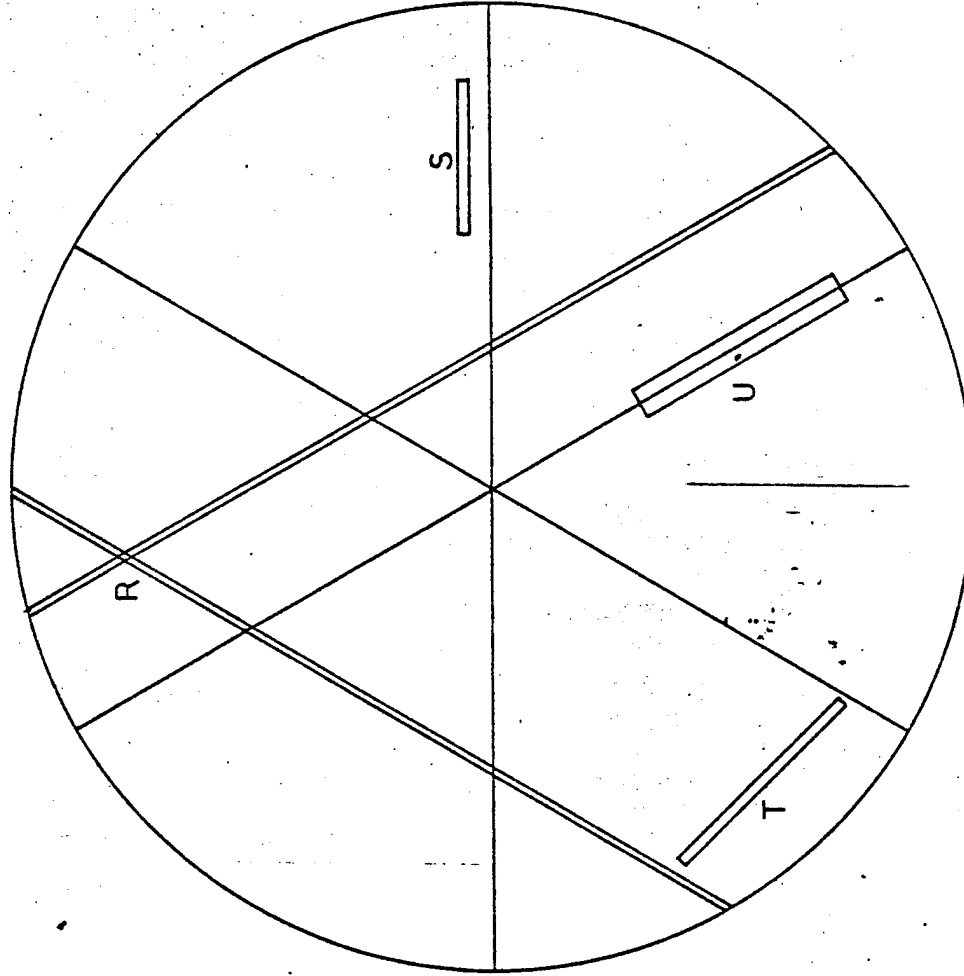
FIG.11 Plan of laminate defects (layer 1 is nearest to the core).

| <u>Phase</u> | <u>Test No.</u> | <u>Input Level</u> | <u>Frequency</u> | <u>Comments</u> |
|---|---|---|---|---|
| | 3 | 20 | 400 | A.E. event. Source located at defect U (Fig. 11). |

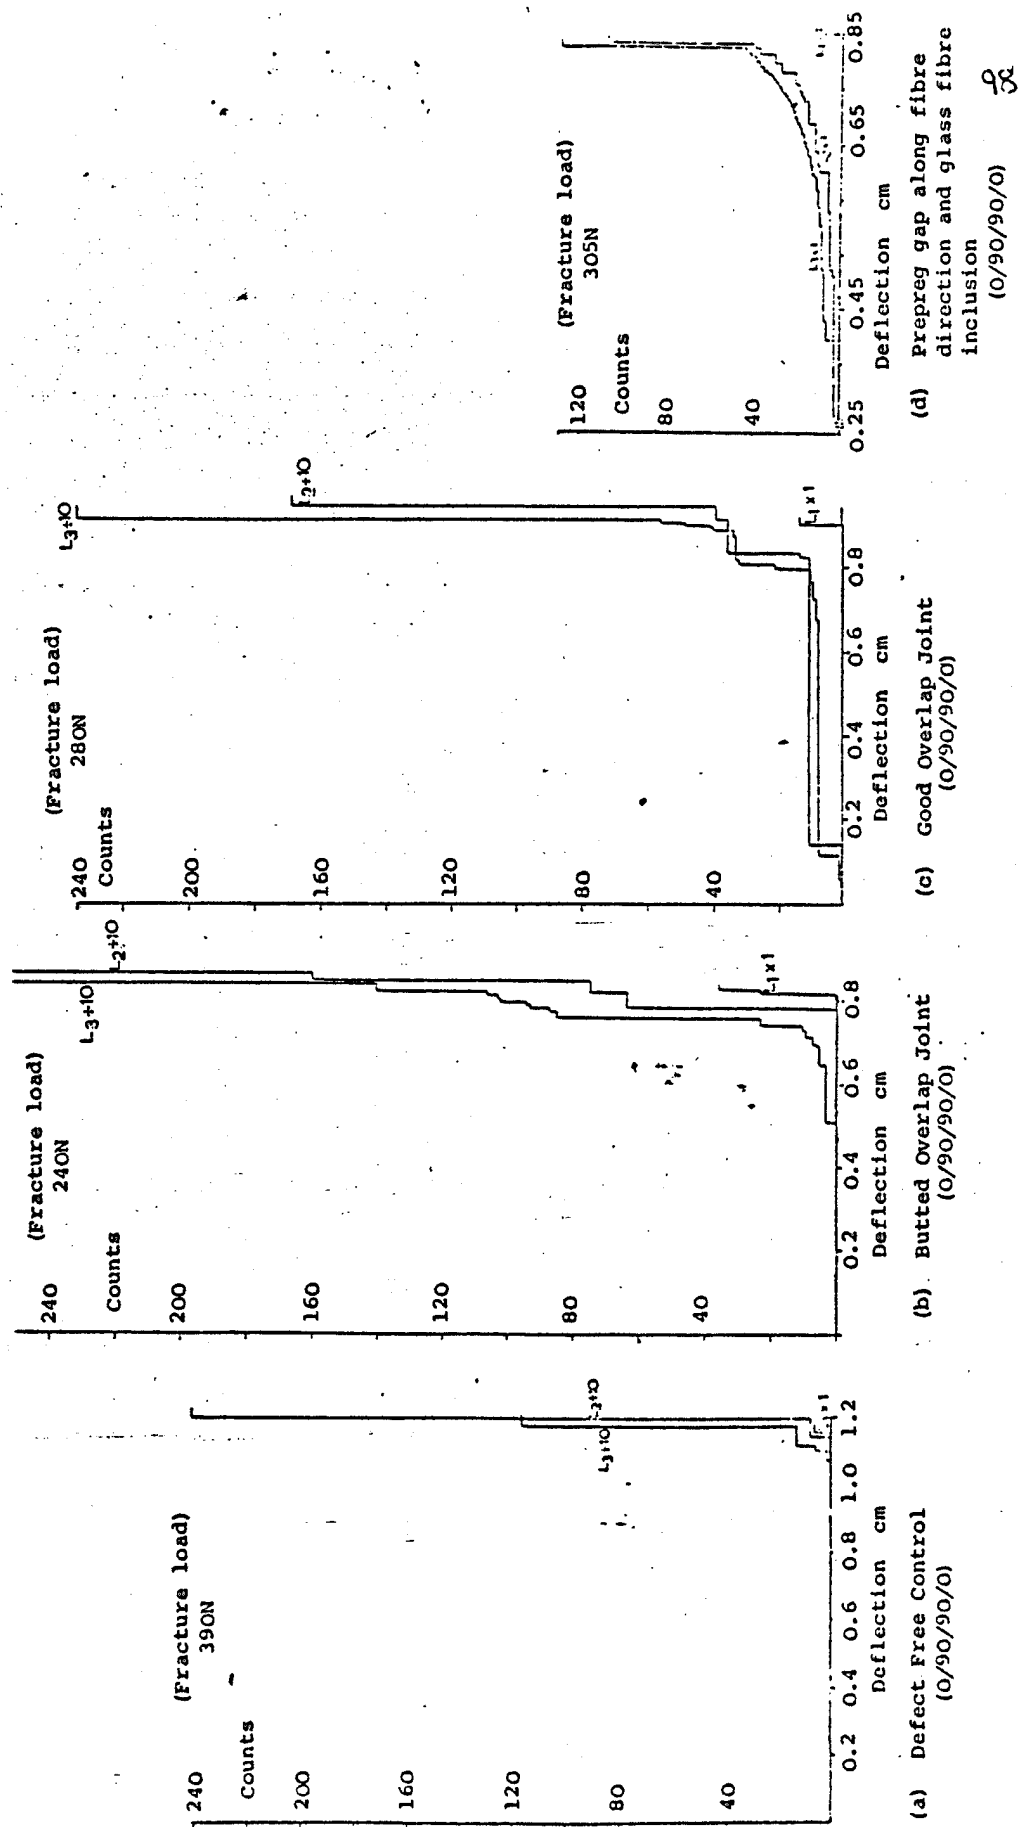
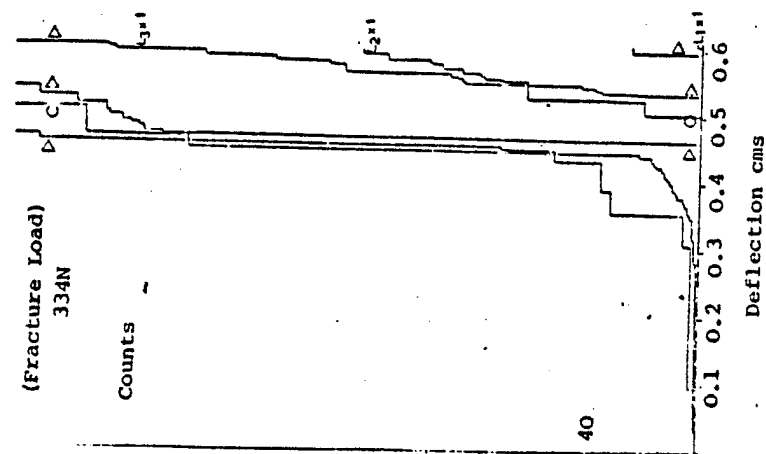
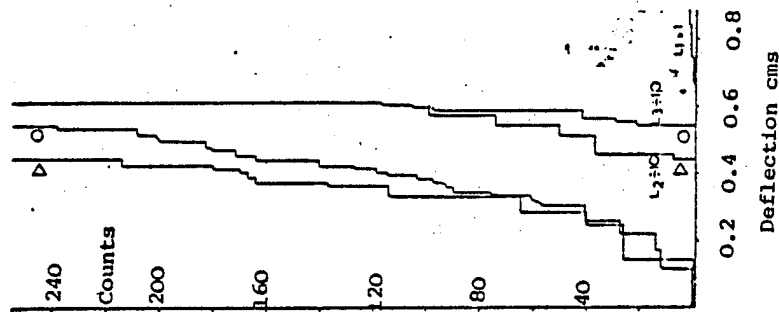
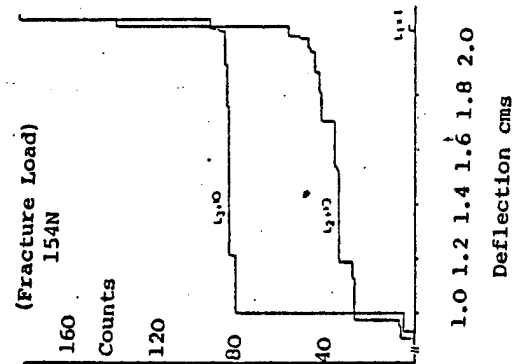
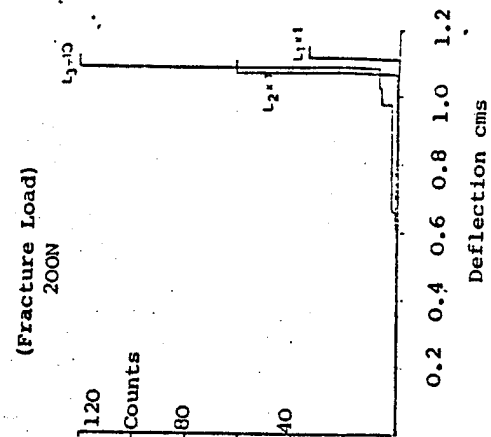
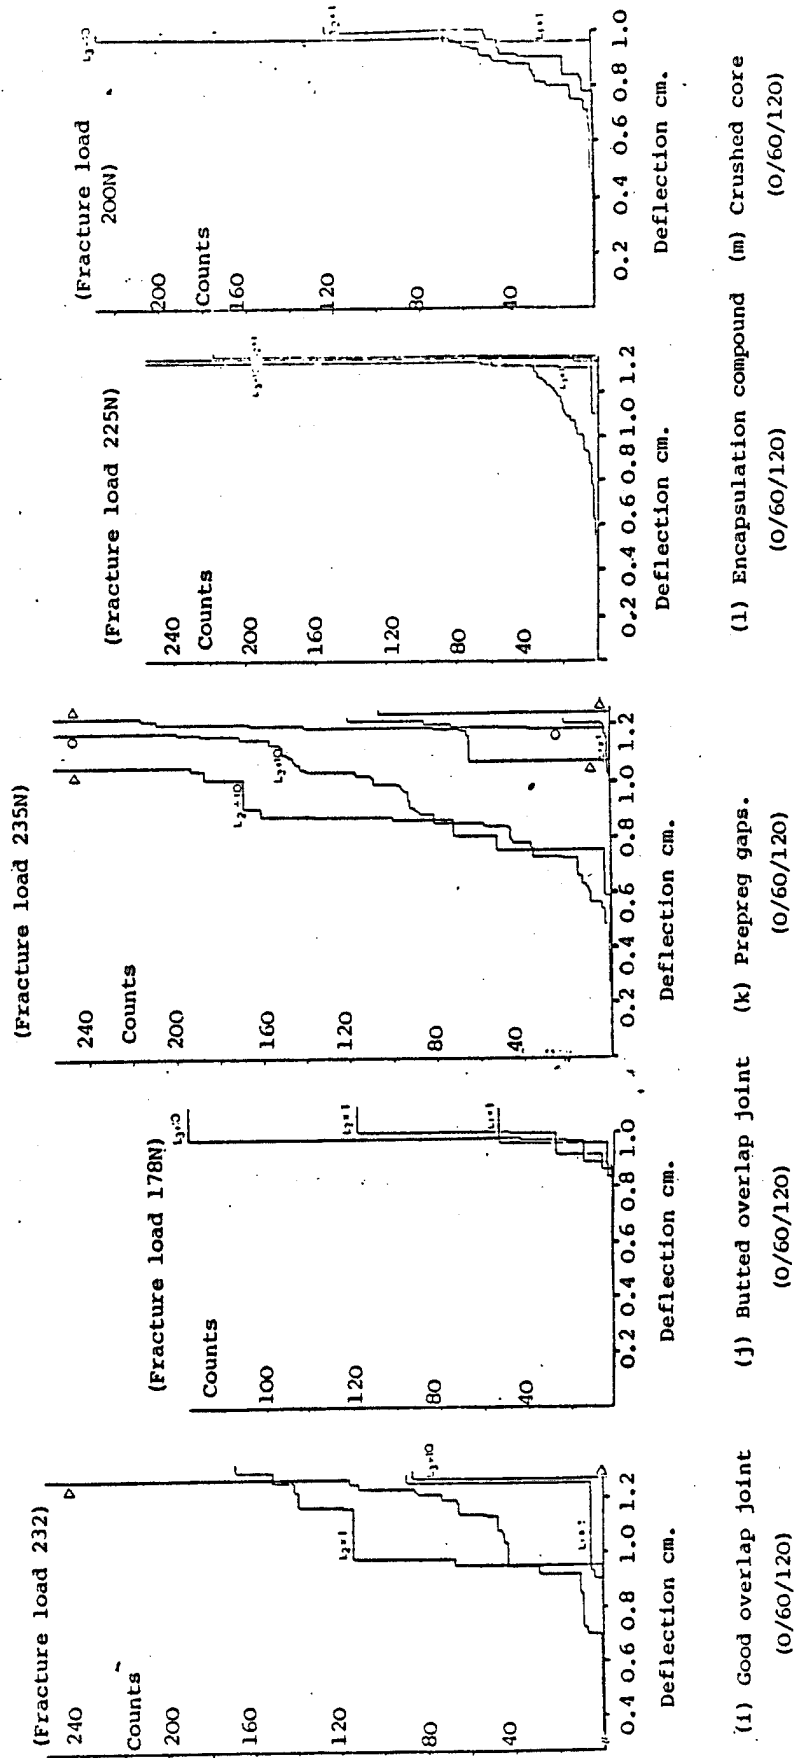
Figure 21 Acoustic Emission from Flexural Tests on CFRP/Al Honeycomb Beams Containing Deliberate Defects.

(e) Solvent Contamination  
(0/90/90/0)

(f) Backing sheet  
contamination in an  
overlap joint  
(0/90/90/0)

(g) Specimen axis at 45°  
to fibre axes  
(0/90/90/0)

(h) Defect Free Control  
(0/60/120)
