FOREWORD

FLIGHT SERVICE EVALUATION BY KEVLAR-49
FIBRE COMPOSITE PANELS ON ALGA-80000
COMMERCIAL TRANSPORT AIRCRAFT

South Atlantic Wings - Summary Report

APPENDIX A
DETAIL OBSERVATIONS OF
KEVLAR-49 FAIRING PANELS -
AIR CANADA SHIP CF-TNB-502 (SERIAL 1021) -
MAY 1979

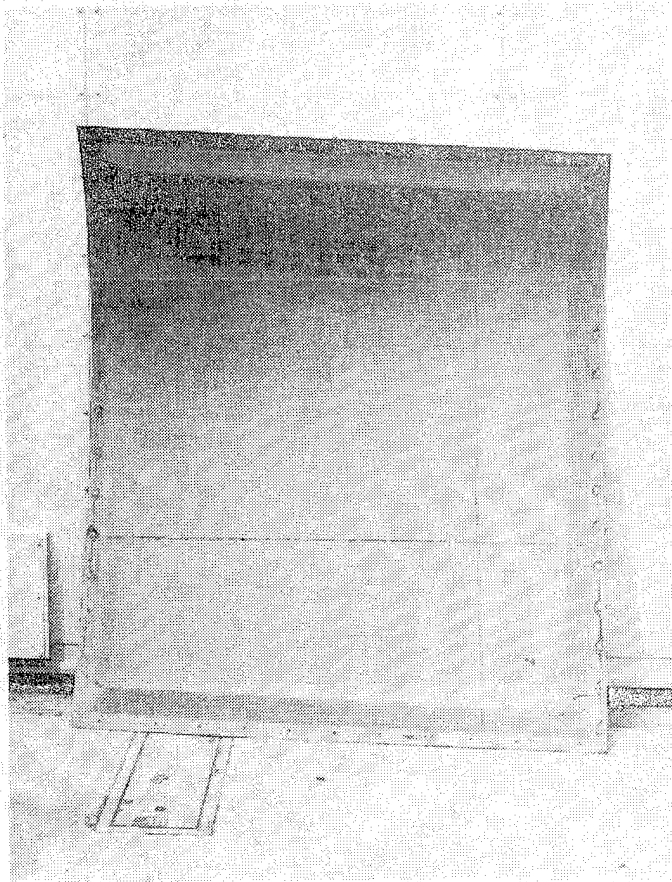
Figure 1. - Right-hand wing-body fairing-inner surface.

- o A left-hand and right-hand set of a large 152- by 170-cm (60- by 67-inch) sandwich wing-body fairing panel. The exterior skin is 0.05 cm (0.02 in.) thick with one ply of 181 style Kevlar-49 fabric and two plies of 120 style Kevlar-49 fabric. The interior skin is 0.04 cm (0.015 in.) thick with three plies of 120 style Kevlar-49 fabric. The honeycomb core is Nomex with 0.3 cm (1/8 in.) cells, and 0.05 gm/cm³ (3.0 lb/cu ft) density. Overall panel thickness is 2.24 cm (0.88 in.), with a solid lead-in edge 0.25 cm (0.10 in.) thick, built up of 181 style Kevlar-49 plies (figure 1).
