NASA TN D-8411

EFFECT OF LOW-VELOCITY IMPACT DAMAGE  
ON THE COMPRESSIVE STRENGTH OF  
GRAPHITE-EPOXY HAT-STIFFENED PANELS

*Marvin D. Rhodes, Jerry G. Williams,  
and James H. Starnes, Jr.*

*Langley Research Center  
Hampton, Va. 23665*

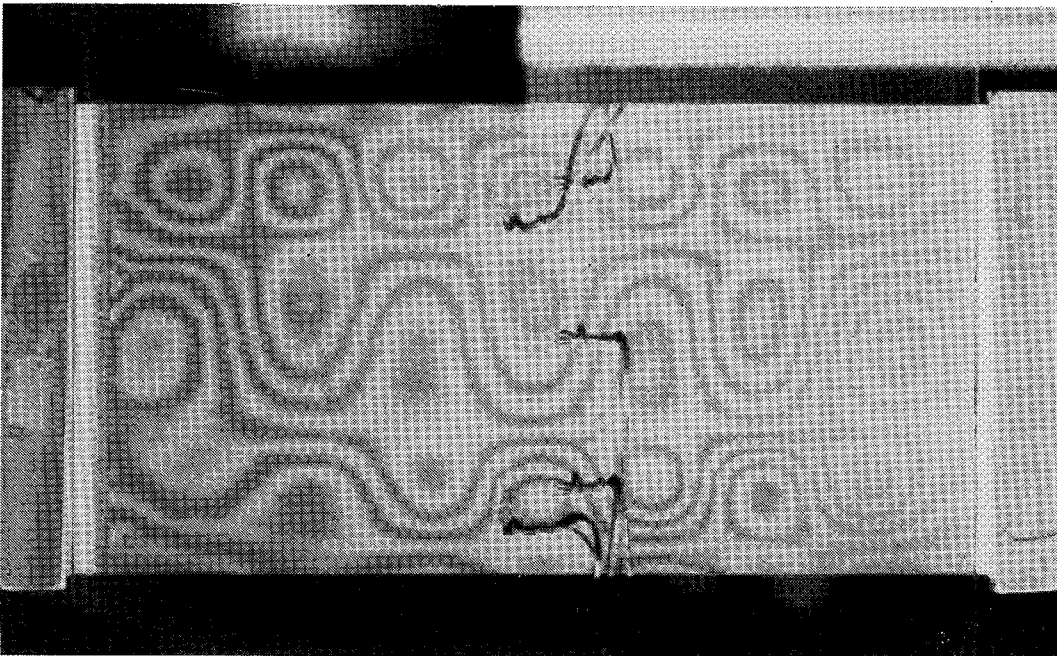
Undamaged panels.- Three panels of design A and four of design B were tested in the undamaged condition to evaluate panel behavior due to applied axial compressive load. The response of each panel to the indicated applied load, or strain, is presented in table II. The design A panels buckled near the design strain of 0.0034 and exhibited postbuckling behavior. The design B panels exhibited strength failure near the design strain of 0.0080 prior to buckling. Photographs of a typical normal displacement field as indicated by the moiré-fringe pattern for both design configurations are shown in figure 3. Test panel A1 (fig. 3(a)) has a fully developed buckle pattern at an imposed strain of 0.0036. Test panel B2 (fig. 3(b)) is shown at an imposed axial strain of 0.0079 which is near the strain at which the panel exhibited failure. The pattern seen at the ends of the panel is the result of in-plane restraints imposed by the flat-end test condition (ref. 2).

(a) Panel A1 designed for strain of 0.0034  
loaded to strain of 0.0036.

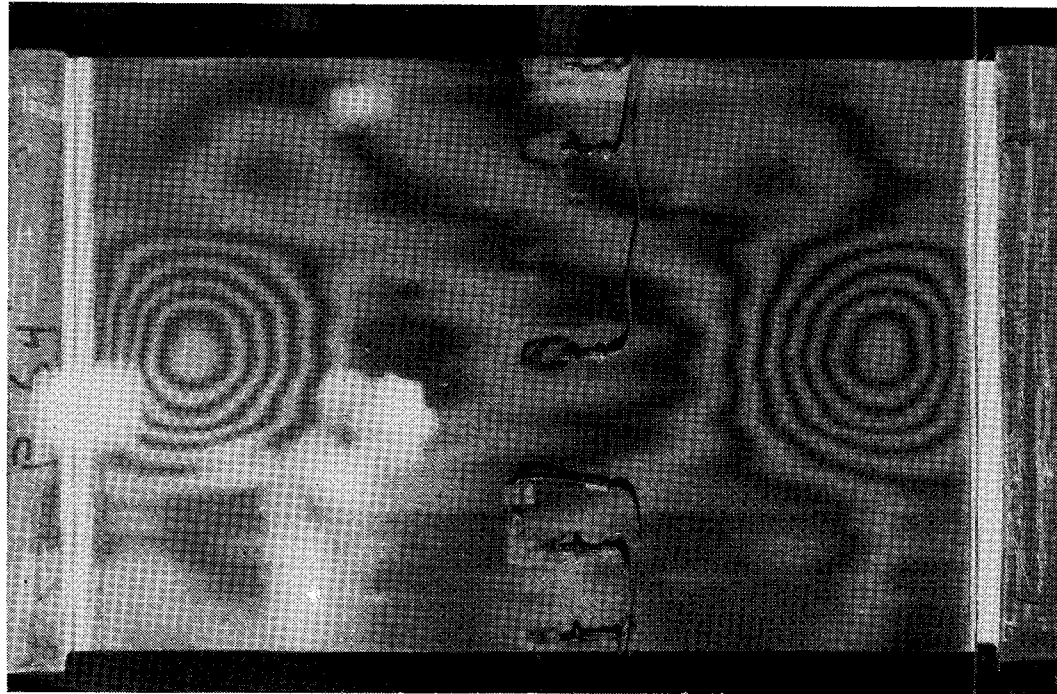
(b) Panel B2 designed for strain of 0.0080  
loaded to strain of 0.0079.

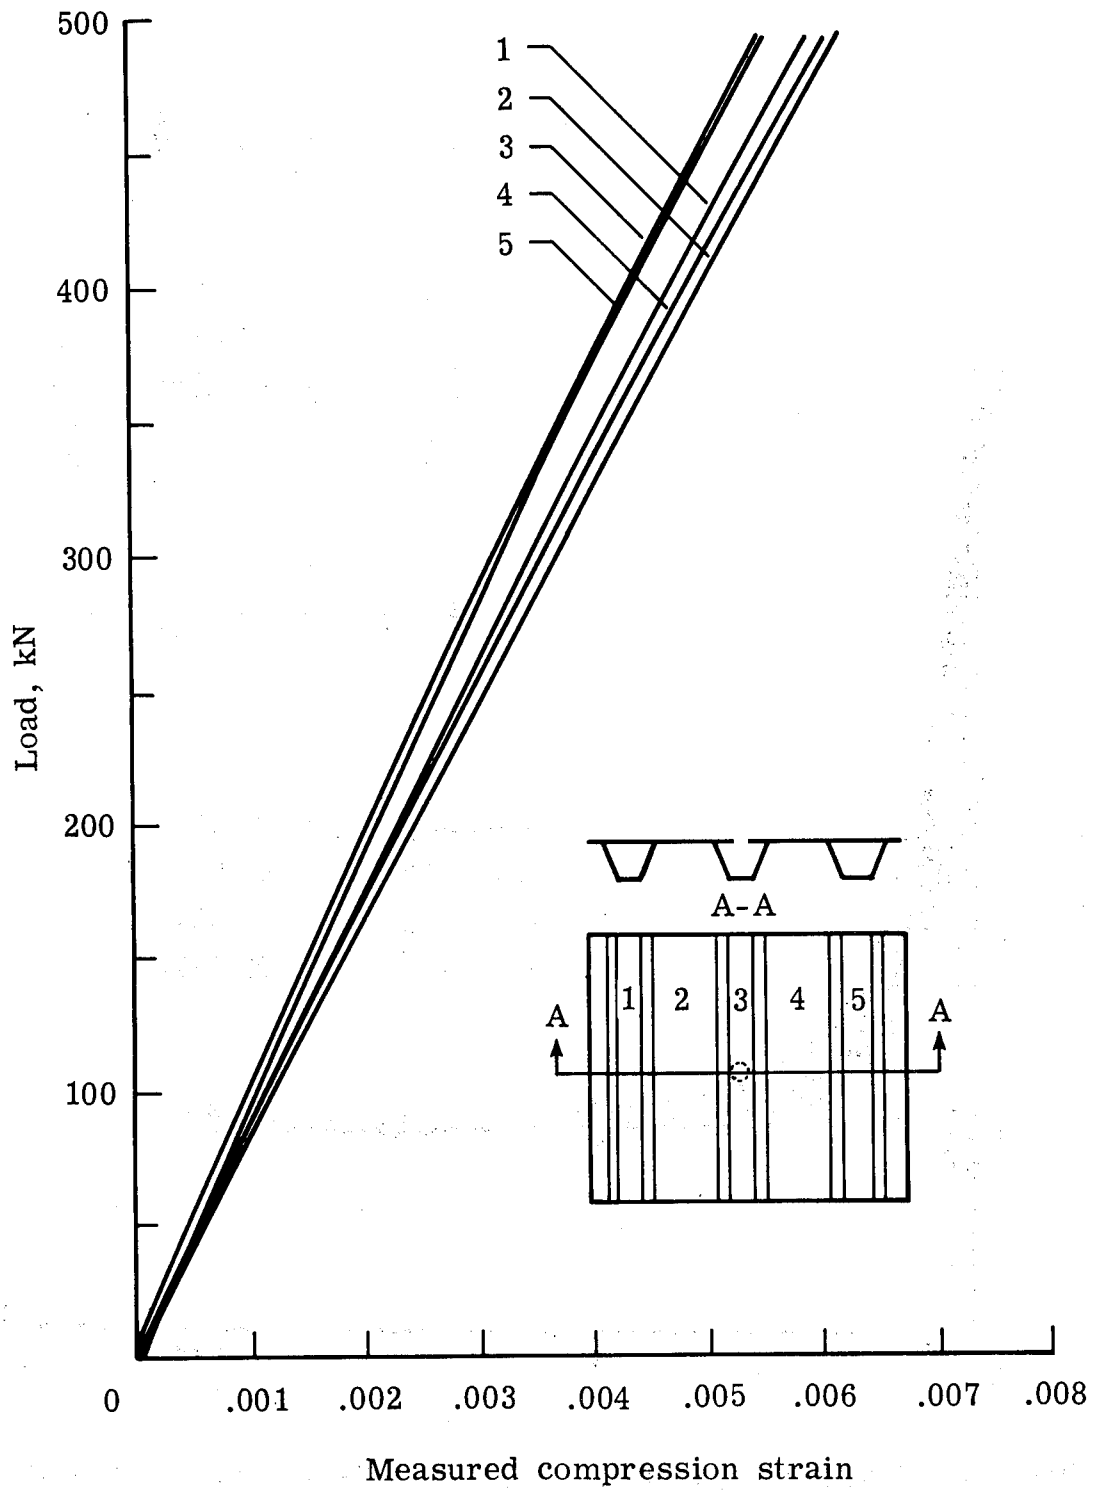
Panel with a cutout.- Panel B5 with the 1.27-cm-diameter cutout was loaded to failure in axial compression. Far-field axial strains were measured during the test by five strain gages located on a line across the panel, 6.35 cm from the cutout center. The locations of those gages and the strains as a function of load are shown in figure 4. These data indicate a nearly uniform far-field axial strain distribution across the panel and a linear load-strain relationship to failure. The average of these gages is referred to in this paper as the applied strain. Panel failure occurred at an applied strain of 0.0058 (applied load of 496 kN) which is 73 percent of the 0.0080 design strain.

Figure 4.- Compression load-strain curves at five locations across panel B5 which has 1.27-cm-diameter cutout in high-axial-stiffness region of center stiffener.

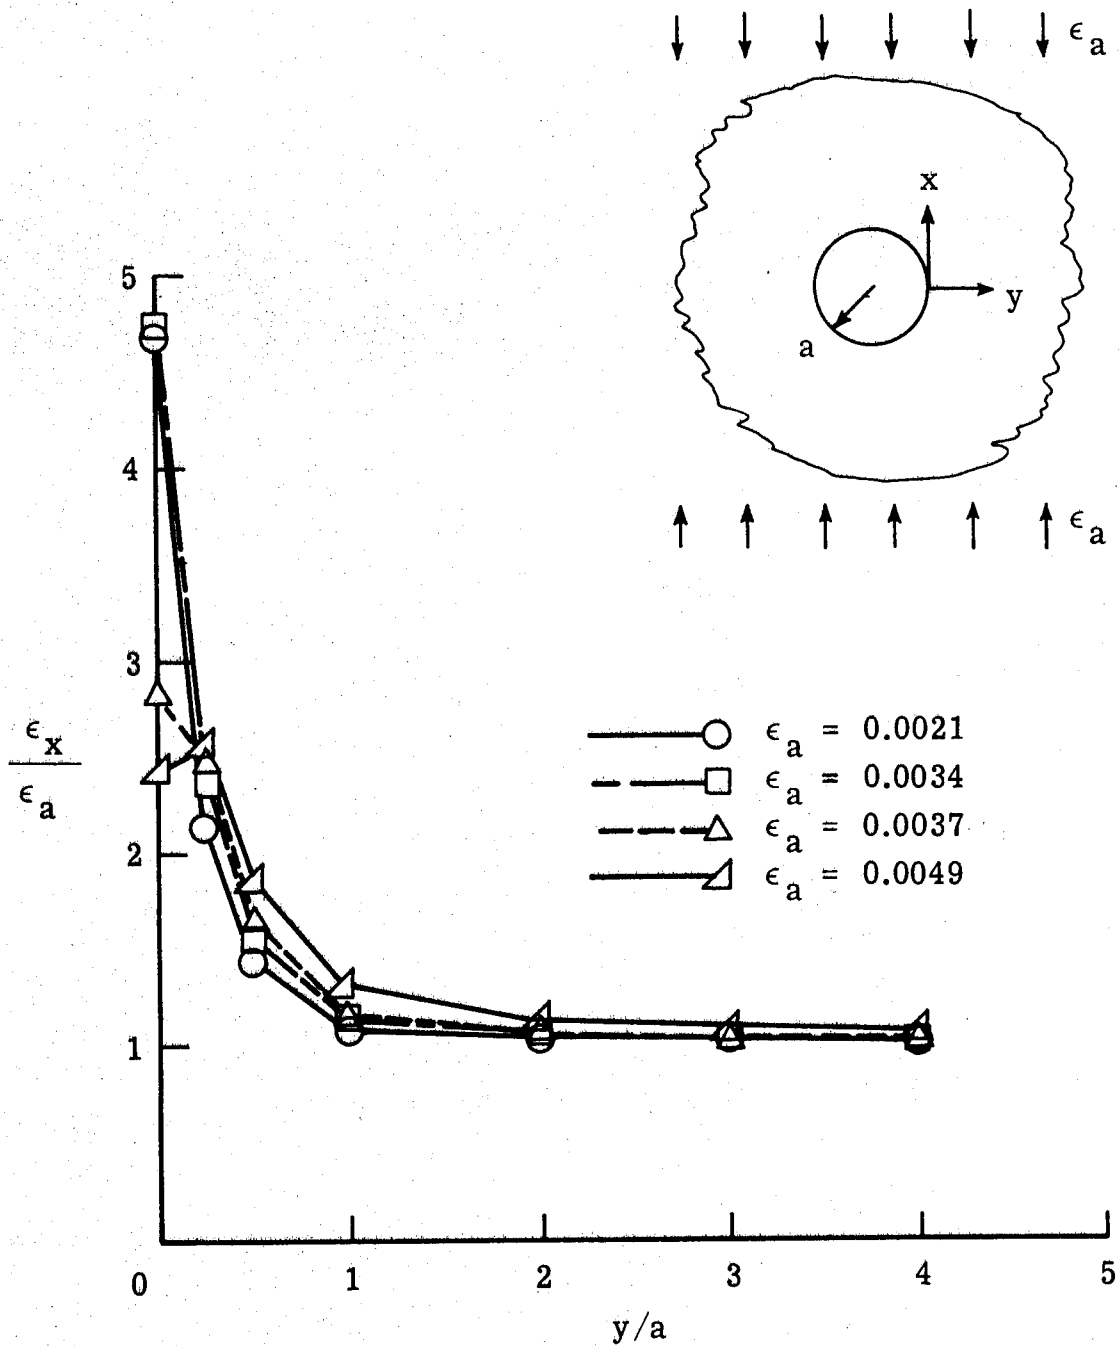
cutout and one gage was located on the cutout free-edge surface. The distribution of strain as determined by these gages across the right side of the panel normalized by the applied strain is shown in figure 5. The strains are several times greater near the cutout edge than those 3 cutout radii away and there are steep strain gradients near the cutout edge. Up to an applied strain of about 0.0034 the strain at the cutout edge is approximately 4.6 times greater than the far-field strain. At an applied strain of 0.0034 the strain at the cutout edge was initially 0.016 and then dropped suddenly to 0.012. It is suspected that a local material failure occurred at this very high strain level. At applied strains between 0.0034 and 0.0049 the strains at the cutout edge were only 2.4 to 2.8 times as great as the far-field strains as indicated by the results shown in figure 5.

Figure 5.- Strain measured in vicinity of 1.27-cm-diameter cutout on panel B5 ( $\epsilon_x$  denotes measured strain at indicated location at applied axial strain  $\epsilon_a$ ).

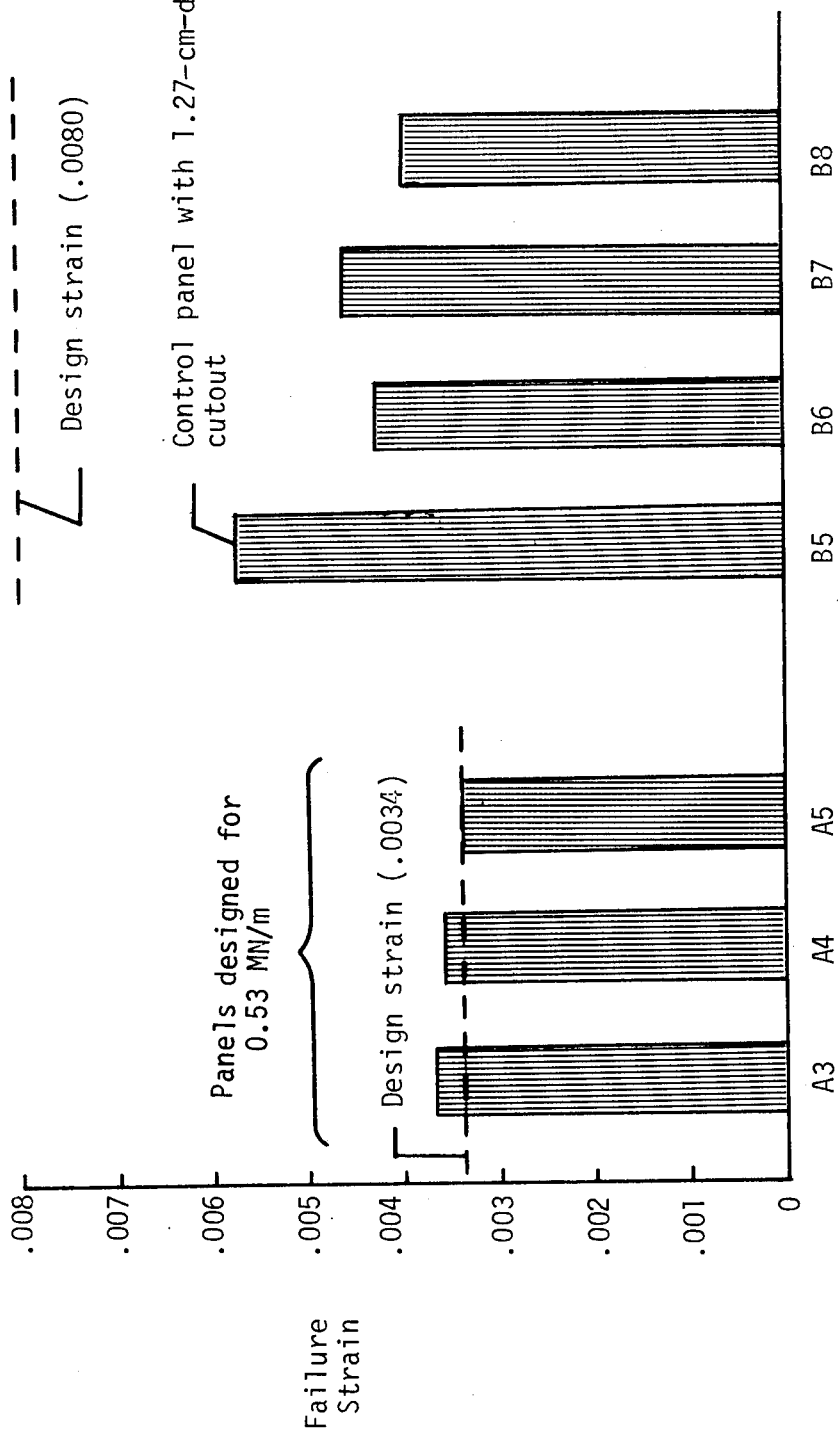
Impact-damage characterization: A comparison of test results for impact damage in the high-axial-stiffness region indicates both similarities and differences in the results for panels of design A and design B. The extent of local damage induced by impact increased with the magnitude of applied axial-compression strain for both designs. The design A panels satisfied the design-strain requirements with the presence of impact damage and also exhibited post-buckling behavior. The design B panels, however, failed due to impact damage at applied axial strains between 50 and 58 percent of the design strain level. Failure strains for impact-damaged panels and the control panel with circular cutout can be compared in figure 12. Limited local impact damage that was not noticeable by visual inspection (panel B6) reduced the ultimate strength of the design B panels as much as extensive visible localized damage (panel B7). All three of the design B panels damaged by impact failed at lower applied strain levels than the control test panel with the 1.27-cm-diameter cutout. The damaged region caused by impact, however, was larger than the cutout. For all design B panels the damage in the high-axial-stiffness region precipitated failure at an applied strain well below the design strain level.

Figure 12.- Failure strains for panels damaged by impact in high-axial-stiffness region and for control panel.
