ACCEPTABLE GLASS WINDOW/WINDSHIELD REPAIR PROCESSES AND APPROVED VENDORS

RICHARD J. OLSON

BATTELLE
505 KING AVENUE
COLUMBUS, OH 43201

MATERIAL AND PROCESS SPECIFICATION REPORT FOR 09/91 - 12/31/95
CONTRACT NUMBER FO9603-90-D-2217-SD02

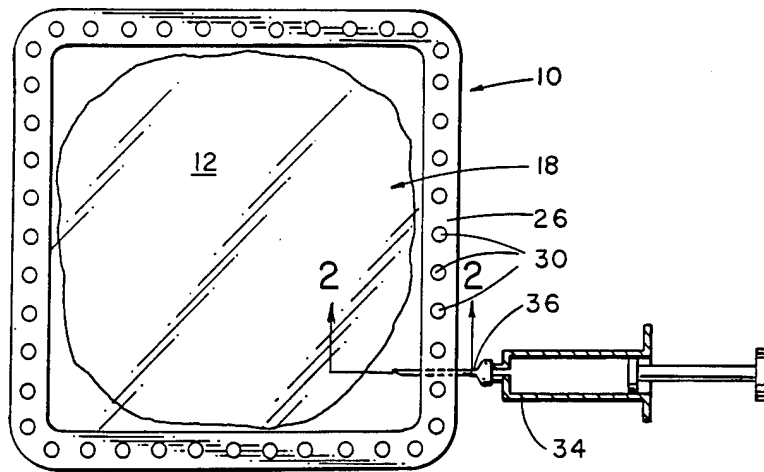
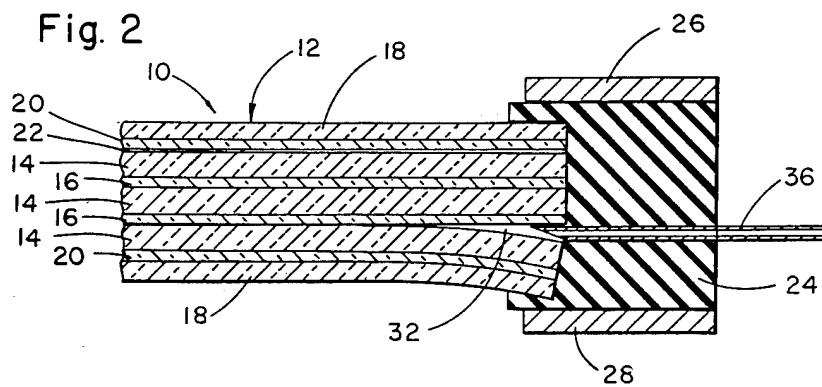
Figure 3.1 The Glass Doctor Patented Technique for Repair of Delaminations in Glass W/WS, U.S. Patent # 4,780,162

The Glass Doctor has developed special techniques for repairing chips, nicks, and delaminations in W/WS. Unlike the other aircraft W/WS repair vendors, The Glass Doctor does not rely solely upon polishing and re-autoclaving of the W/WS to effect the repairs. As described in U.S. patent #4,780,162^[1], The Glass Doctor repairs delaminations by injecting an adhesive between the delaminated plies per Figure 3.1. Conventional autoclave relamination and polishing for scratch and distortion removal is also done.
