**DEVELOPMENT OF REPAIR PROCESSES  
AND SOURCES FOR B-52 AIRCRAFT  
WINDOWS/WINDSHIELDS**

# REPORT

**FEBRUARY 1996**

**TECHNICAL REPORT FOR 09/91 - 12/31/95  
CONTRACT NUMBER FO9603-90-D-2217-SD02**

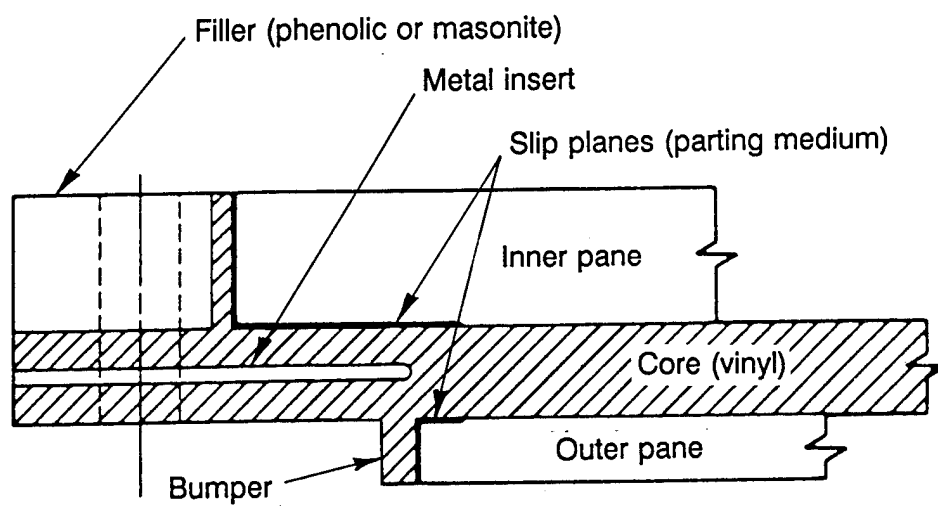
**Figure 2.1 B-52 W/WS General Construction**

To provide a context for discussing W/WS repairs, it is important to understand the construction of glass cockpit W/WS. Figure 2.1 shows the general construction of the glass B-52 W/WS. The W/WS have a three-part glass and vinyl laminate construction. The inner layer is thick, heat-strengthened plate glass designed to withstand cabin pressure forces. A transparent, plasticized, polyvinyl butyral core layer acts as the "fail-safe" load carrying member and prevents shattering in the event of inner ply failure. The outer ply is a relatively thin layer of heat-strengthened glass with no structural significance, but it provides rigidity and a scratch-resistant surface. A phenolic or masonite filler strip, located around the edge of the W/WS, and a metal filler strip embedded in the vinyl provide the means to attach the W/WS to the airframe. Vinyl or vinyl and rubber bumpers protect the edges of the glass plies.

An integral part of the B-52 W/WS construction is slip planes or a parting medium at the edges of the glass. A slip plane is located between both the inner glass ply and the vinyl and the outer glass ply and the vinyl as shown in Figure 2.1. The slip planes are thin strips of material at the glass-vinyl interface that keep the glass from bonding to the vinyl. This allows the various plies to move independently at these locations in response to pressure loads and differential thermal expansion. Without the slip planes, the glass at the edges of the W/WS

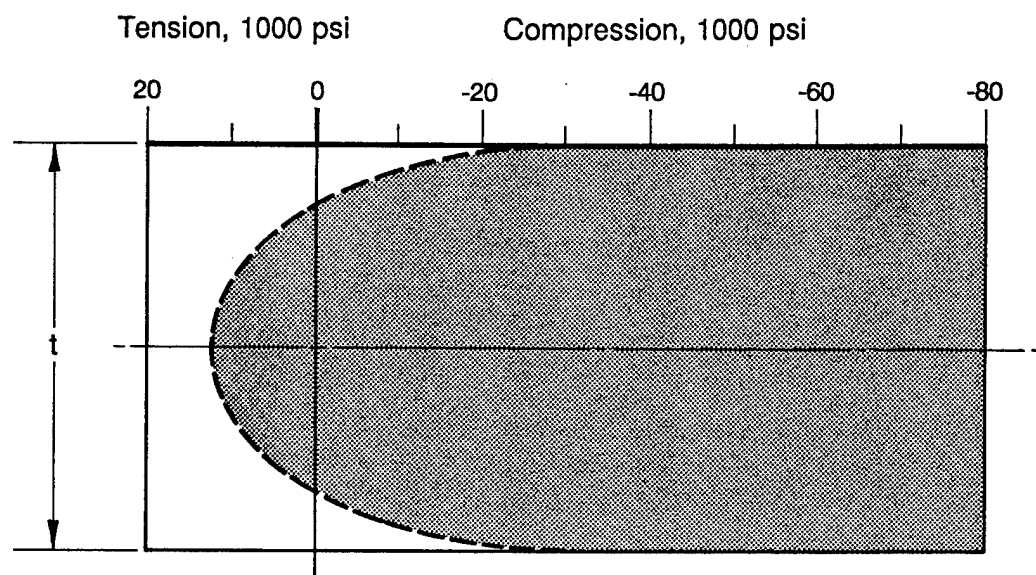
**Figure 2.2 Heat Strengthened Glass Residual Stresses**

The glass used in B-52 W/WS is heat strengthened to provide resistance to cracking. The glass is heated to near the softening point and then quenched to produce compressive residual stresses that extend from the outer surface into a depth of about  $1/6^{\text{th}}$  of the glass thickness. Below the compressive stress layer lies tensile residual stresses, see Figure 2.2. As long as surface defects do not penetrate into the tensile layer, the glass will exhibit a high resistance to fracture. Once a crack does fully penetrate the tensile layer, the glass will shatter as the tensile stresses are relieved.

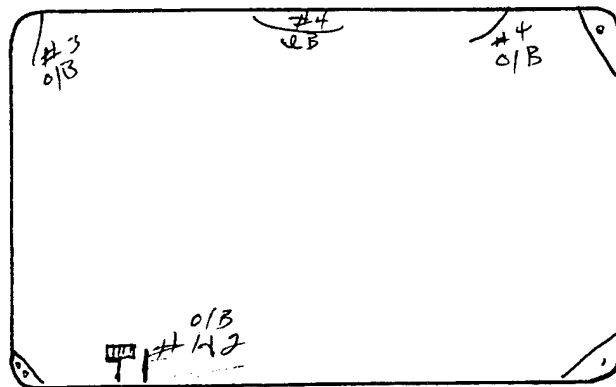
PPG Part Number: Bac-061-4  
Customer Part Number 10-30347-7  
Unit Serial Number 37-A-11-02-614

Scratches see Sketch

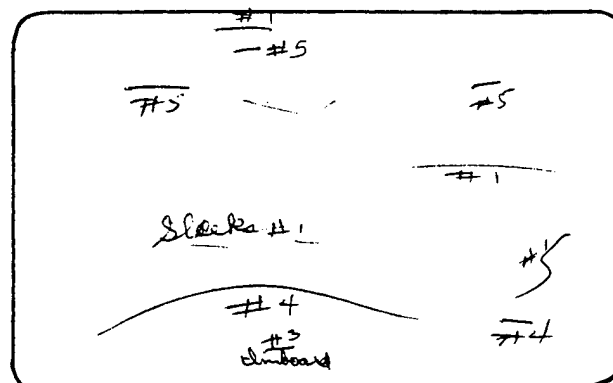
PPG Part Number: Bac-061-4  
Customer Part Number 10-30347-7  
Unit Serial Number 87-A-11-02-396

Oil in S/E of Slip plane  
Scratches on C/B one on I/B

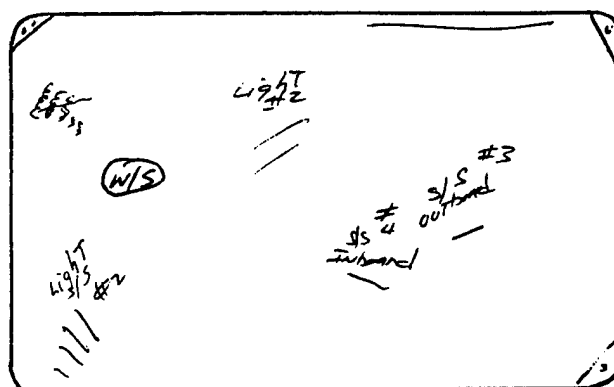
PPG Part Number: Bac - 061-4  
Customer Part Number 10-30347-7  
Unit Serial Number 86-H-03-17-221

Excessive Scratches Non larger than #4

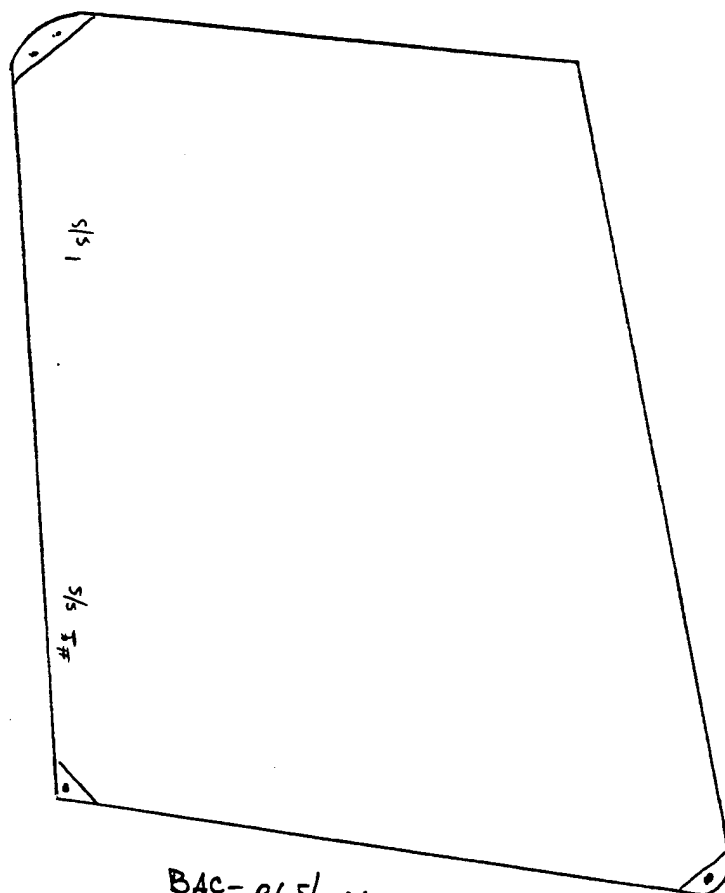
PPG Part Number: Bac 065  
Customer Part Number 10-30347-1  
Unit Serial Number 8-H-11-20-434

Air in Slip PLANE ? Light S/S

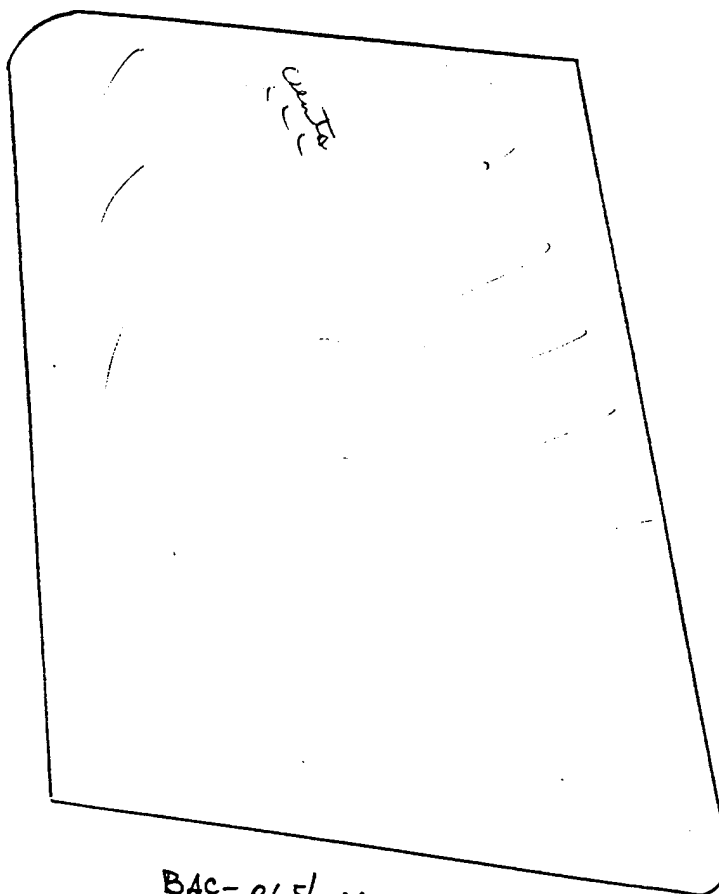
PPG Part Number:

Excessive Scratches IB + OB none larger than #7

air in Dig Plane

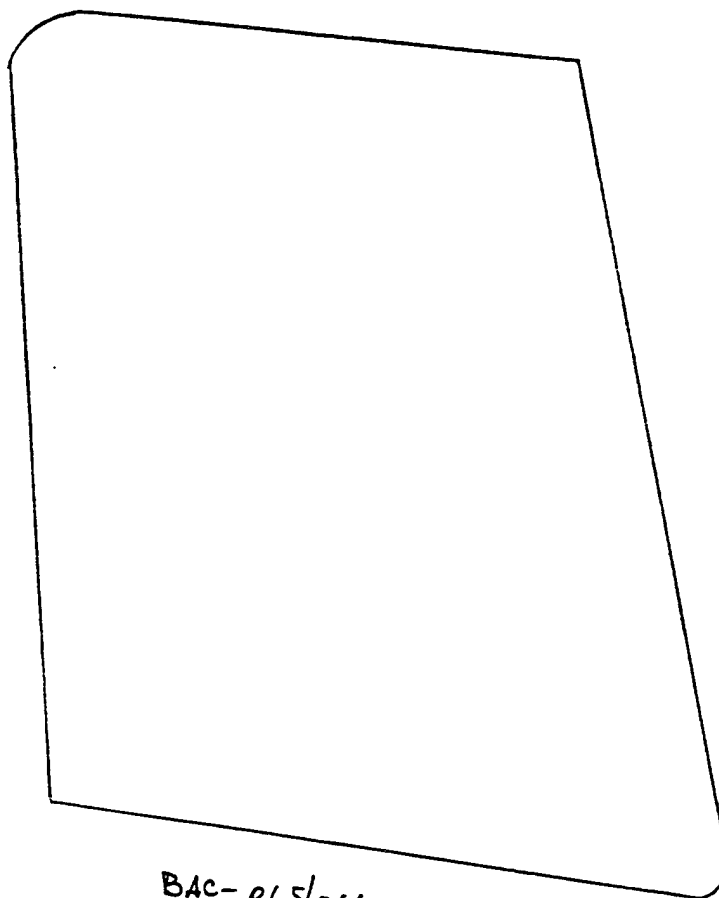
SEAL CONDITION- Good

ELECTRICAL CONNECTOR CONDITION- Good

VISUAL INSPECTION AND COMMENTS

Good  
\_\_\_\_\_  
\_\_\_\_\_  
\_\_\_\_\_  
\_\_\_\_\_  
\_\_\_\_\_  
\_\_\_\_\_

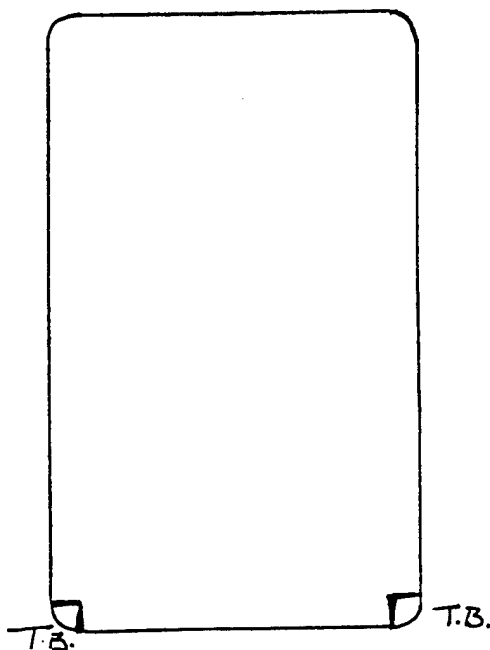
BAC-105/106

SEAL CONDITION- N/A

ELECTRICAL CONNECTOR CONDITION- Chipped T/B

CONVEX SURFACE  
SHOWN

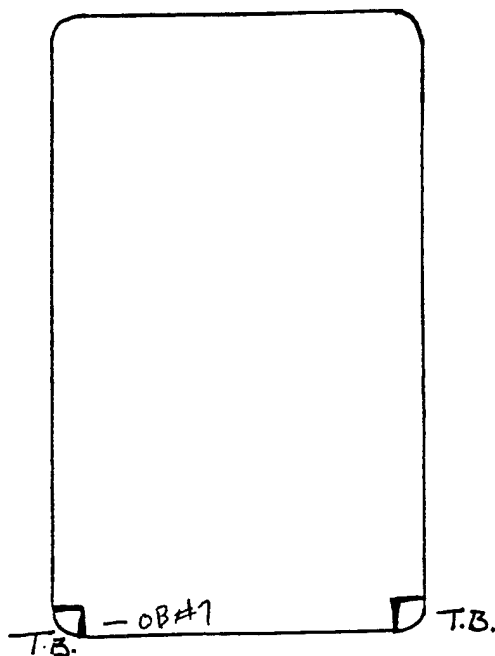
BAC-105/106

SEAL CONDITION- N/A

ELECTRICAL CONNECTOR CONDITION- Good

Convex surface  
shown

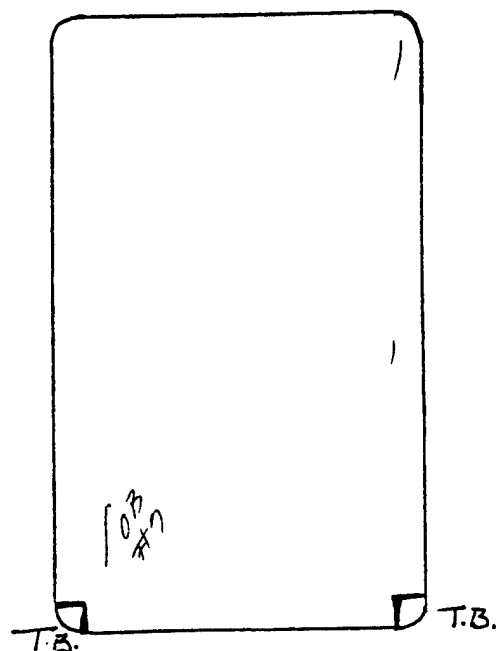
BAC-105/106

DELAMINATION- OK  
VINYL CRACKS- OK  
SCRATCHES- See Sketch  
SEAL CONDITION- N/A  
ELECTRICAL CONNECTOR CONDITION- Good

Convex surface  
shown

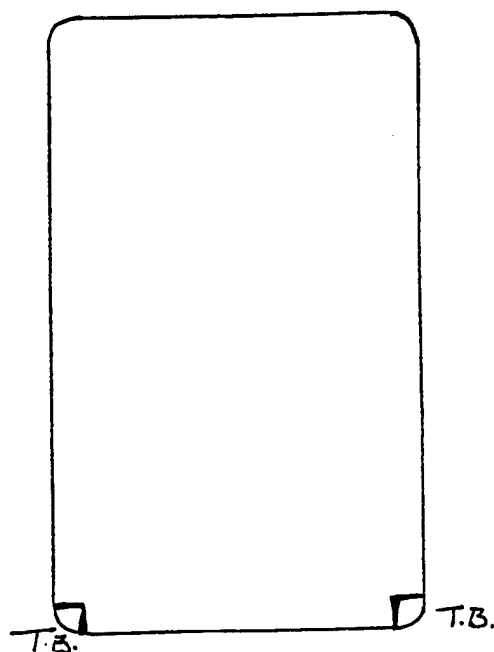
BAC-105/106

SEAL CONDITION- N/A

ELECTRICAL CONNECTOR CONDITION- Good

Convex surface  
shown
