NASA TN D-6721

# APOLLO EXPERIENCE REPORT - WINDOW CONTAMINATION

by L. J. Leger and R. W. Bricker

Manned Spacecraft Center

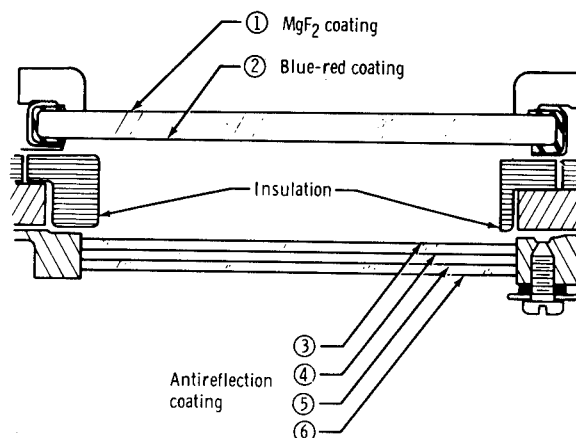
Figure 5. - Command module window-surface notation used in contamination locations.

Because of the high temperatures that are encountered during entry, insulation is necessary between the heat shield and the pressure-vessel structure. This insulation, as shown in figure 5, extends to the edge of the aluminum window frame and consists of four 1/2-inch layers of silicone-resin-impregnated glass fibers bonded with silicone rubber RTV-511 (General Electric). The exterior of this composite, silica fibers and silicone rubber, is coated with an additional layer of RTV-511. Any area of the insulation that is exposed to astronaut view is sealed in a layer of aluminum foil reinforced with glass cloth and is overcoated with black silicone rubber 92-018 (Dow Corning) for antiglare purposes.

After the pressure-vessel panes are mounted and sealed to the frame, the area between the panes is evacuated and repressurized to 389 torr with dry nitrogen ( $N_2$ ). Then, the assembly is sealed and remains sealed throughout its use. The space between the pressure-vessel windows and the heat-shield windows is vented to ambient pressure. During flight, the pressure in this space is approximately  $1 \times 10^{-4}$  torr.

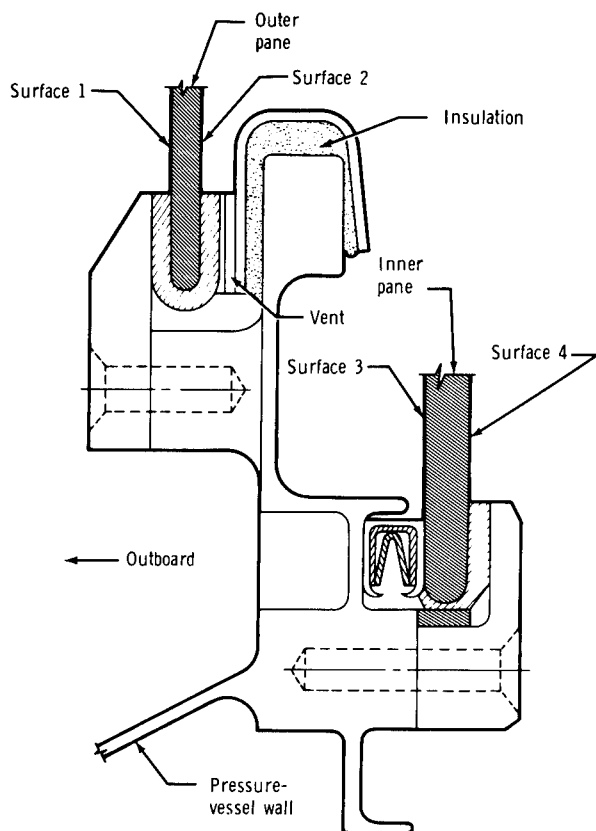
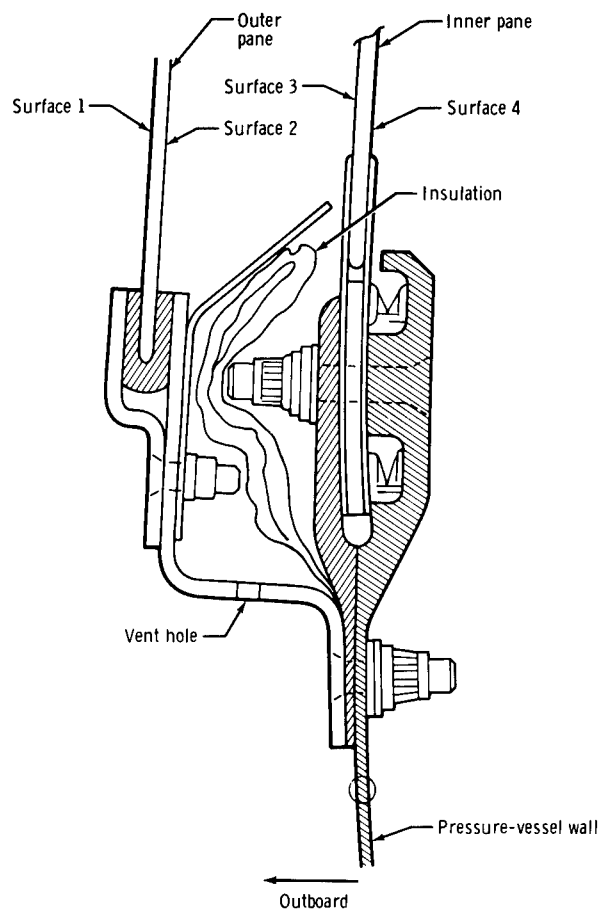
All three outer panes are sealed into the vehicle structure by the use of a heat-molded rubber (Dow Corning Silastic 675-24-480), as shown in figures 15 and 16. The thermal-insulation blanket that protects the window frame is held in place by an epoxy/fiber-glass retainer ring. The forward-window pressure seal is made by pressing, with a Teflon and Silastic-jacketed metal spring, the inner pane against a silicone-rubber seat. The docking-window pressure seal is made by adhesively bonding the inner pane directly to a Kovar metal frame. Because the LM does not have to survive

The relatively contamination-free condition of these windows might seem surprising because it was indicated earlier that the weight loss of the materials that were used in construction was rather large in some instances. However, if table II and figures 15 and 16 are examined, it is clear that the materials that sustain large weight losses are used in very limited amounts and, in general, are not exposed to the area between the panes. There is one exception: the fiber-glass retainer that involves an epoxy as the matrix material. The weight loss for this material was 0.65 percent. Because no contamination problem was encountered, the amount of condensable outgassing products from the epoxy was assumed to be very low.
