NASA Contractor Report 178246

## Test Results for Composite Specimens and Elements Containing Joints and Cutouts

P. T. Sumida, R. C. Madan, and A. V. Hawley

Douglas Aircraft Company  
McDonnell Douglas Corporation  
Long Beach, CA 90846

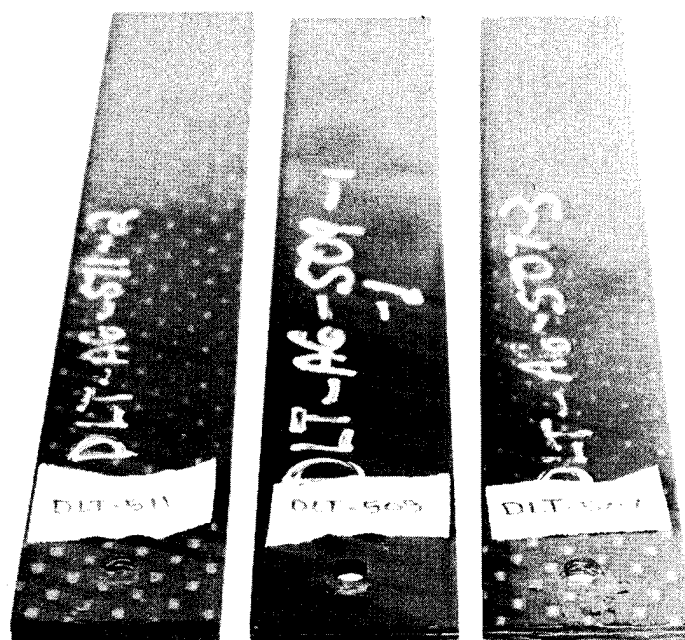
Figure 5-6 shows typical failures for each of the three wide DLT configurations. The -509 configuration (lay-up No. 2) clearly failed in bearing. The failure zone of the -507 configuration (lay-up No. 4) extends to the edge of the specimen, indicating edge effects could have been significant. (Edge distance for all of these specimens was 0.625 inch, which is just over  $3d$ ). The -511 configuration (lay-up No. 3) appears to have failed in a shearout mode. Figure 5-7 summarizes the results of the bearing tests. Note that the narrow DLT configuration for lay-up No. 3 (-505) is included because of the similarity in failure mode with the -511 configuration.

Figure 5-6. Bearing and Shear-Out Failures of Wide DLT Specimens ( $W/D = 6$ )

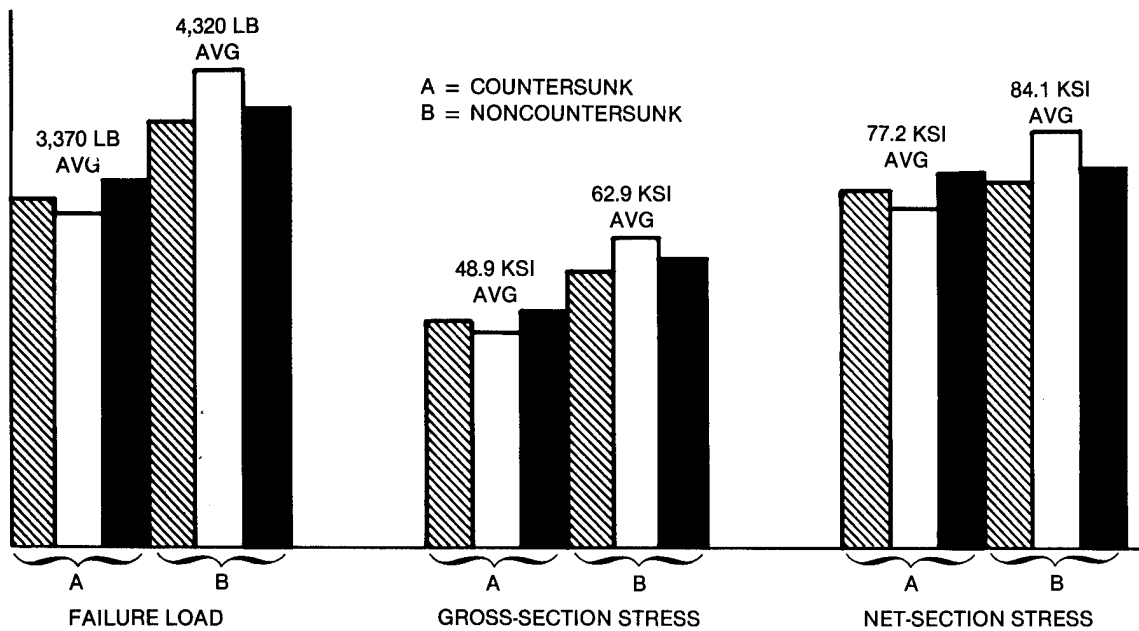
The results of the ULT-507 configuration tests are presented in Figure 5-12. Comparisons are shown between this configuration and its noncountersunk counterpart (ULT-503). As indicated, failure load and gross-section stress are down by an average of 22 percent. Net-section stress, however, shows considerably less reduction (only 8 percent).

Figure 5-12. Unloaded-Hole Tension Specimen Results (Lay-Up No. 2, Countersunk)

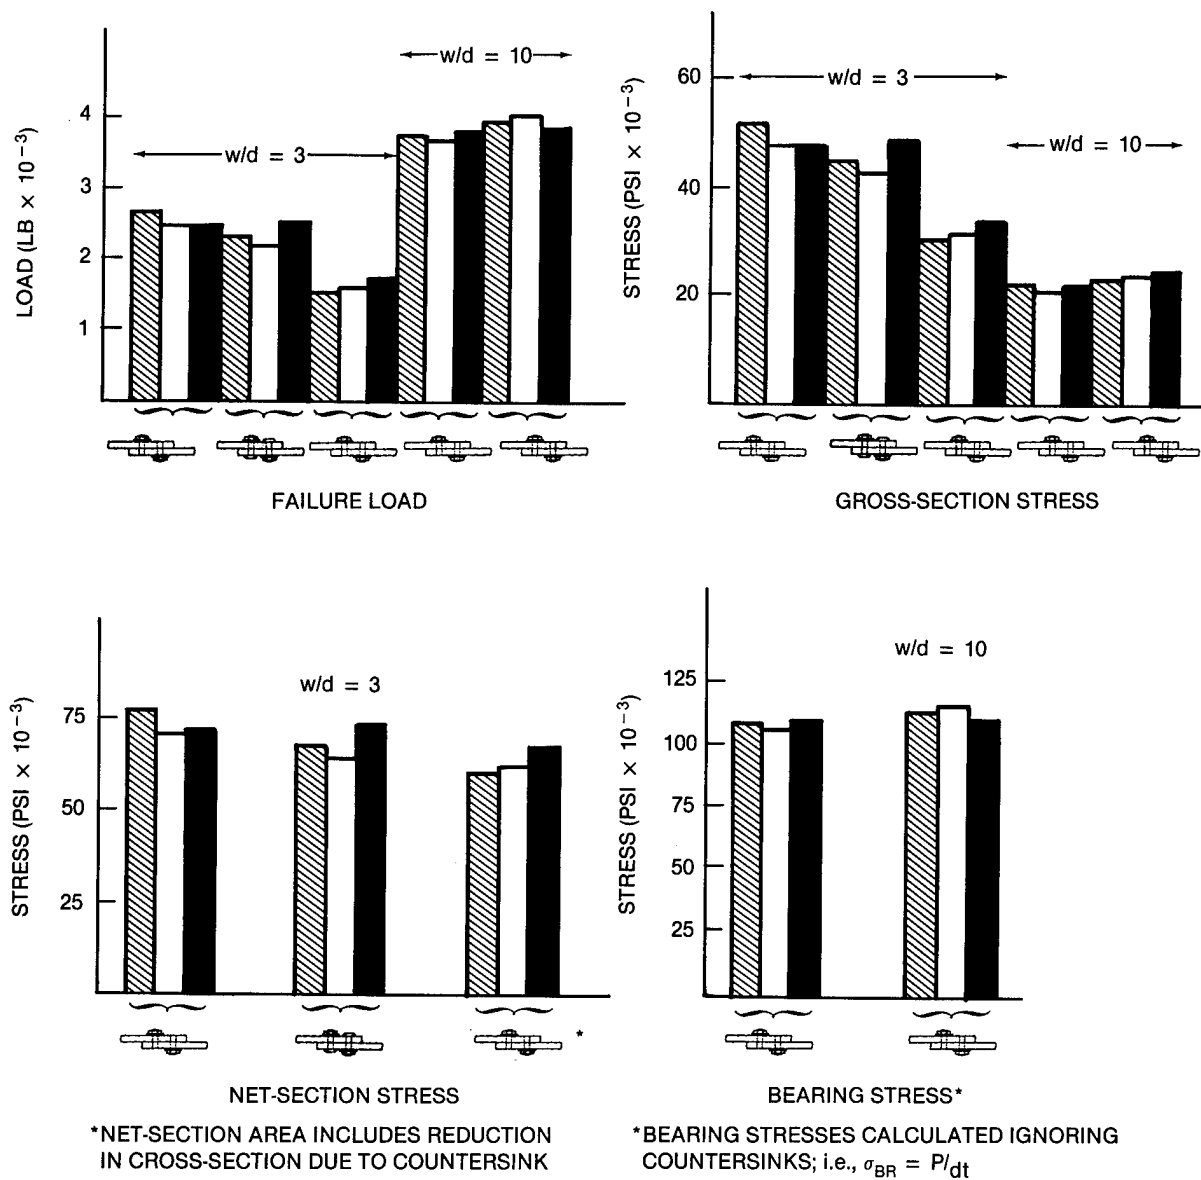
The single-lap tension specimens (SLT) were designed to provide coupon level data for single shear joints. Figure 5-18 summarizes the SLT test results. All of the narrow specimens failed in net-section tension at one of the "bearing + bypass" locations. In the case of the -507 configuration, the net-section stresses shown account for the area removed by the countersink. (This was the only configuration that was countersunk at the failure location.)

Figure 5-18. SLT Specimen Test Results

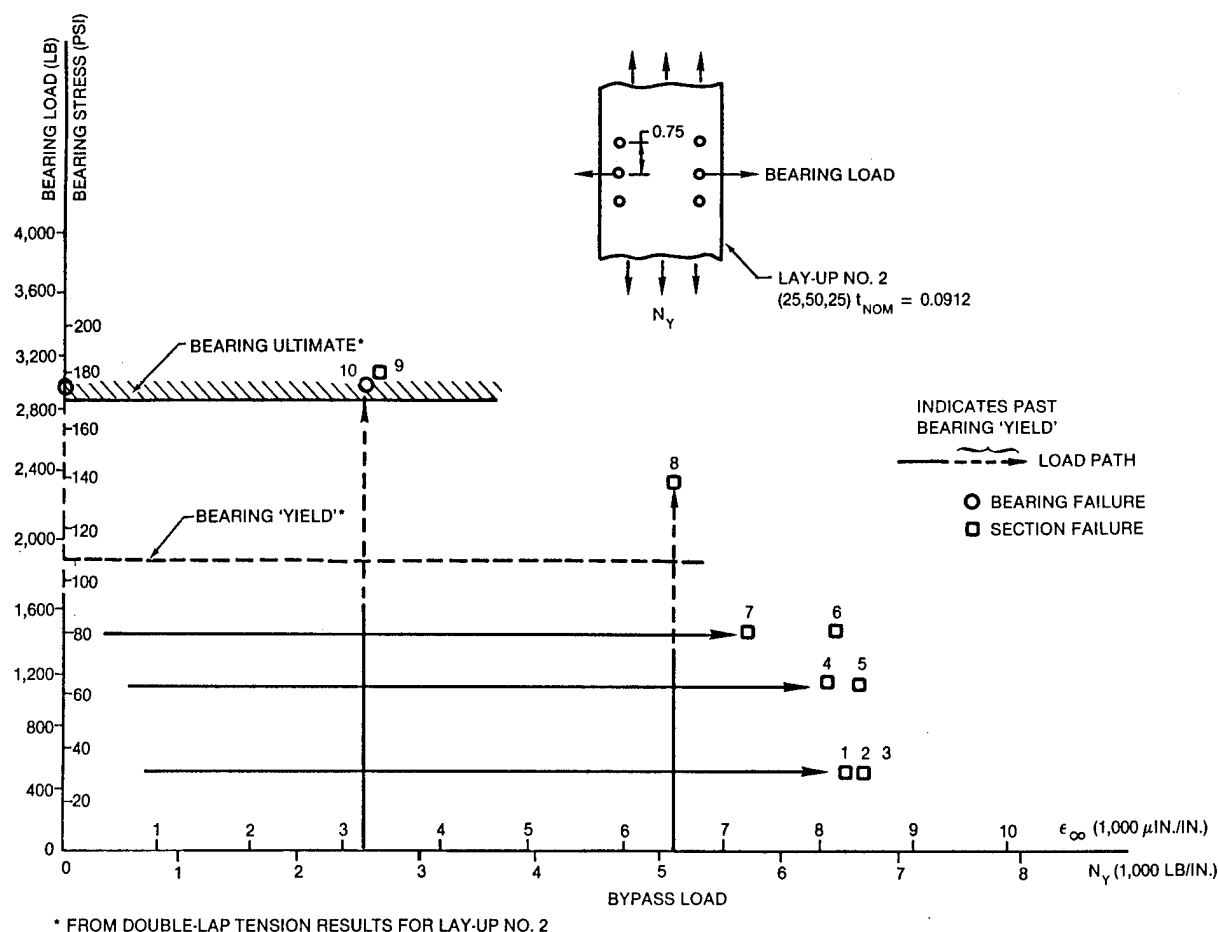
The results of the biaxial tests are summarized in Figure 5-19. These data indicate that bearing stresses of up to 60 ksi had virtually no effect on the orthogonal bypass strength. Likewise, specimens 6 and 7 show only a small loss in bypass strength at 80 ksi bearing. Specimen 9 indicated that an orthogonal bypass load of 2,500 lb/in. (roughly 3,300  $\mu\text{in./in.}$  gross-section strain) had no effect on either the onset of non-linearity (bearing yield) or the ultimate bearing strength. The only specimen which demonstrated any significant interaction was specimen 8, and this is at levels of bearing (140 ksi) and bypass (6,500  $\mu\text{in./in.}$  gross-section strain).

Figure 5-19. BAS Specimen Test Results

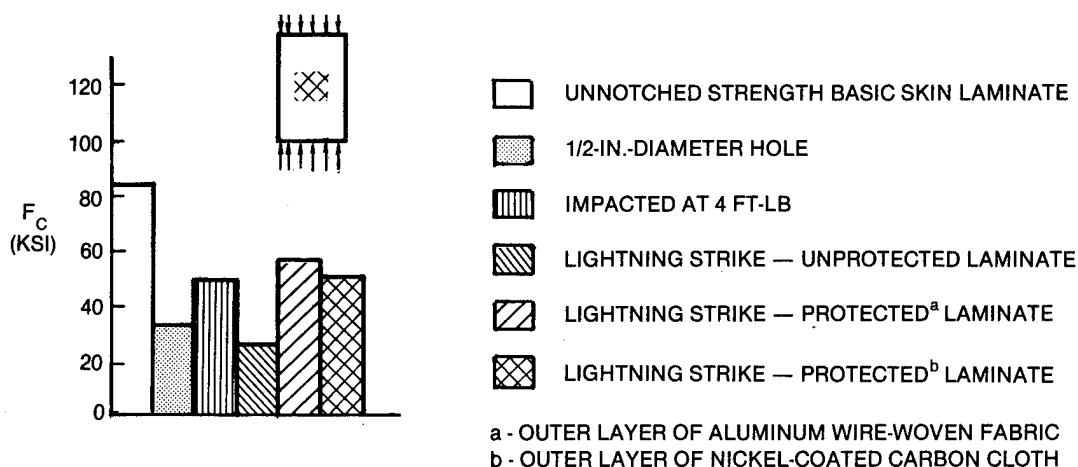
The last of the Group A specimens were the compression-after-impact or CAI panels. The results of these tests are summarized in Figure 5-20. The highest strength loss observed was for the unprotected panel subjected to lightning strike, followed by the panel with a 1/2-inch-diameter hole. However, the impacted panel and the protected panels subjected to lightning strike all exhibited strengths greater than 39 ksi (the stress corresponding to the design ultimate strain of  $4,500 \mu\text{in./in.}$ ).

Figure 5-20. CAI Specimen Test Results

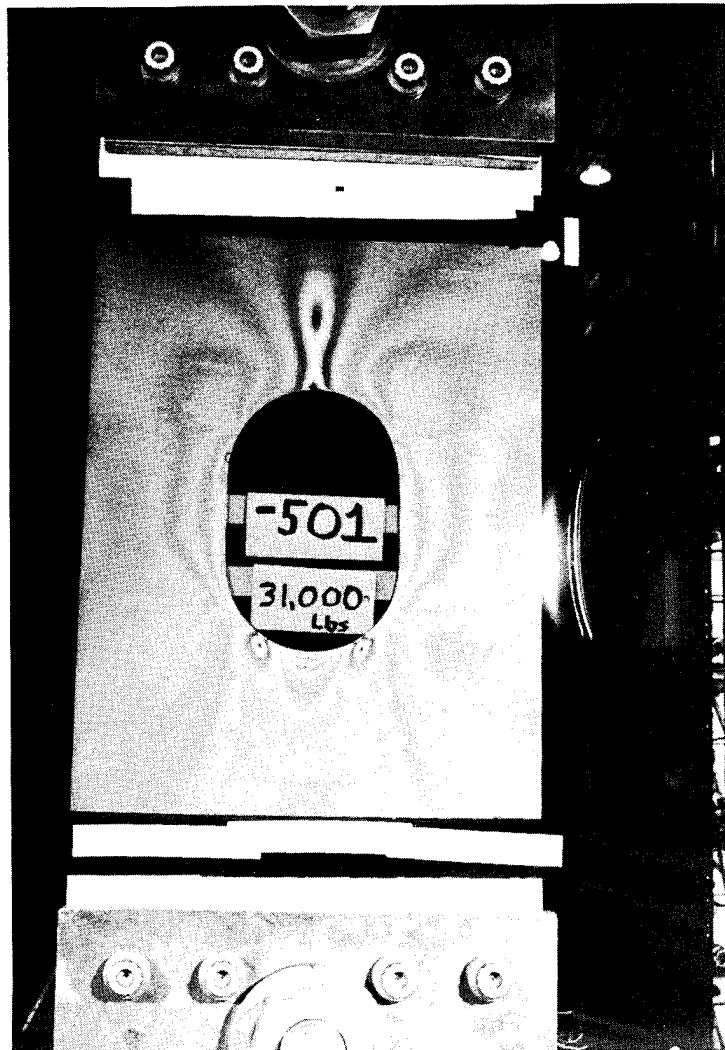
The baseline panel (-501) was the only one to buckle in opposite directions at the top and the bottom of the cutout. This is illustrated in Figure 5-22 by the asymmetry of the photoelastic fringe pattern at 31 kips. Although difficult to discern, the top of the cutout buckled toward the camera, producing tensile strains on the surface being viewed, which subtract from the membrane compressive strains to produce a black, or zero-principal-strain, region. Likewise, the buckle at the bottom of the cutout is away from the camera, producing bending strains which add to the compressive membrane strains. Typical plots of strain gage and photoelastic data are shown in Figures 5-23 and 5-24.

Figure 5-22. Photoelastic Fringe Pattern for -501 Tension Cutout Panel

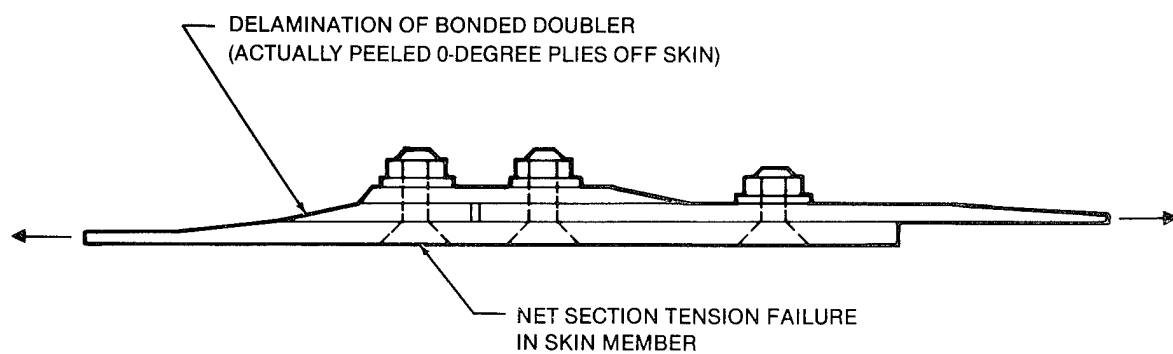
**Figure 5-32. Failure Mode of Tailored Longitudinal Splice Specimens**

The tailored longitudinal splice specimens experienced premature doubler delaminations prior to failure. Figure 5-32 illustrates the location of the initial delamination as well as that of the ultimate (net-section tension) failure. The taper angle of the small doubler bonded to the left-hand skin was apparently too steep to allow it to conform adequately to the deformed curvature of the skin. The resultant peel force at the end of the doubler thus precipitated the premature delamination. (Note that this was not a bondline failure, but rather was an interlaminar failure in the first ply of the skin.) With the doubler separated from the skin, the ultimate failure occurred in the countersunk skin at the outermost fastener.

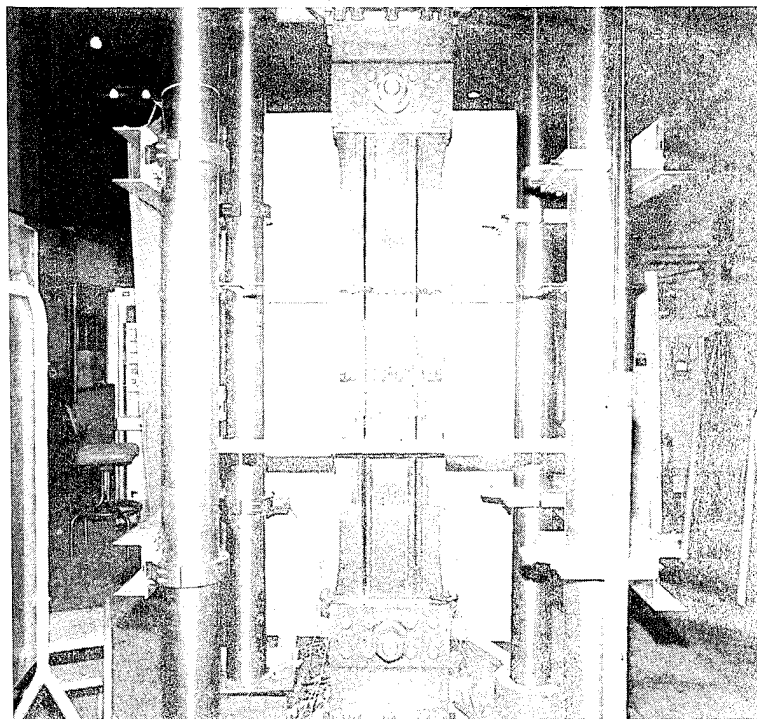
**Figure 5-38. Longeron/Skin Splice Panel (Compression Specimen) Under Load**

Figure 5-38 shows the compression panel during testing at roughly limit load with the skin buckling evident just "outside" of the splice bay (above and below the simulated frame supports).

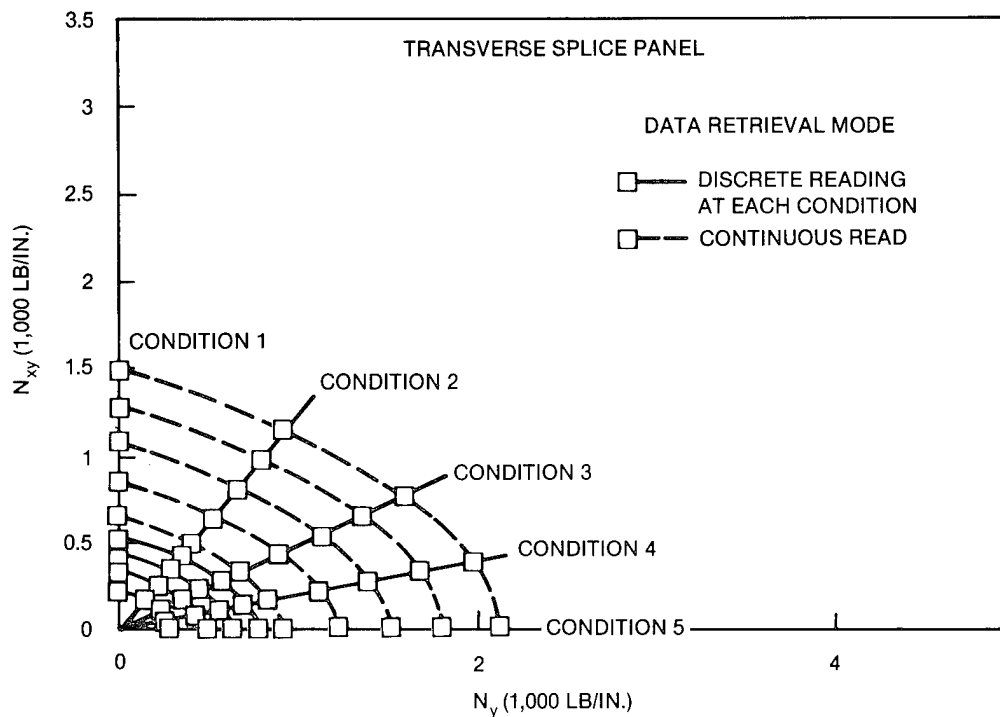
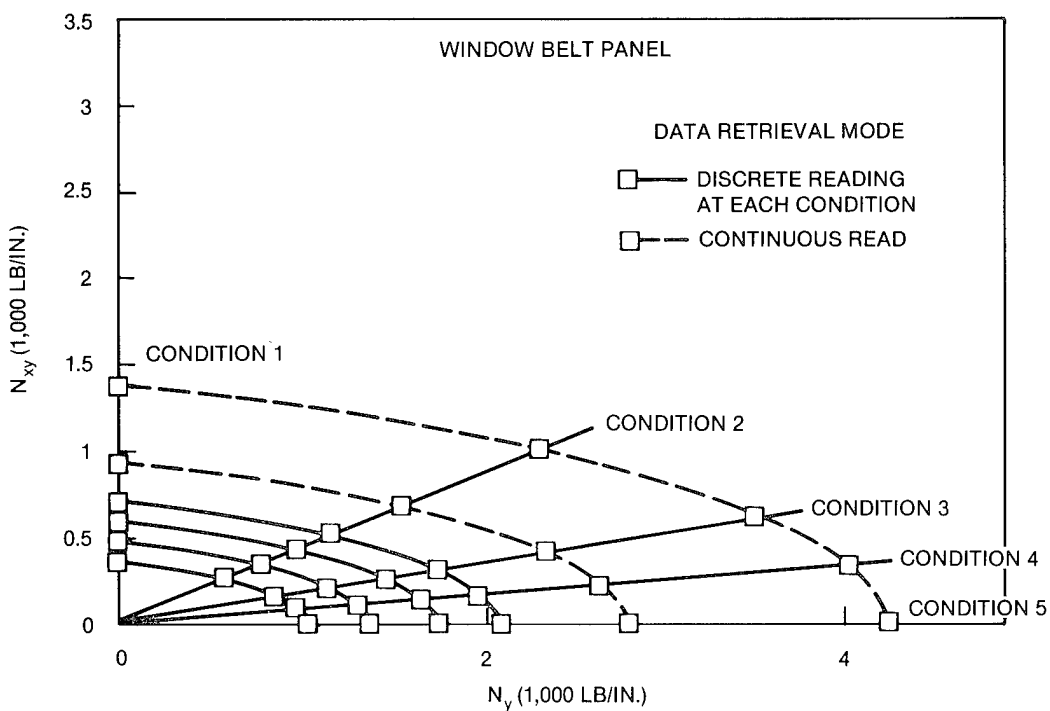
Figure 5-42. Load Schedules for the Group D Panels

Load schedules for the two panels were similar (see Figure 5-42). In both cases, a series of load envelopes (combinations of shear and compression) was defined. Five points on each of these envelopes were designated as test conditions. Condition 1 was the first condition tested for a given envelope and was a 100-percent-shear load condition. After having successfully reached Condition 1, the shear load was decreased to that of Condition 2, which was a shear/compression load combination with a relatively low compression component. The compression load was then increased to that of Condition 2. The same pattern was followed to arrive at Conditions 3, 4, and 5, which were combinations of successively lower shear and higher compression components. Condition 5 was, in fact, a 100-percent-compression condition.

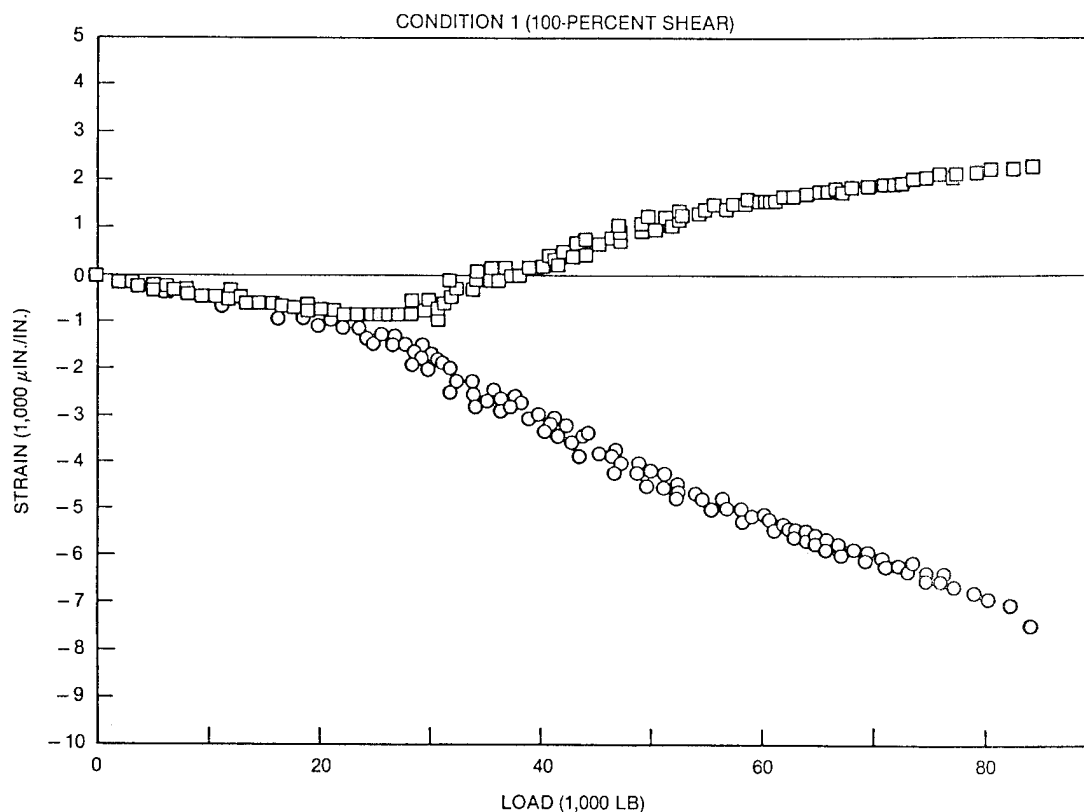
**Figure 5-45. Postbuckling Response of Transverse Skin Splice Panel (Shear)**

Strain gage data for this specimen (see Figure 5-36) provided information concerning skin buckling and the behavior of the transverse splice. The continuously read data for the shear-only conditions (discussed above) are presented in Figure 5-45. The data and the failure load of 84.1 kips suggest a post-buckling ratio for this panel of between 2.5 and 3.0 (depending on the choice for the initial buckling load). Strain gage data from the small skin bay just above the splice (strain gages No. 5 and 6) indicate a small amount of curvature, which suggests a very shallow buckle present here also. (Skin thickness in this bay was nominally 0.0912 in.). Strain gages at the joint indicated behavior similar to that of the two-stiffener transverse splice panel loaded in compression (i.e., nearly equal strains in the Z and L splice members, and tensile strains on the inside surface of the skin splice plate). The strains at the joint were generally quite low due primarily to the fact that the highest compression load applied was 75 kips, corresponding to a running load of about 1,800 lb/in. (this to be contrasted with the failure load of the two-stiffener panel of 3,336 lb/in.).
