Miscellaneous Paper GL-96-19  
August 1996

# **Airfield Pavement Evaluation, Butts Army Airfield, Fort Carson, Colorado**

*by Jeb S. Tingle*

## **Final report**

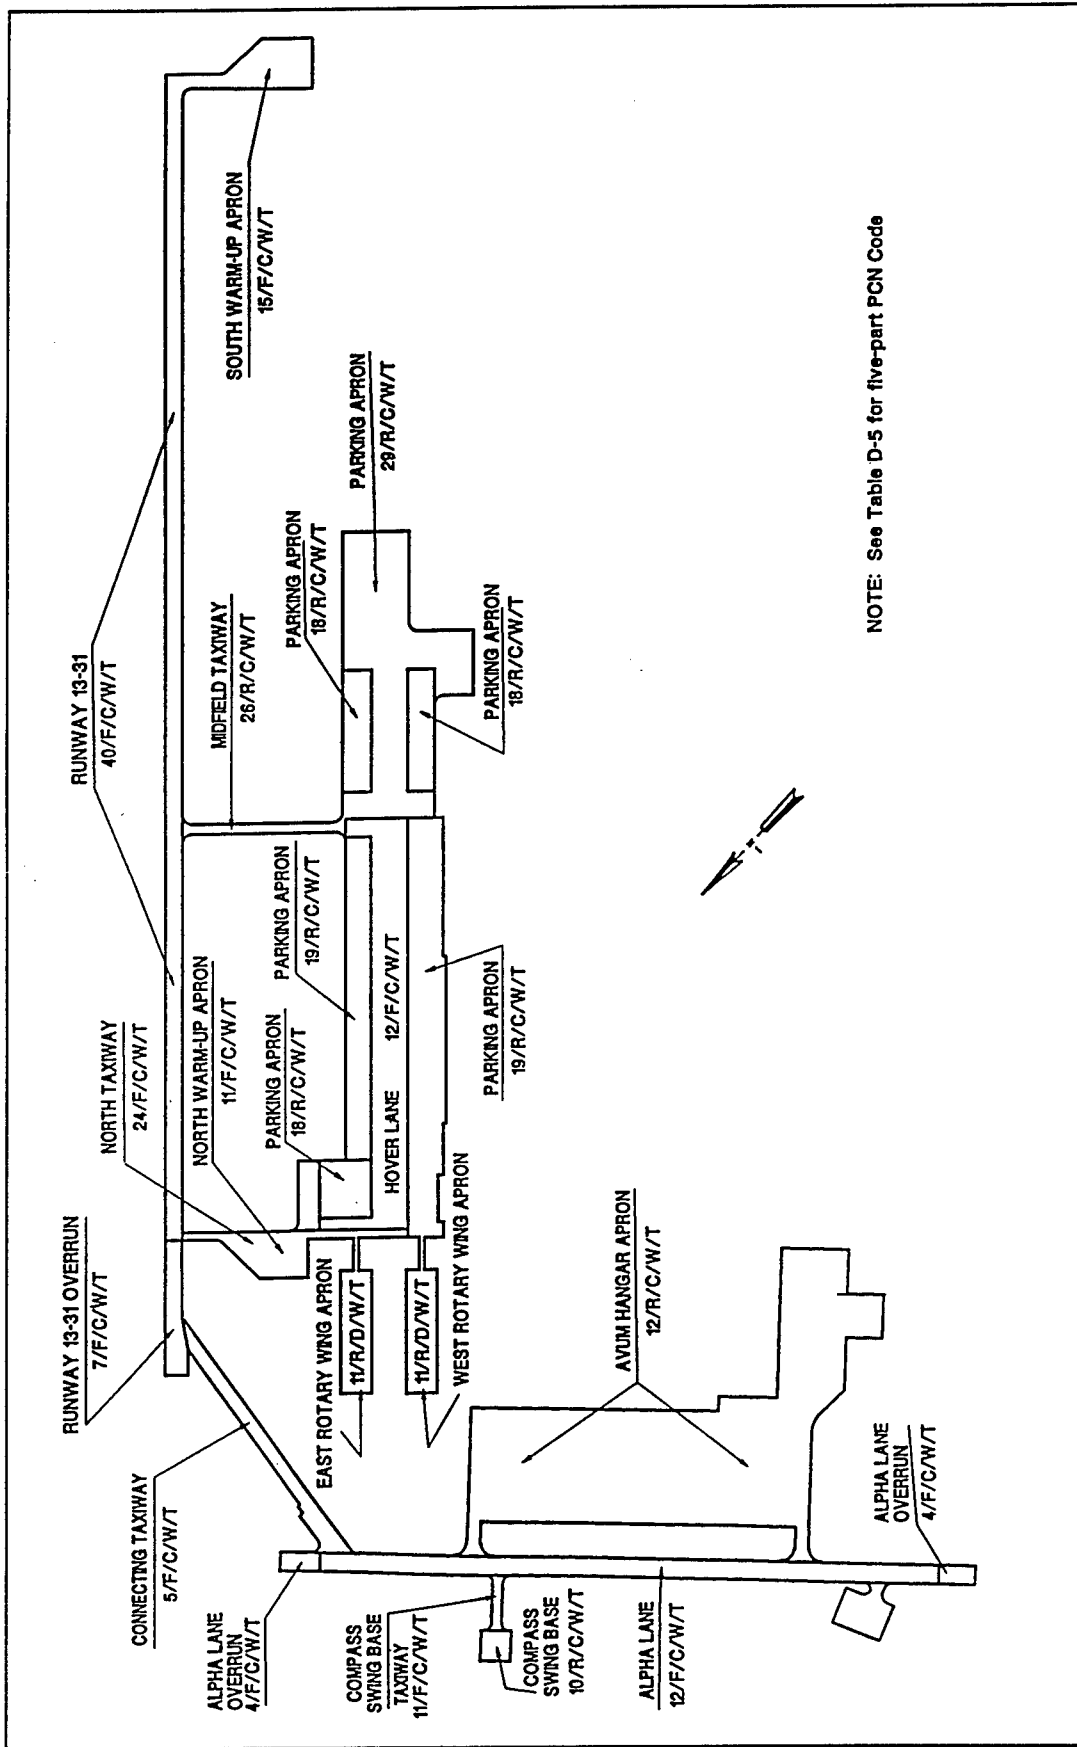
Figure 2-1. Airfield pavement evaluation chart (APEC)

- a. The airfield pavement facilities and their assigned Pavement Classification Number (PCN) are: Runway 13-31, 40/F/C/W/T; Alpha Lane (old Runway 4-22), 4/F/C/W/T; North Taxiway, 24/F/C/W/T; Midfield Taxiway, 26/R/C/W/T; Connecting Taxiway, 5/F/C/W/T; Compass Swing Base Taxiway, 11/F/C/W/T; North Warm-up Apron, 11/F/C/W/T; South Warm-up Apron, 15/F/C/W/T; Hover Lane, 12/F/C/W/T; Parking Apron A4B, 18/R/C/W/T; Parking Apron A5B, 19/R/C/W/T; Parking Apron A6B, 19/R/C/W/T; Parking Apron A7B, 18/R/C/W/T; Parking Apron, A8B, 18/R/C/W/T; Parking Apron A9B, 29/R/C/W/T; East Rotary-wing Apron, 11/R/D/W/T; West Rotary-wing Apron, 11/R/D/W/T; Compass Swing Base, 10/R/C/W/T; and Avum Hangar Apron, 12/R/C/W/T. An airfield pavement evaluation chart showing the facilities and the PCN for each facility is shown in Figure 2-1.

The critical PCN value for each airfield facility is presented in the Airfield Pavement Evaluation Chart (APEC) which is presented in Figure 2-1. A summary of allowable loads and overlay requirements determined for the critical aircraft and its design pass level is shown in Table D3. This table shows that the load-carrying capacities of Runway 13-31 (except feature R1A), Feature A9B on the Parking Apron, the Compass Swing Base Apron, the Compass Swing Base Taxiway, the East Rotary-Wing Apron, the West Rotary-Wing Apron, and the Avum Hangar Apron are capable of sustaining the mission traffic over the 20-year analysis period. The remaining pavement features are not capable of sustaining the mission traffic over the 20-year analysis period.
