Technical Report CERC-96-5
September 1996

Periodic Inspection of Nawiliwili Harbor Breakwater, Kauai, Hawaii

Report 1 Base Conditions

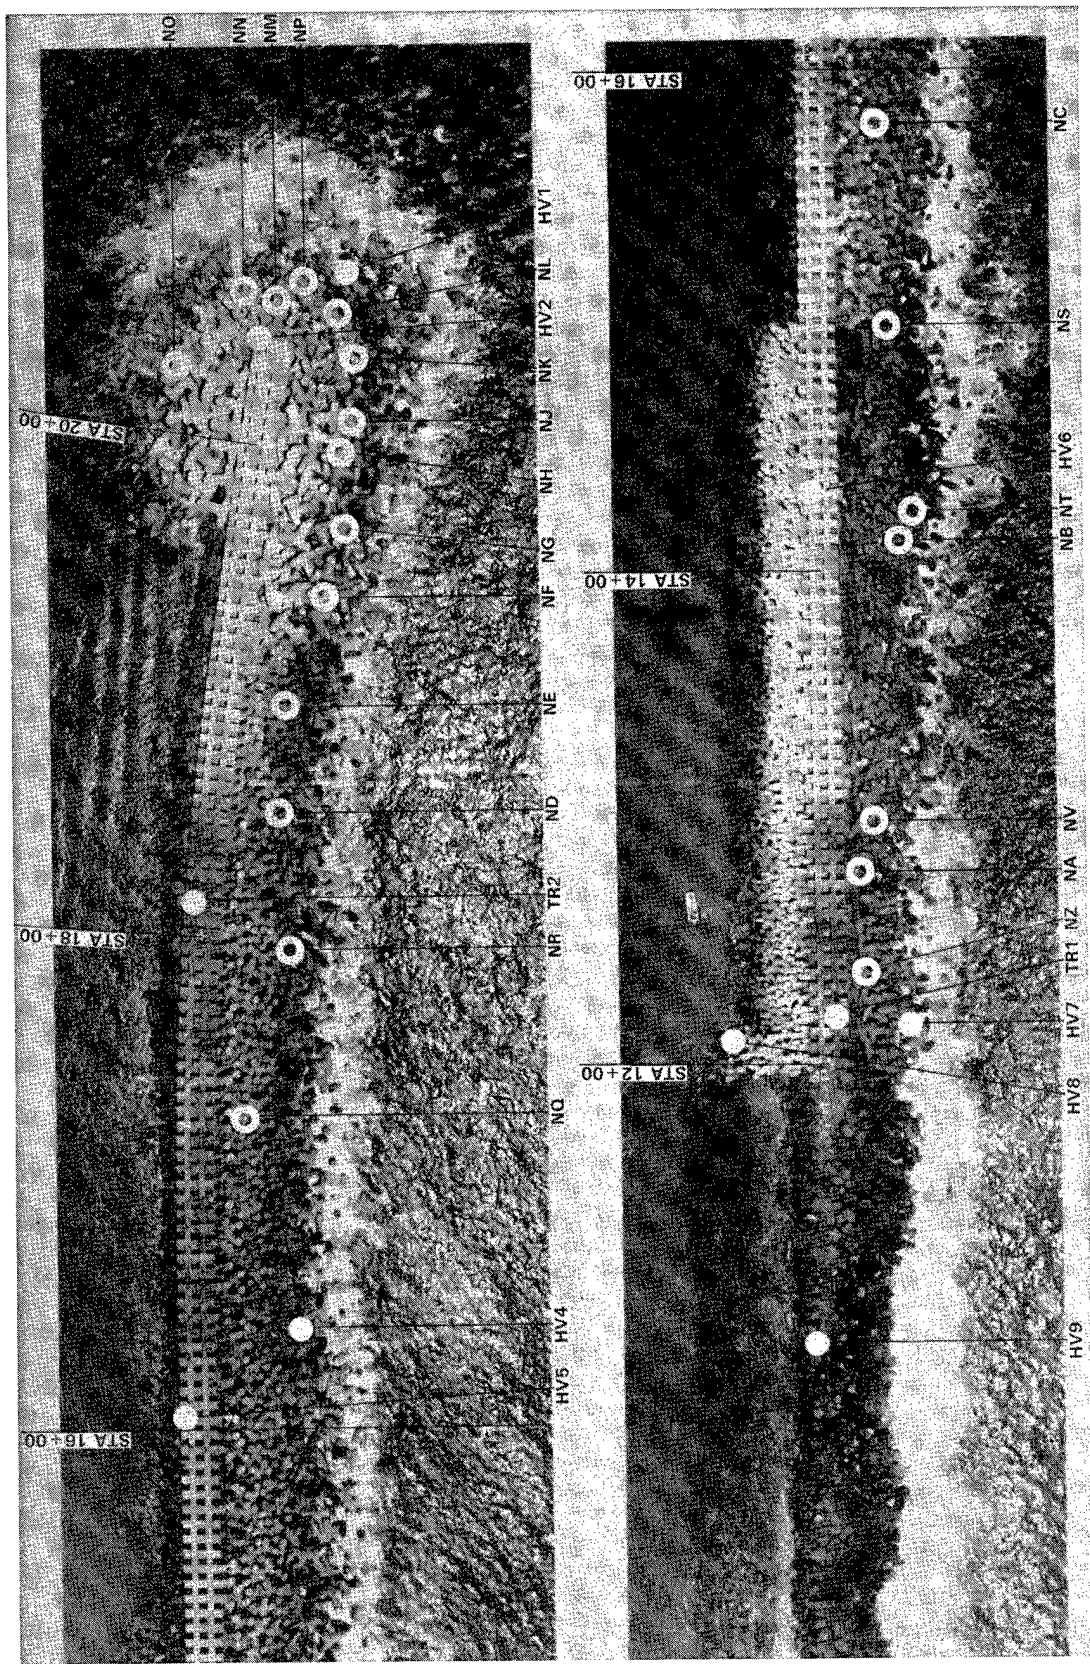
Figure 8. Locations of control points and targeted armor units on Nawiliwili breakwater

Control points were established on the breakwater to serve as control (both horizontal and vertical reference) for the ground-based survey work as well as the photogrammetric work. Ground surveys were initiated from known monuments on shore. Positions and elevations of the control points established on the structure are shown below and in Figure 8.

In addition, targets were established on selected concrete armor units to serve as a control to check the accuracy of the photogrammetric work. A total of 21 armor units were selected for targeting, 11 along the sea side of the breakwater trunk and 10 around the breakwater head. Along the trunk,

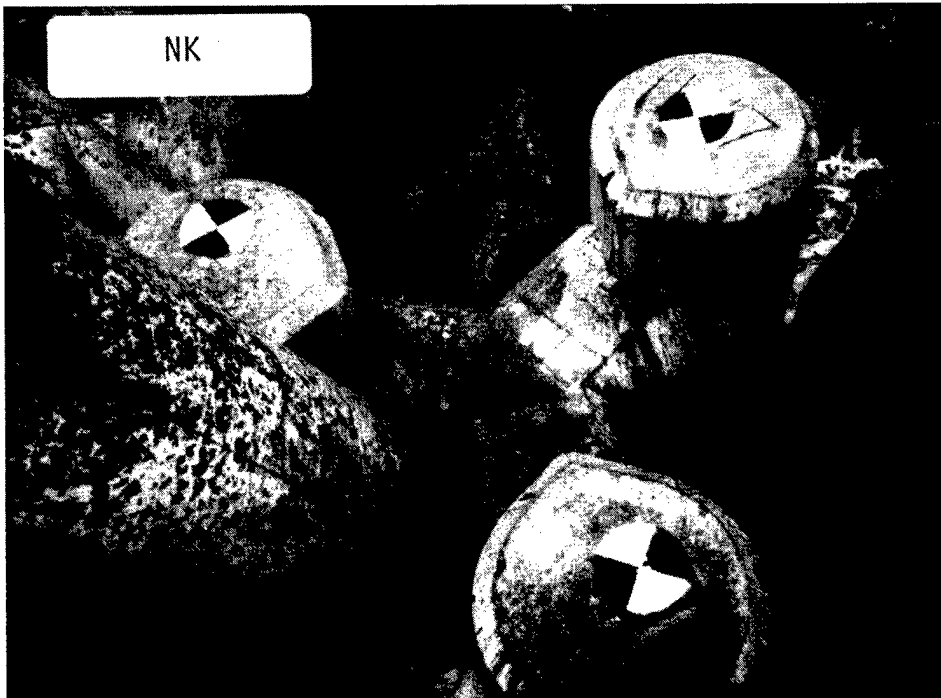
Figure 9. Example of a targeted 17.8-ton tri-bar

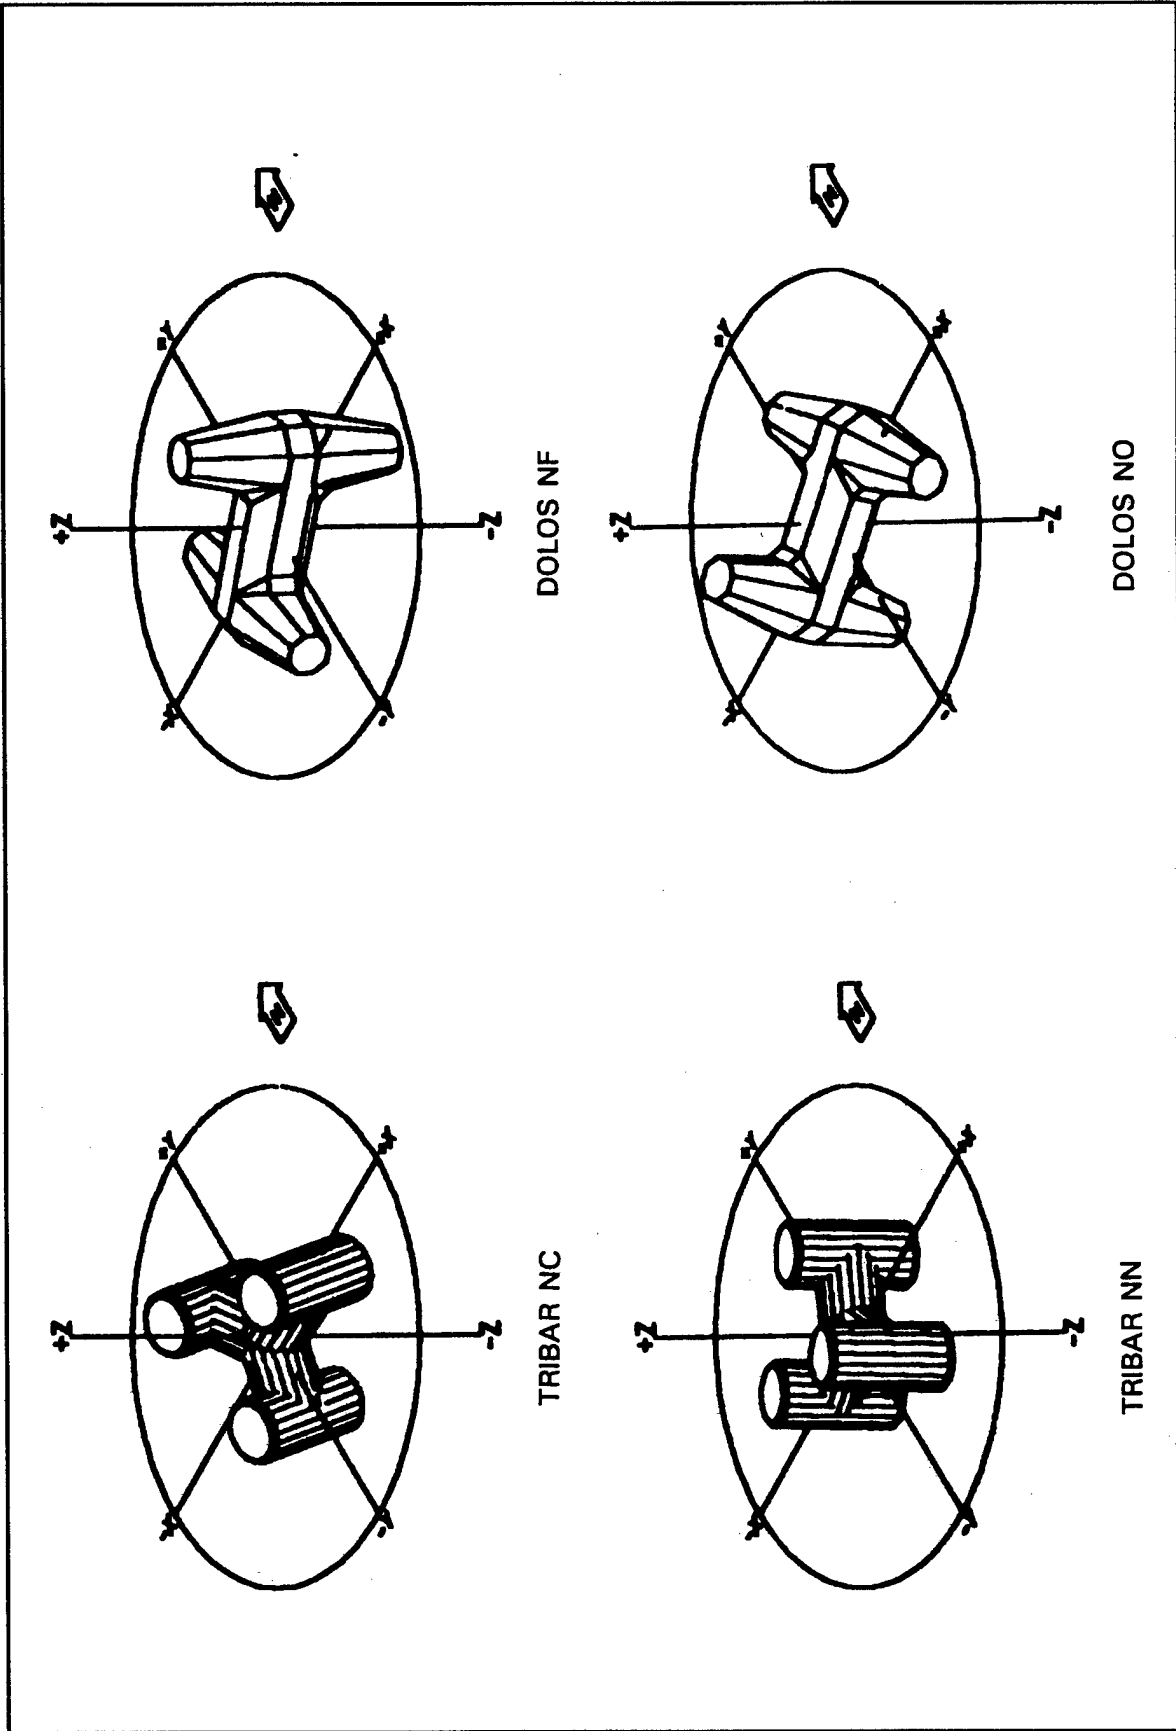
With the x, y, and z (easting, northing, and elevation) coordinates defined for each target on the various armor units, the centroid of each targeted armor unit was computed. In addition, the position of each armor unit relative to the x, y, and z axes was determined. Figure 13 shows the orientation of representative armor units to the three axes. The centroid of each targeted armor unit and each unit's orientation (rotation angle relative to x, y, and

Figure 13. Representative targeted armor unit positions relative to x, y, and z axes
